Martyn Peters
Consulting Structural Engineer Ltd

Barn at Pear Tree Cottage, Peterchurch

I write in response to the request for a report on the barn at Pear Tree Cottage that it is proposed to convert into a dwelling.

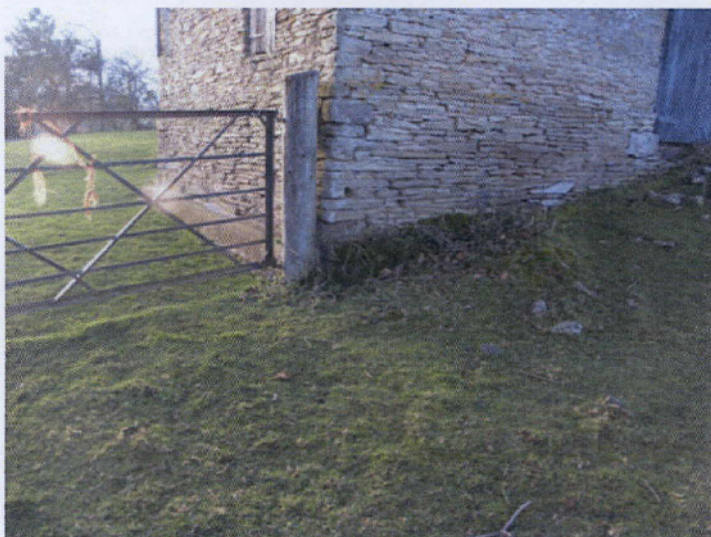
View of the east corner

Note the concrete facing at ground level across the gable.

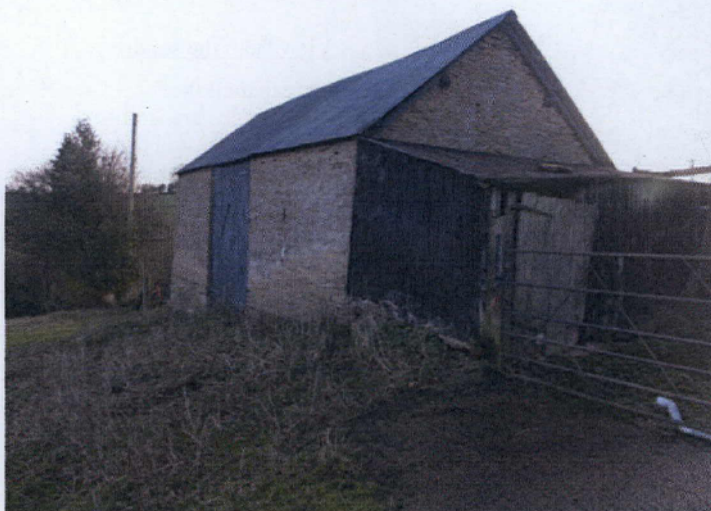
View from the north

Note - I have not reported on the lean to building on the north end.
