# 228 - BANK HOUSE

Structural Report -

15/06/2021

JAKE SMITH ENGINEERING

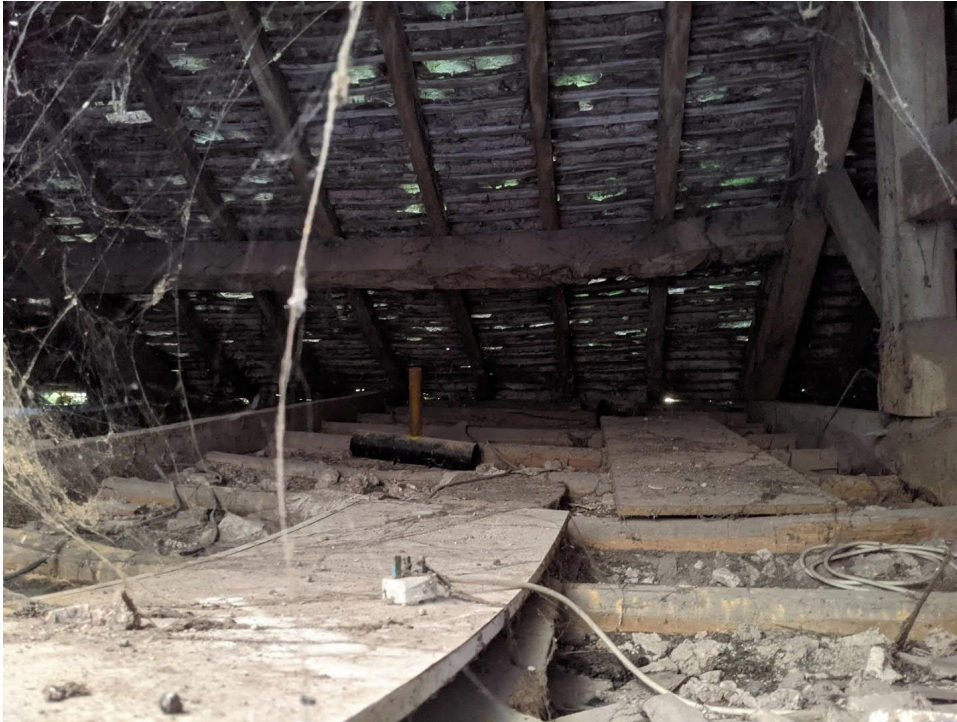
- 7.10. Many of the slates have failed and there are multiple areas of water ingress.

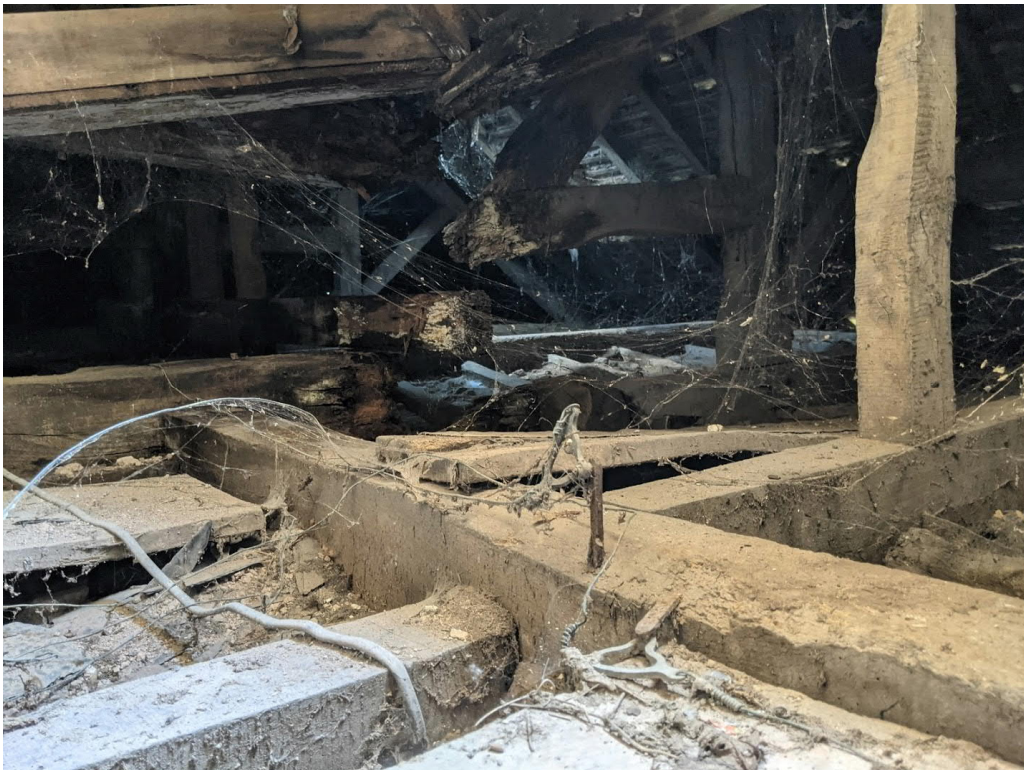
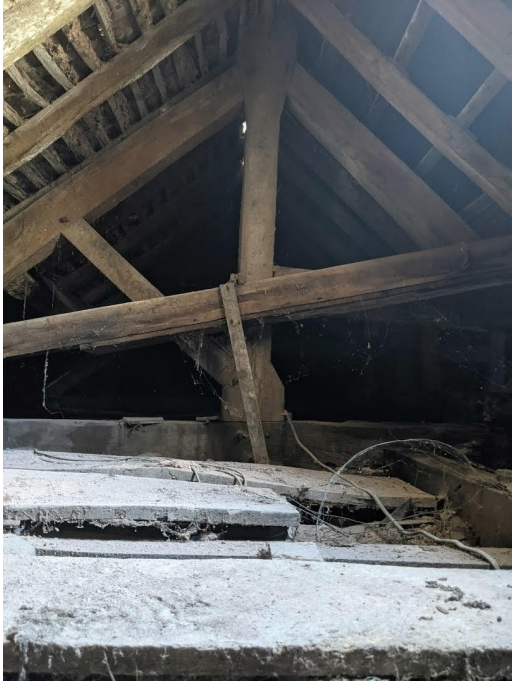
- 7.11. The Some of the roof timbers have rotted through completely leaving the roof in a condition of partial collapse.

- 7.12. Due to the failure of some key structural elements, the roof structure should be treated as unstable as it has the potential to collapse. The most severe failure is under the central valley as would be expected. Propping could provide a degree of support but we believe it is more likely to provide a misplaced sense of security.

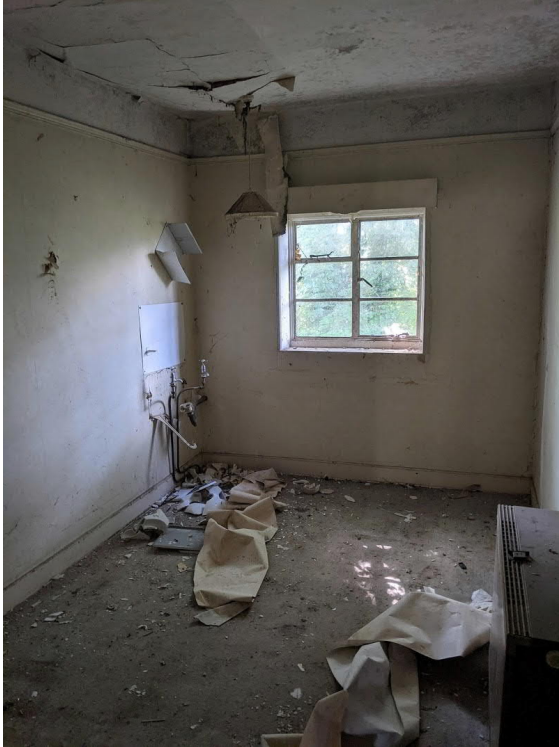
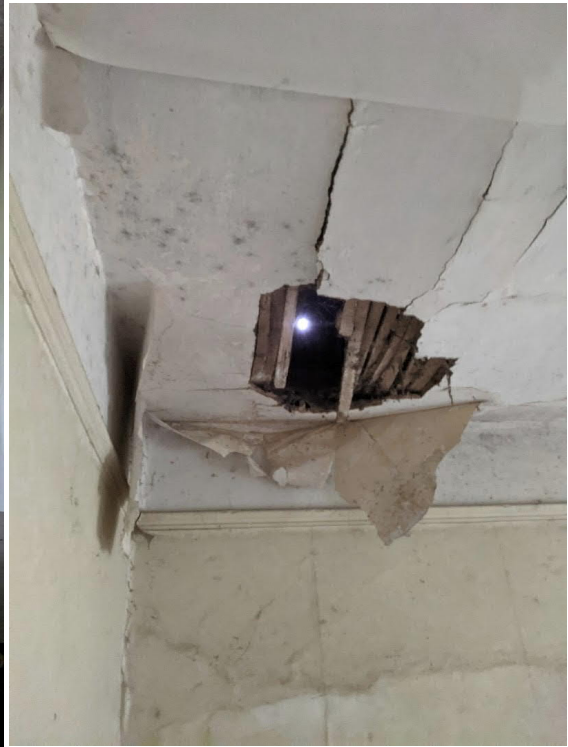
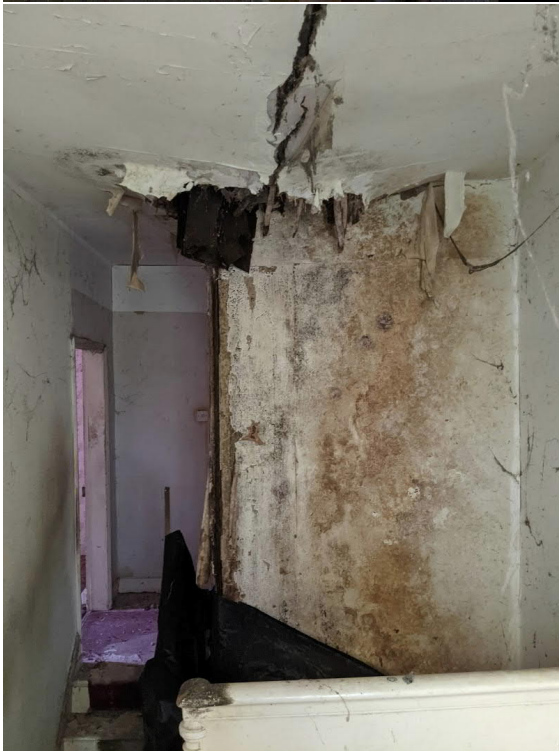
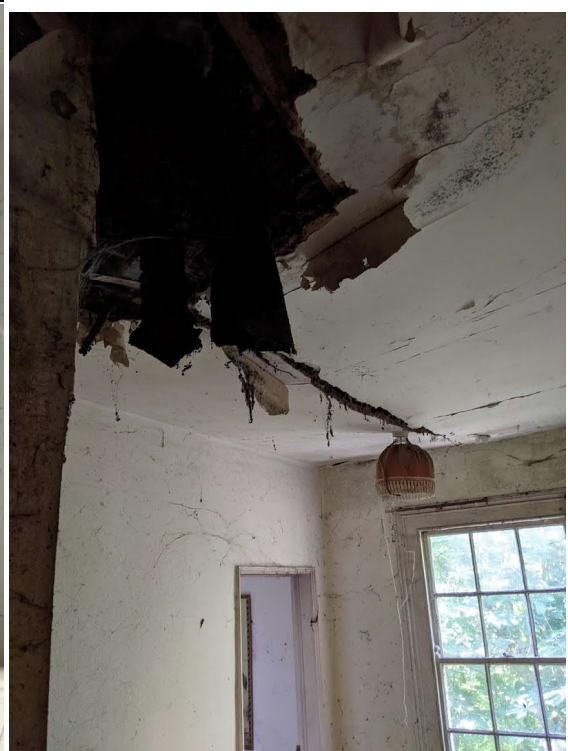
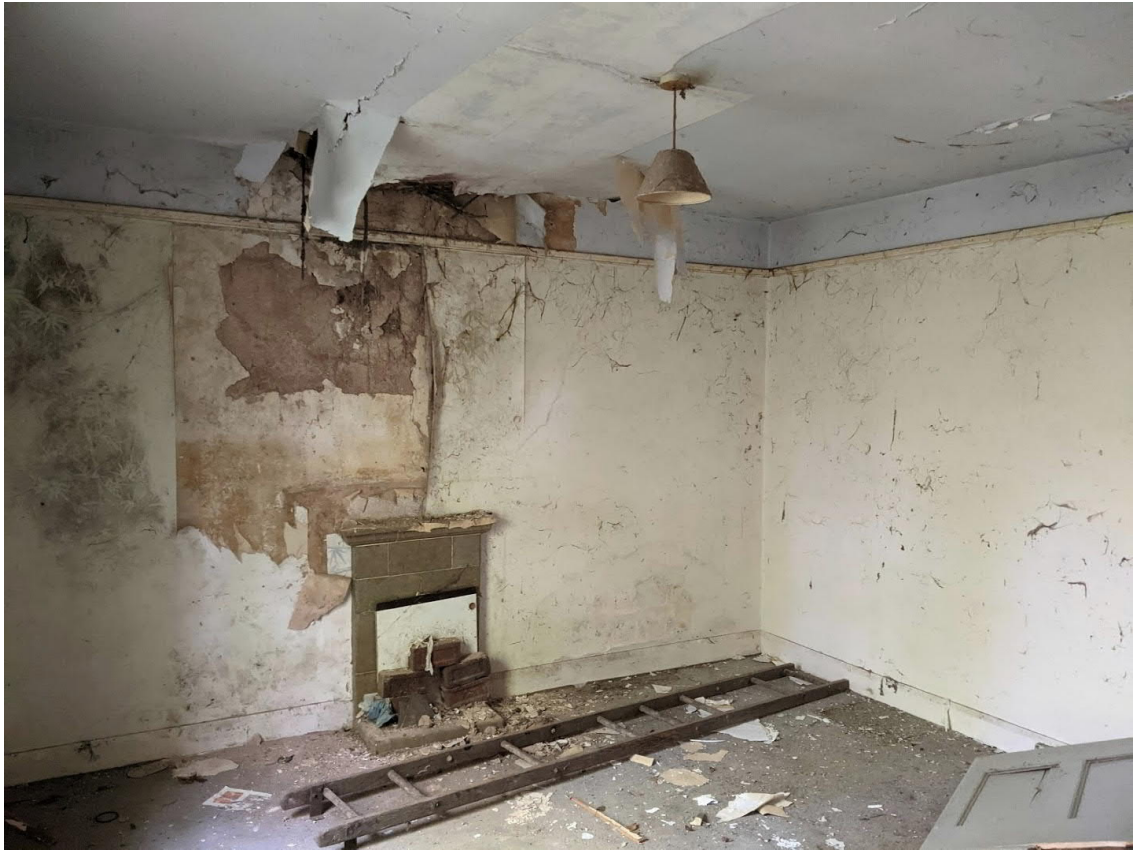
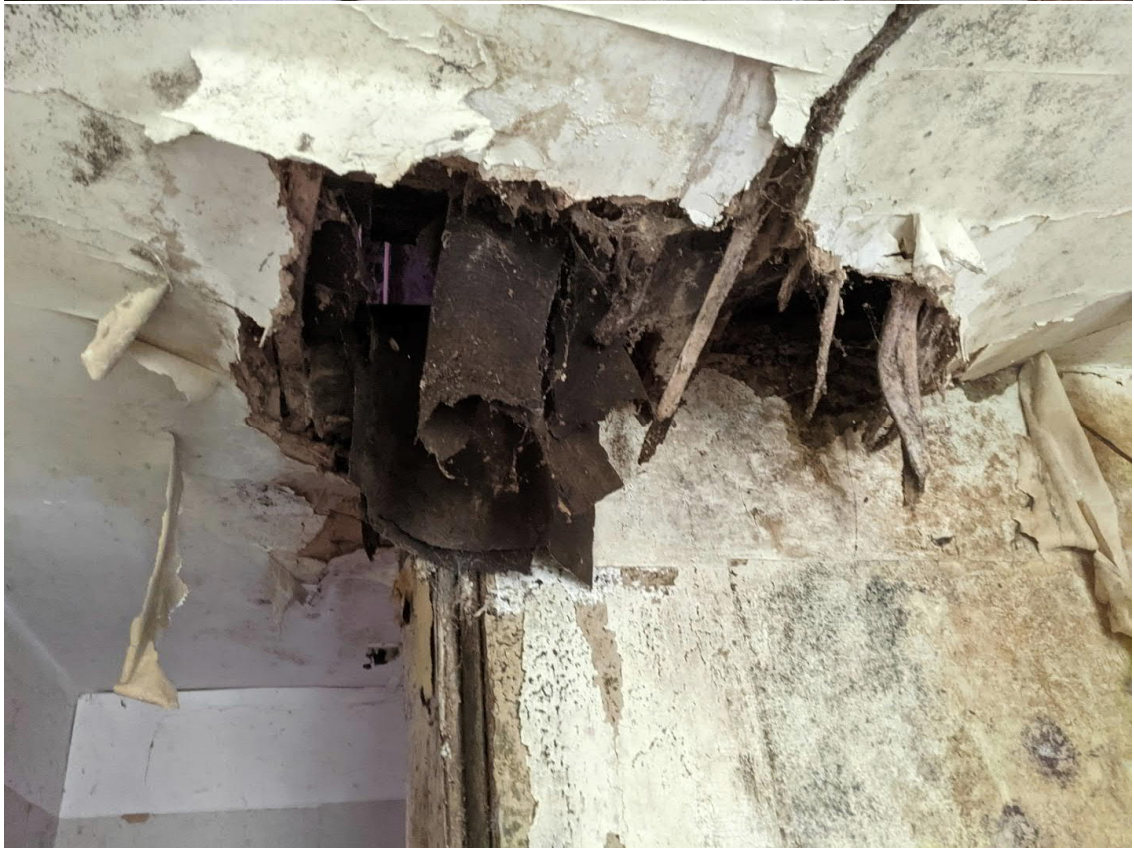
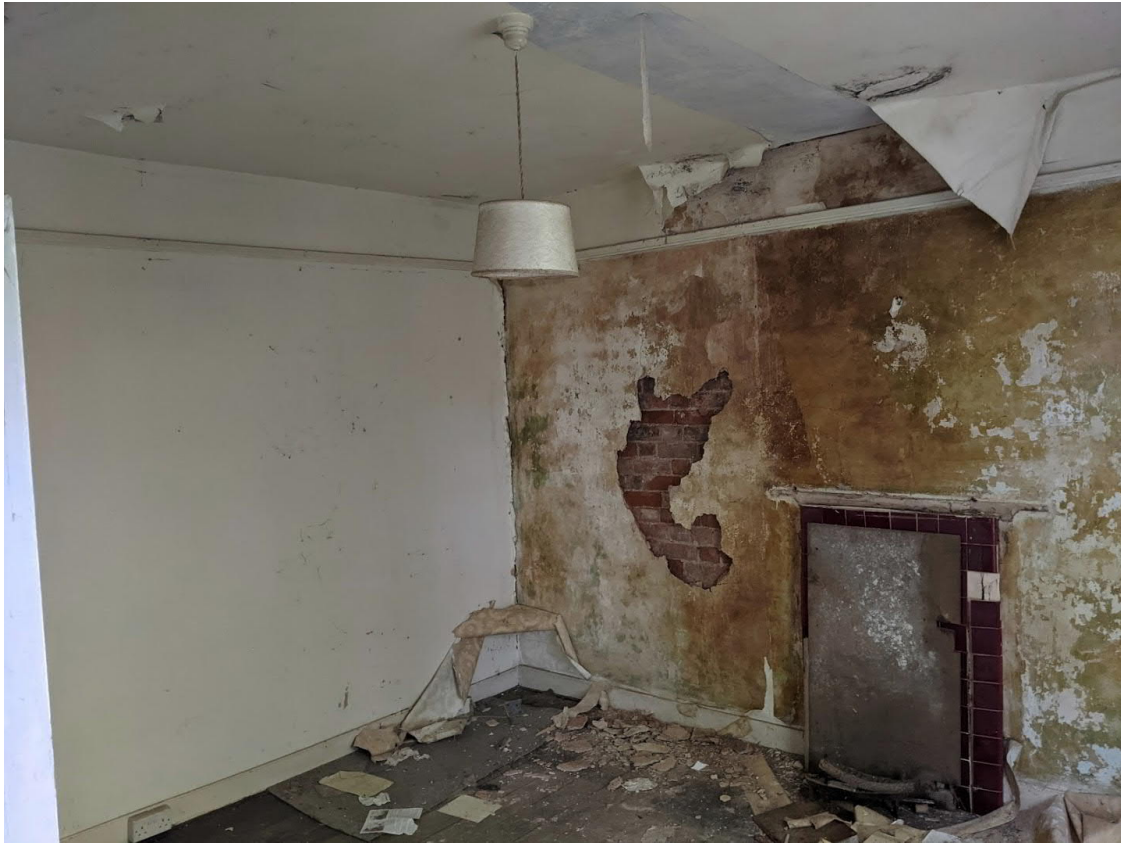
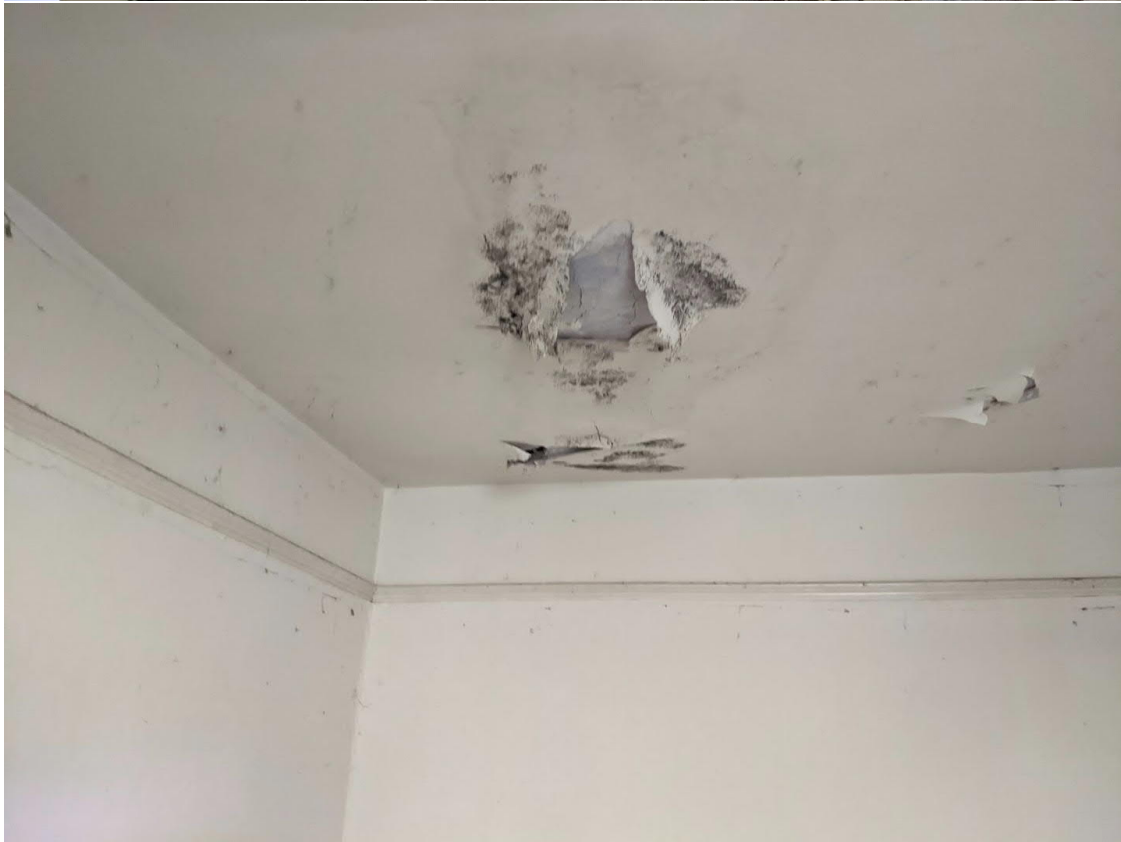
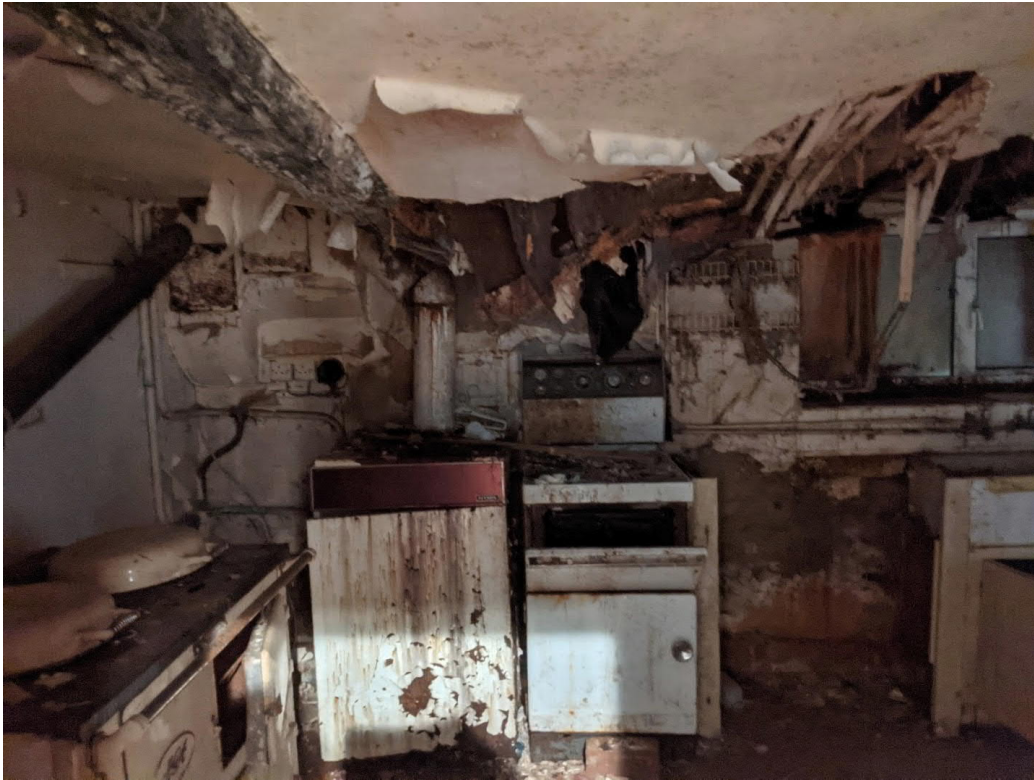
7.13. The ceiling under the roof structure has also failed in most rooms due to water ingress.

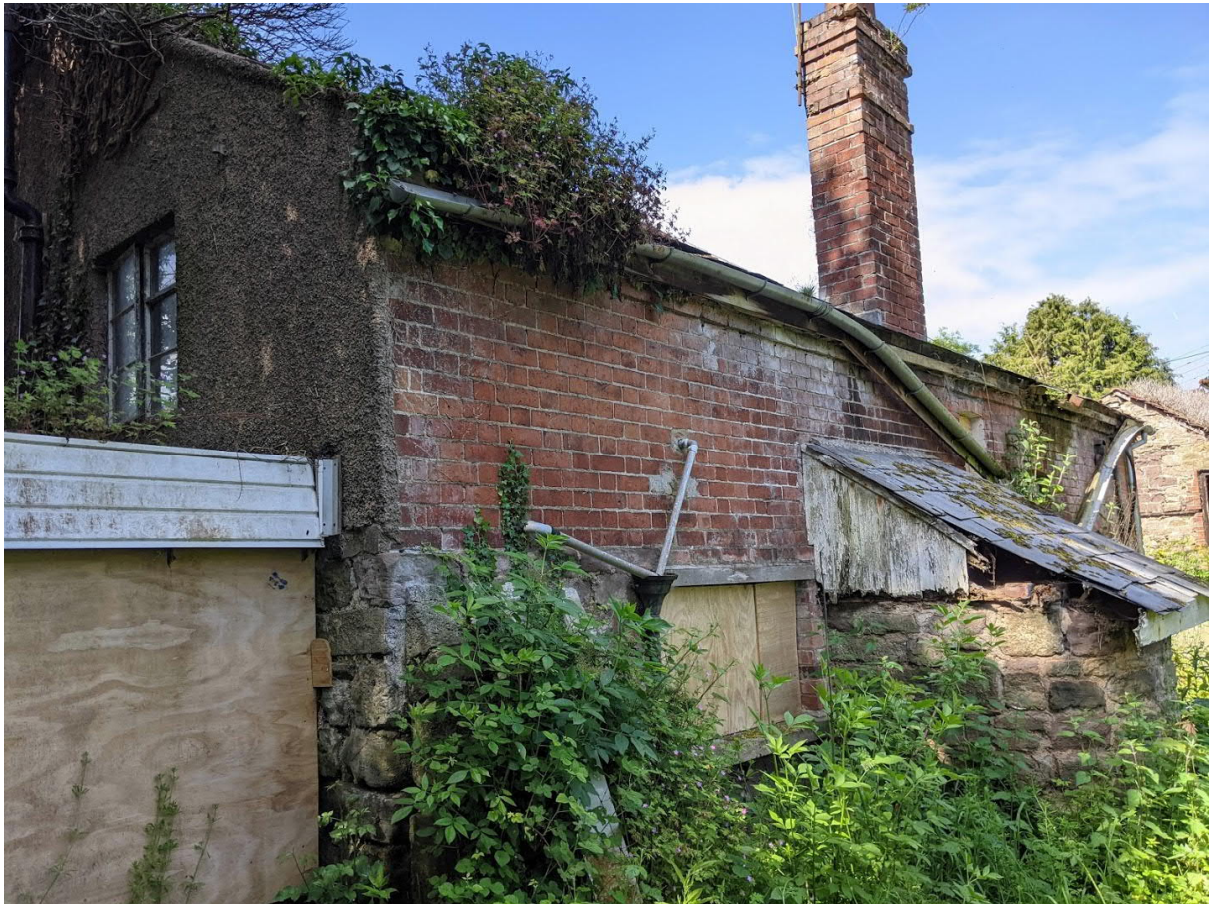
### North Elevation

- 7.15. The brickwork and stonework at the rear is in fair condition. Some plant growth is evident which will be causing damage and the brick chimney is leaning.

- 7.16. There is no significant bow or lean to this wall.

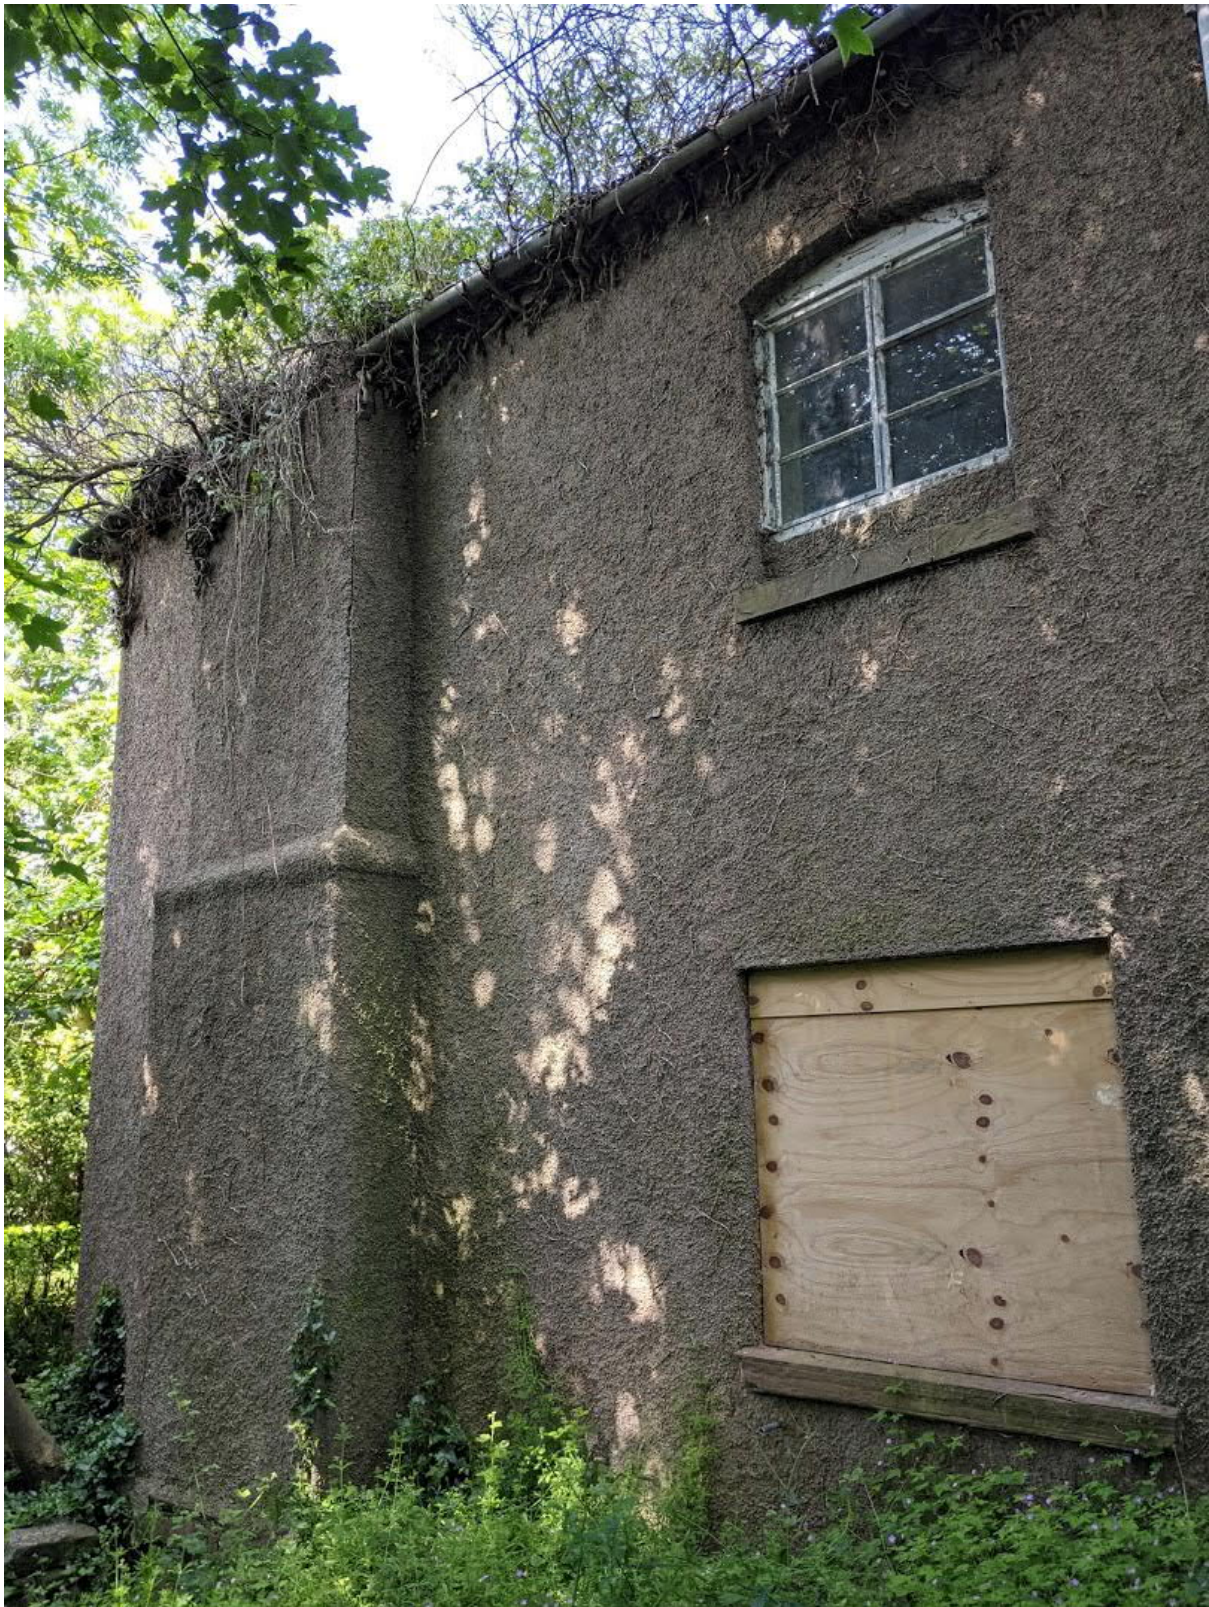
East Elevation

7.17. The Eastern elevation has been rendered. The render cover seems relatively good with only a few visible cracks. There is extensive ivy growth visible at the eaves which has damaged the gutters and roof.

7.18. There is no significant bow or lean to this wall.

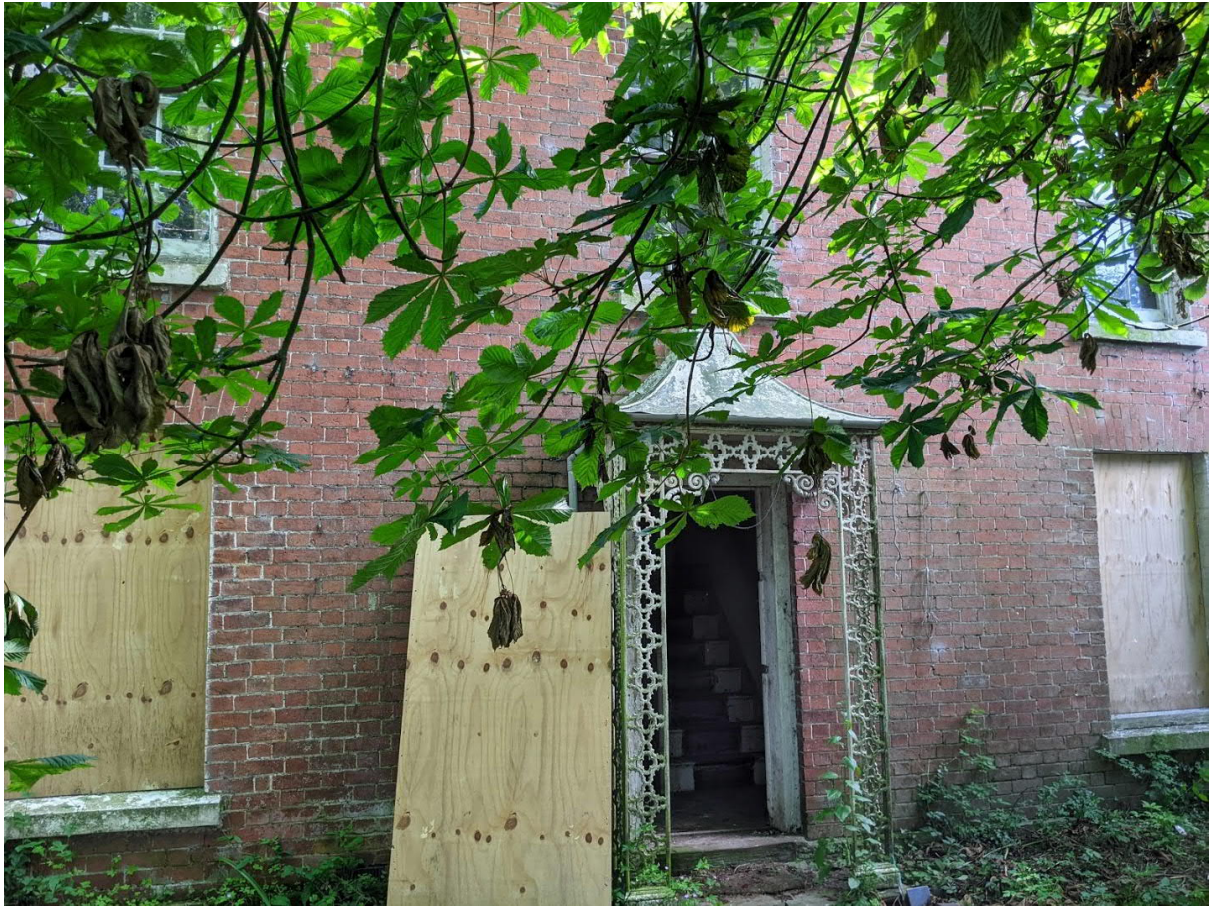
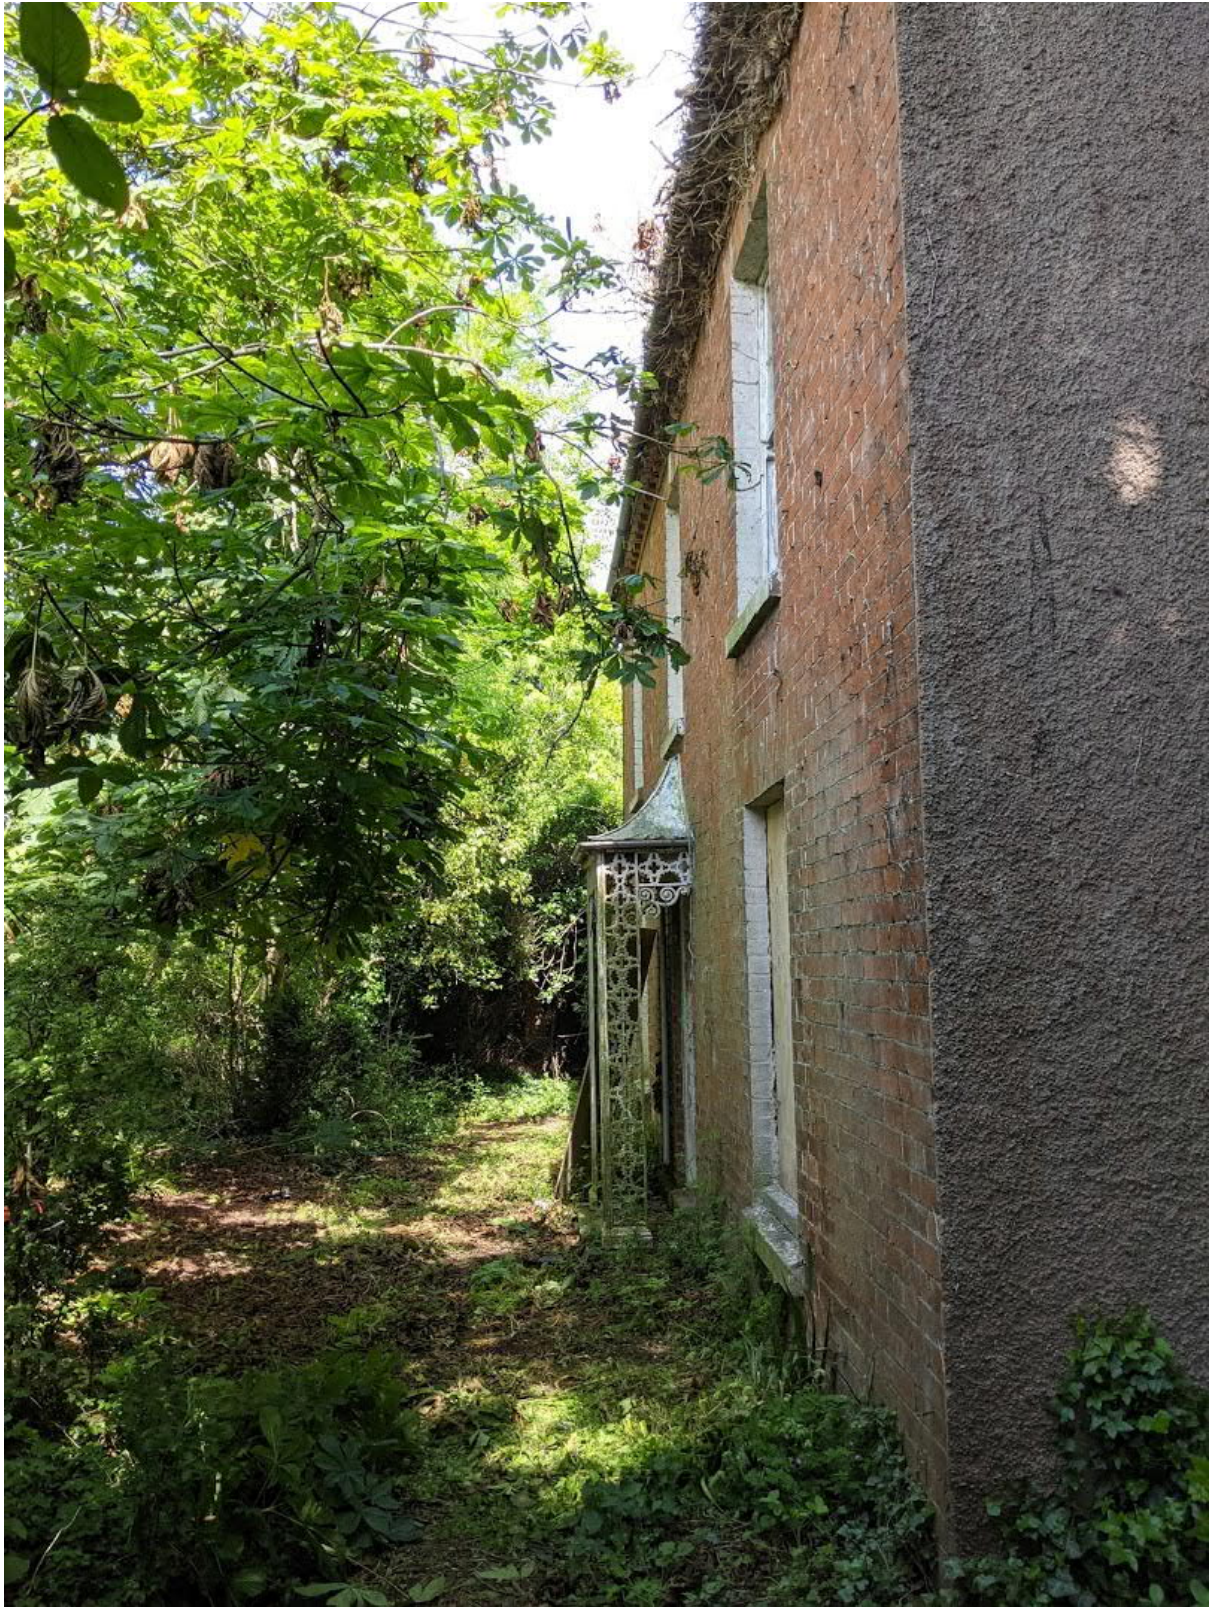
South Elevation

7.20. The brickwork front is in fair condition. Some plant growth is evident which will be causing damage. There is extensive ivy growth visible at the eaves which has damaged the gutters and roof.

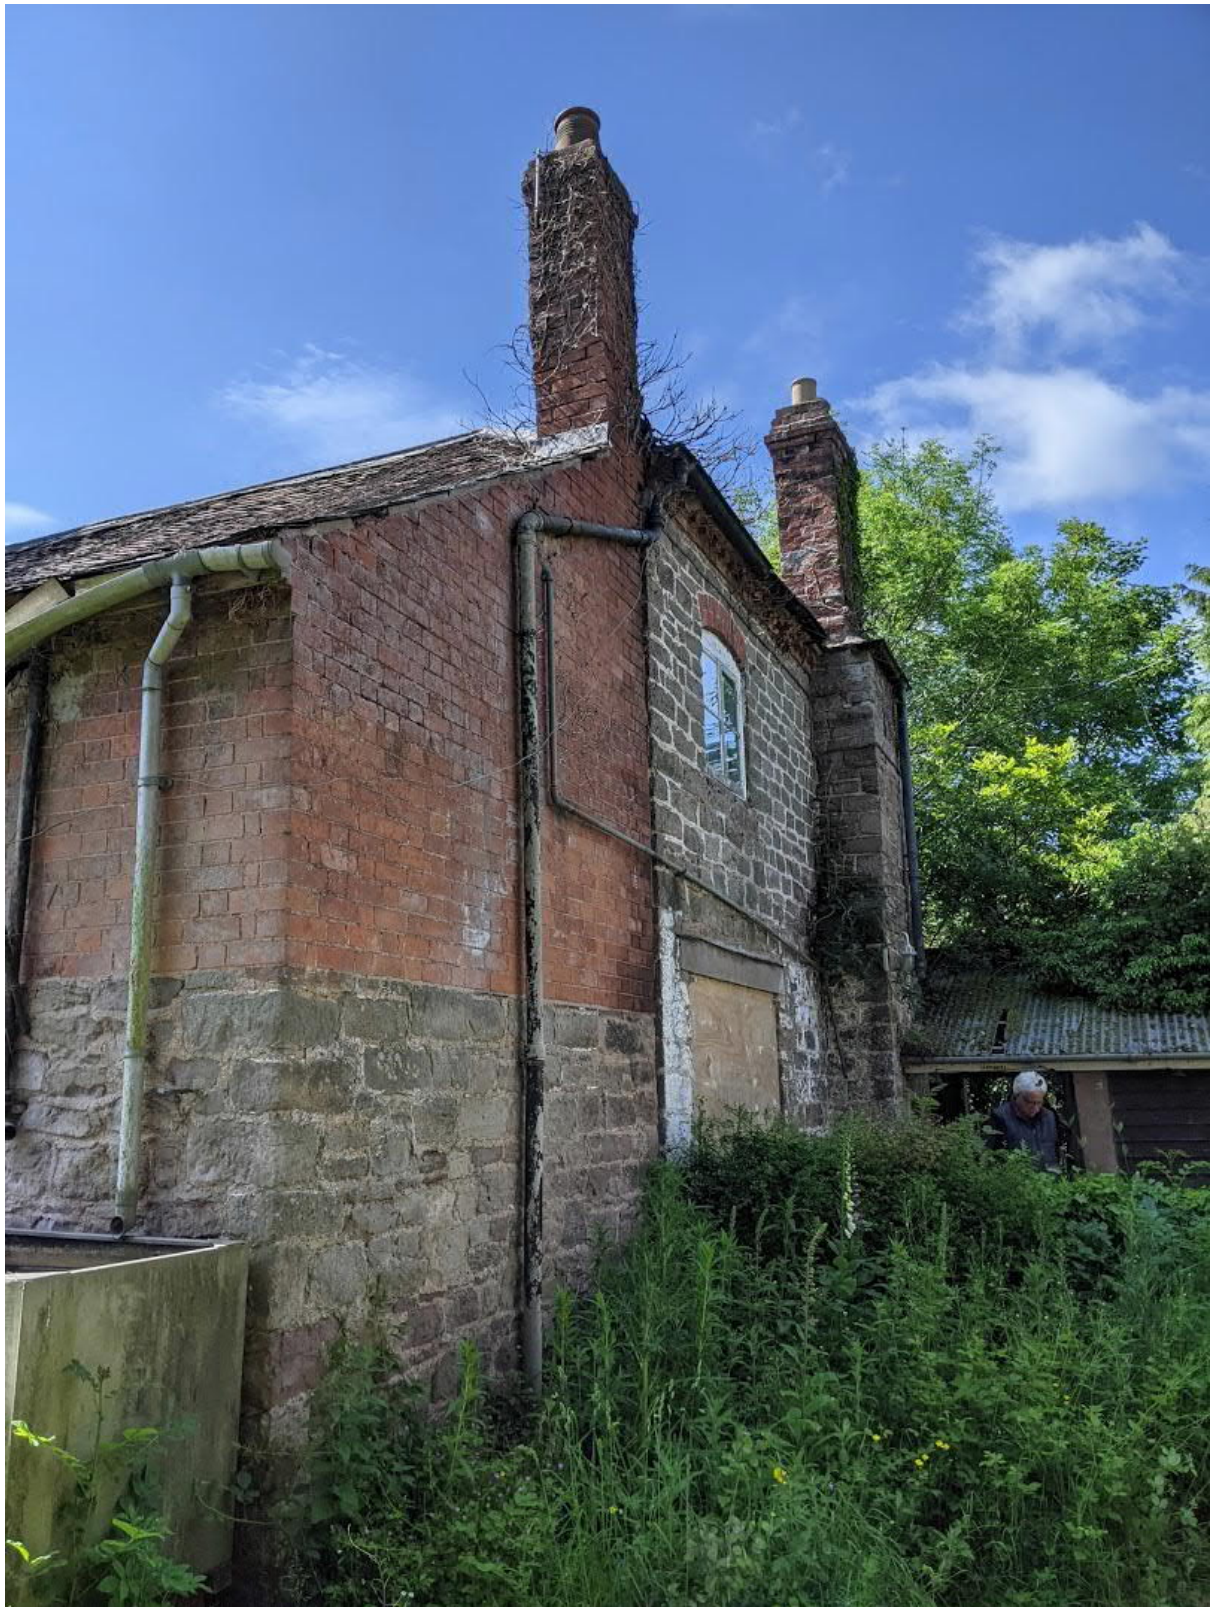
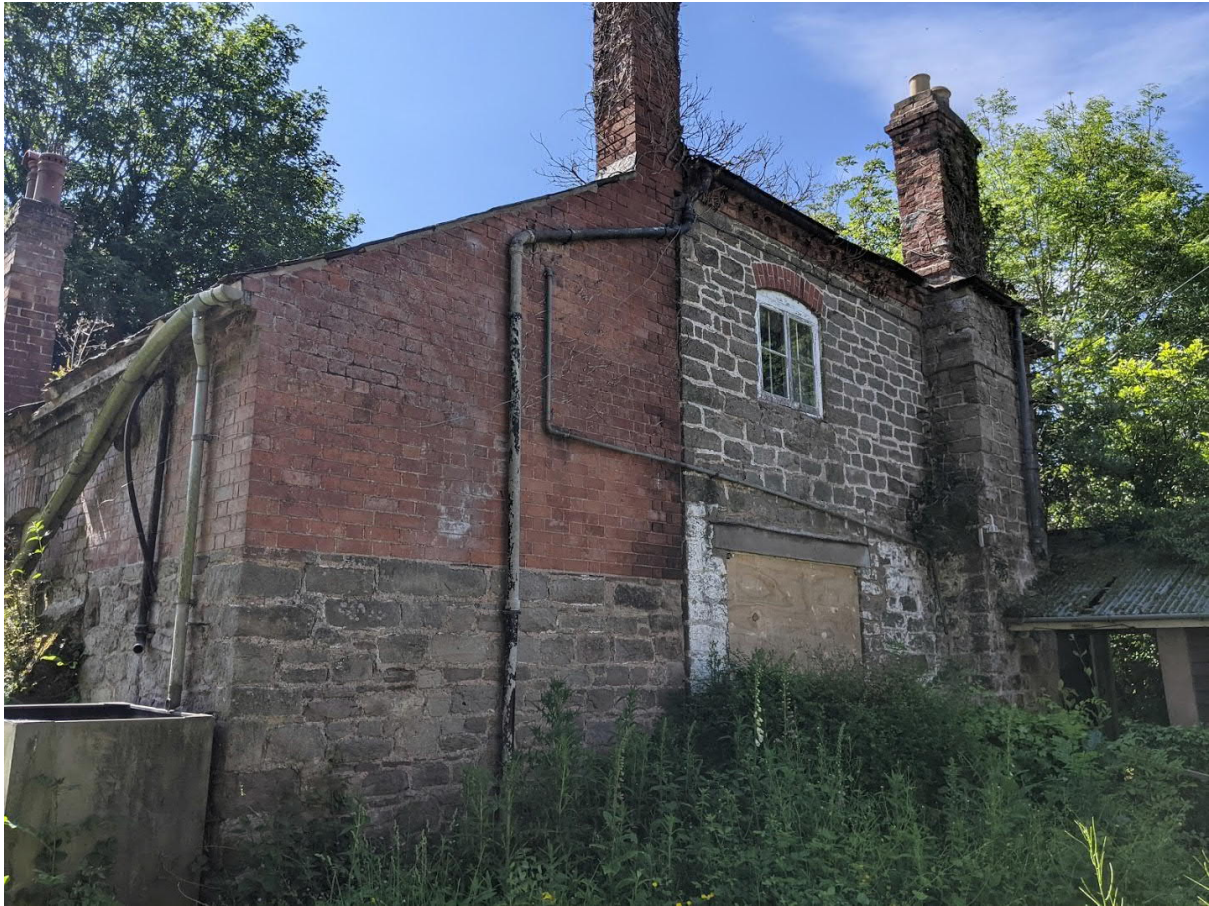
West Elevation

7.23. The west elevation has the most varied stone condition. It appears that the stonework and masonry is of varying age suggesting that the structure has been historically altered.

- 7.24. Some plant growth is evident which will be causing damage. The northerly brick chimney is leaning and the southerly one is showing some weathering to the brickwork.
- 7.25. There is no significant bow or lean to this wall.

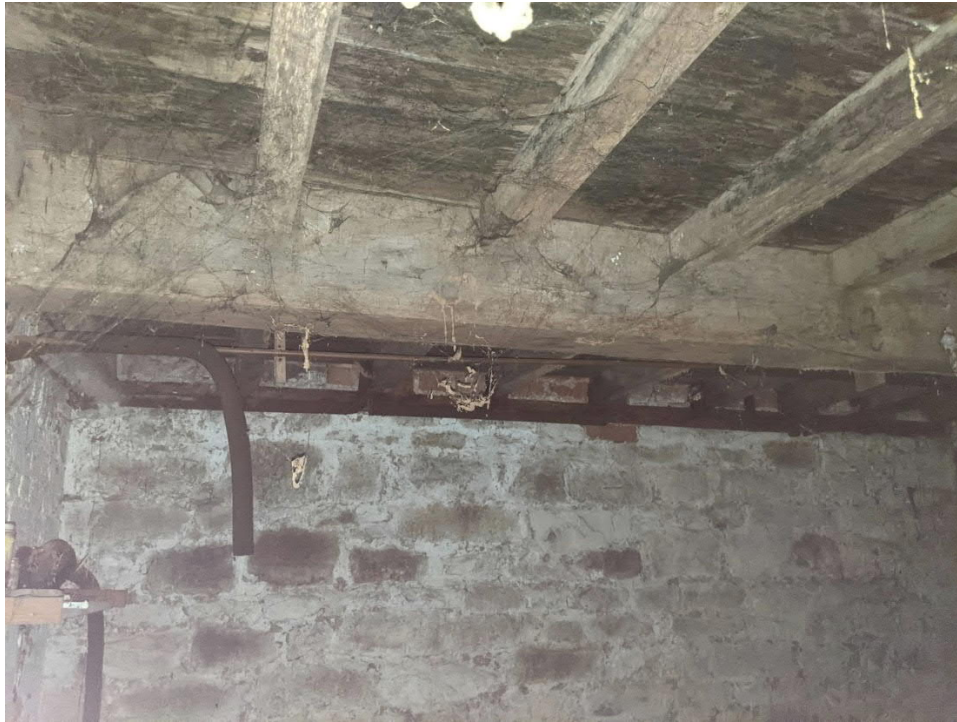
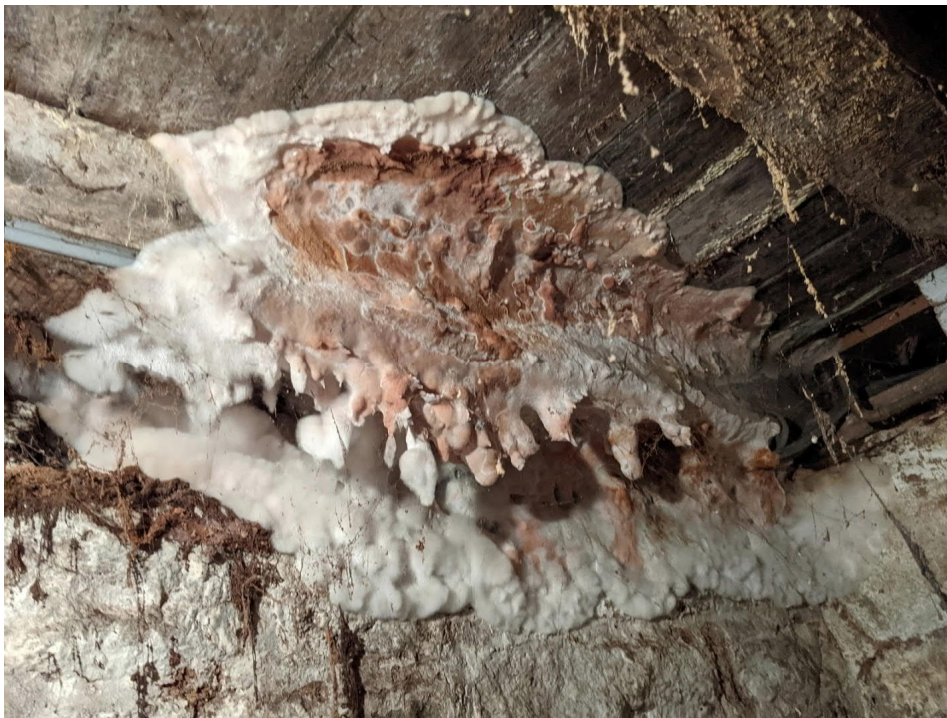
7.27. The floor is supported by a series of oak beams and joists. These are in varying condition as the humidity is very high. Water from the roof is coming through the building to the basement. Whilst some beams may be salvageable, there is quite impressive mould growth on some of the beams.

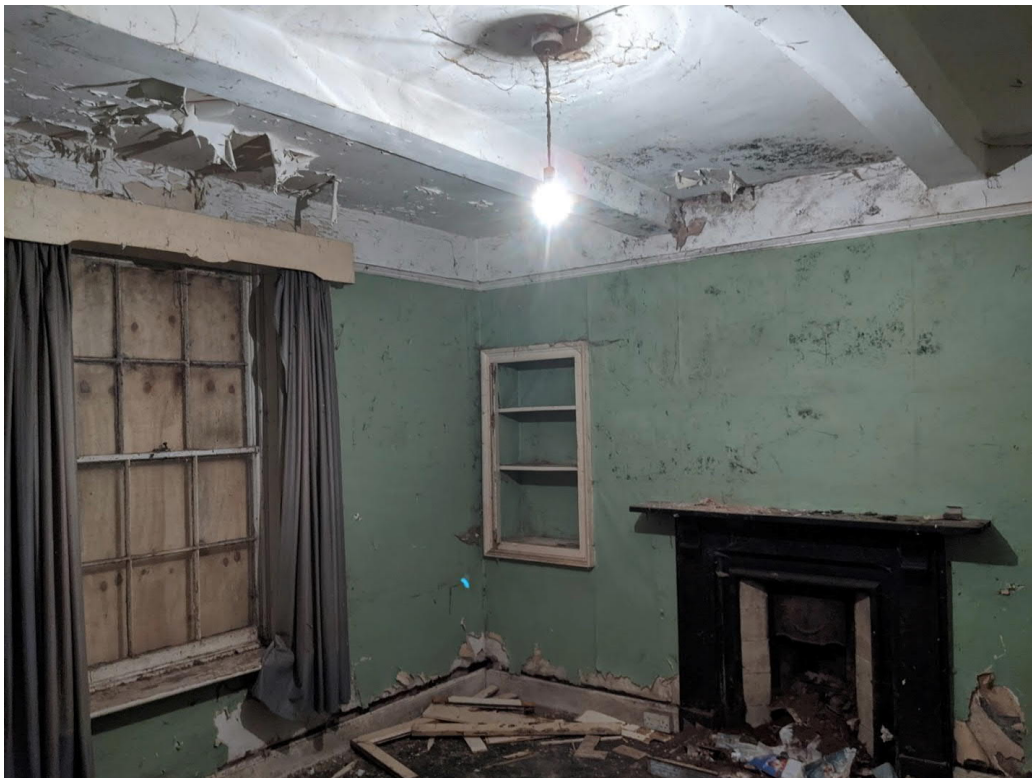
- 7.28. The ground floor is suspended over the southern side of the structure and ground bearing on the norther side under what is assumed to be a later extension.
- 7.29. The ground floor feels solid under foot for the most part but the inspection of the basement timbers suggests significant decay.
- 7.30. The internal fabric of the building is dilapidated having suffered prolonged neglect allowing ingress of weather.

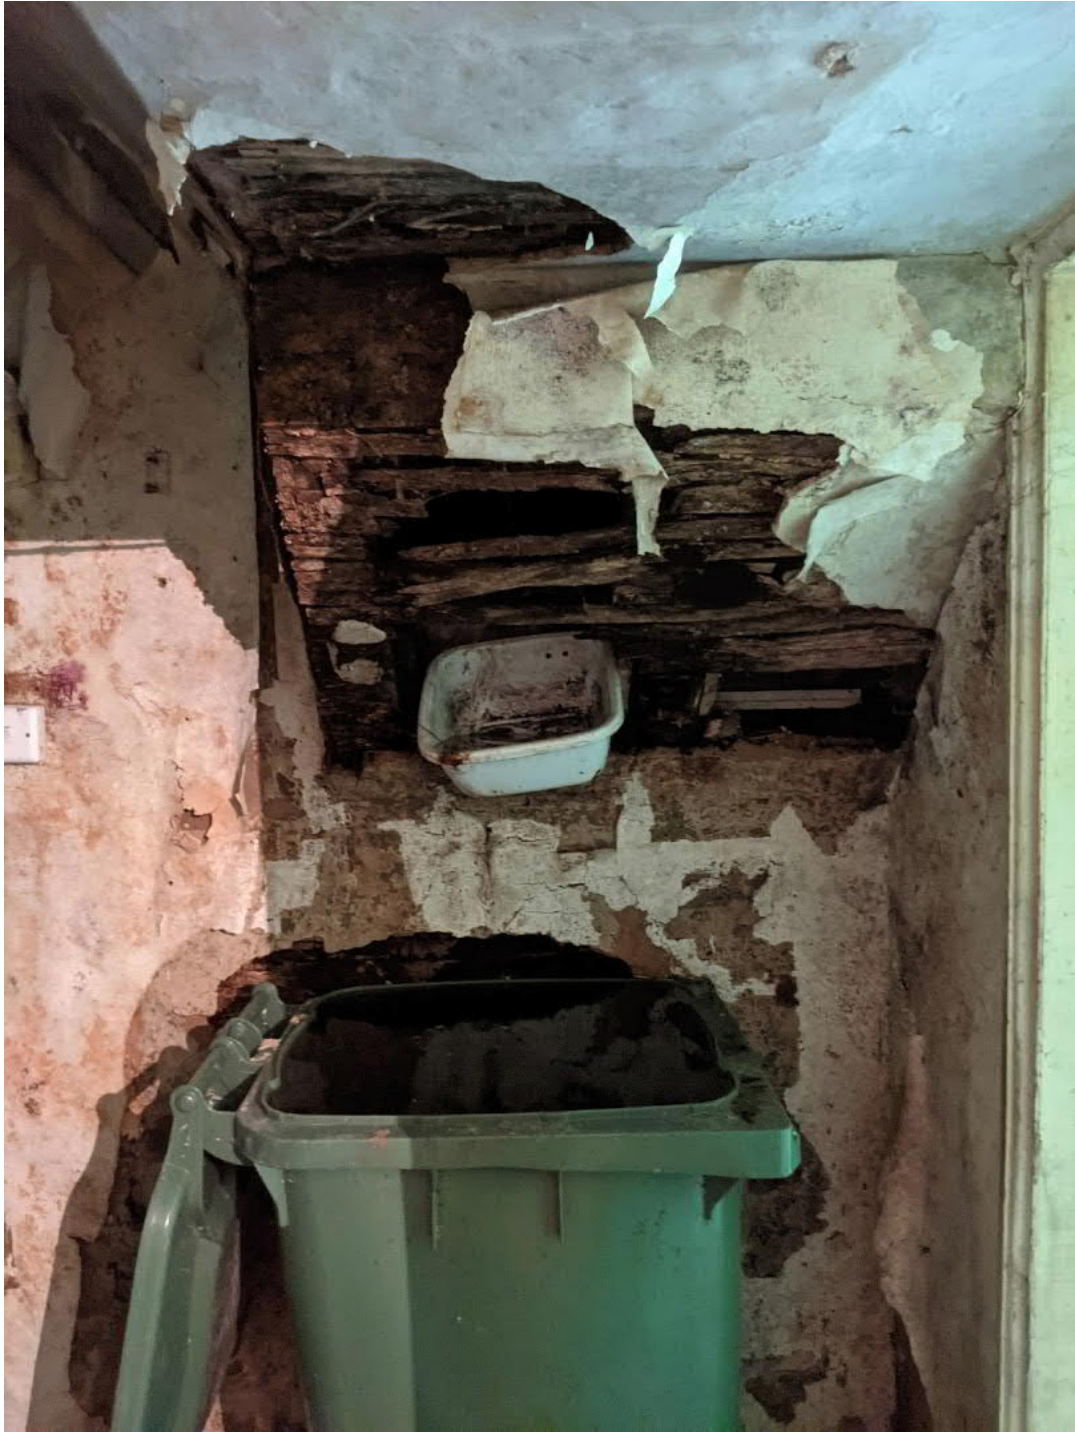
- 7.31. The collapse of the central roof has led to a significant and continuous ingress of water down the central stairs. This has led to significant damage to the stairs and surrounding structure.

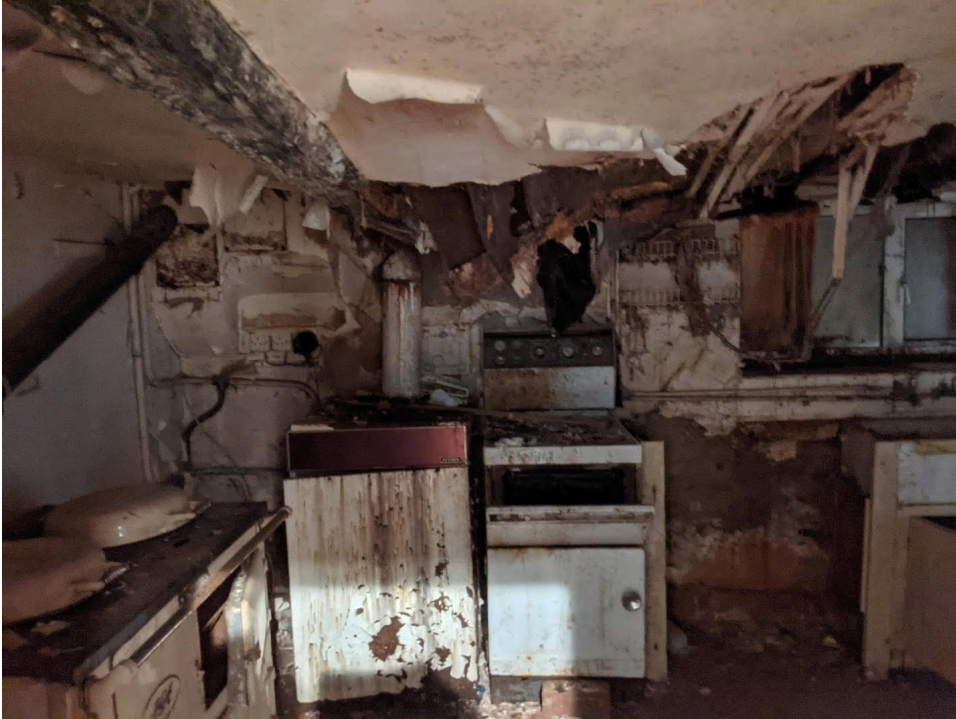
- 7.32. The most significant structural failure on the ground floor is the collapse of the first floor at the rear of the property above the kitchen. A beam (or number of beams) has failed causing the floor to collapse over the kitchen.

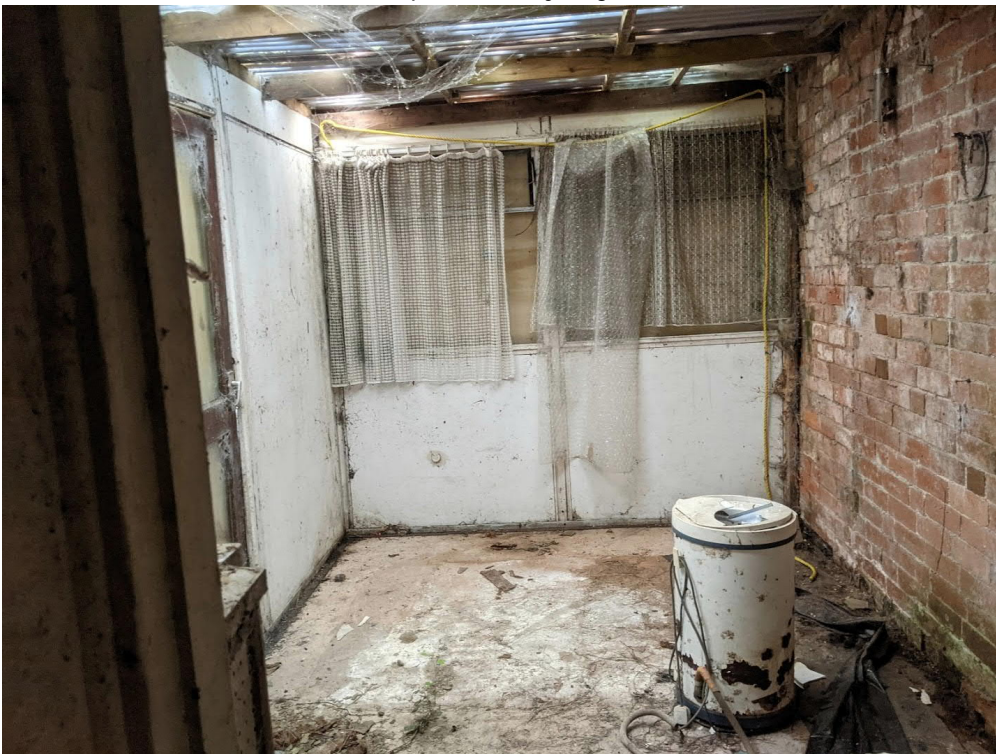
- 7.33. There is a small lean-to extension at the rear off the kitchen with a polycarbonate roof. Again, the structural fabric has been compromised by neglect.
