# 228 - BANK HOUSE

Structural Report -

15/06/2021

JAKE SMITH ENGINEERING

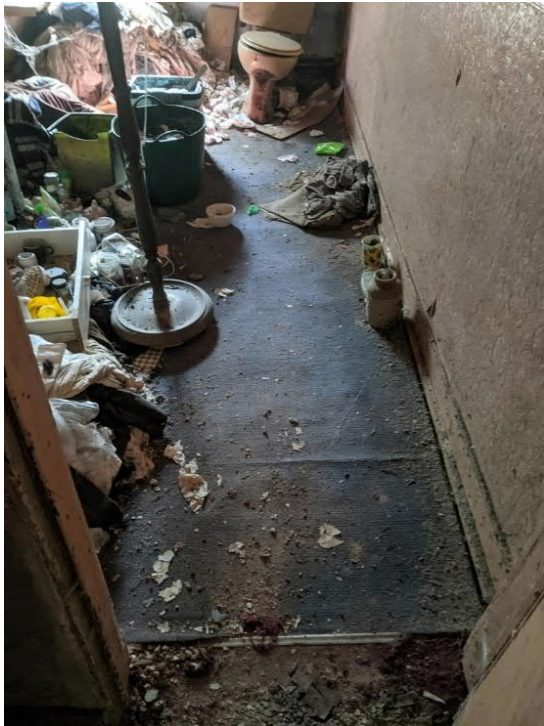
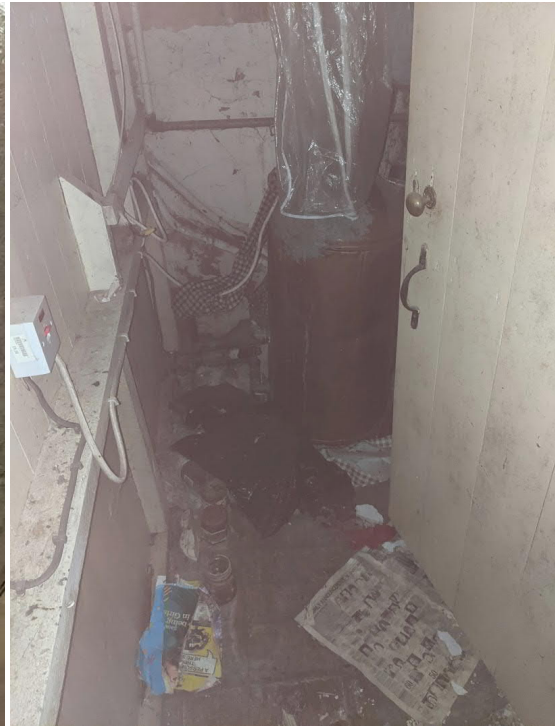
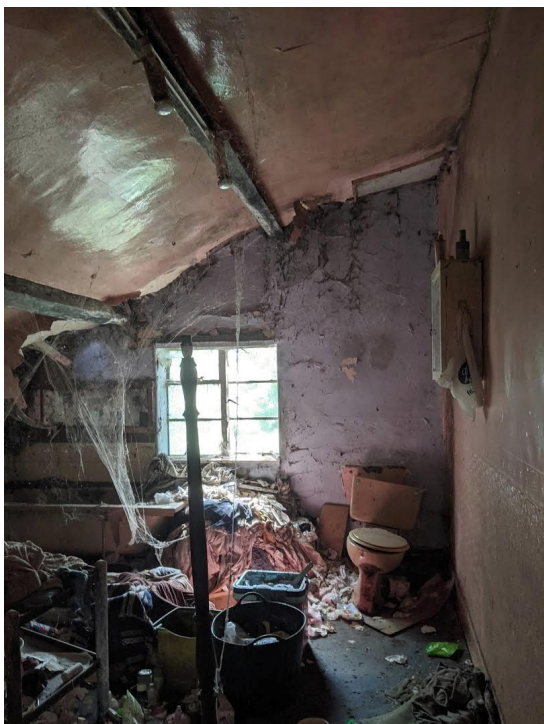
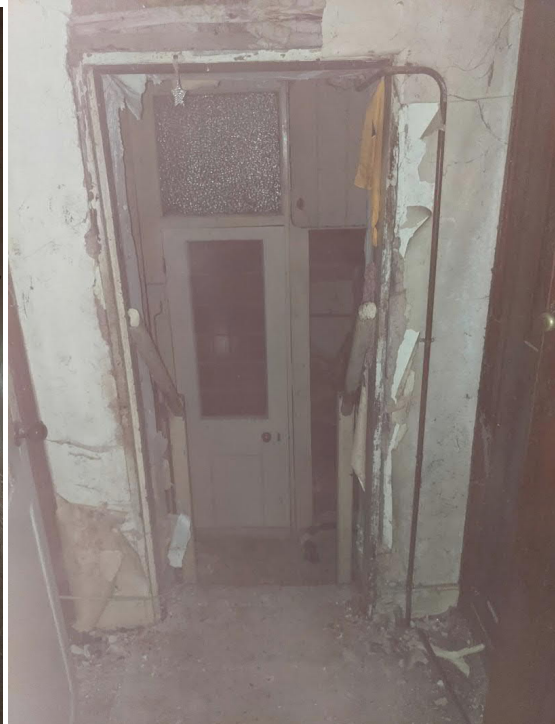
- 7.34. The first floor is a timber floor supported directly off the masonry walls and beams below. The first floor is very dilapidated. The humidity is high and water has been able to enter the rooms from the failed roof (see 7.13).
- 7.35. The floor in the north side of the building has collapsed into the kitchen below. This is likely due to the failure of the roof above coupled with water leaks from the domestic supply.

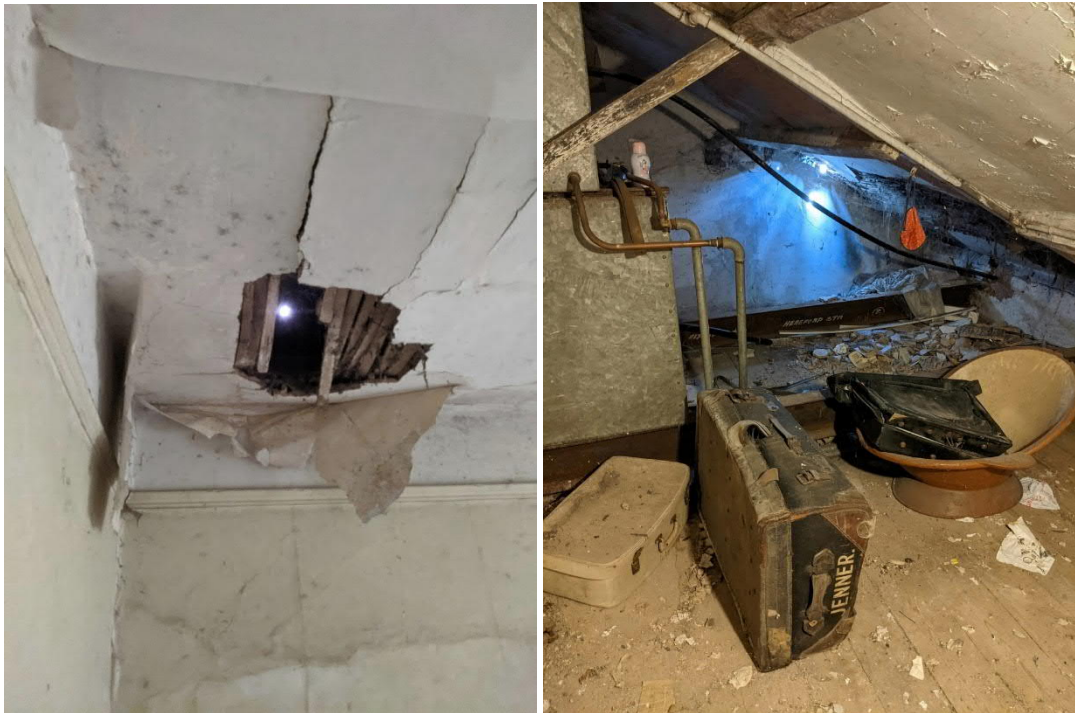
- 7.36. Daylight can be seen directly from some of the first floor rooms through holes in the ceiling and roof above

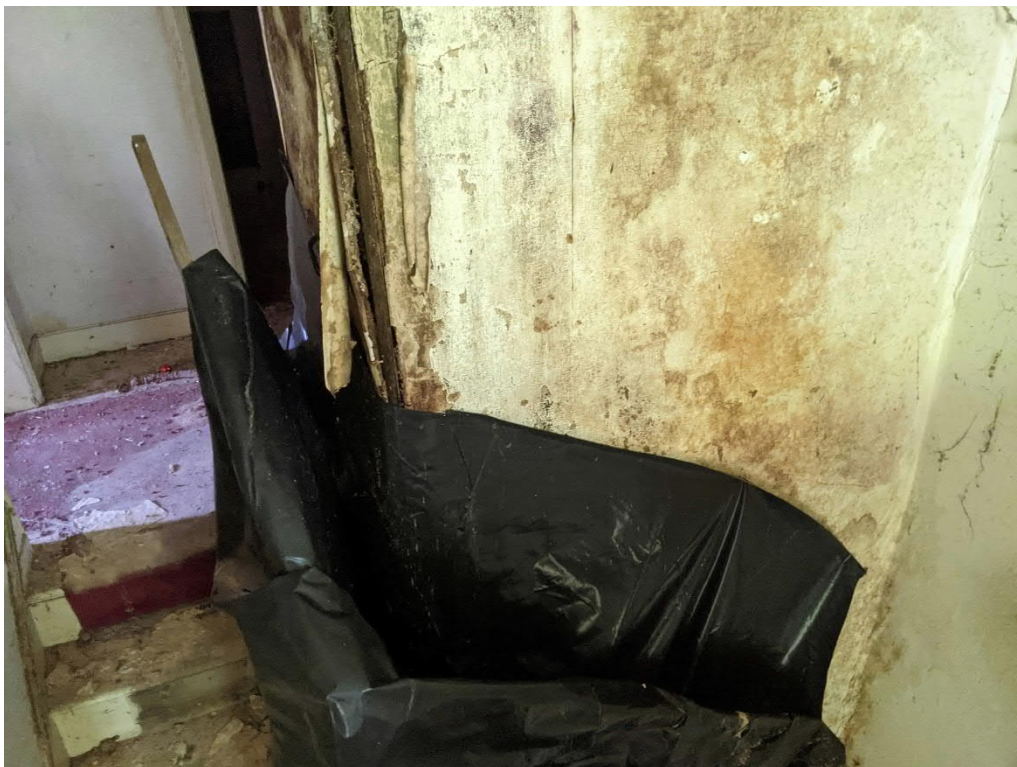
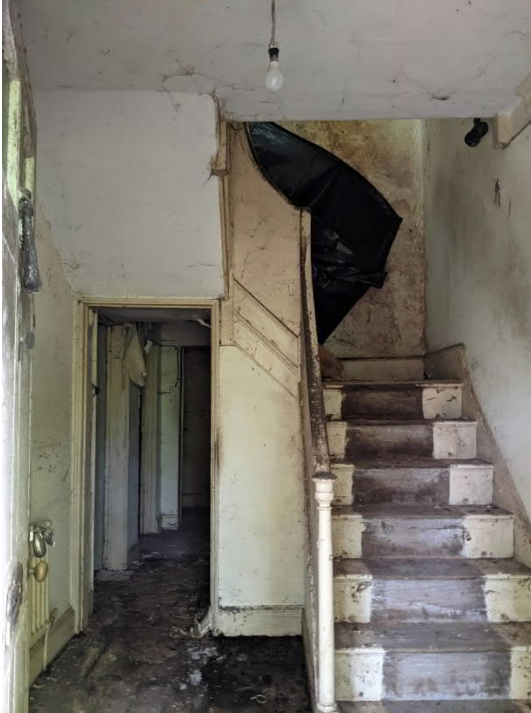
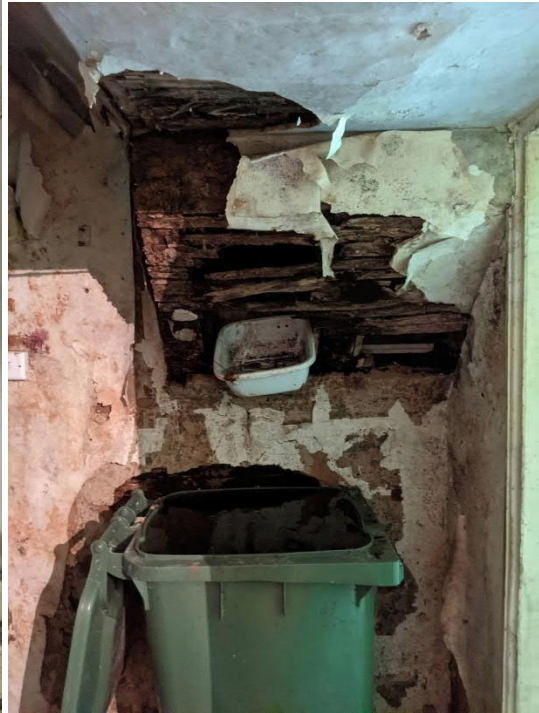
- 7.37. The stairs are in a poor state of repair as explained previously. There is a make shift gutter filling a wheelie bin fashioned around the stairs due to the volume of water being directed down the stairs.
