# **Soakaway and Percolation Test Report**

**Land Adj Orchard Farm, Comberton, Orleton, SY8  
4HF**

**E-47632– SUDs Tests (BRE 365) and percolation testing (BS 6297) – Land Adj Orchard Farm, Comberton, Orleton, SY8 4HF.**

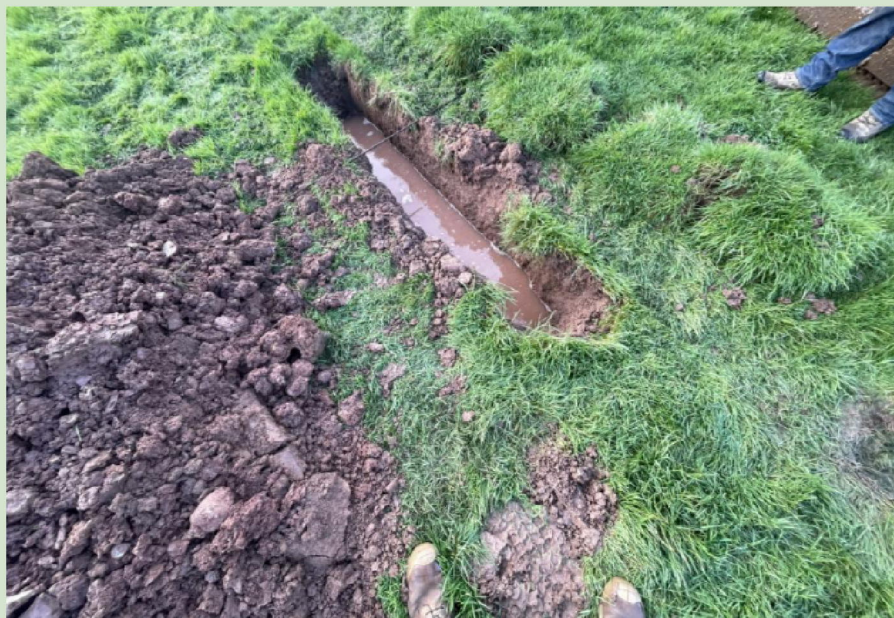
**Photo 01**

TP01 during soakaway test 01

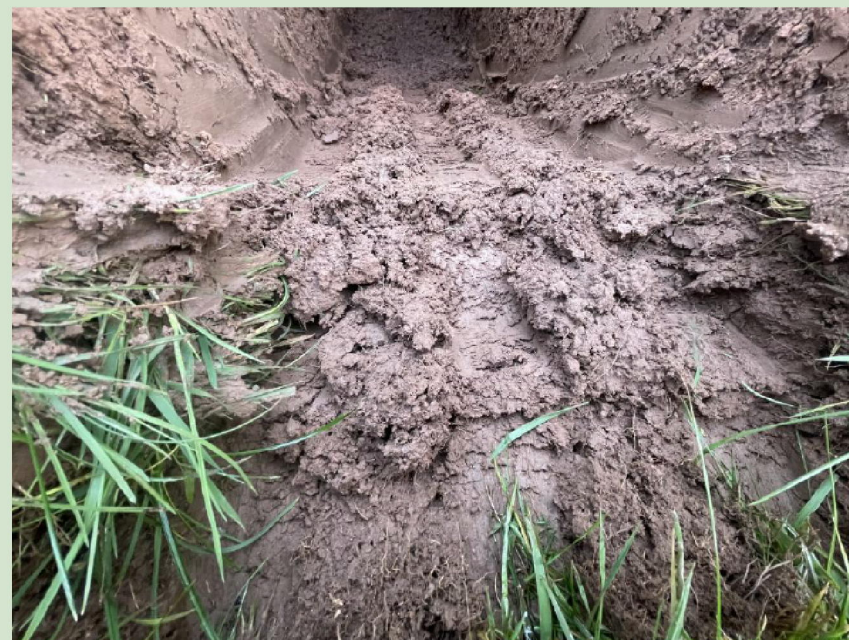
**Photo 02**

Upper soils in TP01 showing a sandy clay/clayey sand.

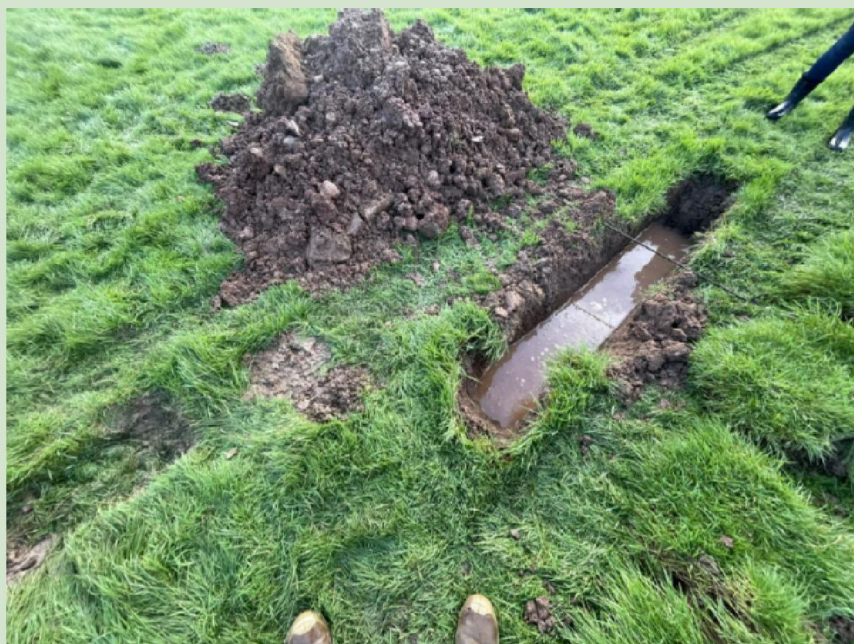
**Photo 03**

TP01 during soakaway test 02

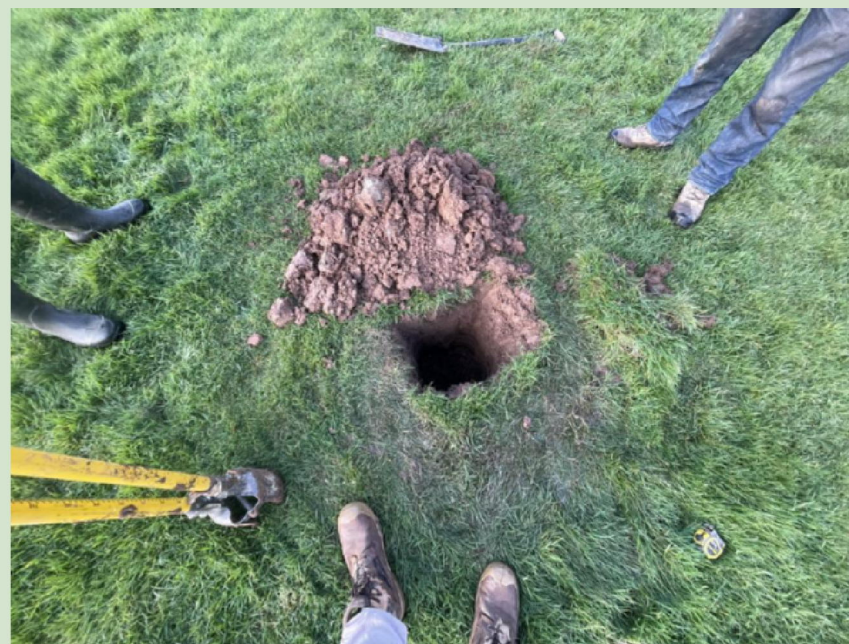
**Photo 04**

Percolation test pit (PT01)

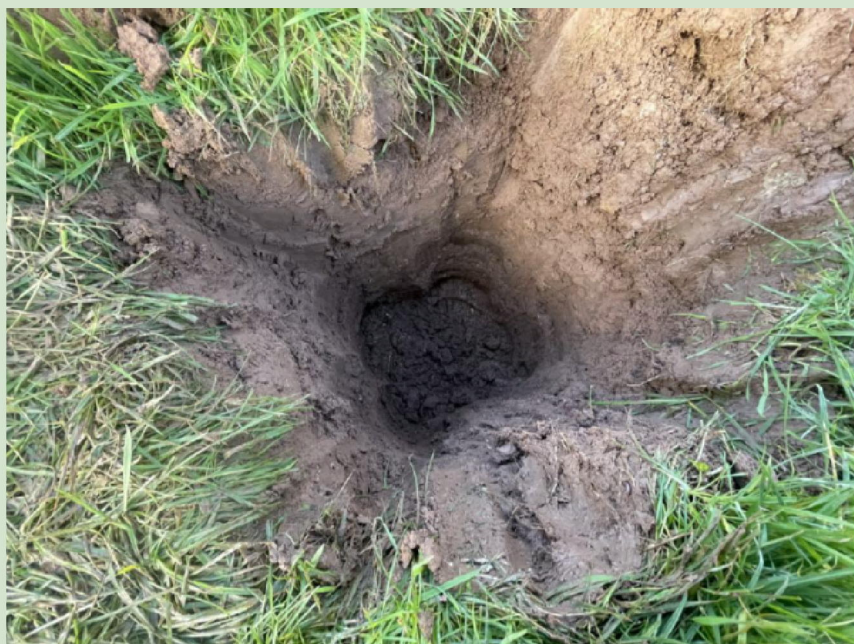
**Photo 05**

Percolation test pit (PT01).

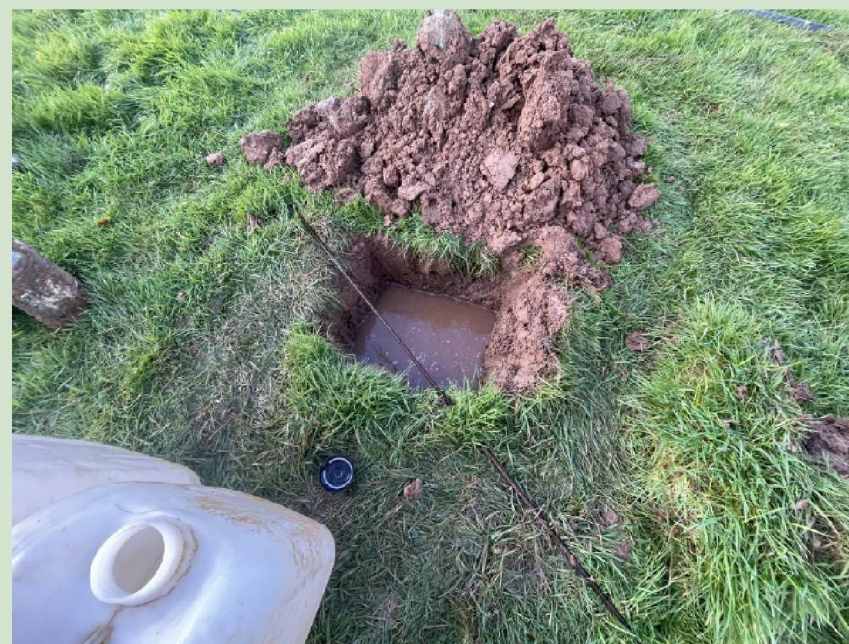
**Photo 06**

Percolation test in PT01

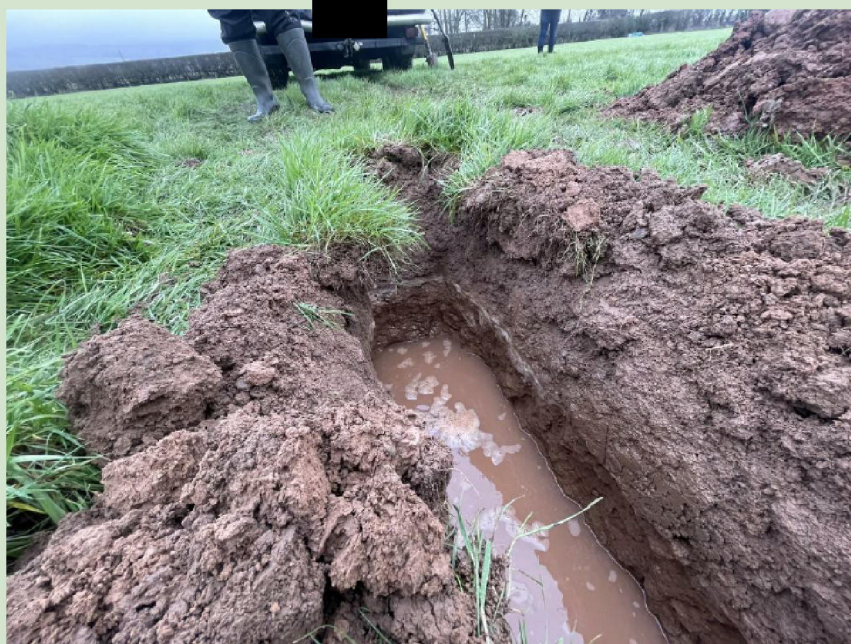
**Photo 07**

Soakaway test pit TP01 during soakaway test

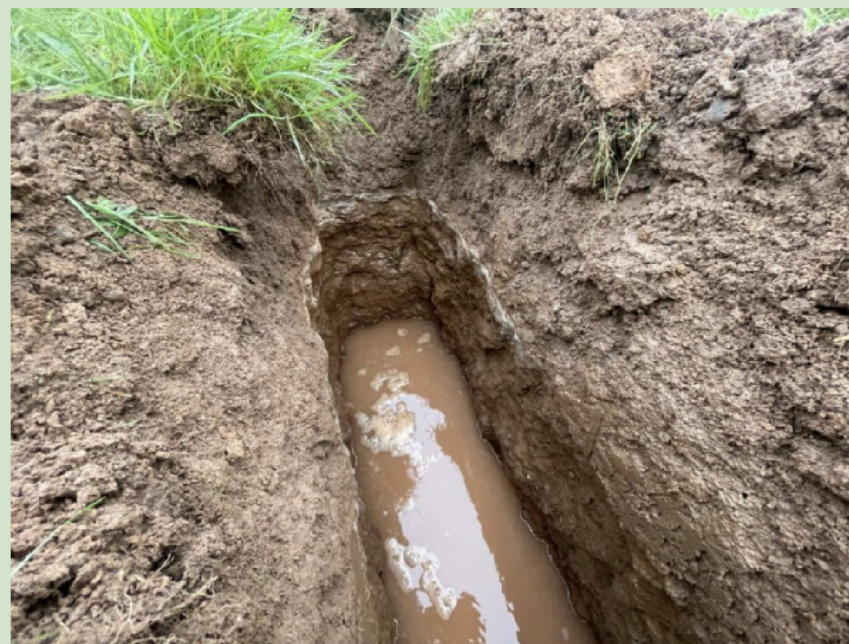
**Photo 08**

The one test location proved slow, but managed to infiltrate fully three times during the course of the testing.

Infiltration proved slow in TP01.

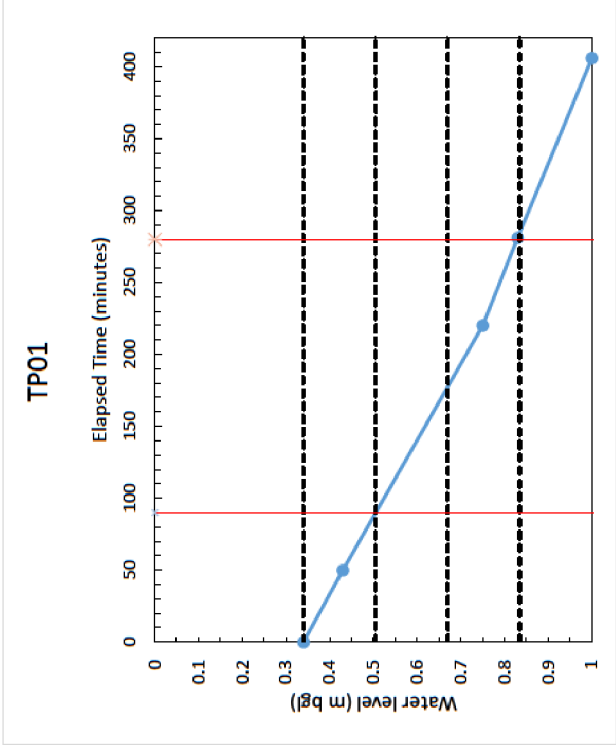
Project Name: Land Adj Orchard Farm  
Project Number: E-47632  
Date of Test: 28/01/2025  
Test Location: TP01 Test 1

$V_{p75-25}$  = 0.14 m<sup>3</sup>, Storage volume from 75% to 25% depth  
 $a_{50}$  = 1.44 m<sup>2</sup> wetted area of pit 50% full;  
 $t_{p75-25}$  = 190 minutes, time to fall from 75% depth to 25% depth  
 **$f$  (soil infiltration rate) = 8.43E-06 m/s**  
(if above is blank/black an infiltration rate has not been established)

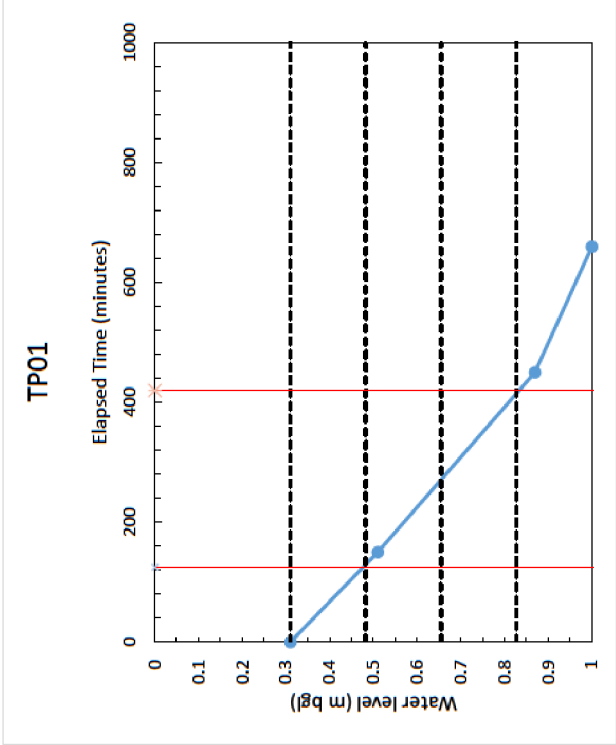
Project Name: Land Adj Orchard Farm  
Project Number: E-47632  
Date of Test: 29/01/2025  
Test Location: TP01 Test 2

$V_{p75-25}$  = 0.14 m<sup>3</sup>, Storage volume from 75% to 25% depth  
 $a_{50}$  = 1.49 m<sup>2</sup> wetted area of pit 50% full;  
 $t_{p75-25}$  = 295 minutes, time to fall from 75% depth to 25% depth  
 **$f$  (soil infiltration rate) = 5.50E-06 m/s**  
(if above is blank/black an infiltration rate has not been established)

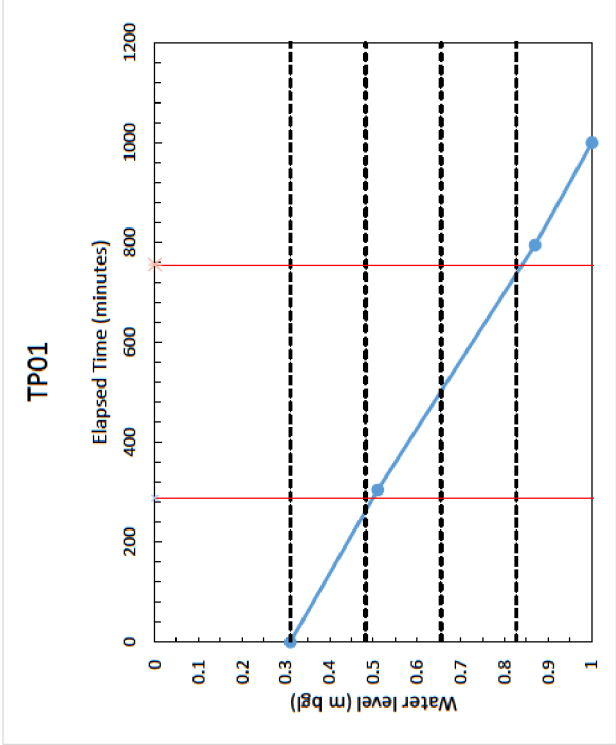
Project Name: Land Adj Orchard Farm  
Project Number: E-47632  
Date of Test: 30/01/2025  
Test Location: TP01 Test 3

**TP01 achieved an infiltration rate of  $3.47 \times 10^{-6}$  m/s between 0.30 and 0.97 mbgl after three fills.**

$V_{p75-25}$  = 0.14 m<sup>3</sup>, Storage volume from 75% to 25% depth  
 $a_{50}$  = 1.49 m<sup>2</sup> wetted area of pit 50% full;  
 $t_{p75-25}$  = 467 minutes, time to fall from 75% depth to 25% depth  
 **$f$  (soil infiltration rate) = 3.47E-06 m/s**
