Land adjacent to
The Link,
Church Lane,
Weston-under-Penyard

Tree & Hedge Assessment
and
Arboricultural Constraints Report

Based on an inspection
carried out

14 & 15/11/2016

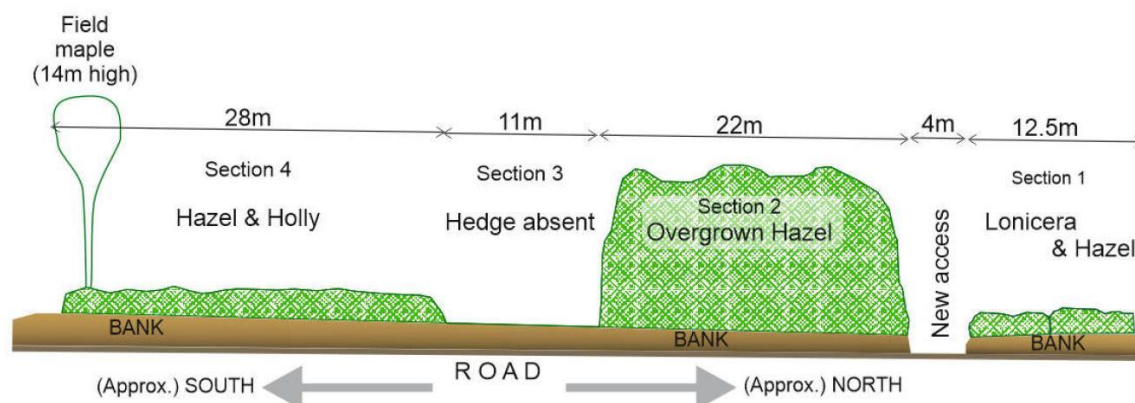
- 3.1 As already noted, the hedge forming the boundary between the site and Church Lane is set on a bank that ranges up to 1.5 metres above the road surface. It itself is of very variable quality and appearance, as indicated by the diagram below and by photos on the following page.

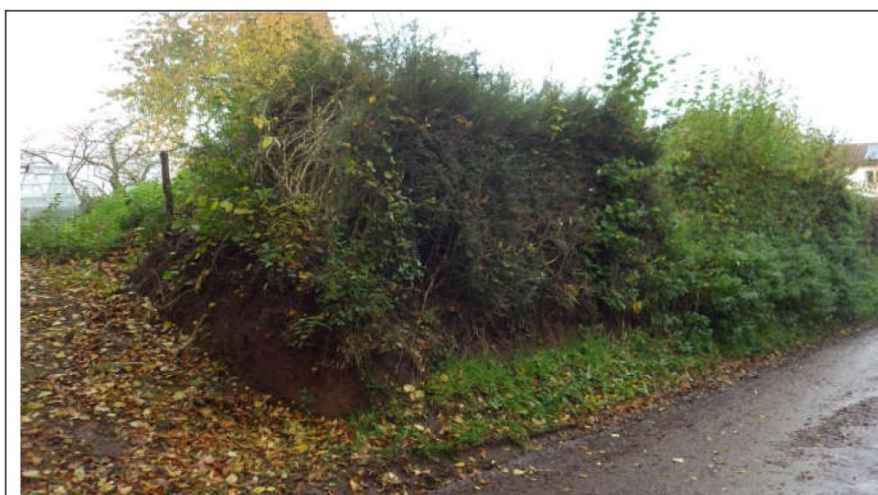
Section 1: coppiced hazel at far north end; shrubby honeysuckle (*Lonicera nitida*) adjacent. 1.5-2m high. Note the cutting for the new access.

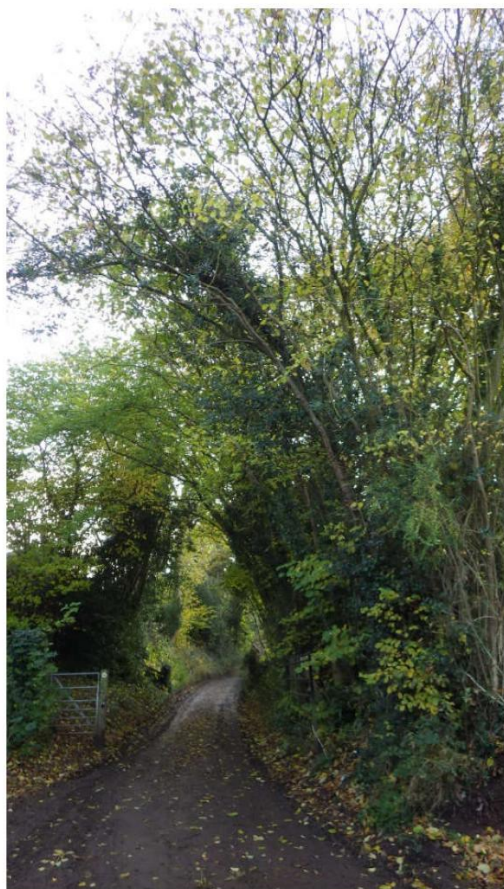
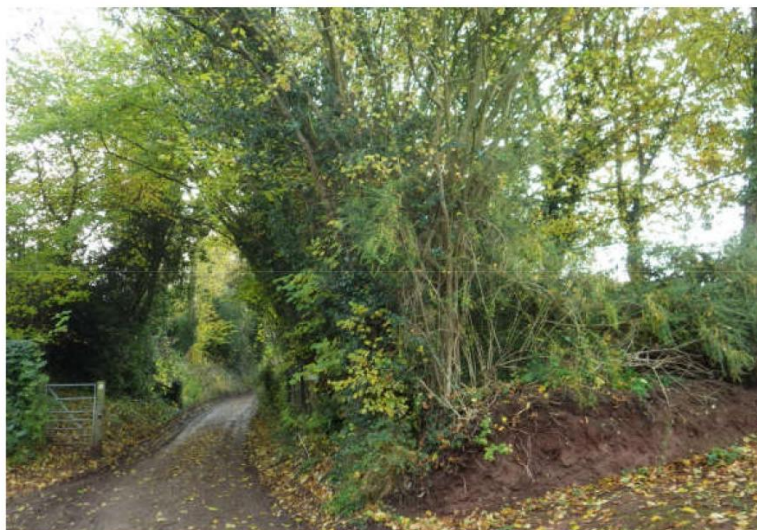
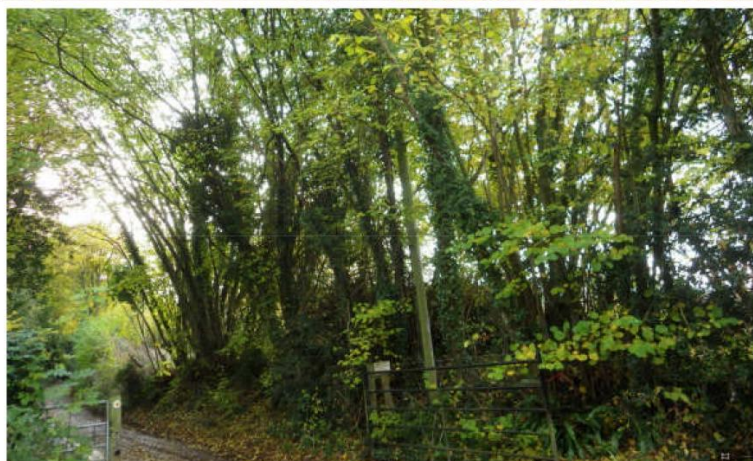
Section 2 (above): Very overgrown hazel (plus x1 Field Maple); growing from rather widely-spaced coppice stools, at about 1 to 3 metre spacing. Plants are now up to 9-10 metres in height, some with ivy. Many slender stems arch widely across the lane

- 3.4 Normal management would require the extremely overgrown hazels and field maple in section 2 to be cut back, re-coppiced or perhaps laid, in order to prevent them reaching a stage where they plants will begin to break up and fall across the lane, possibly destabilising the bank. The drawings of the proposed scheme indicate a 'new' hedge along the roadside; I would recommend that along this section cutting back to promote new growth would be considerably less disruptive than planting anew, which would

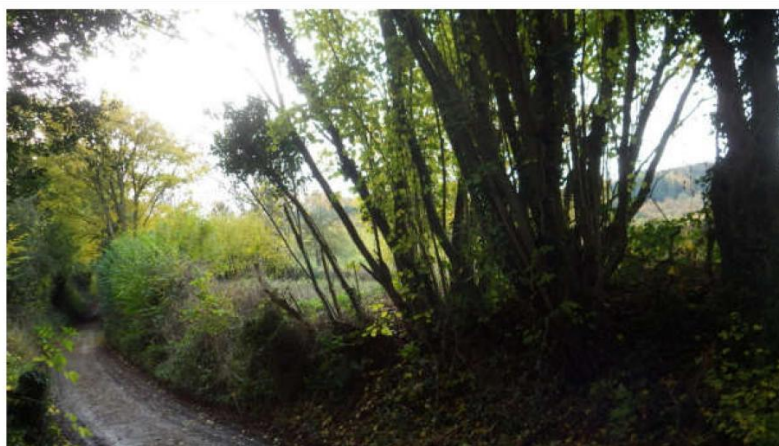
Section 2 & 3

Overgrown, rather widely-spaced hazels in section 2 (on right) with section 3 being about 11 metres long where no woody plants are present.

involve grubbing out the existing hazels. Regrowth from these long-established plants will; be quick, but some Infill planting is likely to be required in the gaps between the stools. New planting *will* be required to make good the large gap currently present at section 3.

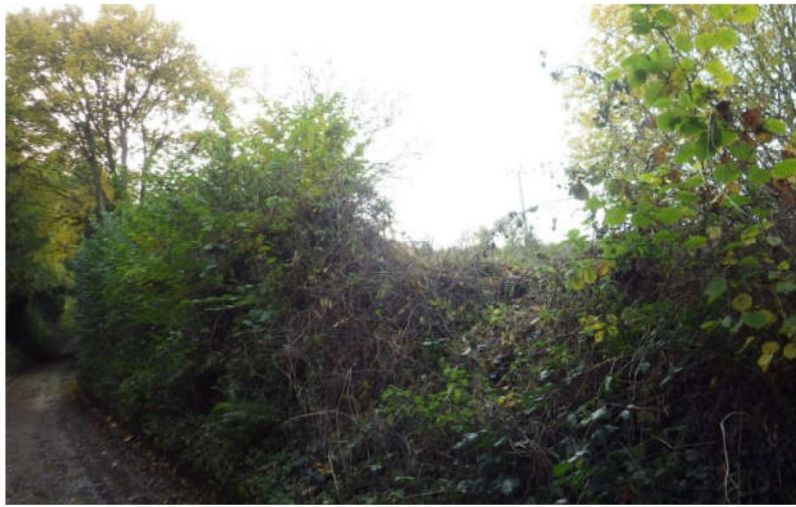
Section 3 with no hedge plants and section 4 beyond, comprising hazel and holly cut to about 1 metre with regrowth to 2 metres overall.

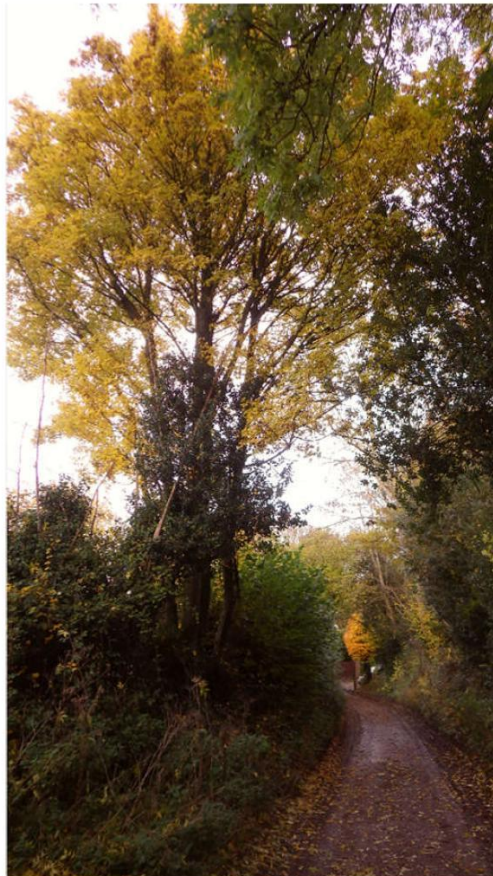
Maple tree at far south-east corner of site, viewed south to north.

X4 stems, approx. 210-300mm in diameter; tree about 14 metres tall.
