**CONSERVATION STRUCTURAL ENGINEER'S REPORT IN SUPPORT OF PRIOR  
NOTICE FOR CHANGE OF USE UNDER CLASS Q OF THE GPDO 2015**

**Pennywink Farm**

Report No. J9277-ST-R001

14 May 2025

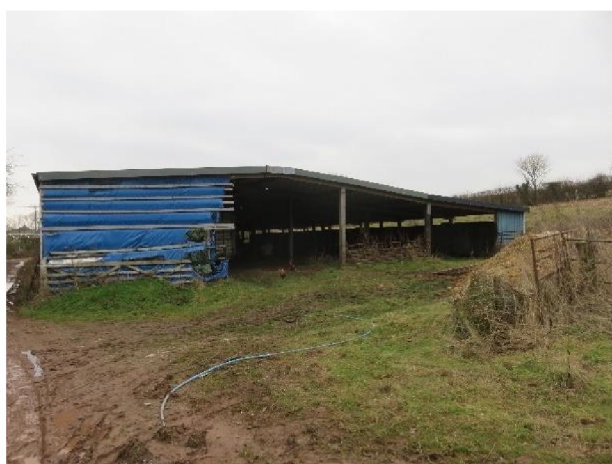
P36

[3.3] Timber framed building, **P36**, 10 bays long with central access aisle, **P40**. Single aisle of stalls to the right and open aisle to the left, another penned-in aisle to the left of that and a narrow access aisle along the left-hand, south side, **P66**.

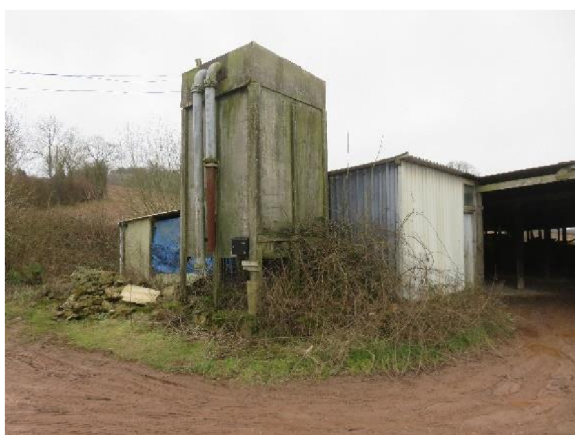
P62

[3.4] Roof completely covered in square corrugated industrial style steel sheeting to a very shallow slope with flat central portion which for about 50% of the length is raised to give ventilation P41.. The ends are open apart from a concrete blockwork construction at the front left-hand corner for a fuel tank. P62. The long sides are sheeted with similar industrial sheeting full height along the north side P60, and on the south side with about a 400mm gap for ventilation at the top. P42.

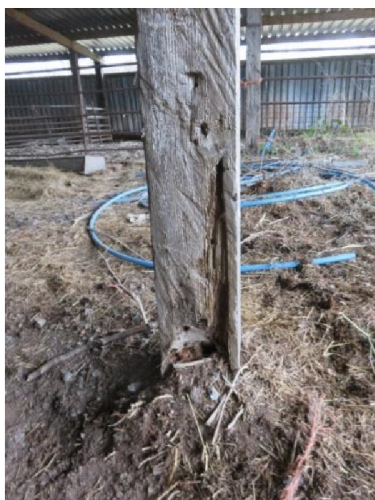
- [3.5] All the vertical structure is identical timber posts, about 145mm square set in earth, in varying states of condition. There are about 77 such posts. Typical examples are shown in **P46** and **P48**.

- [5.2] The ad-hoc additions will be removed.
- [5.3] All of the timber rafters, purlins and posts will need to be inspected as a matter of routine good practice and any localised decay remedied by small-scale structural interventions to mitigate the defect.

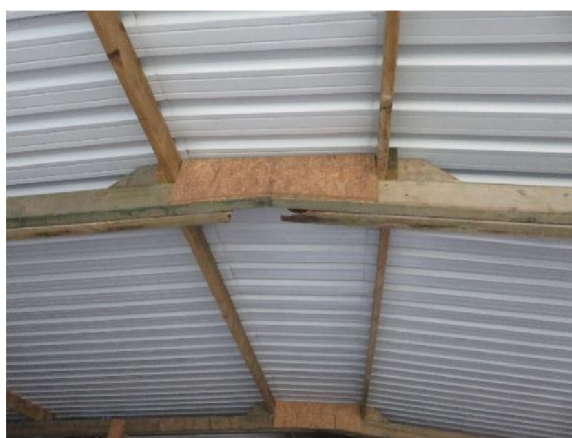
**P45**

- [3.6] The primary rafters are double timbers set on top of the posts with timber blocks to hold purlins, and in the centre a butt joint between these primary rafters secured with pieces of compressed wood board. **P45**.

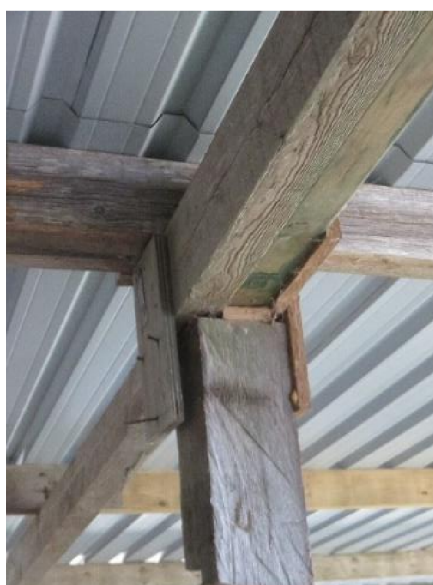
- [3.13] There are simple nailed connections between the purlins sitting on the rafters and the rafters sitting on the posts, nothing that could be construed as a serious moment or stiffness connection. **P53**

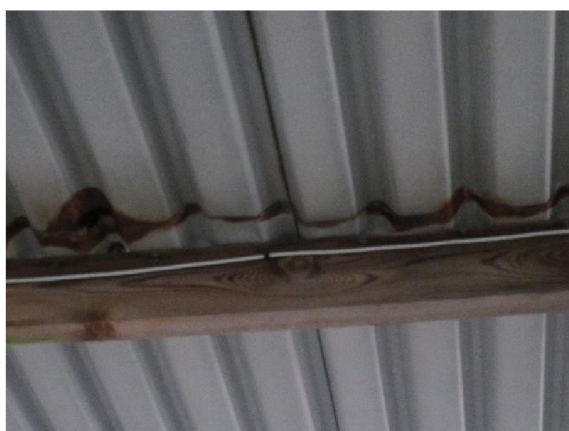
P54

[3.19] Some of the edges of the corrugated sheeting is corroded suggesting leaks through the nail fixings or corrosion at overlap or significant water penetration from the laps being too short. Also examples of where the side laps or overlaps of the sheets are not sufficient. The flat roof of the ventilated strip which seems to be just flat sheet metal nailed to 50 x 50mm timber runners. **P54, P55, P56**

- [4.5] The continuous sheeting to the external walls will provide stability as at present, though with the benefits of localised repairs as necessary.

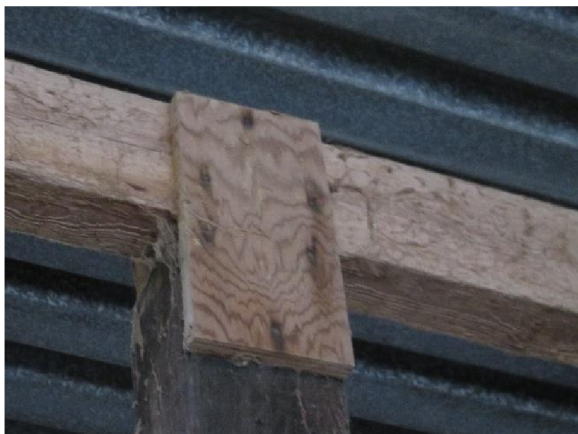
P57

[3.21] The building is sheltered to the south with the ground rising up but is completely open to the other three sides in a fairly exposed position. Typical post to single primary rafter connection is one timber plate about 300 x 150 plywood or other timber boarding. **P57, P63.**
