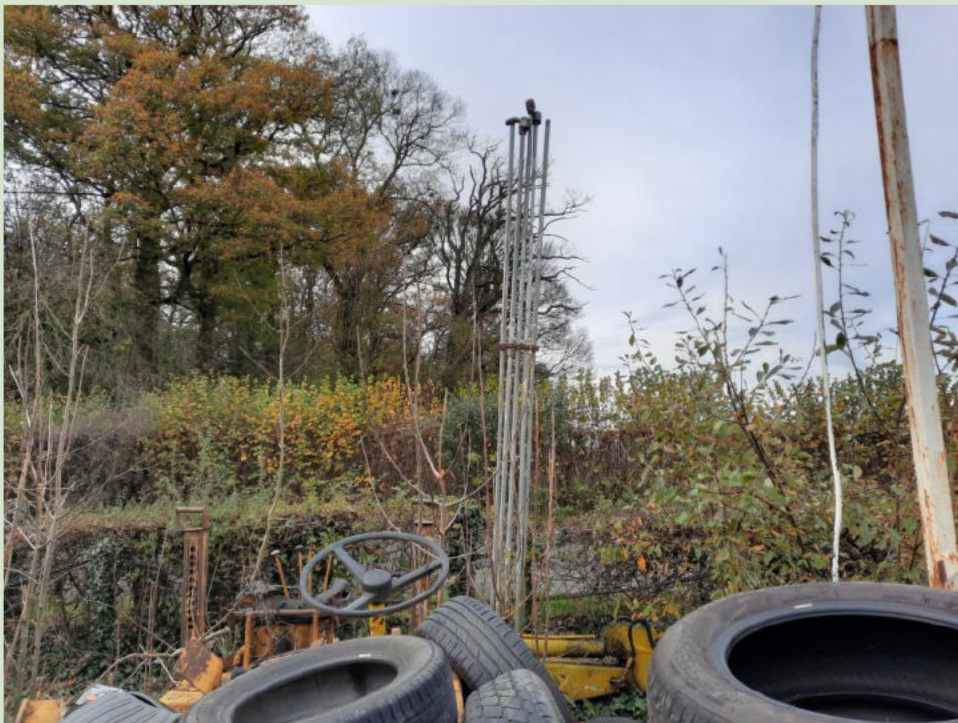
Photo 19

West of site behind tyre storage area

Gas vent pipework (possibly redundant) behind tyre storage area and adjacent to western site boundary.

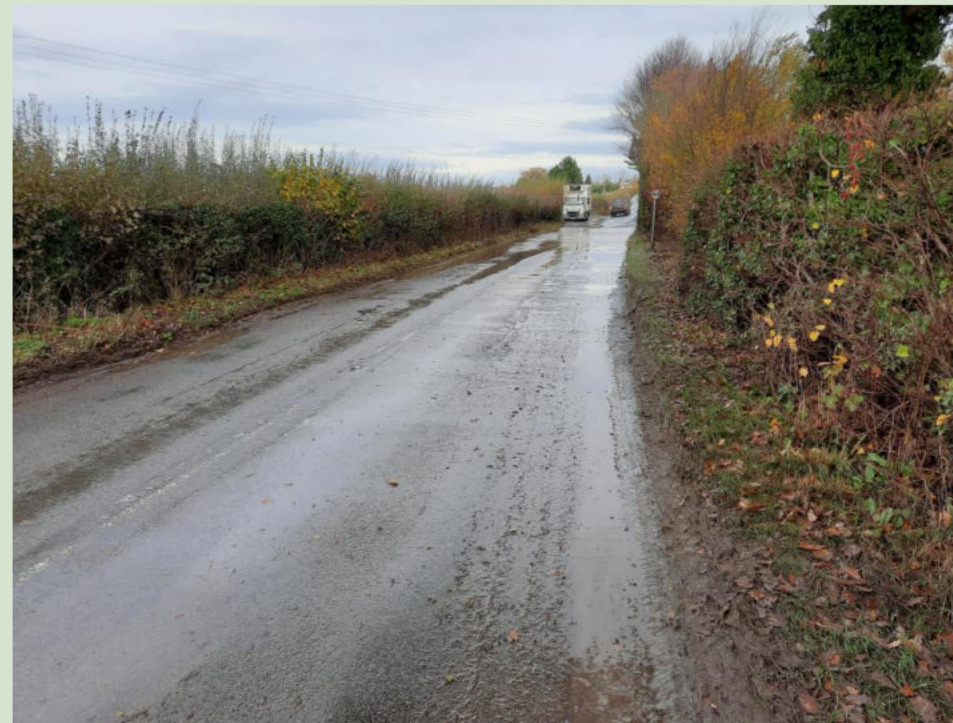
Photo 20

View along Panniers Lane looking North-West from the north-west site access

Surface water pooling on Panniers Lane approximately 50m north of the north-western site entrance.

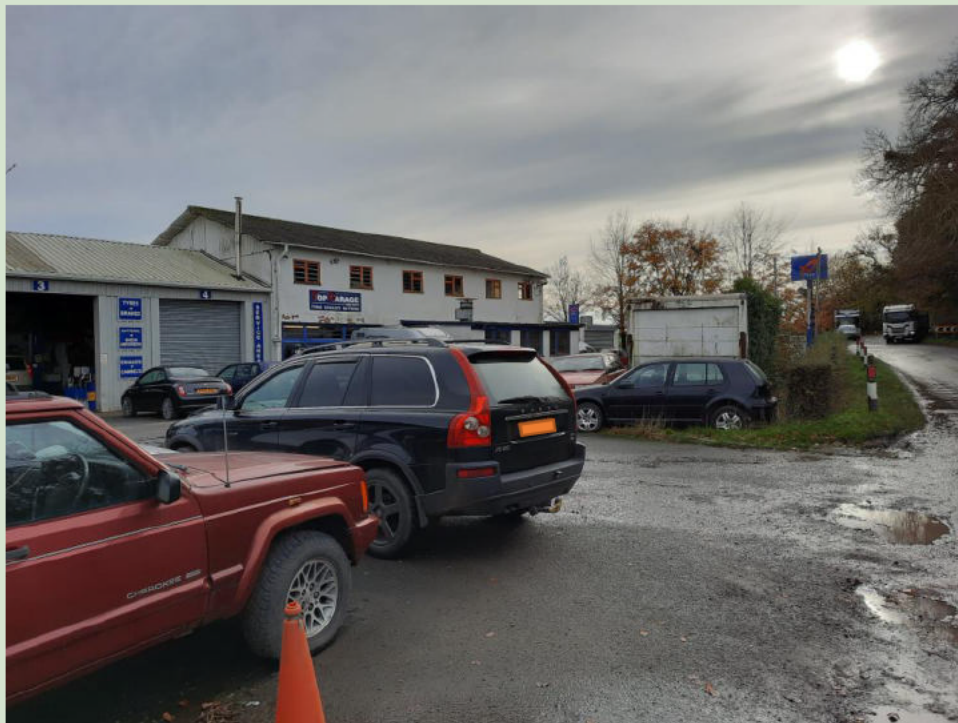
Photo 21

Top Garage Main Building looking from the north-west to the south-east

Top Garage main building with a slight view of the Workshop to the central left of the image. 2 large metal flues, one from the flat roof at the front of the image and an other extruding from the workshop roof on the right

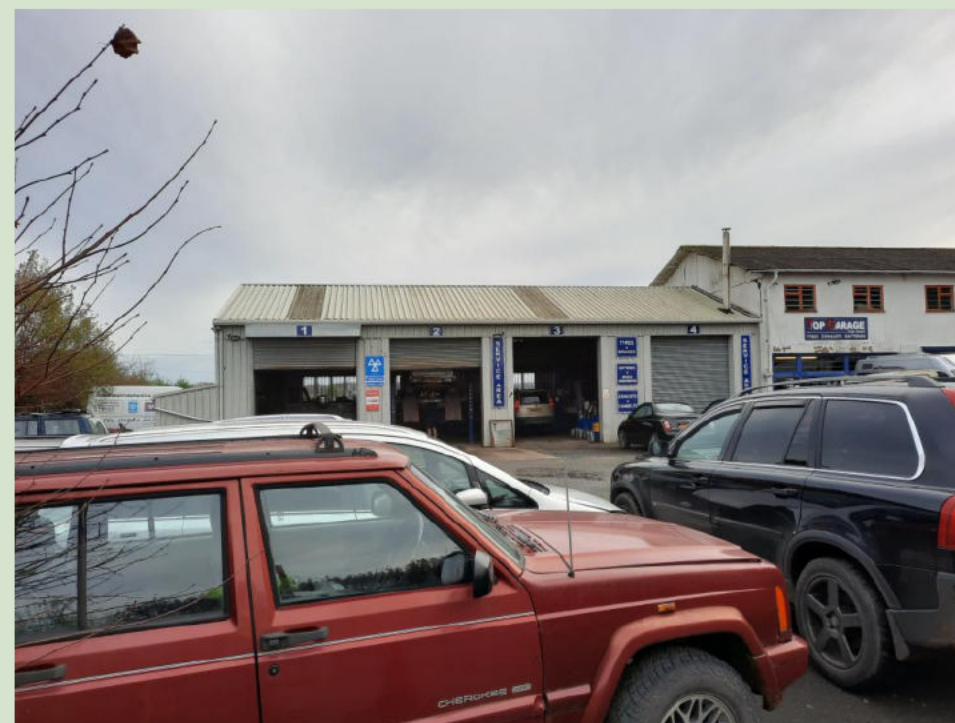
Photo 22

Top Garage main building looking from the north-west towards the east

Workshop of the main building shown with 4 access bays. Building is metal clad.

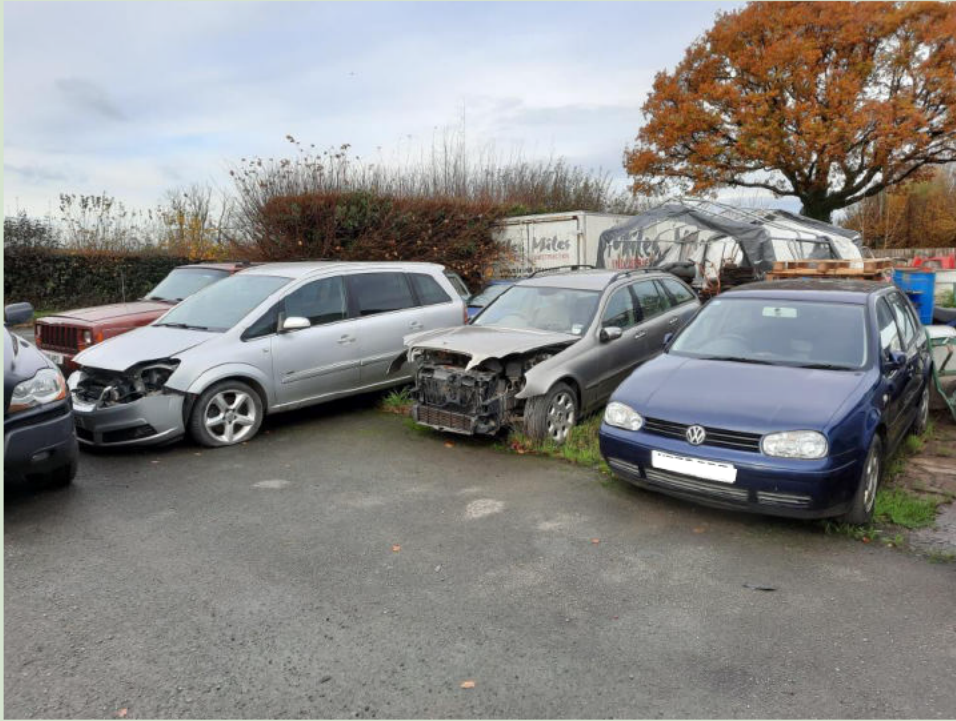
Photo 23

**'Car refuse area' in north western corner of site – looking northwest**

'Car refuse area' in north-western corner of site. This area is approx. 30mx20m and there are various things stored here. Mainly cars in states of disrepair and car parts. Mix of gravel and concrete hardstanding with some smaller areas of soil visible.

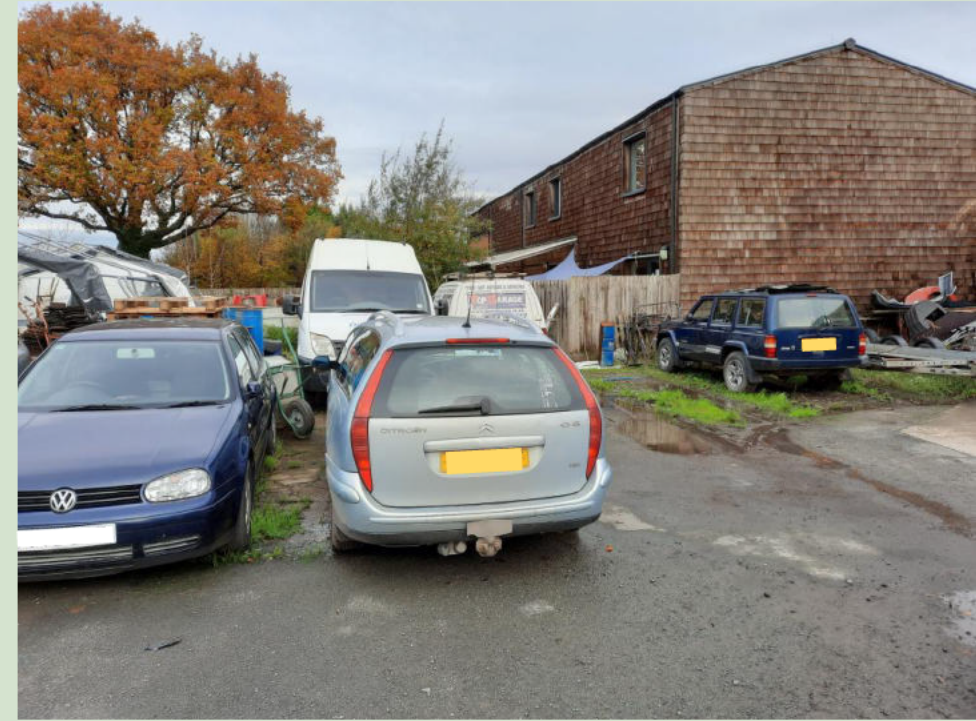
Photo 24

**'Car refuse area' in north western corner of site – looking north**

'Car refuse area' in north-western corner of site. This area is approx. 30mx20m and there are various things stored here. Mainly cars in states of disrepair and car parts. Mix of gravel and concrete hardstanding with some smaller areas of soil visible.

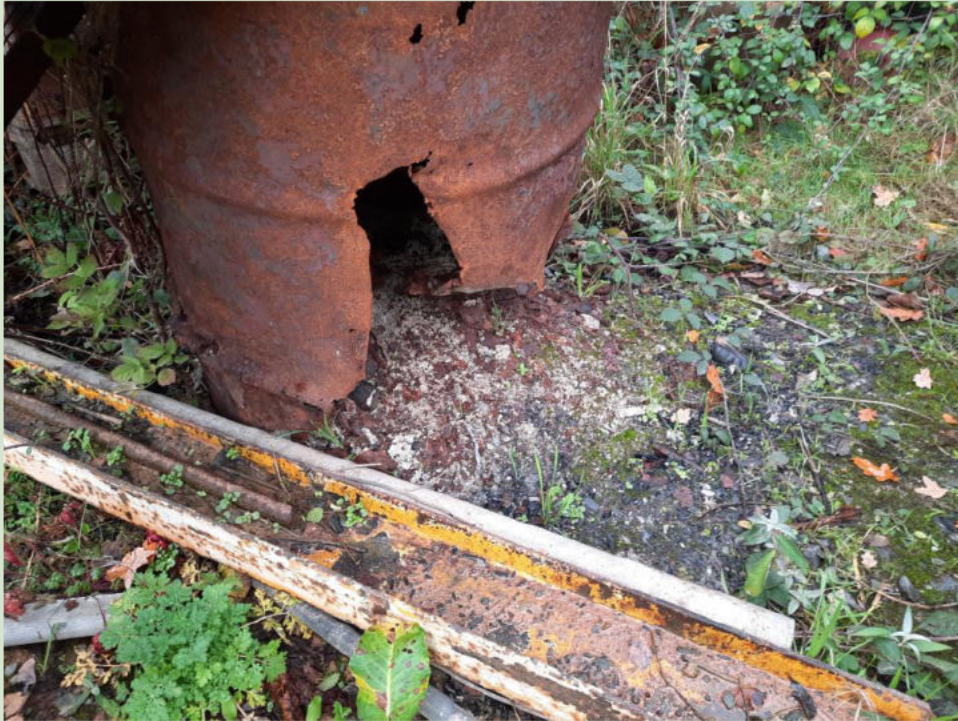
Photo 25

**'Car Storage Area'**

Barrel used for burning has opened at the base and ash and coal fragments lie on the floor of this area. Some gravel hardstanding but depth unknown.

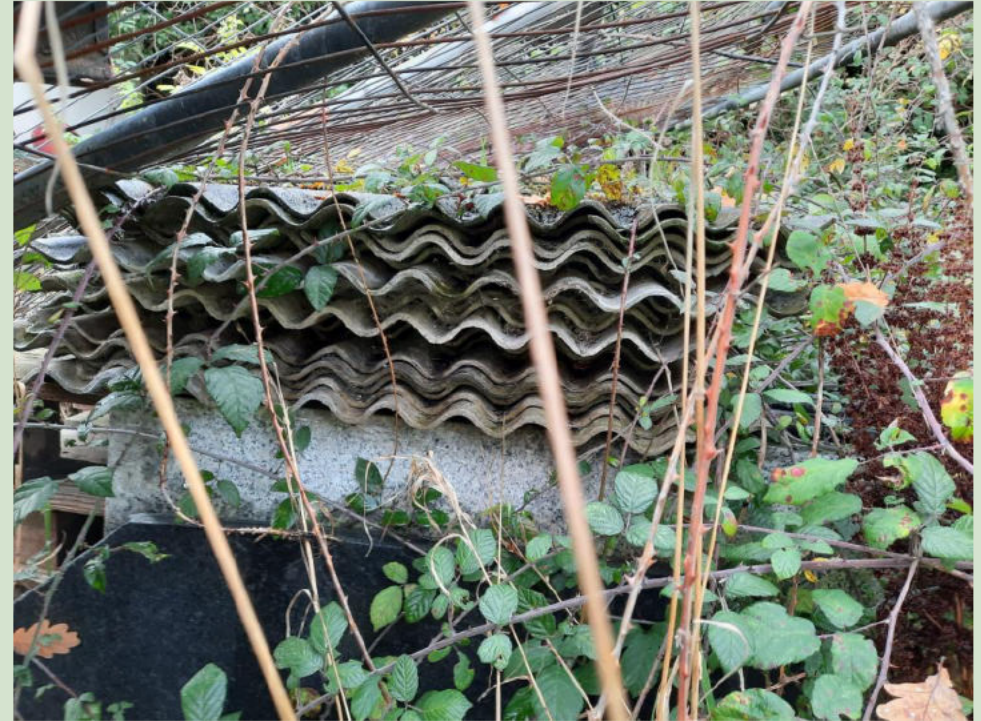
Photo 26

**'Car Storage Area'**

Profiled cement sheet stockpile in car storage area. Possibility this is asbestos cement and if so is not stored appropriately for a commercial site. An asbestos refurbishment/demolition survey (ASG-RDS/ADS) should be completed on this site prior to any refurbishment or demolition taking place and recommendations should be followed.

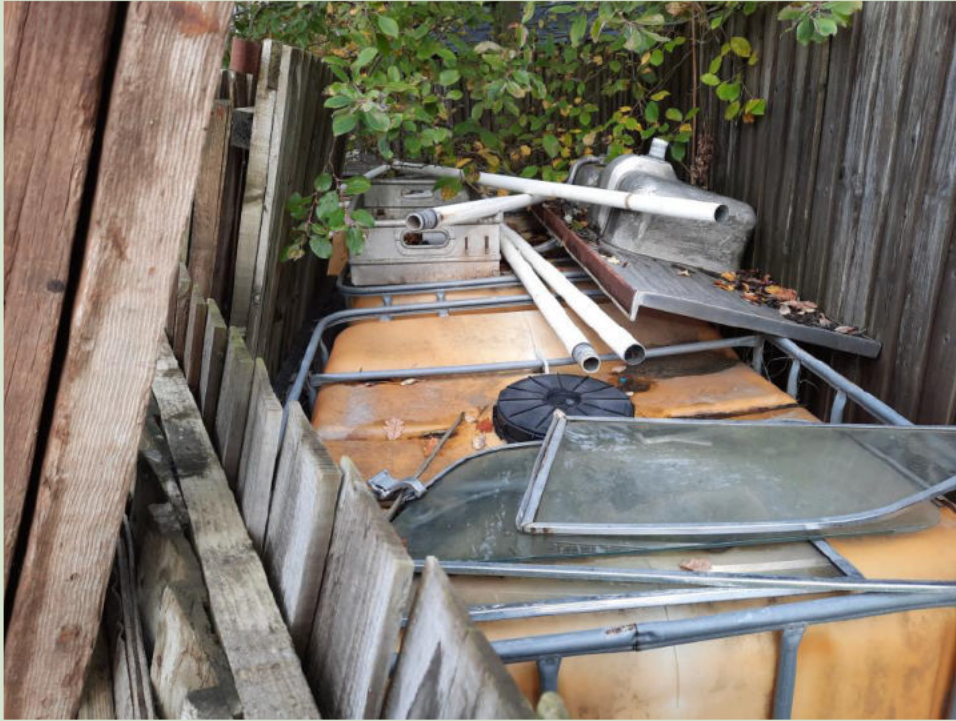
Photo 27

'Car Storage area' north-east corner

3 no. bowzers with unknown contents sat on soil & gravel

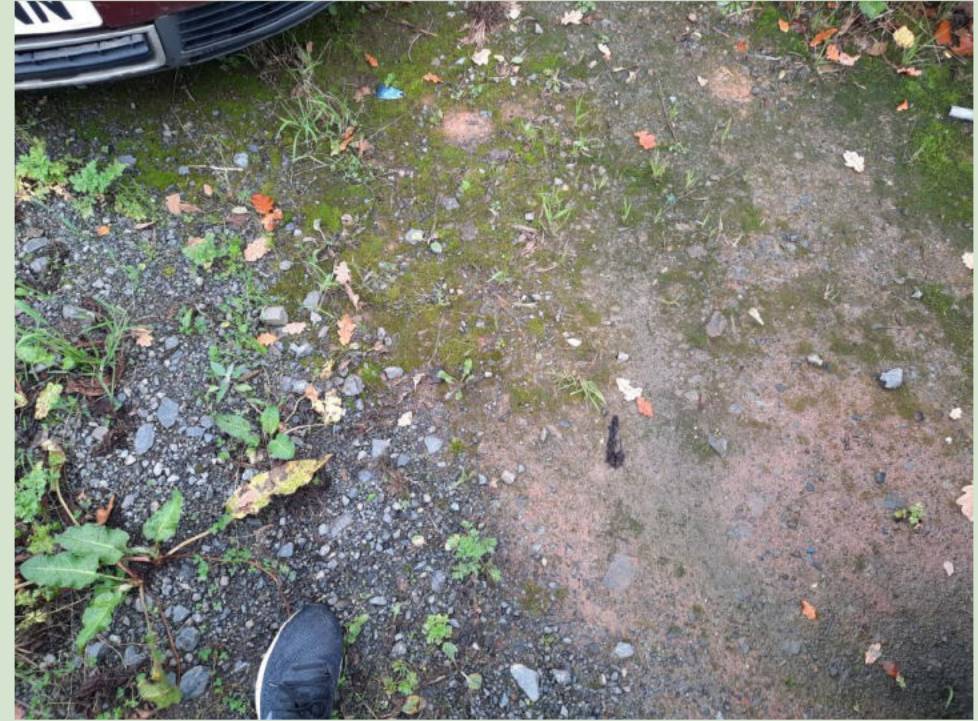
Photo 28

'Car storage area'

A look at the general makeup of the ground in the car storage area (where there is no concrete hardstanding) shows a mix of gravel and soil.

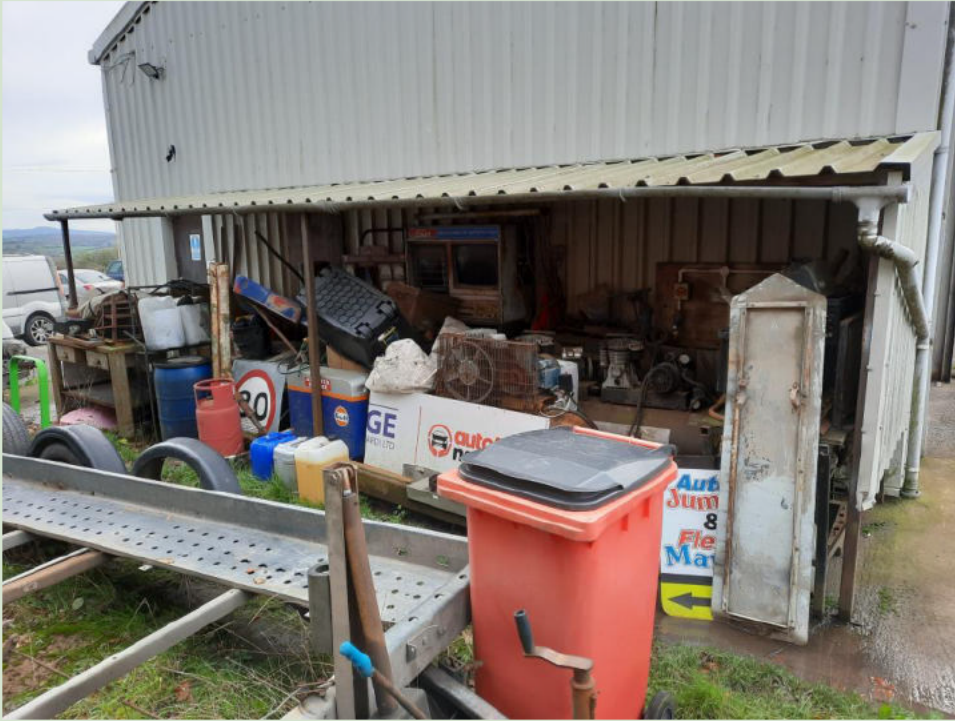
Photo 29

Top Garage Main Building lean-to looking south from north of site

Storage area in lean-to adjacent north of workshop. Several motor units and chemical storage are

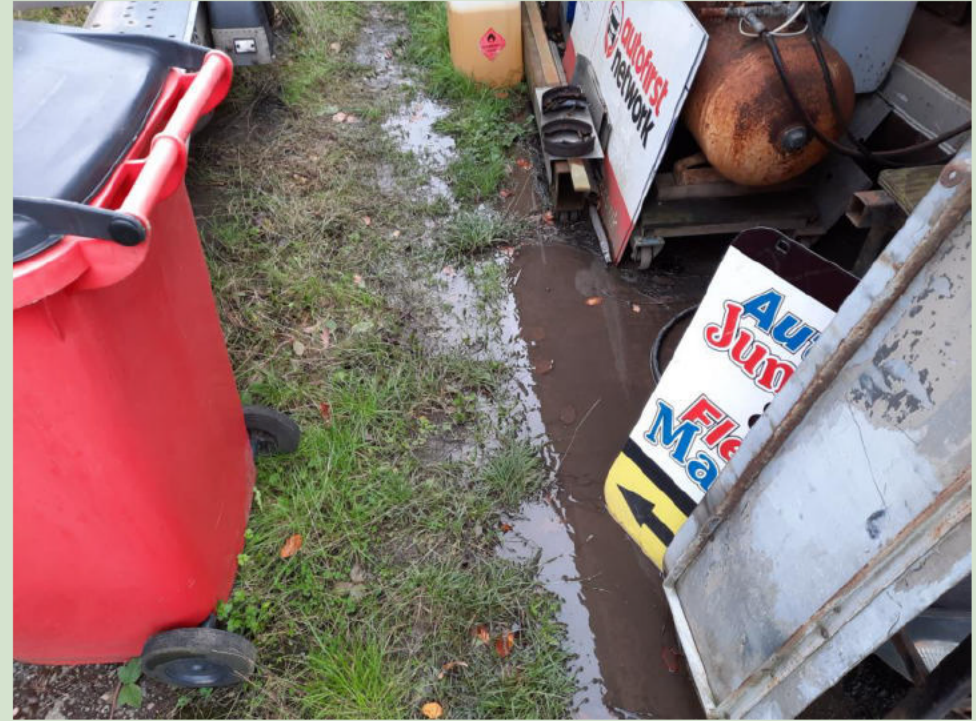
Photo 30

Top Garage Main building Lean-to

Pooling water adjacent to lean-to from main building. Running motors and chemical storage in this area.

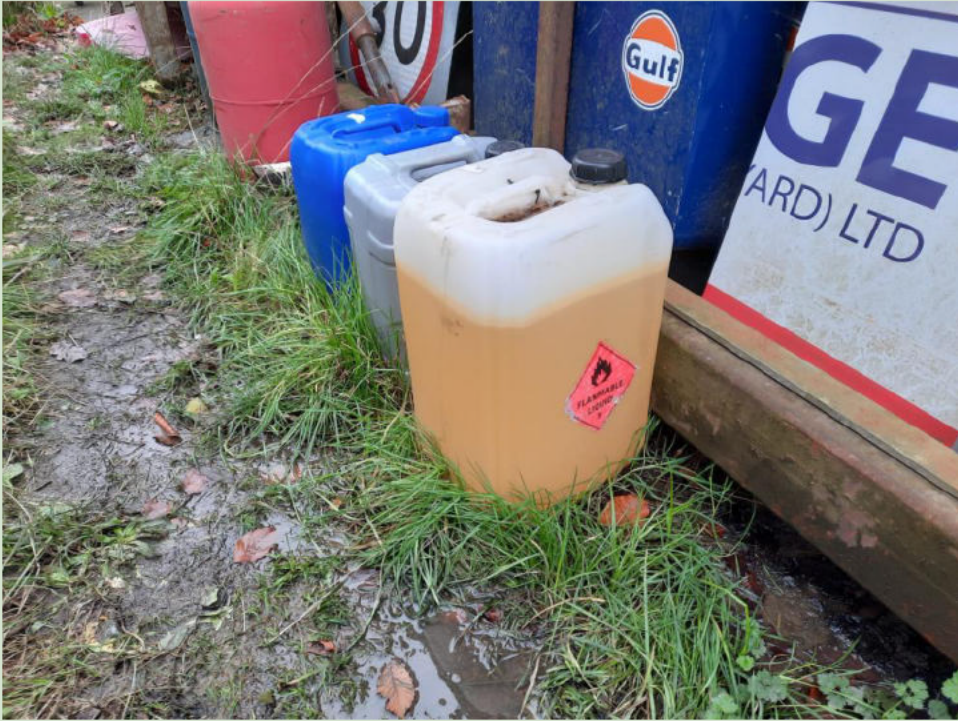
Photo 31

Top Garage Main Building lean-to

Flammable chemical storage (2ltr drum) in north lean-to with some smaller drums with unknown contents.

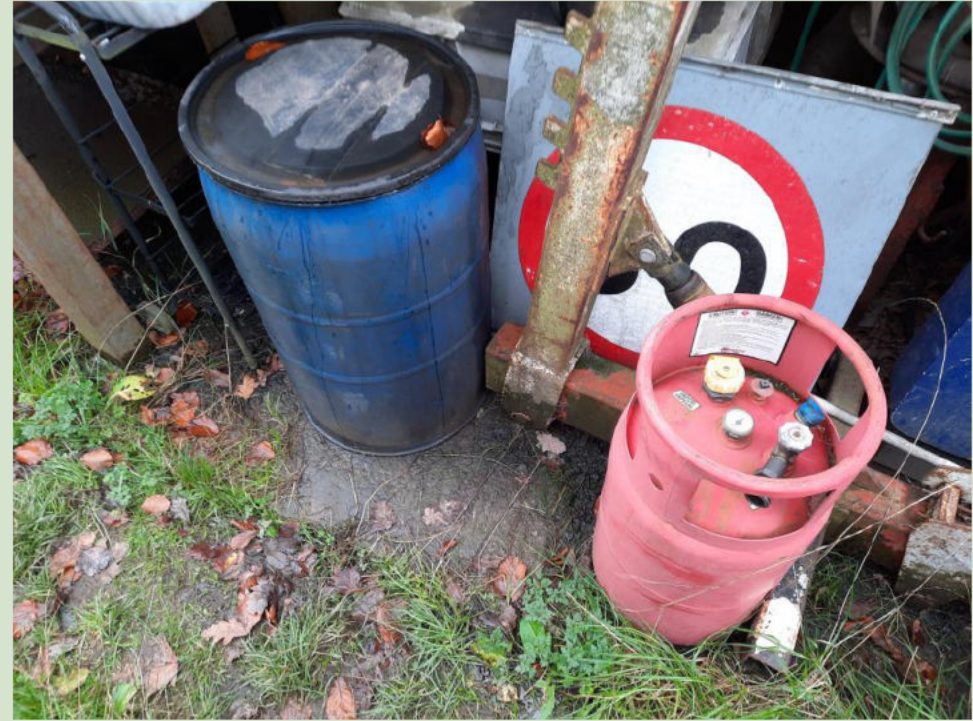
Photo 32

Top Garage Main building Lean-to

Storage drum with unknown contents and gas bottle in north lean-to

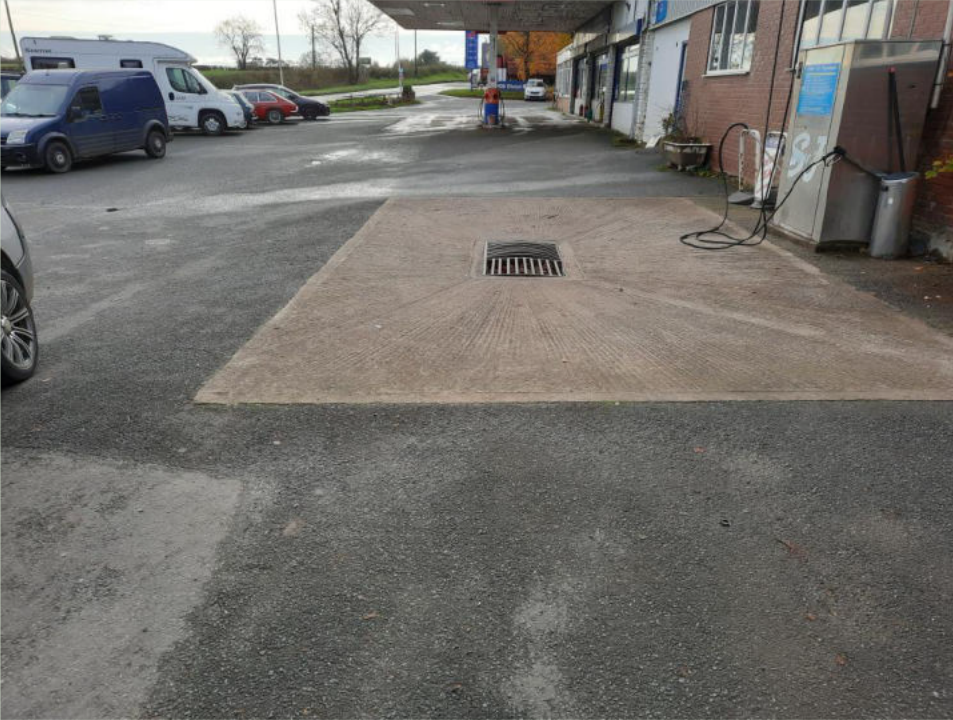
Photo 33

North eastern corner of Top Garage main building looking south

Car wash area with associated drainage. This drainage covers runoff from the car wash area only. Petrol forecourt can be seen just south of this area on the east of the building.

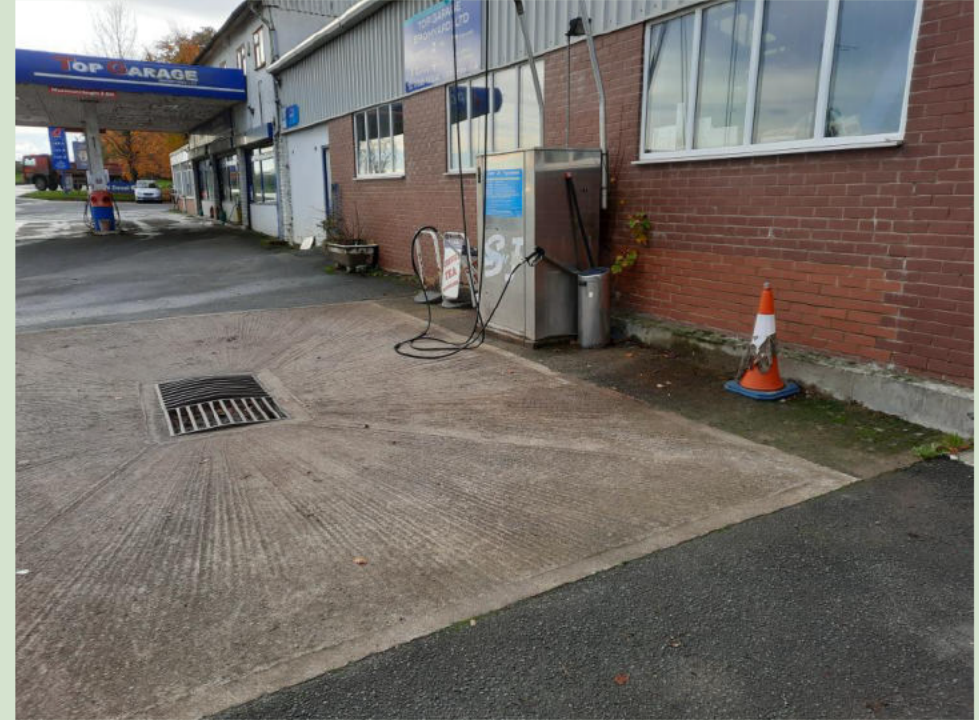
Photo 34

North eastern corner of Top Garage main building looking south-west

Car wash facility with

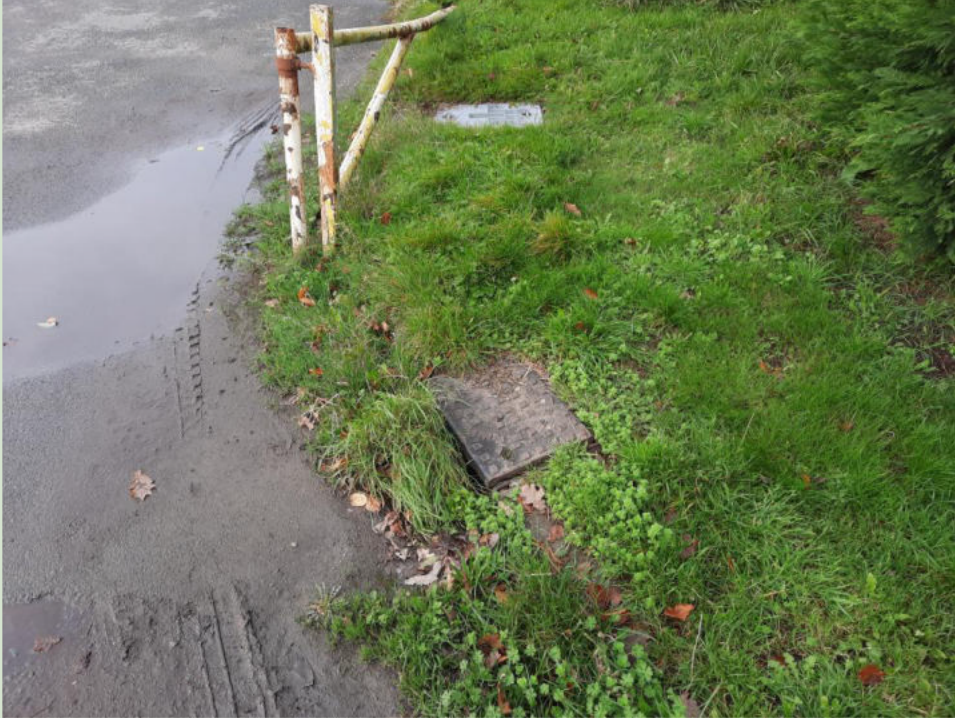
Photo 35

North-east corner of site adjacent to north-east site access

Drain and sewer covers for drains which deal with surface water runoff and sewerage culminate here before heading off site in a north/north-east direction.

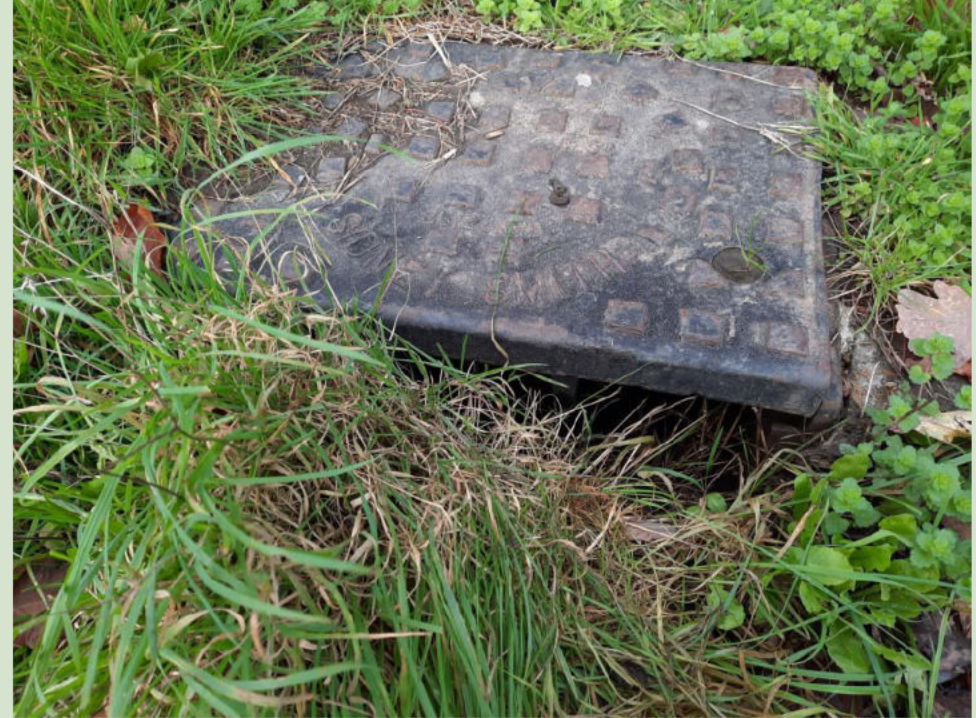
Photo 36

North eastern corner of Top Garage main building looking south-west

Drain cover for drain dealing with surface water runoff from the site.

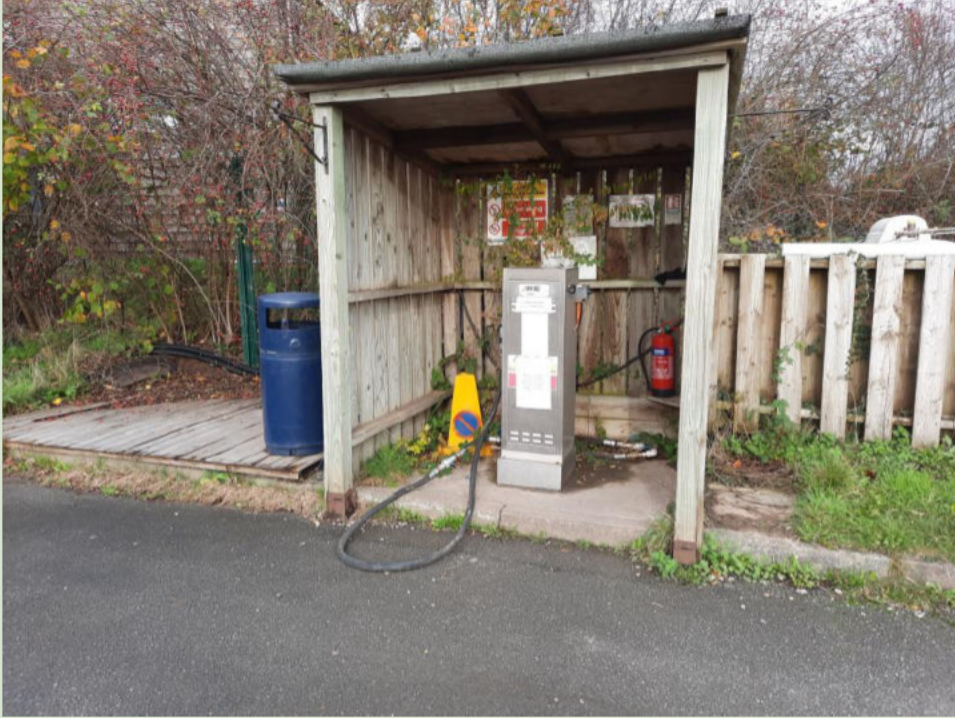
Photo 37

North-east corner of site adjacent to north-east site access

LPG tank dispenser/pump with associated open shed.

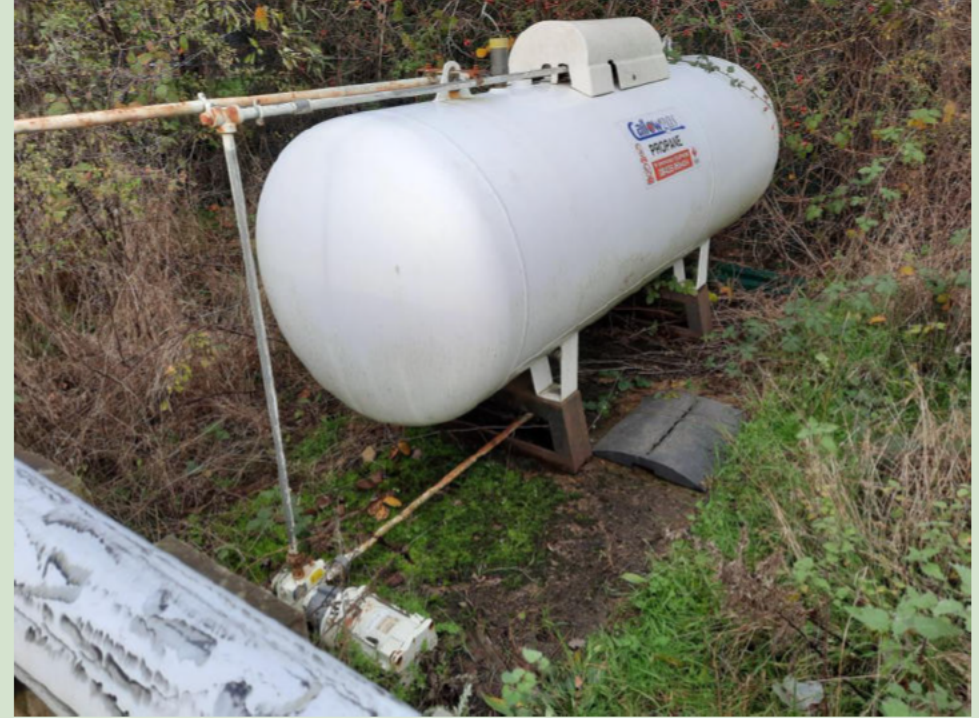
Photo 38

North-east corner of site adjacent to north-east site access

LPG tank housed in timber fencing on north-east corner of site.

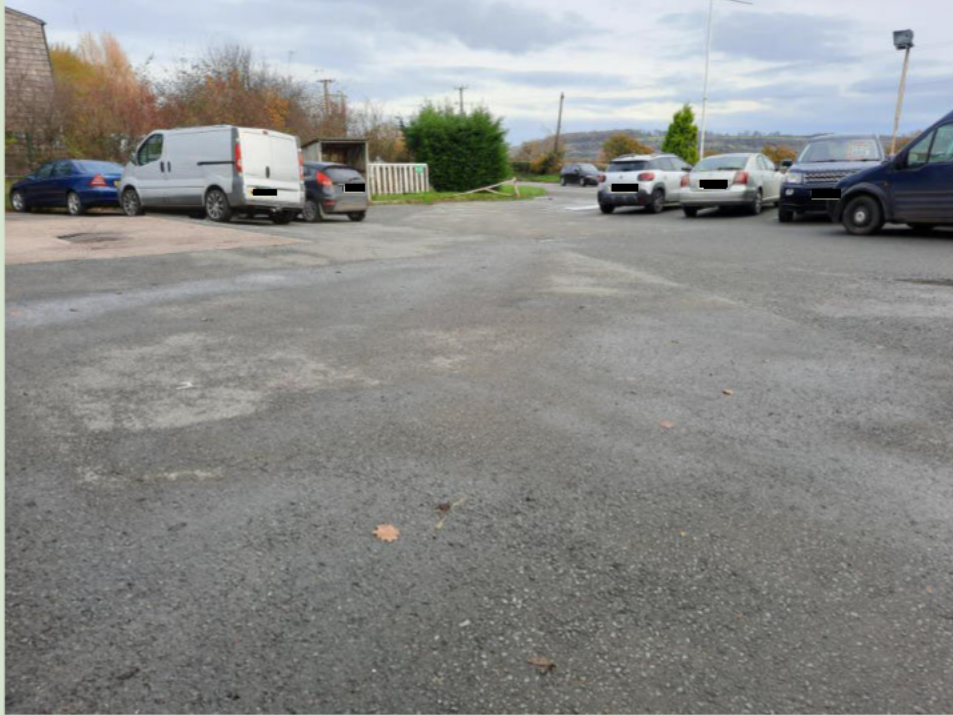
Photo 39

**North-east corner of site looking from the Main Top Garage Building**

General site topography would lead surface water in a north-east direction towards the main surface water drainage area, however there are no surface collection drains in the north-east corner and water anecdotally pools in this area.

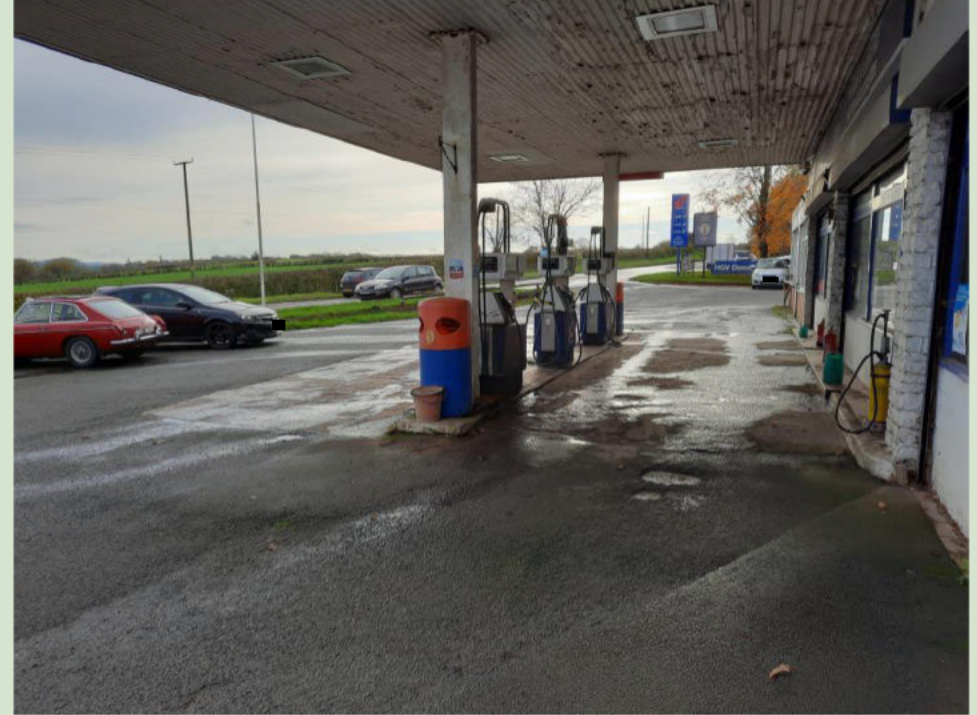
Photo 40

**Looking south/south-east from the main Top Garage Building.**

Petrol forecourt to Top Garage adjacent east of the main building. Surface collection drains are present and hardstanding, although in moderate condition, covers the filling area.

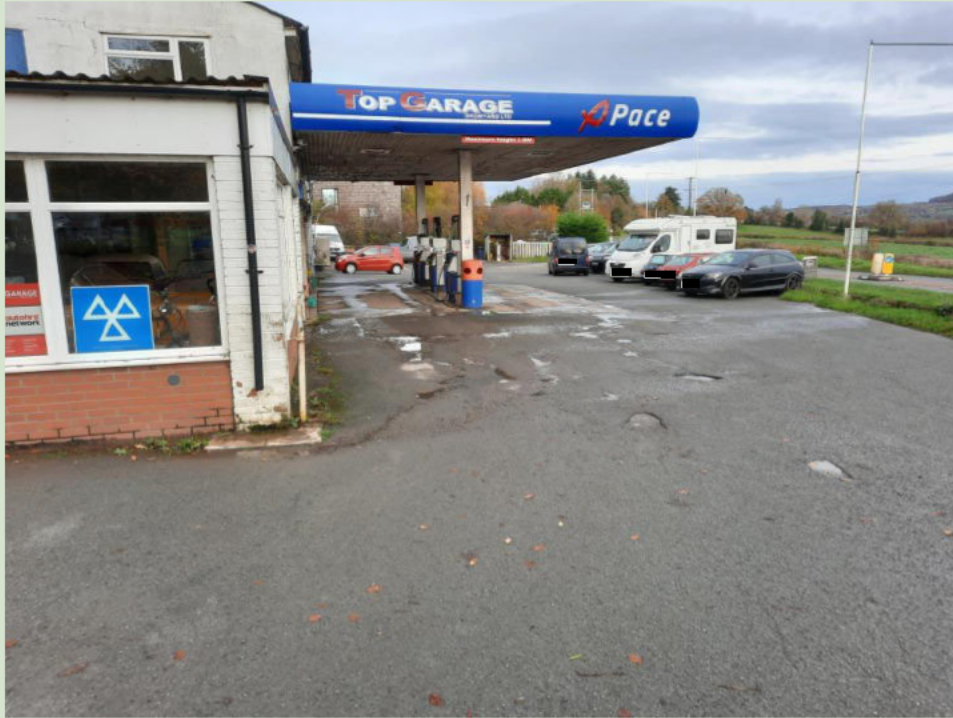
Photo 41

Looking north from central south of site (Car Park)

Forecourt seen from a southern perspective with surface water pooling and damaged areas of bituminous hardstanding.

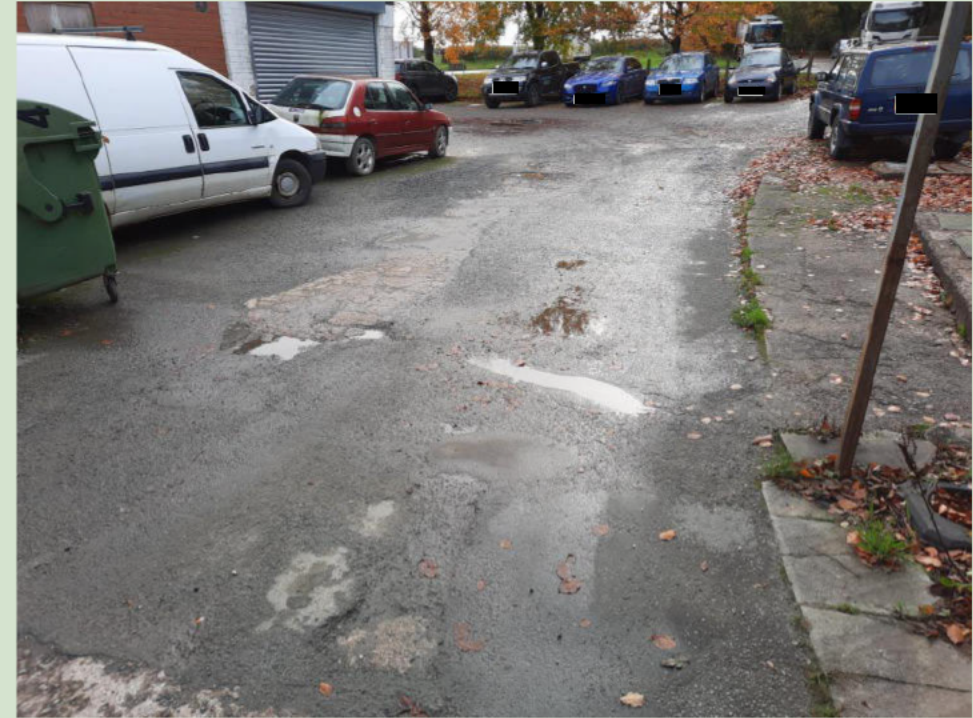
Photo 42

Looking south on Western side of main Top Garage building next to open shed

Surface water pooling on the bituminous hardstanding which is in moderate condition.

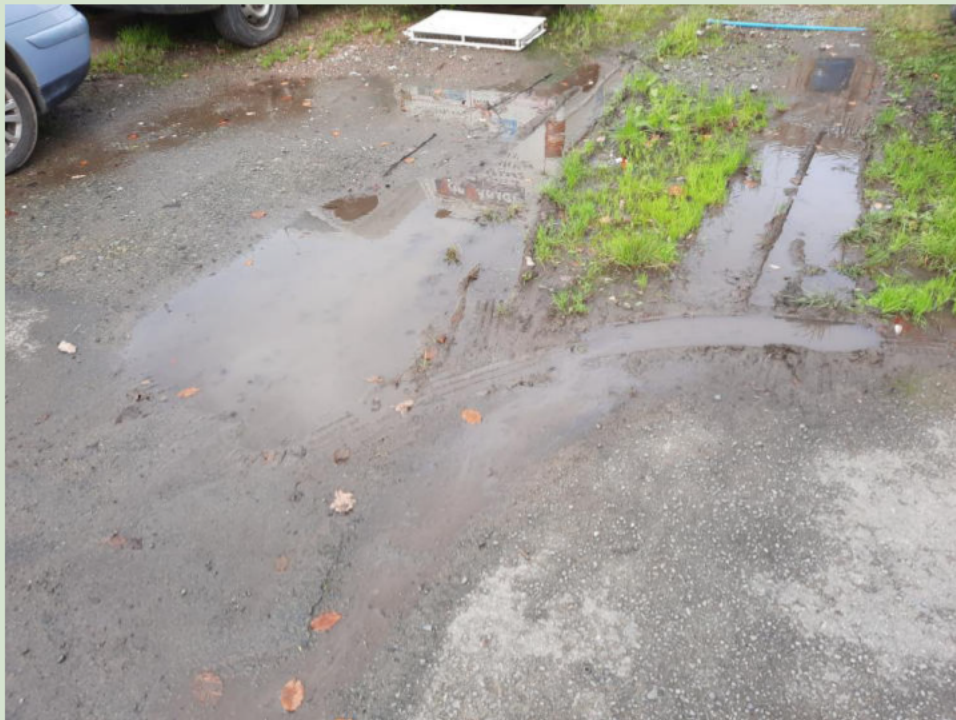
Photo 43

Looking north at southern end of 'Car Storage area'

Surface water pooling.

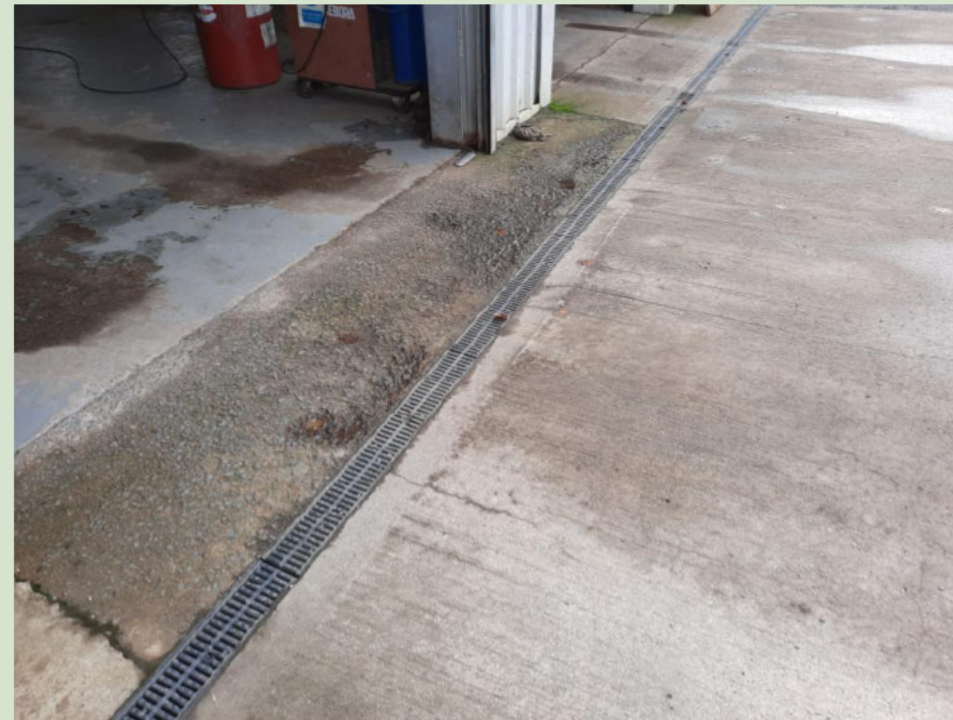
Photo 44

Western edge of Workshop near bays

Surface collection serving runoff from the workshop. The route where material flows from this drain off site is unknown.

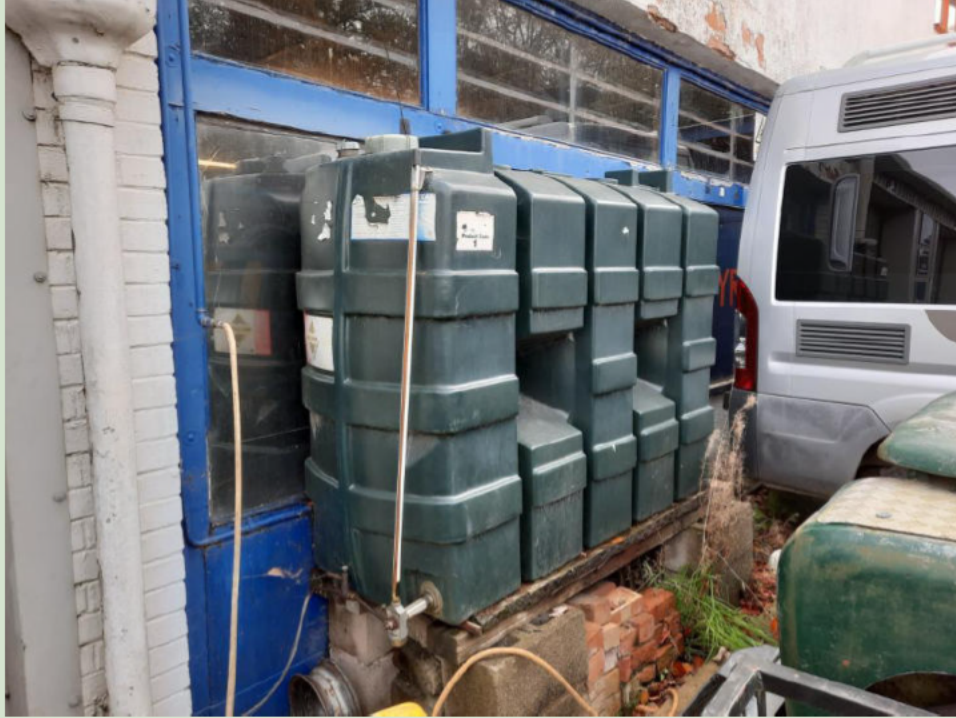
Photo 45

Looking south-east at the Main Top Garage Building (west elevation)

UPVC storage tank with unknown contents.

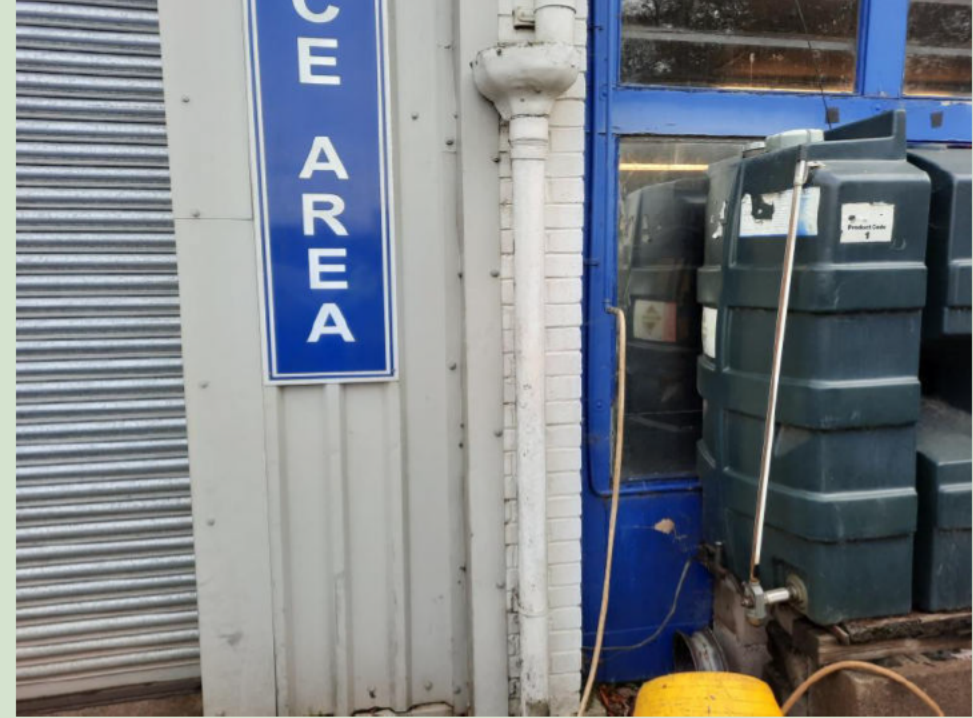
Photo 46

Looking east at the Main Top Garage Building (west elevation)

Cement rain water goods on west elevation to main building could contain asbestos. An asbestos refurbishment/demolition survey (ASG-RDS/ADS) should be completed on this site prior to any refurbishment or demolition taking place and recommendations should be followed.

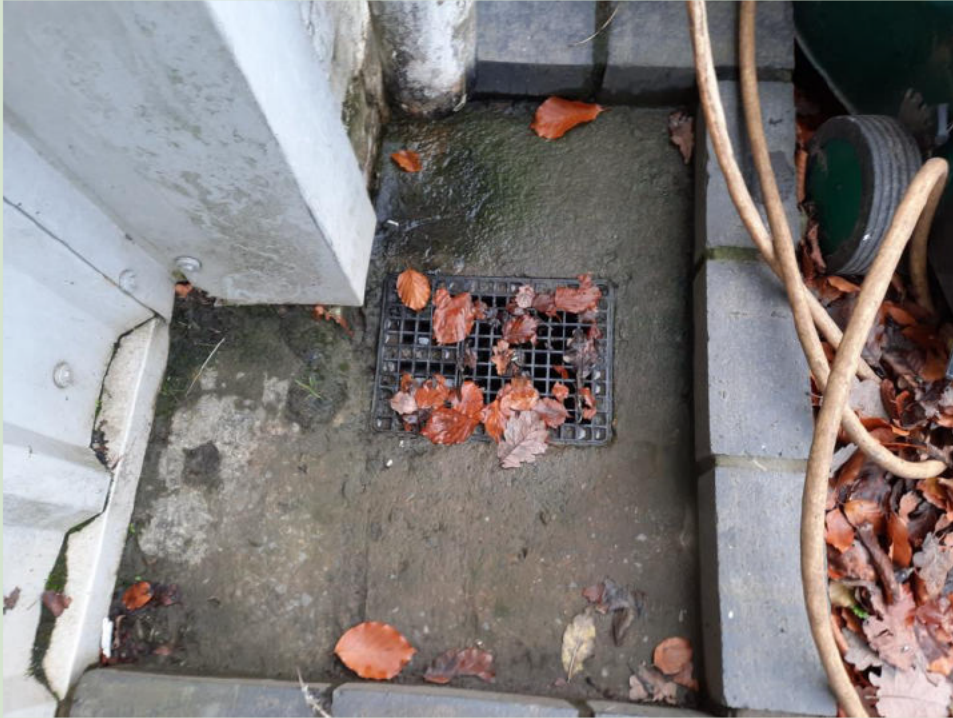
Photo 47

Adjacent to west elevation of main Top Garage Building

Drain serving runoff from the workshop.

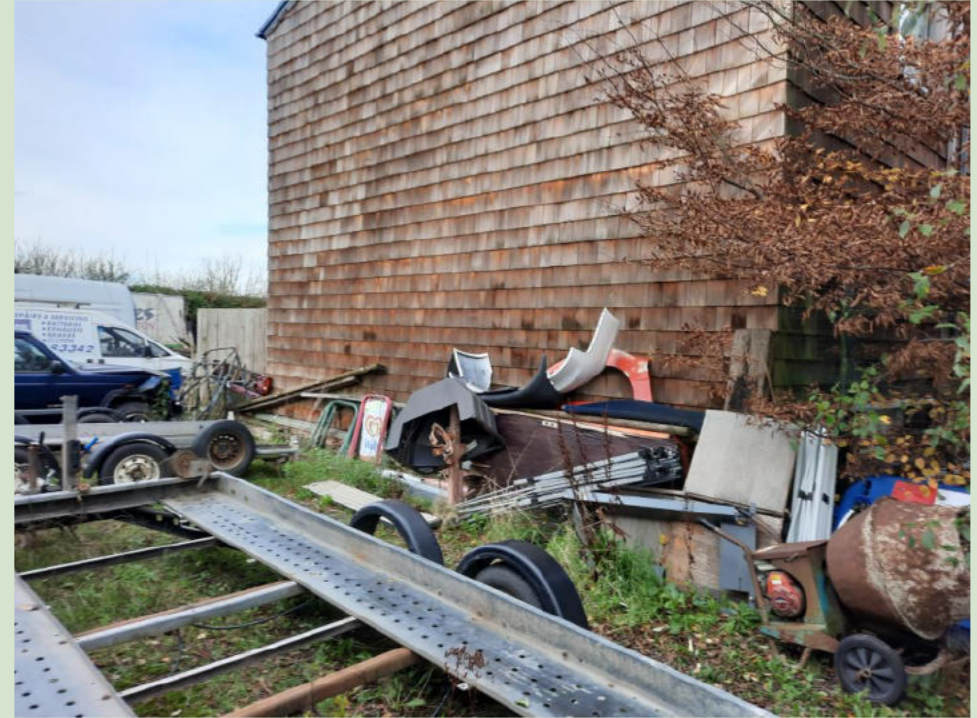
Photo 48

Looking north-west from south east at the northern end of site.

Adjacent property rear wall used as boundary on this site. There are also several things stored in this area although no deteriorated materials, oils, chemicals or asbestos were seen.

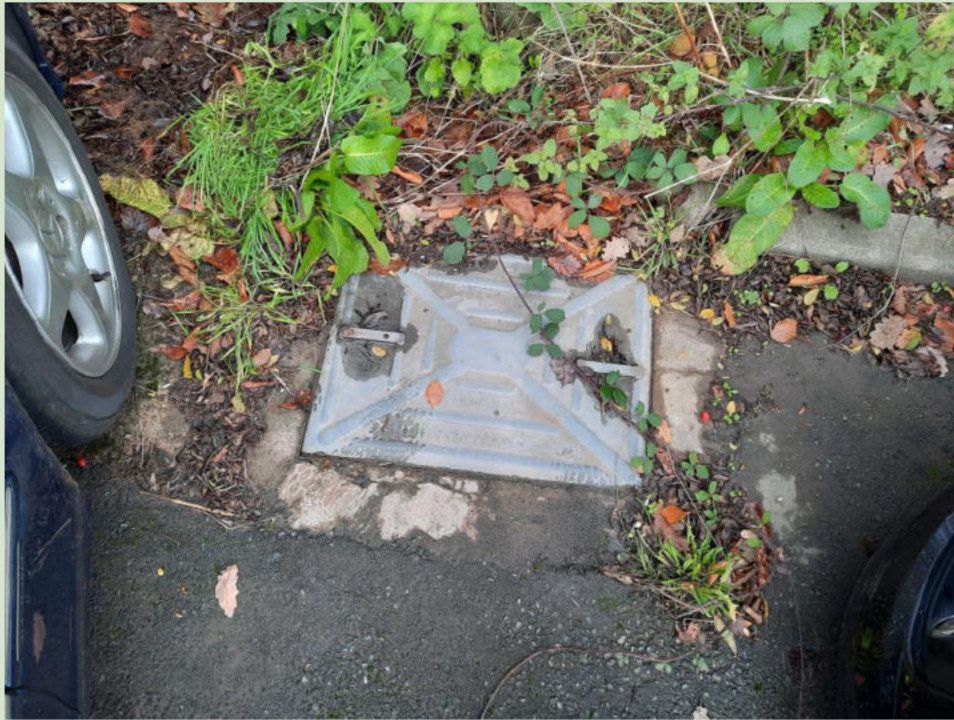
Photo 49

North-eastern corner of site adjacent to LPG Tank

Additional drain cover on the north-east of site.
