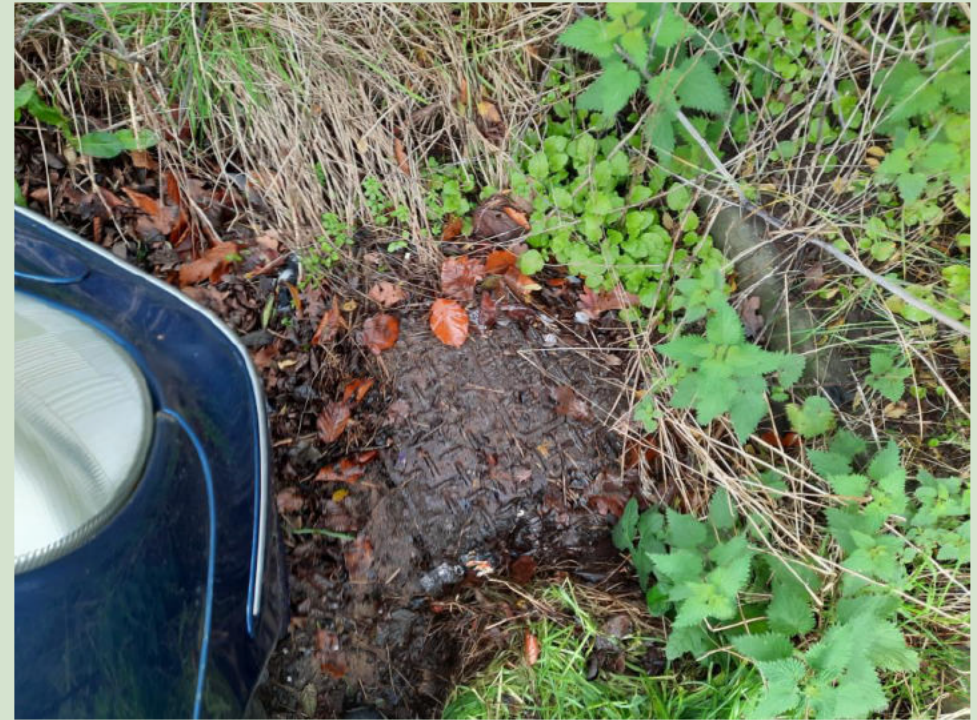
Photo 50

North-eastern corner of site adjacent to LPG Tank

Additional inspection drain cover on north-east of site.

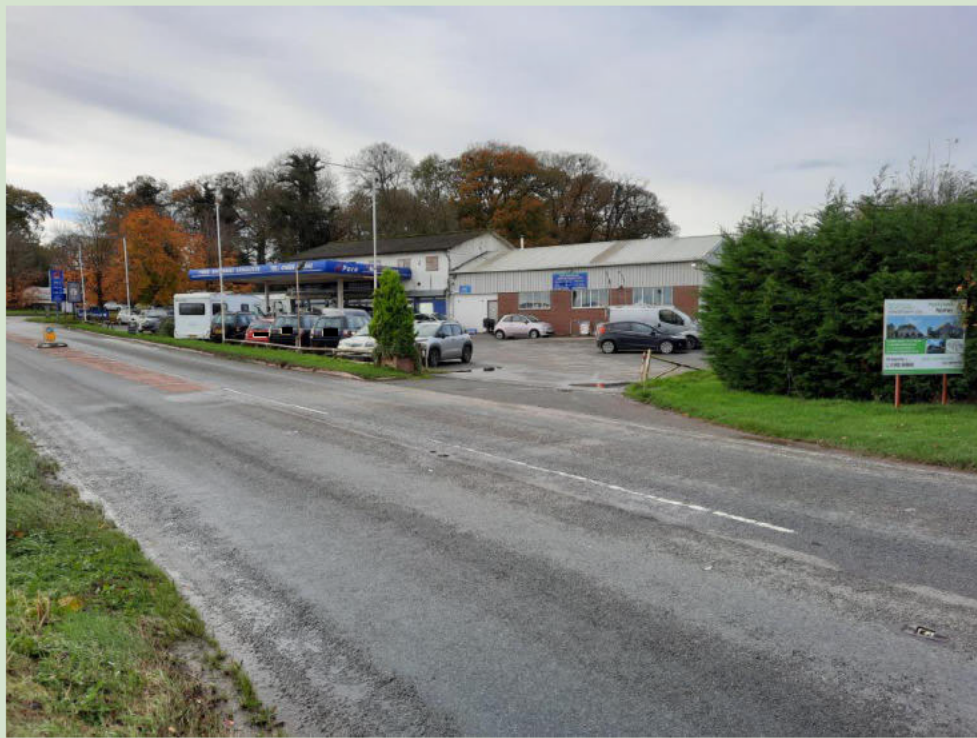
Photo 51

**View of entire site from the north-east looking south-west**

Site view from the north-east on the east side of Hereford Road looking at site towards the south-west.

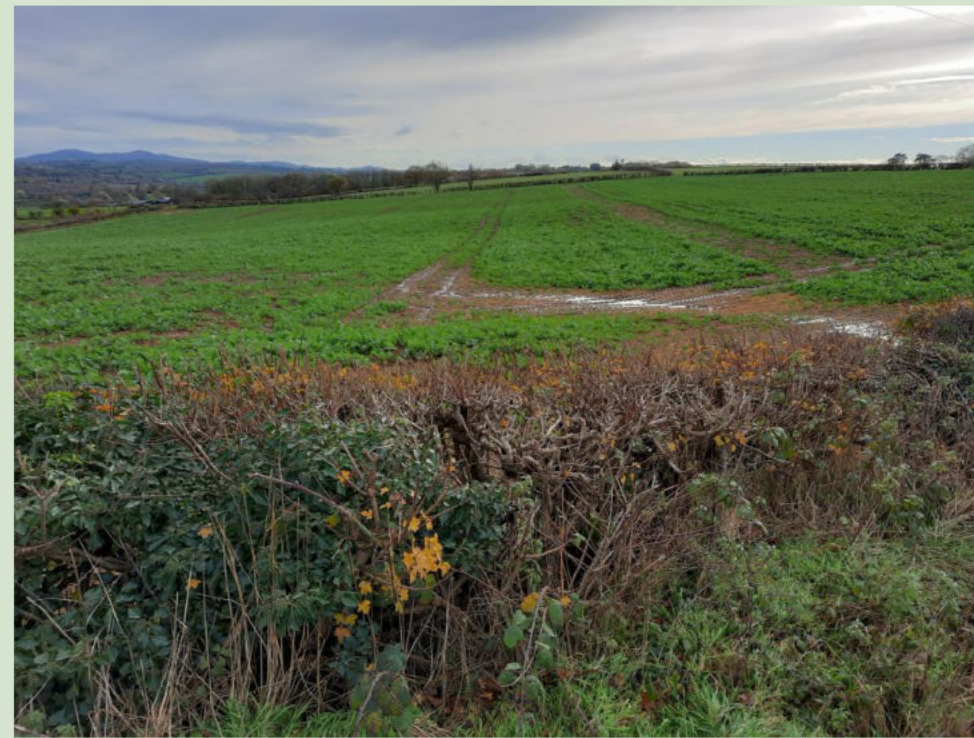
Photo 52

**Adjacent field east of Hereford Road**

Limited surface water pooling in field. General topography clearly dips towards the north-east.

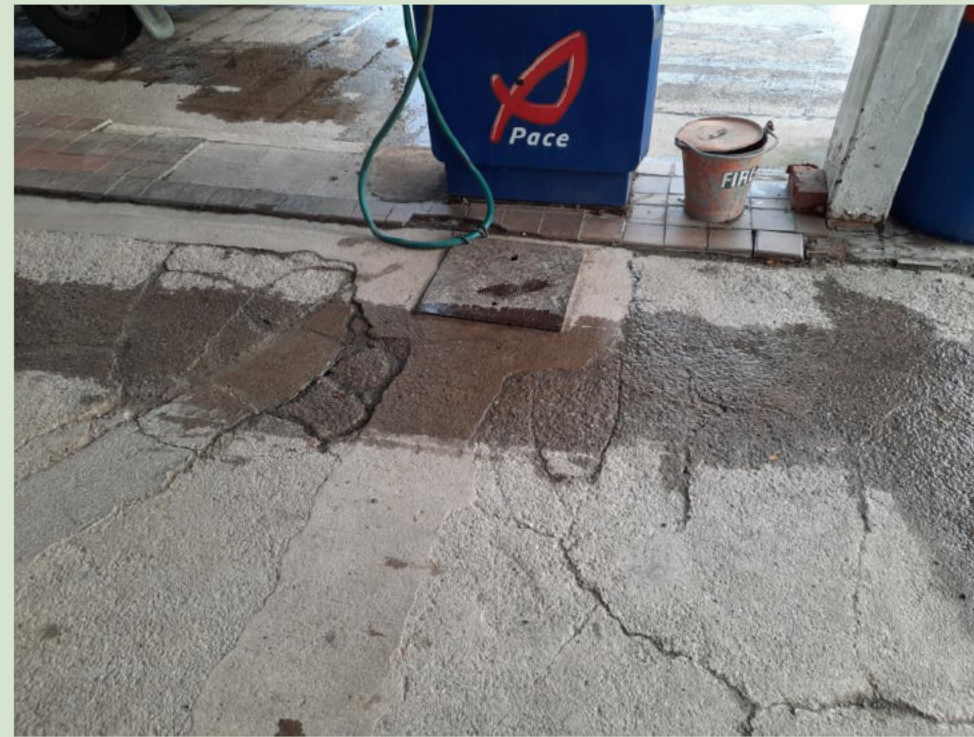
Photo 54

Main Fuel Forecourt on site

Drain cover in fuel forecourt. To note are the cracks in the hardstanding beneath the refilling areas.
