Moccas Court
Herefordshire

South External Elevation
As Proposed

Project	MCH01	No	2001
Scale (A1)	1:50	Status	S
		Revision	C

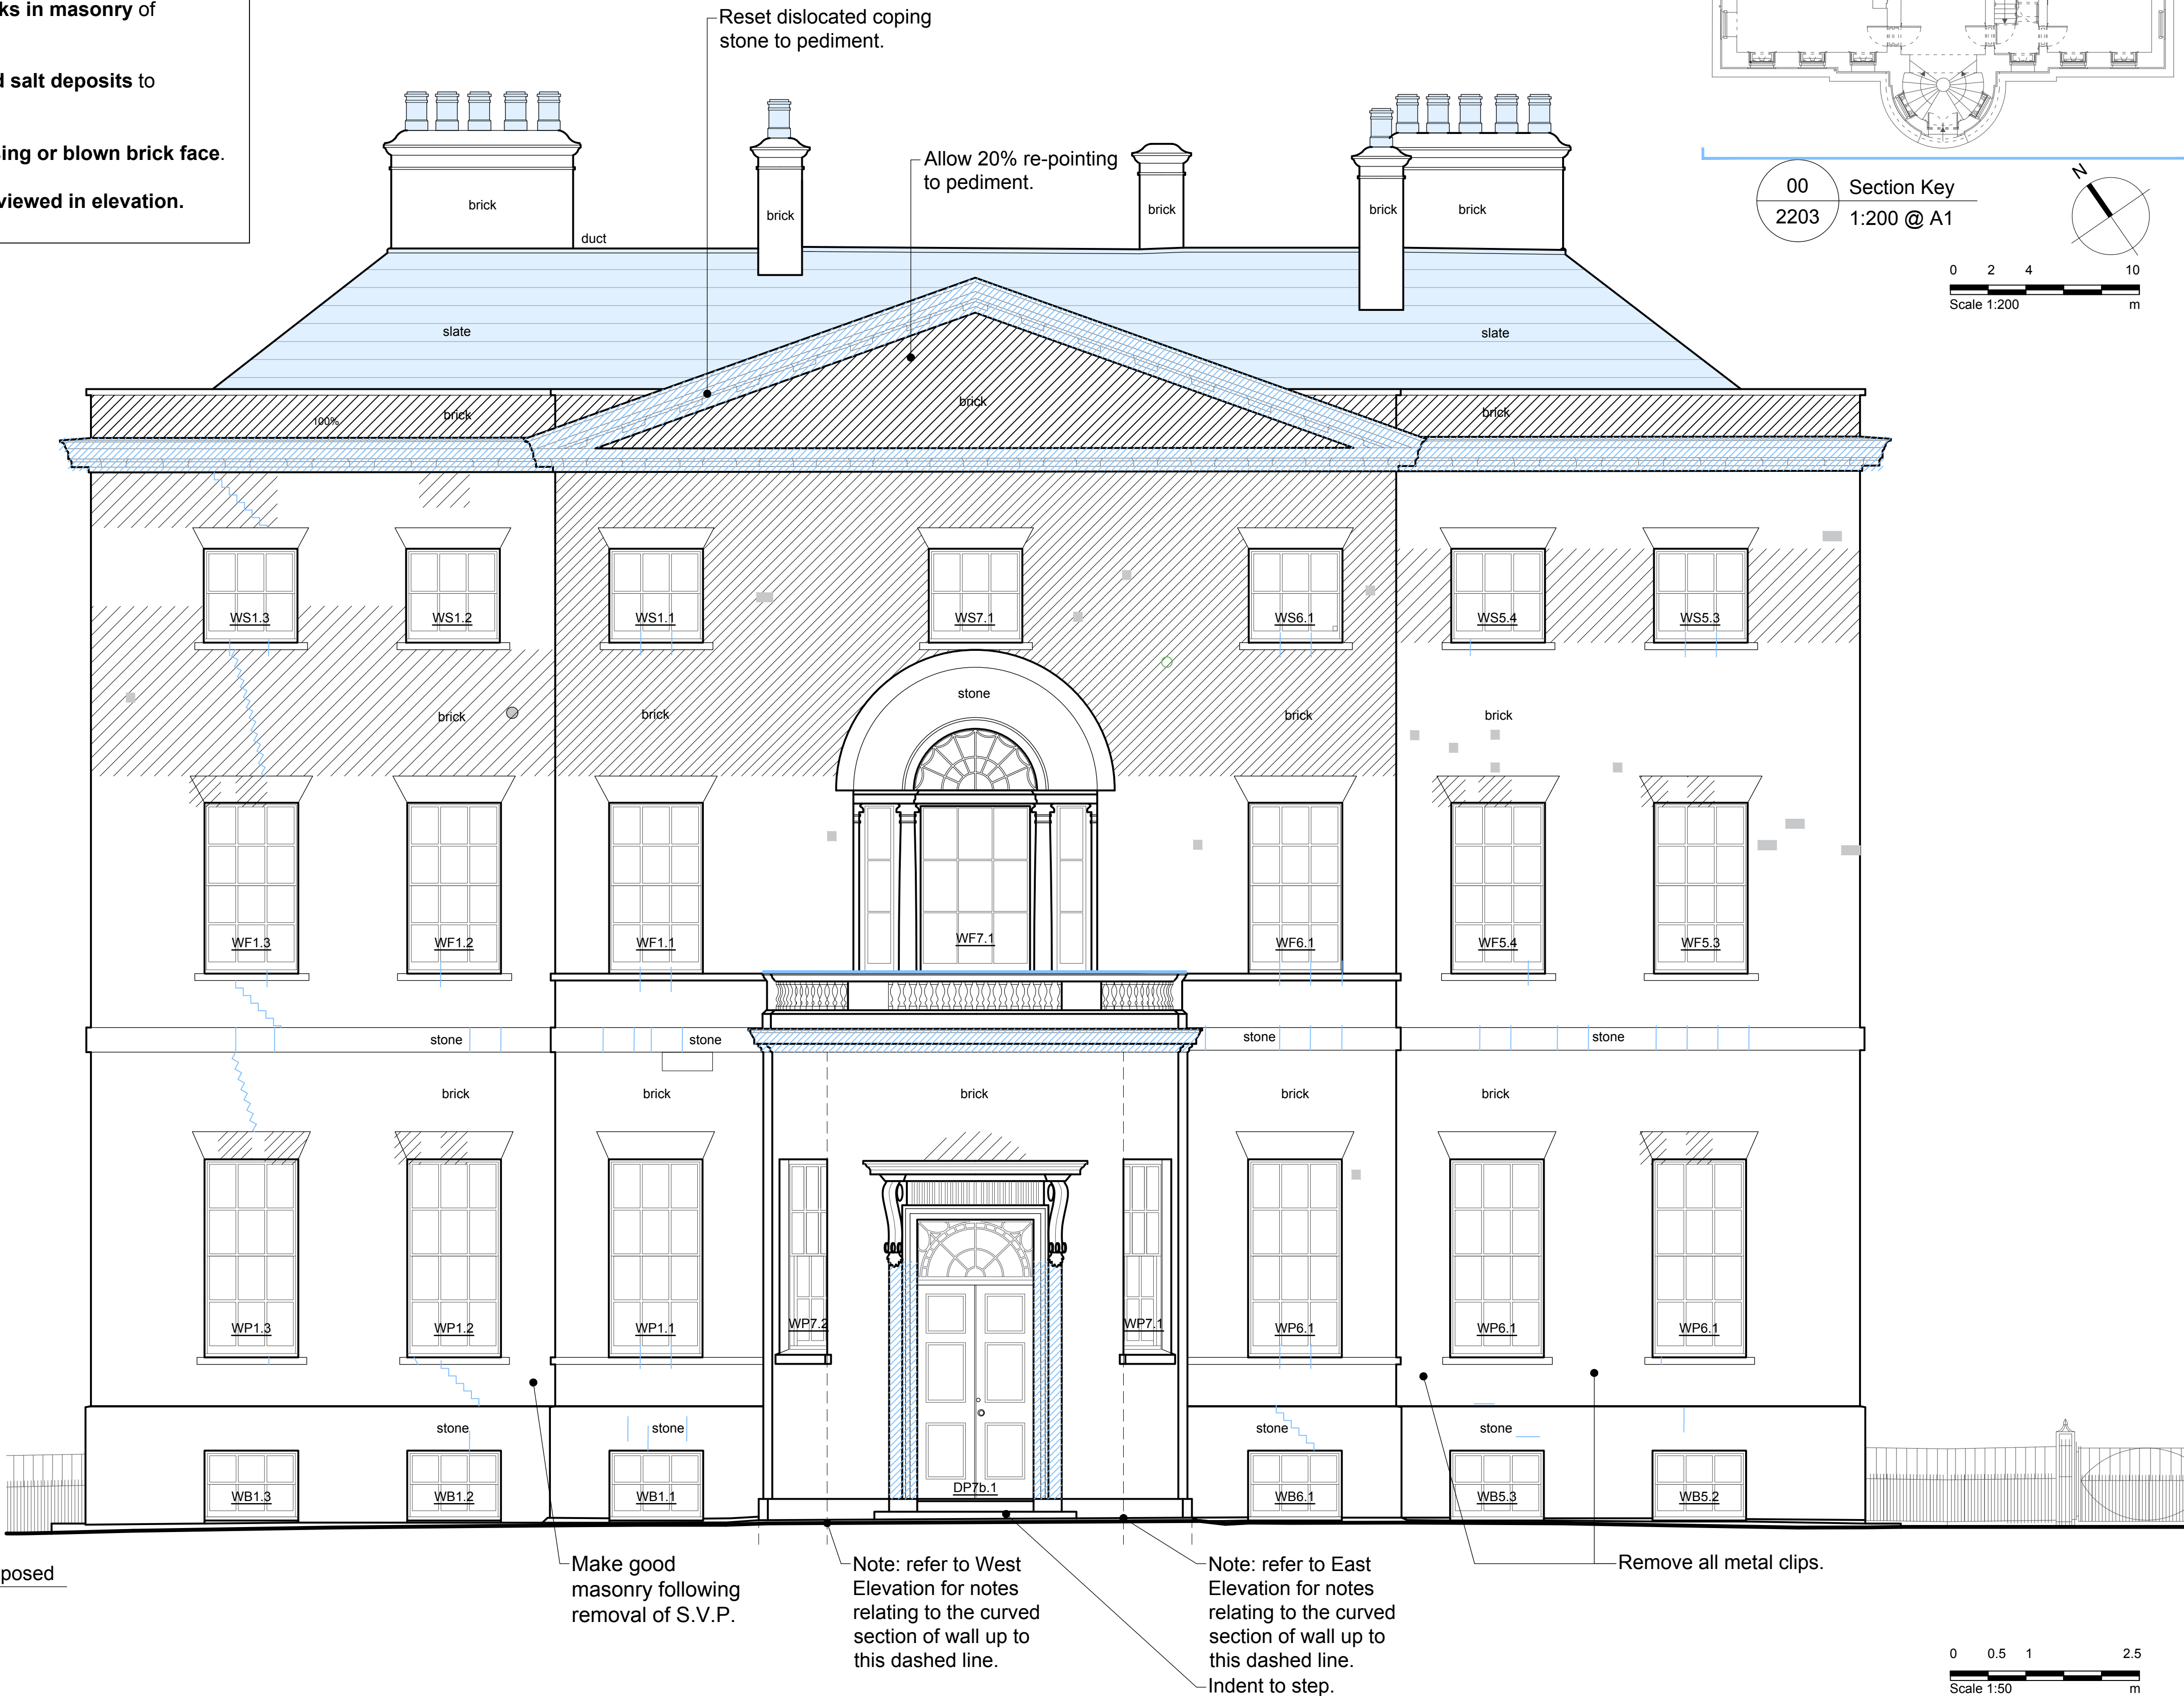
01 South External Elevation - As Proposed
2001 1:50 @ A1

- Repairs to voussoirs of flat gauged brick heads to include re-pointing of false joints where present, in a soft lime mortar as per Architect's specification.
- Where fixings or fittings are removed from the external facade, any remaining holes or openings are to be made good to match the surrounding surface materials.
- Allow to repair joint beneath all stone cills and projecting stone features.
- Rake out junction between timber window frame, masonry, reveal and ... with ... sand mastic, to all windows.

Repoint open jointed brickwork areas, with associated percentages. (Note - this should be assumed to have 100% open joints unless otherwise stated).

Repoint open jointed entablature or cornice, between stonework.

Repoint open jointed copings, removing vegetation growth where present in places.

Repair and re-point cracks in masonry of stone or brickwork.

Hand clean staining and salt deposits to brick and stonework.

Replace damaged, missing or blown brick face.
