Structural Appraisal Report

Proposed Barn Conversion

Parkmill,
Llangarron,
Herefordshire,
HR9 6NH

Davidson John Ltd.
Ref.No. 900/37/01/TJ

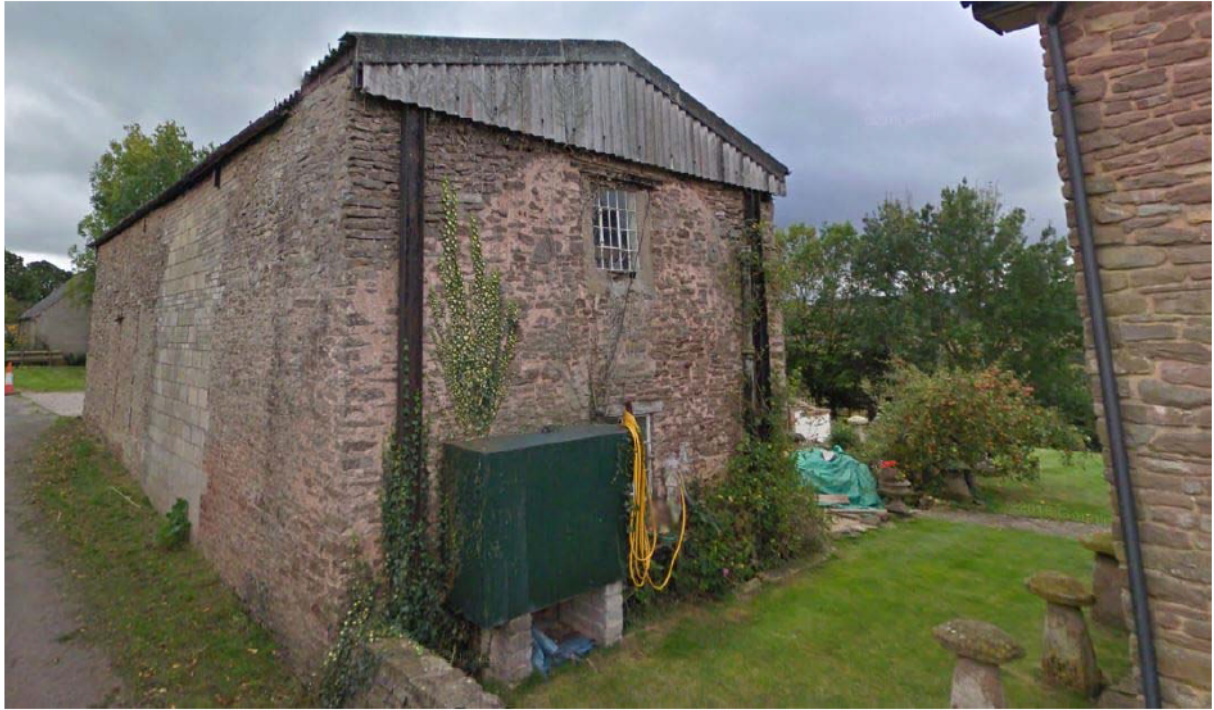
Photo 1

The barn was originally of solid natural stone masonry (rubble fill) construction (Please refer to photos 1 and 2) with walls approximately 450mm in thickness. The historical alterations to the building have been formed in concrete blockwork. Blockwork has been used to infill the cartway type door opening on the east side of the building (photo 2 and 3) to form the internal gable currently separating the storage / workshop mezzanine levels (photo 3), to form the upper part of the west side wall of the building (photo 4), and to form the large opening on the south side of the building (photo 4). At high level on the east wall, the inner leaf of stone has been removed (photos 5 and 6), presumably for building use elsewhere. The cartway door on the west side has been infilled at mezzanine level using a lightweight timber frame with timber cladding (Photos 7 and 8). The gable end to the north of the building is the original stone masonry construction (Photo 1).

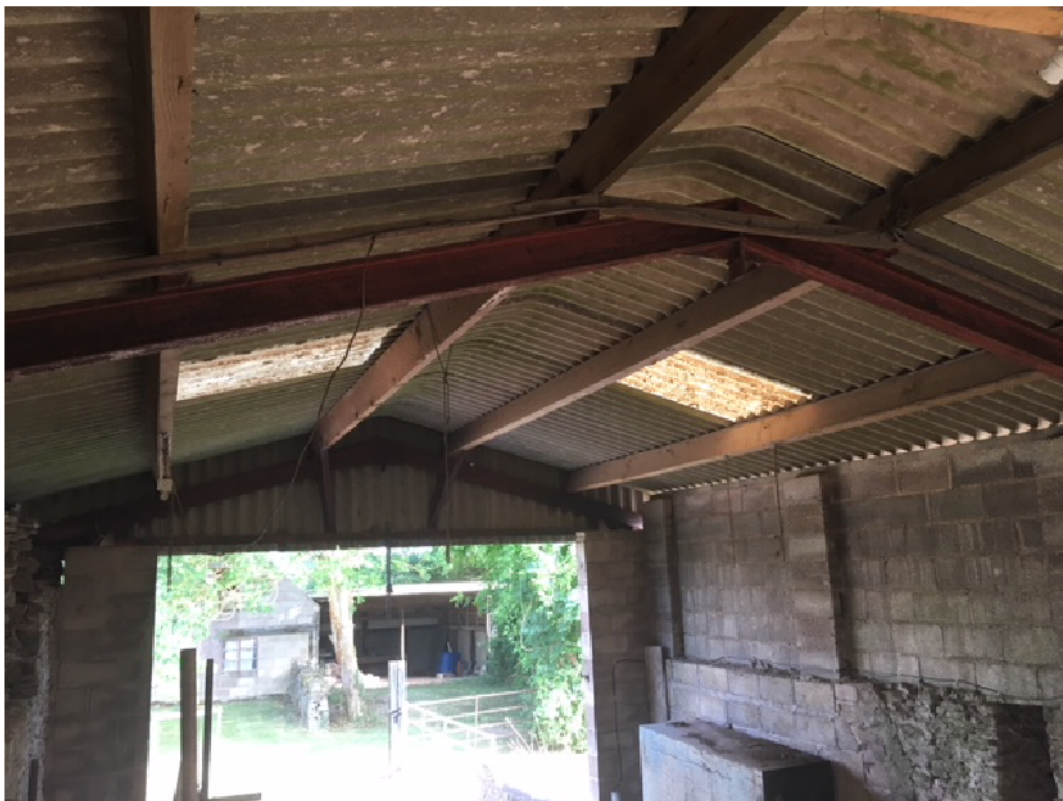
Photo 4

The roof to Barn 1 is a shallow two pitch gable ended structure, covered with lightweight corrugated sheeting. The sheeting is supported on wider spaced timbers running across the pitched faces of roof, spanning between steel portal frames (photo 4).

The roof structure to this barn, is not original and would be replaced as part of the works. It is likely that conventional pitched rafters would be used, spanning from wall plate to ridge with intermediate support provided by a timber purlin. It should be possible to incorporate feature trusses within the new roof arrangement.

7. The roof structure to both barns will require replacement.
8. The First floor finished level in Barn 1 is not yet established. The timber first floor structure is likely to require strengthening or replacement.

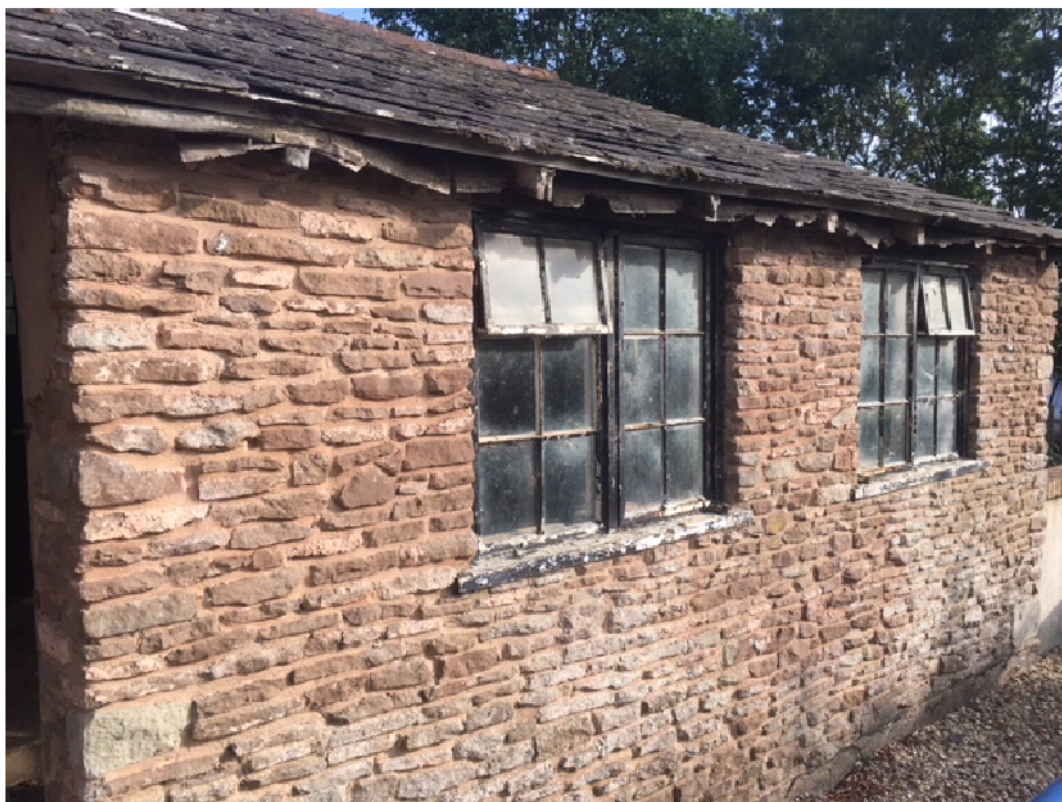
Photo 9

On the north side the wall has been constructed as blockwork to the inner face with stone facing externally (Photo 9). The wall on this side steps back to form a porch area, with the oversailing roof pitch supported on timber post and beams (photo 10). The posts are in poor condition (Photos 11 and 12). The west and south walls are constructed of blockwork internally with render finishes externally (photos 13 and 14). The roof gable on the west side is a timber framed construction with timber cladding.

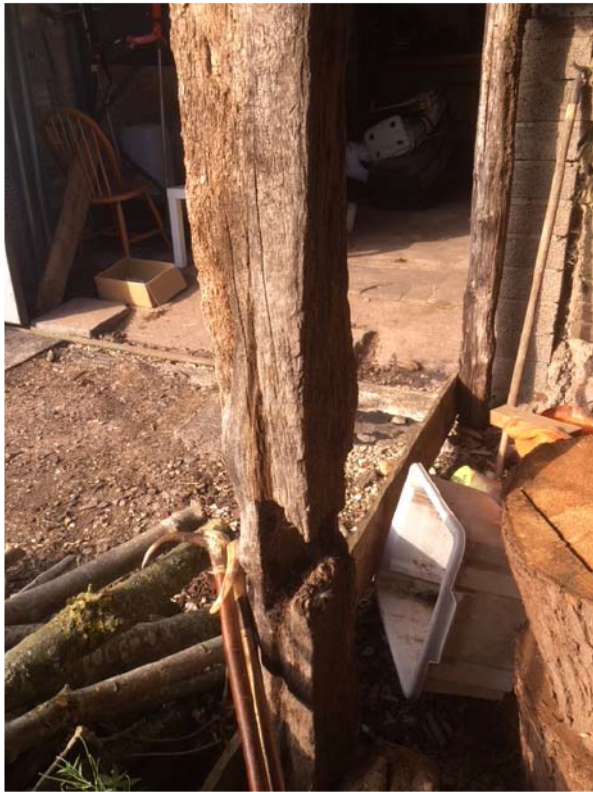
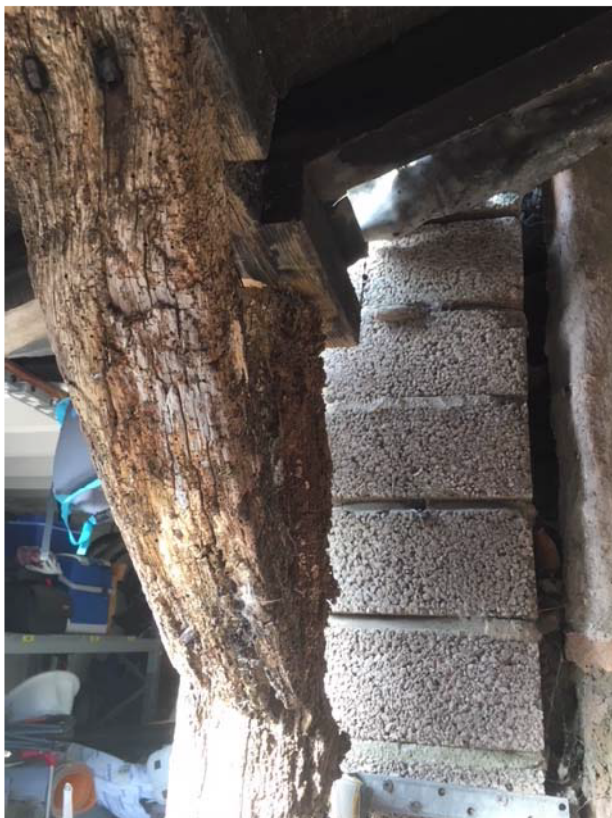
The timber post and framing on the North side of the building has extensive woodworm damage and would require replacement with a similar post , brace and beam arrangement.

9. The timber posts forming the porch area on the North side of Barn 2 are to be replaced. The new framing would be timber posts supported on staddle stones with arched braces to a new timber beam over.
