APPENDIX A

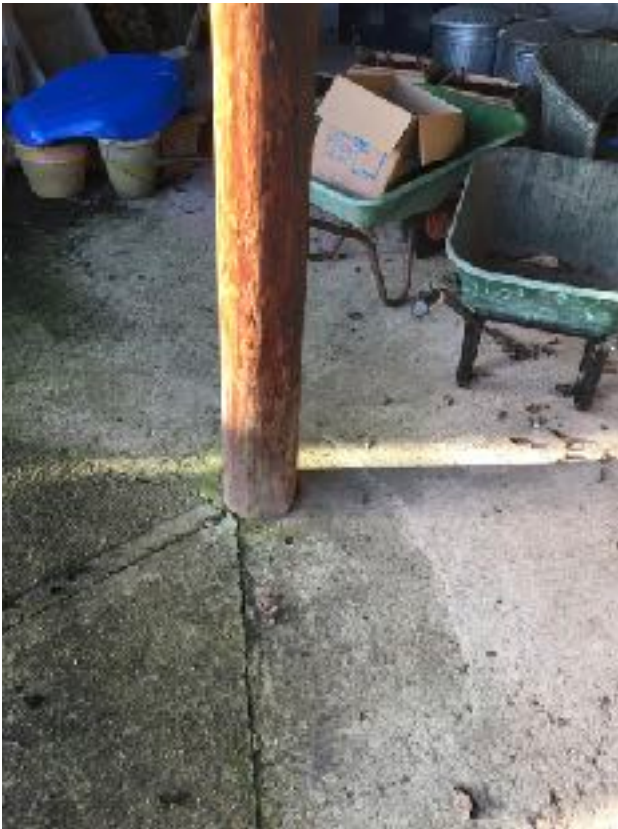
fig.1

3.1.1 Some dampness was evident at ground floor slab level around the base of the load bearing timber post.

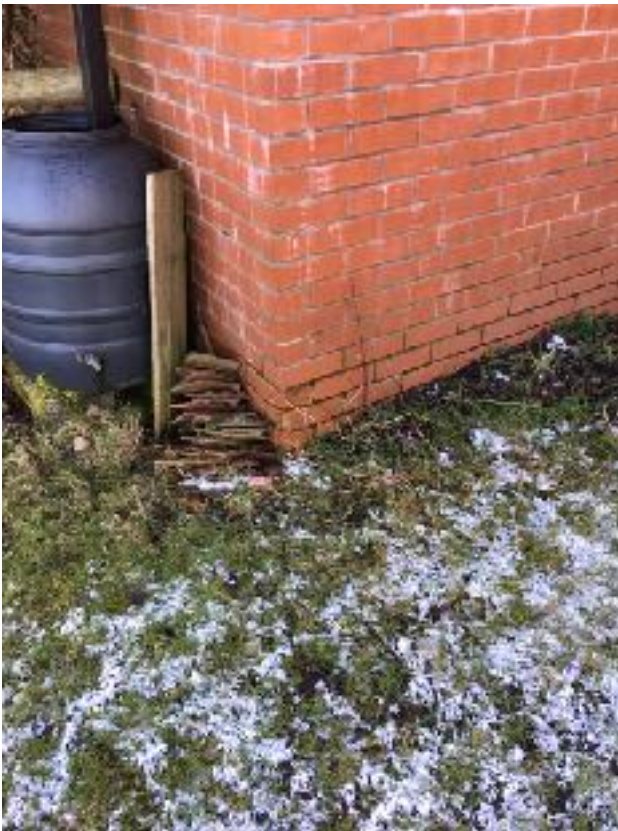
fig.2

3.2.1 Slight frost damage was noted to the external facing brickwork immediately above external ground floor level at the return to the north elevation

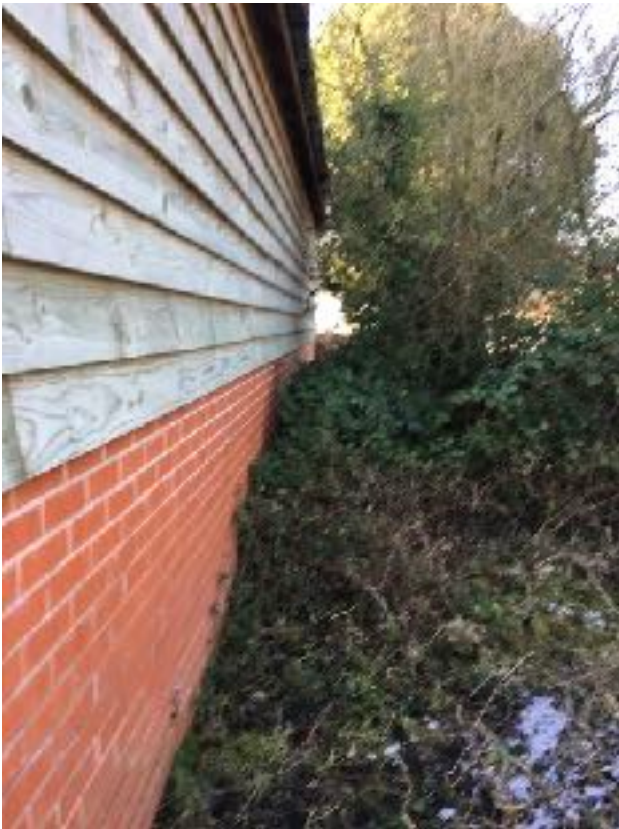
fig.3

3.3.1 There was considerable vegetation growth along this elevation precluding an inspection of the masonry at external ground floor level
