Eurlng **Allan Pearce** BscEng ACGI CEng MICE MStructE  
**Consulting Civil and Structural Engineer**

Your ref:  
My ref: ACP/08191  
12 October 2010

**North Barn at Lower House, Hillhampton, Ocle Pychard, Hereford**

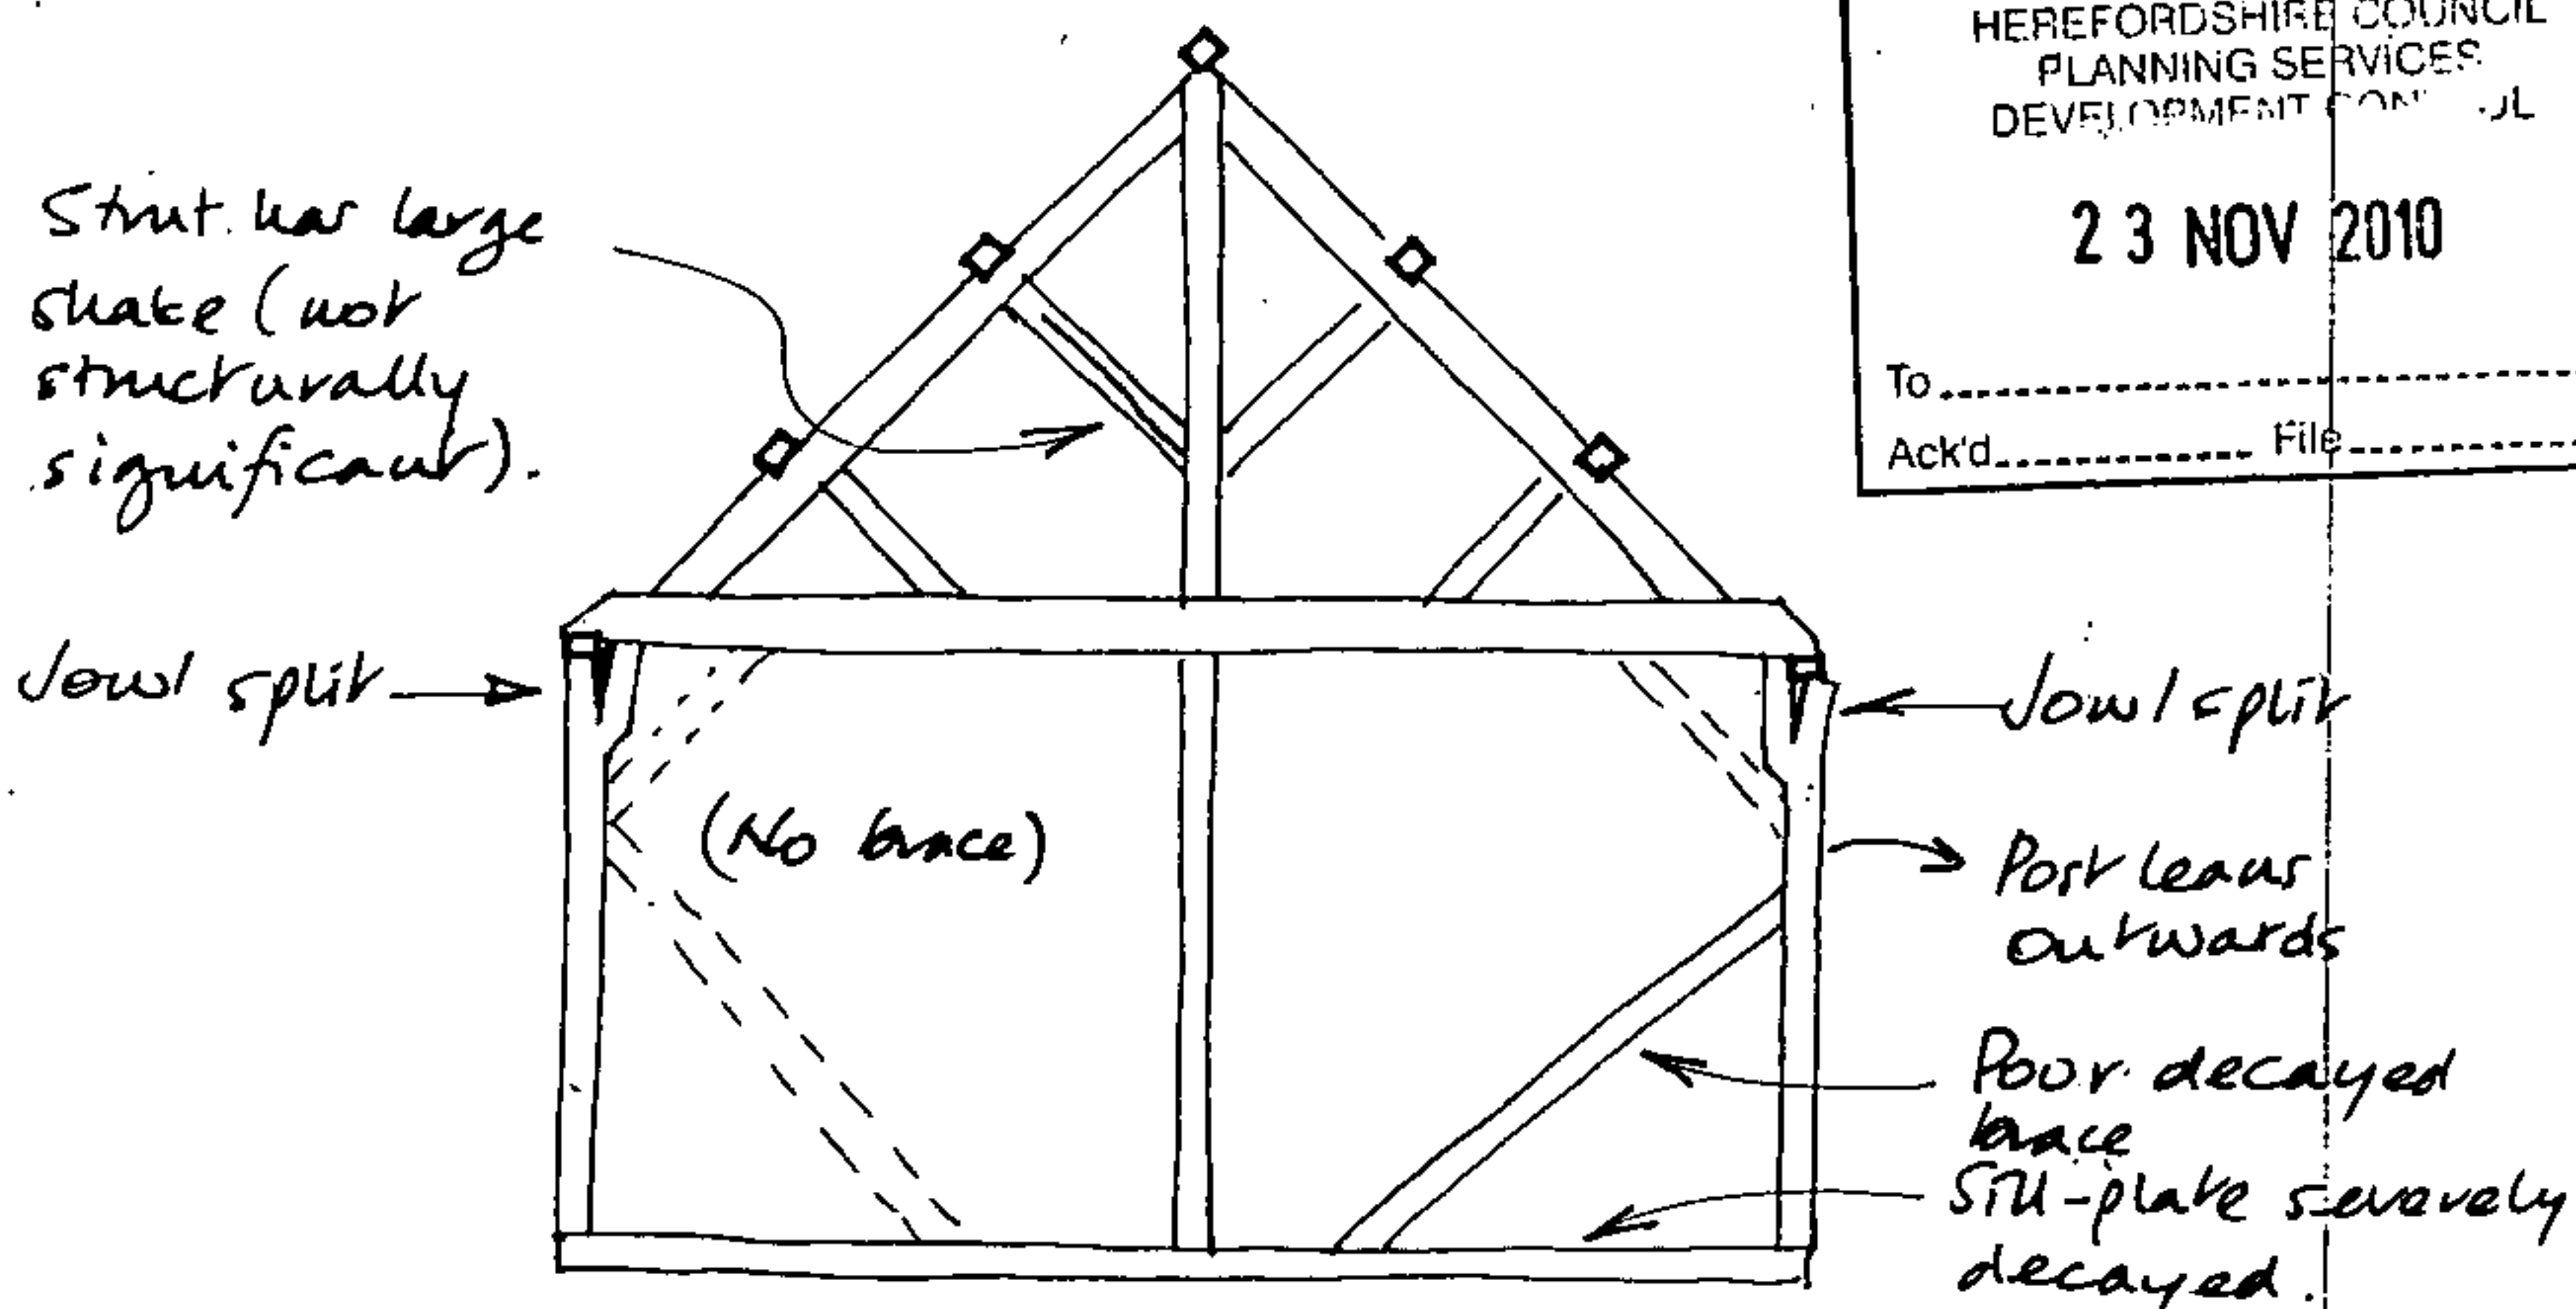
#### FRAME 2.

Frame has been re-worked - mortices in posts support former knee-braces and down-brace missing.
