**APPENDIX B**

**SITE PHOTOGRAPHS**

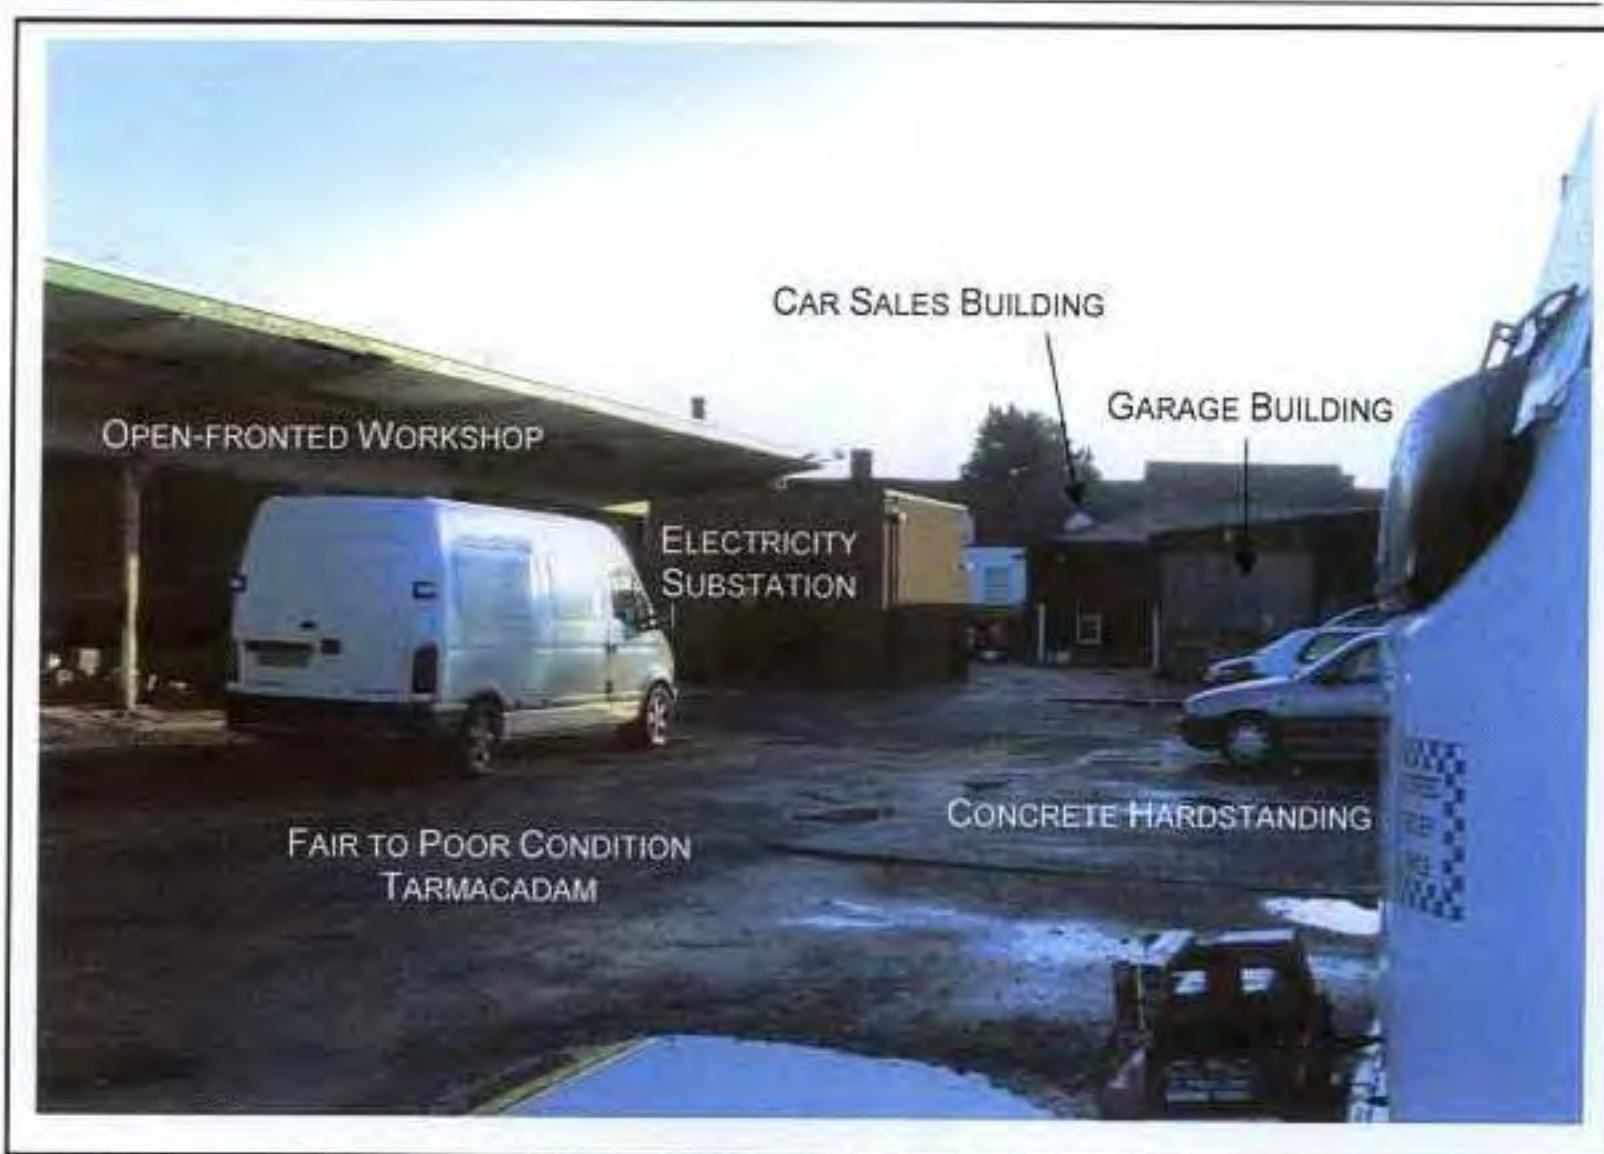
**Photograph 1: View looking north-east through the site from the south-west corner.**

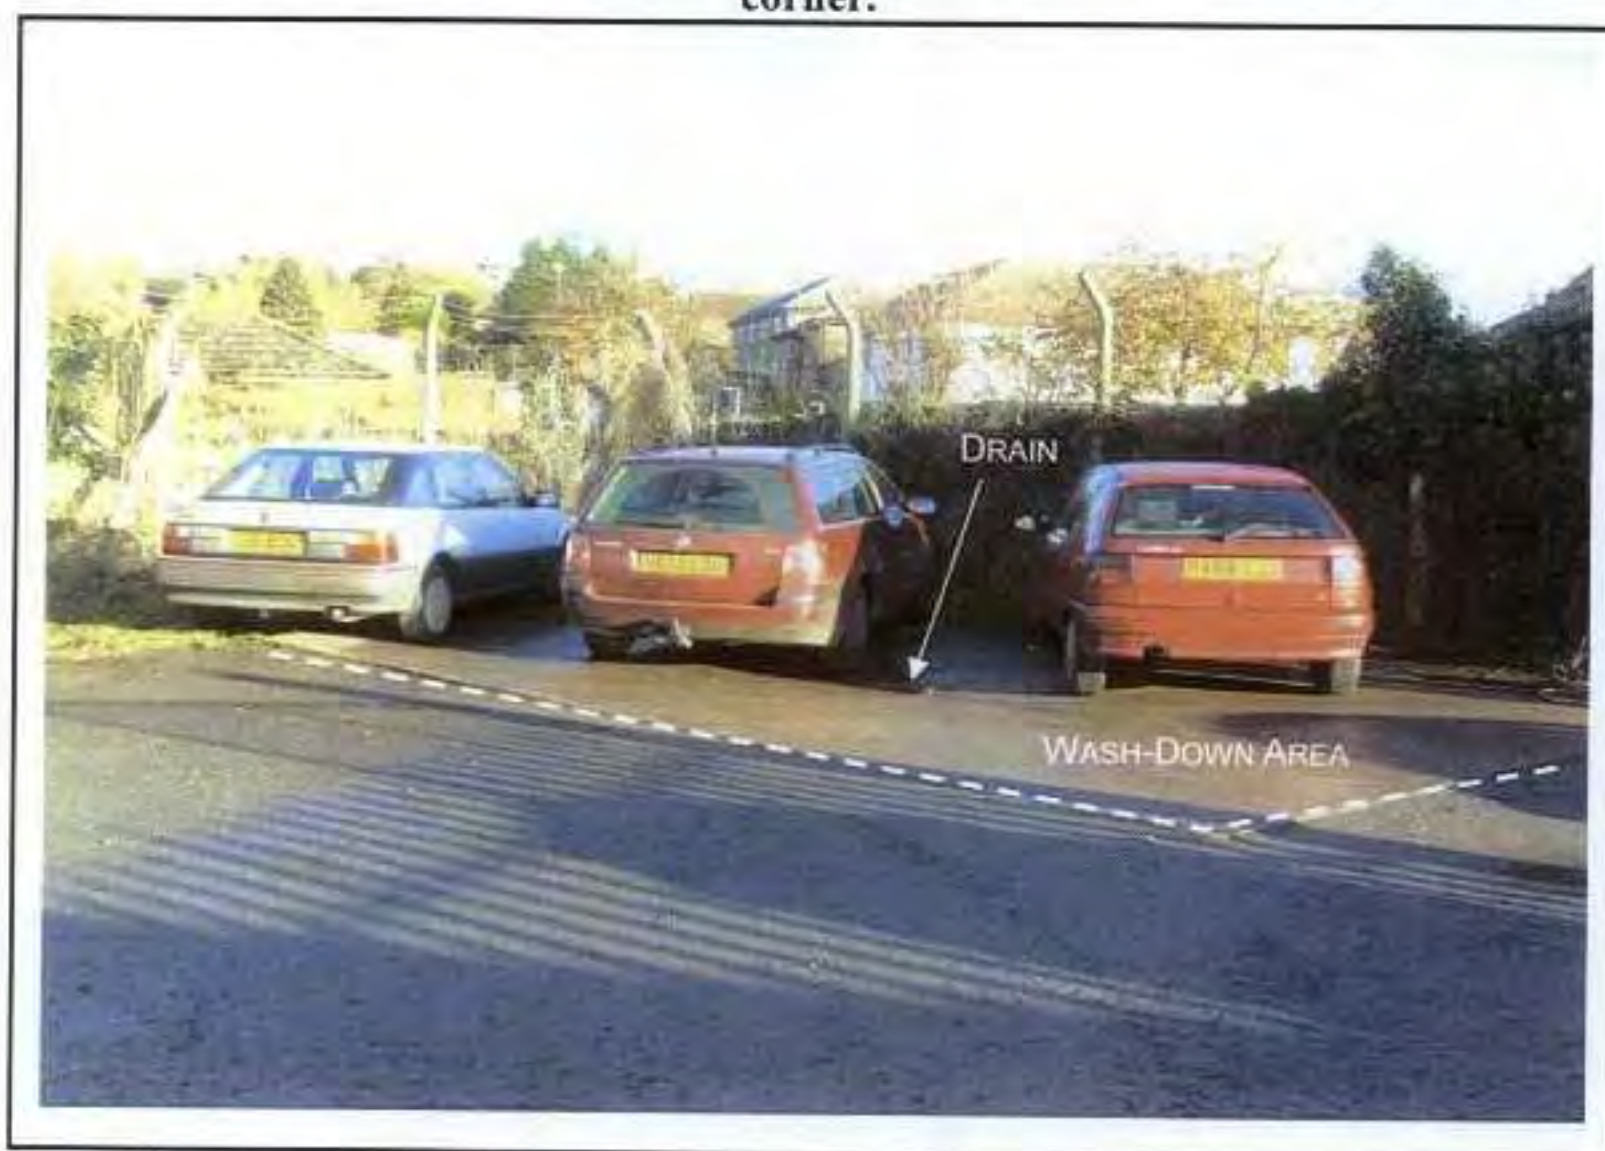
**Photograph 2: Concrete 'Wash-Down Area' in north-west corner of the site.**

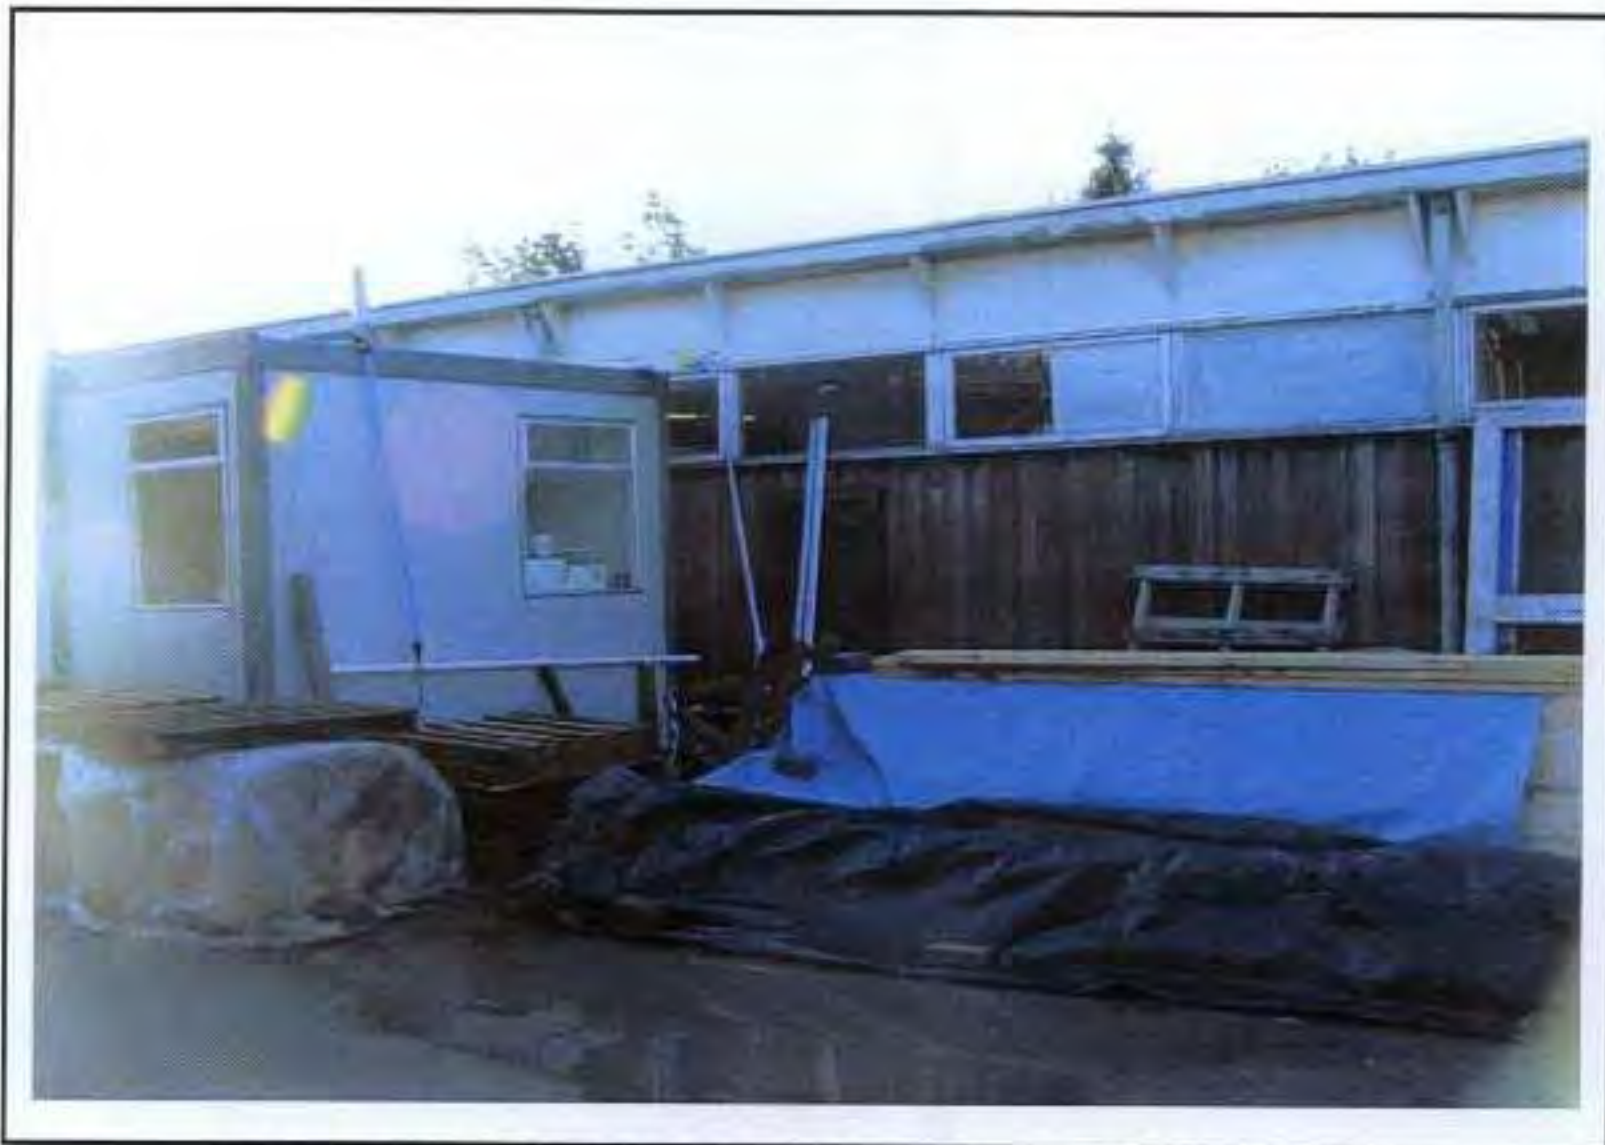
**Photograph 3: Builder's Yard Area in the north of the site.**

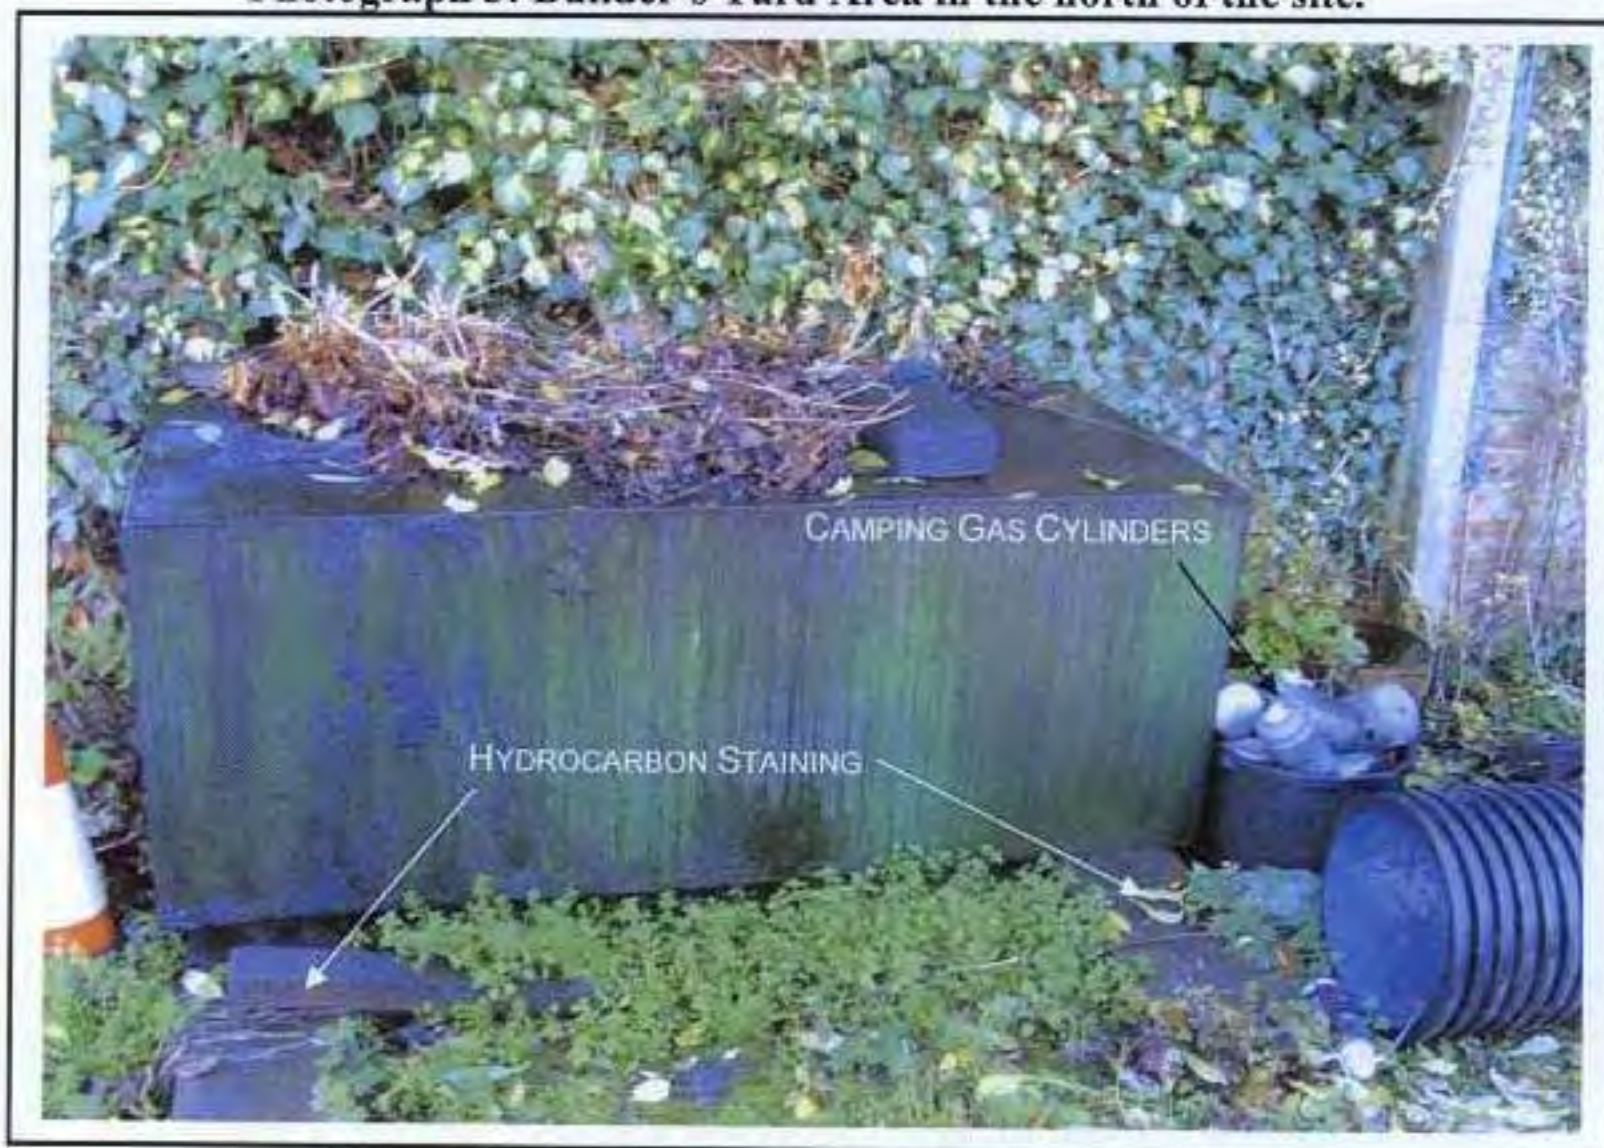
**Photograph 4: Waste Oil Above Ground Storage Tank.**

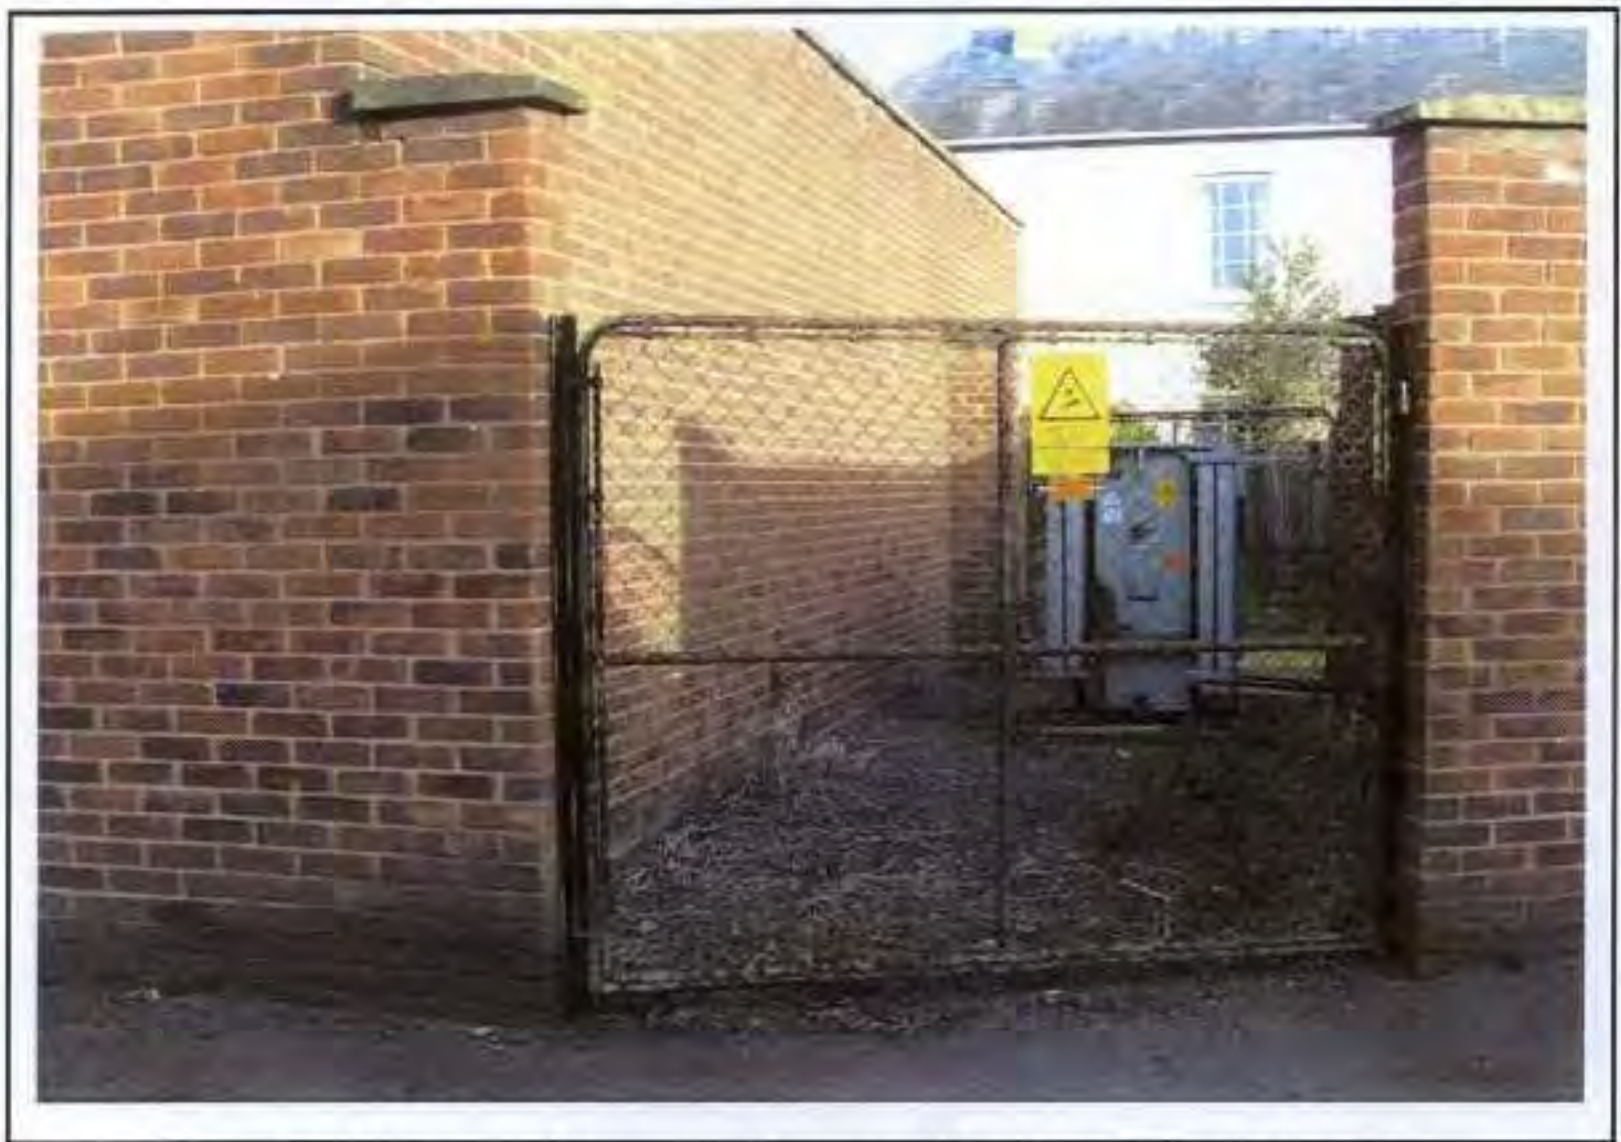
**Photograph 5: Transformer to the east of the Electricity Substation.**

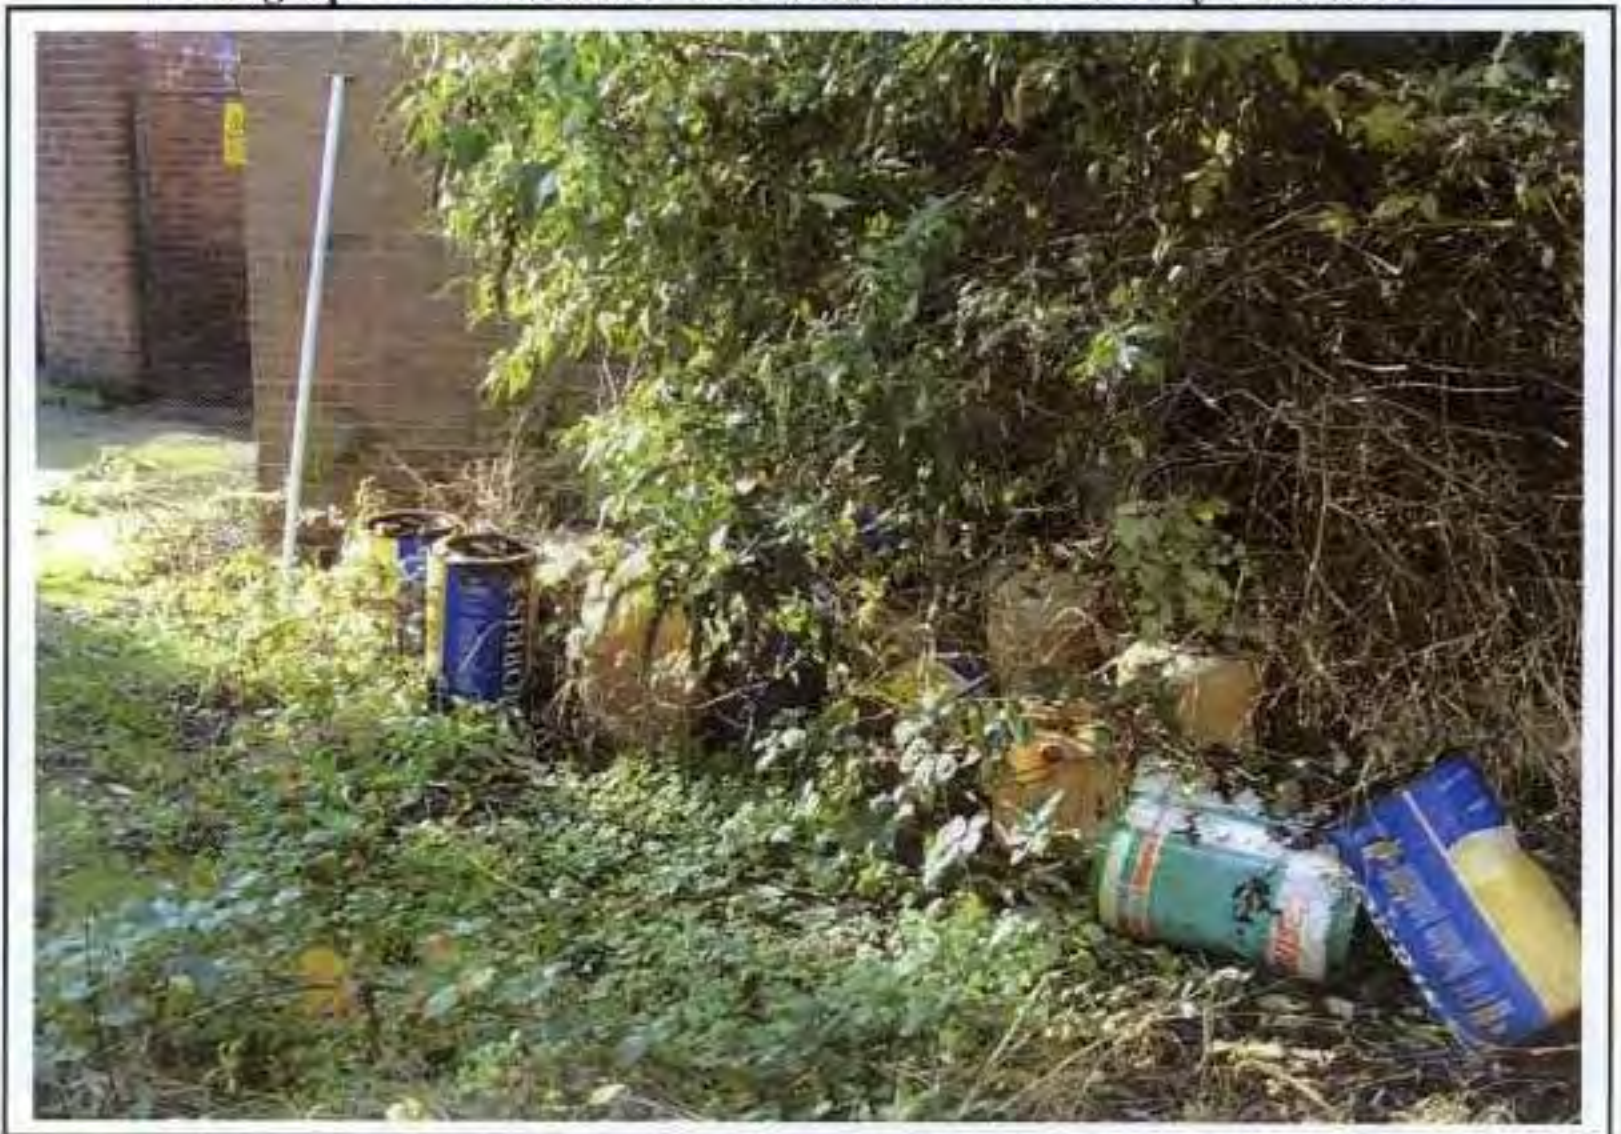
**Photograph 6: Waste drums of Hydraulic Oil & Lubricants left to the north of the Electricity Substation.**

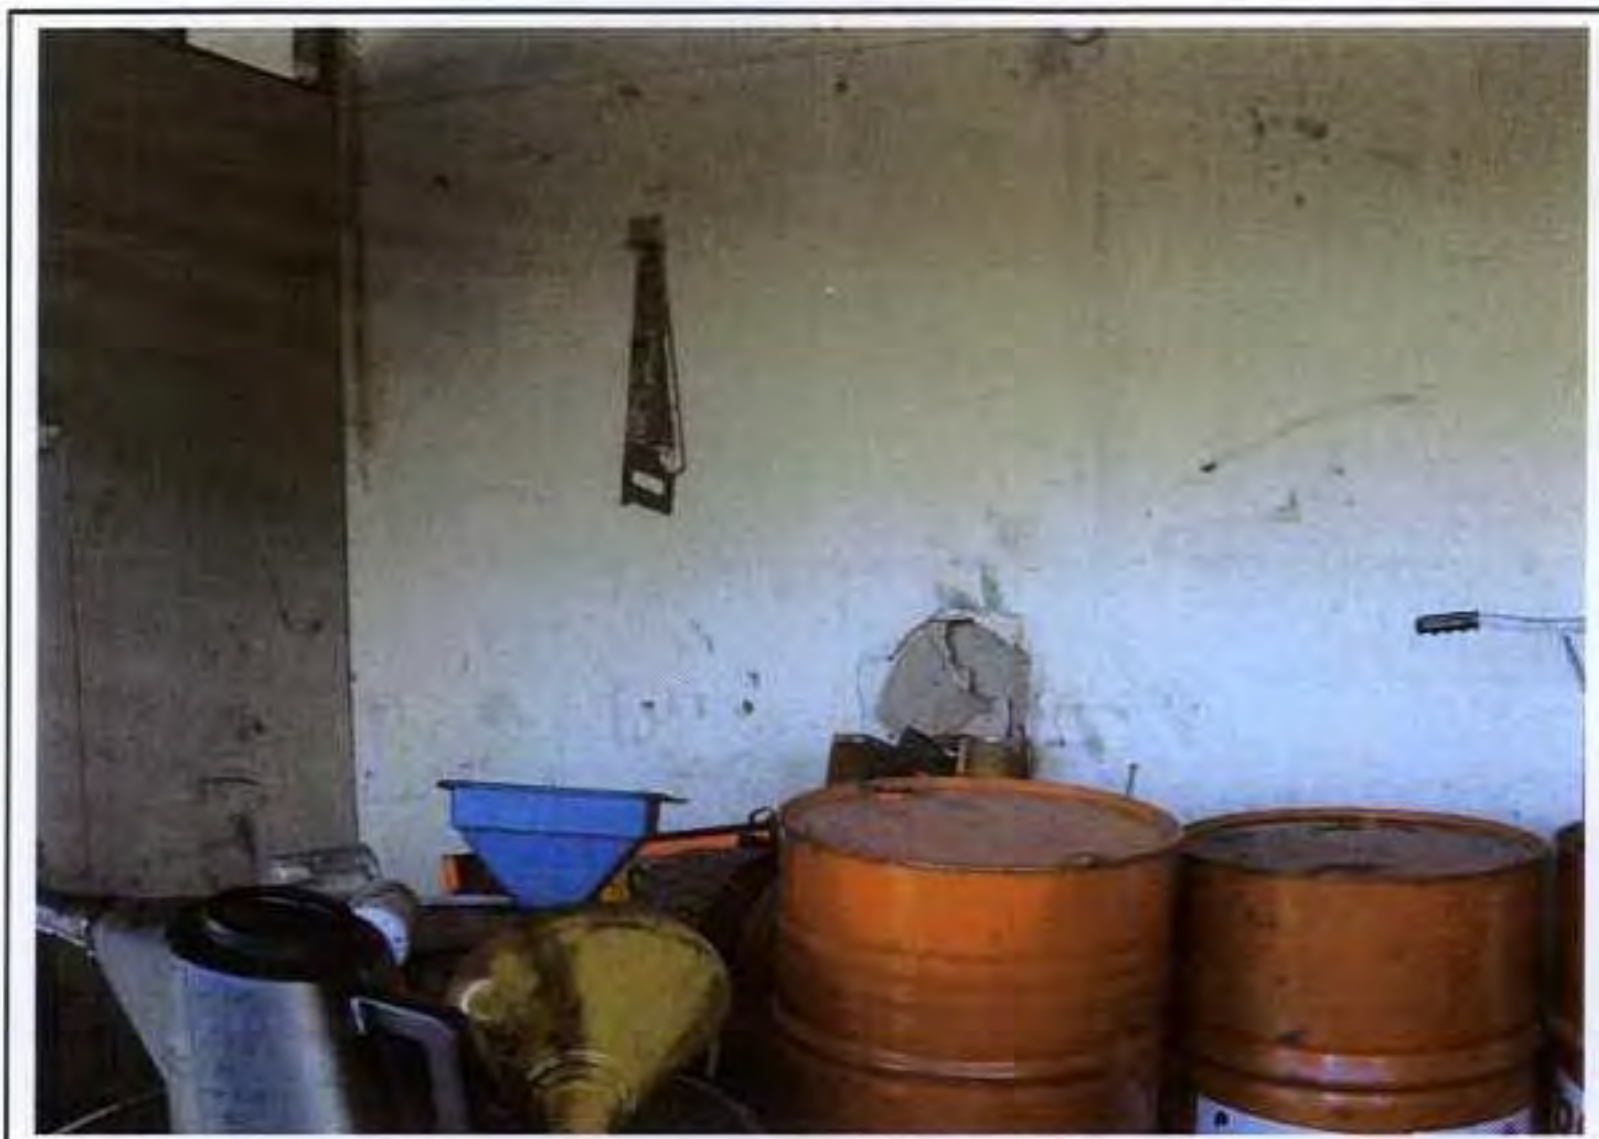
**Photograph 7: Taped damaged areas in pACMs Insulation Board within the open fronted workshop building.**

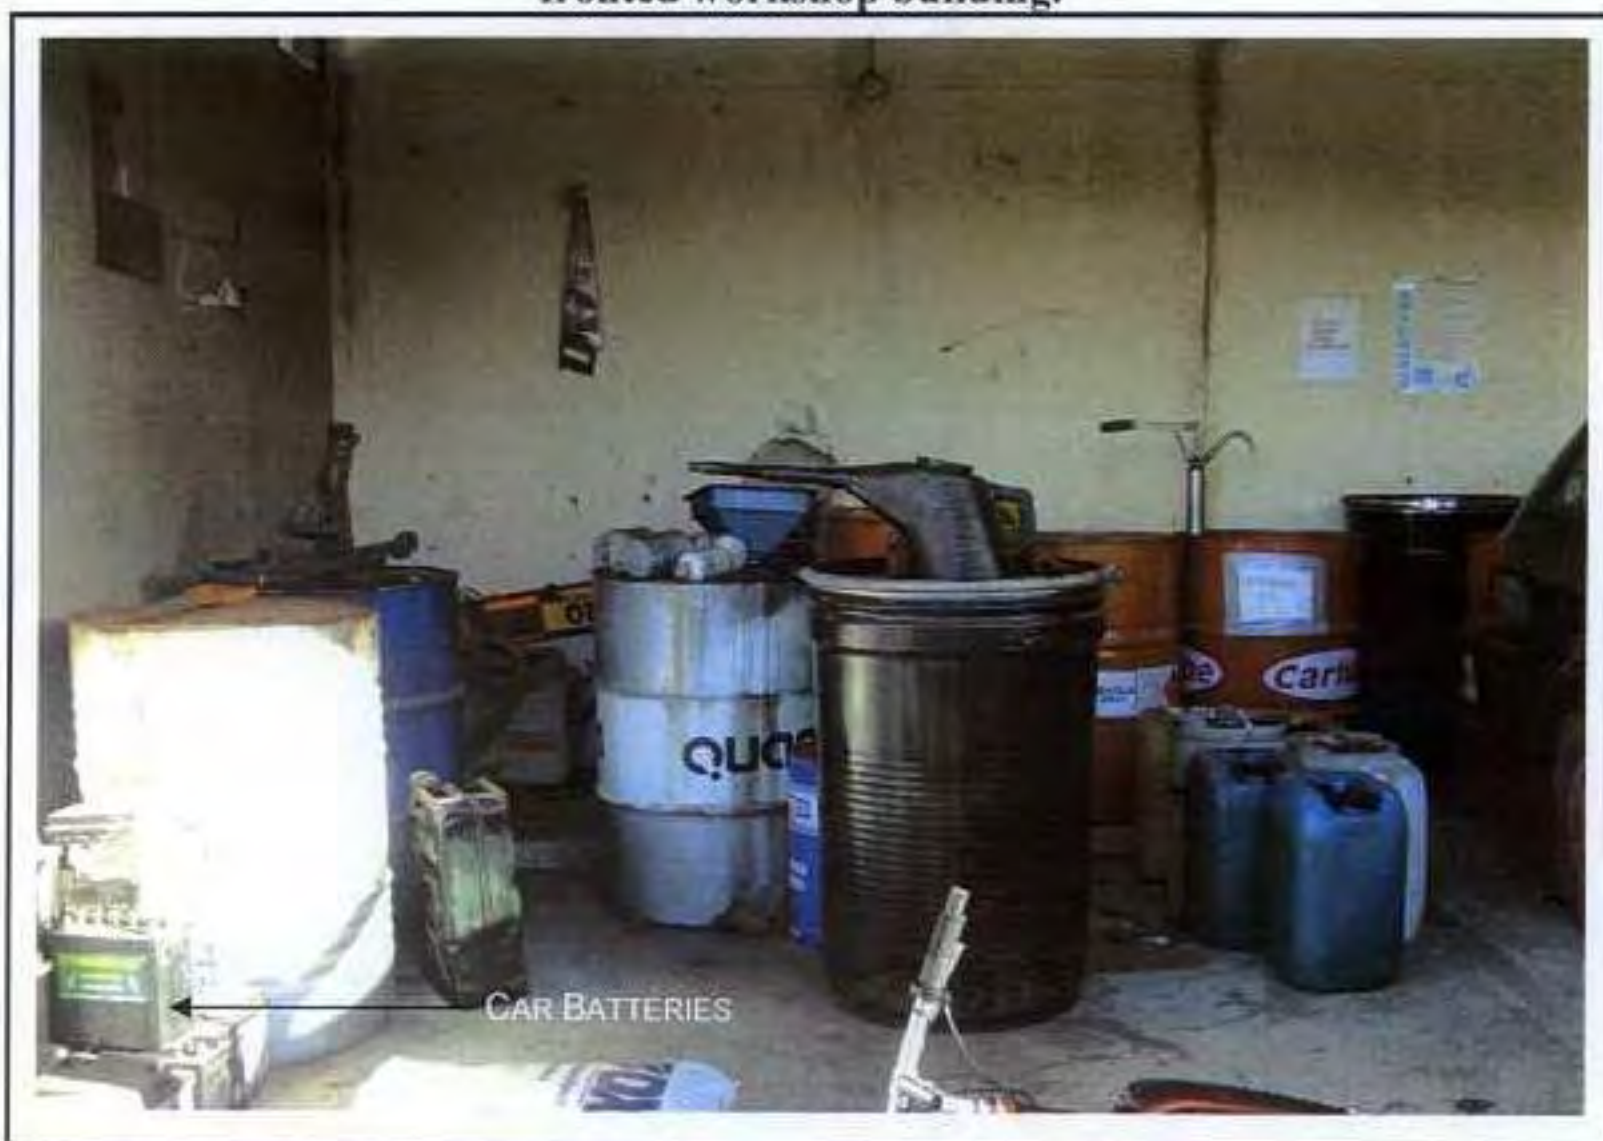
**Photograph 8: Oil drum storage in open fronted workshop building.**

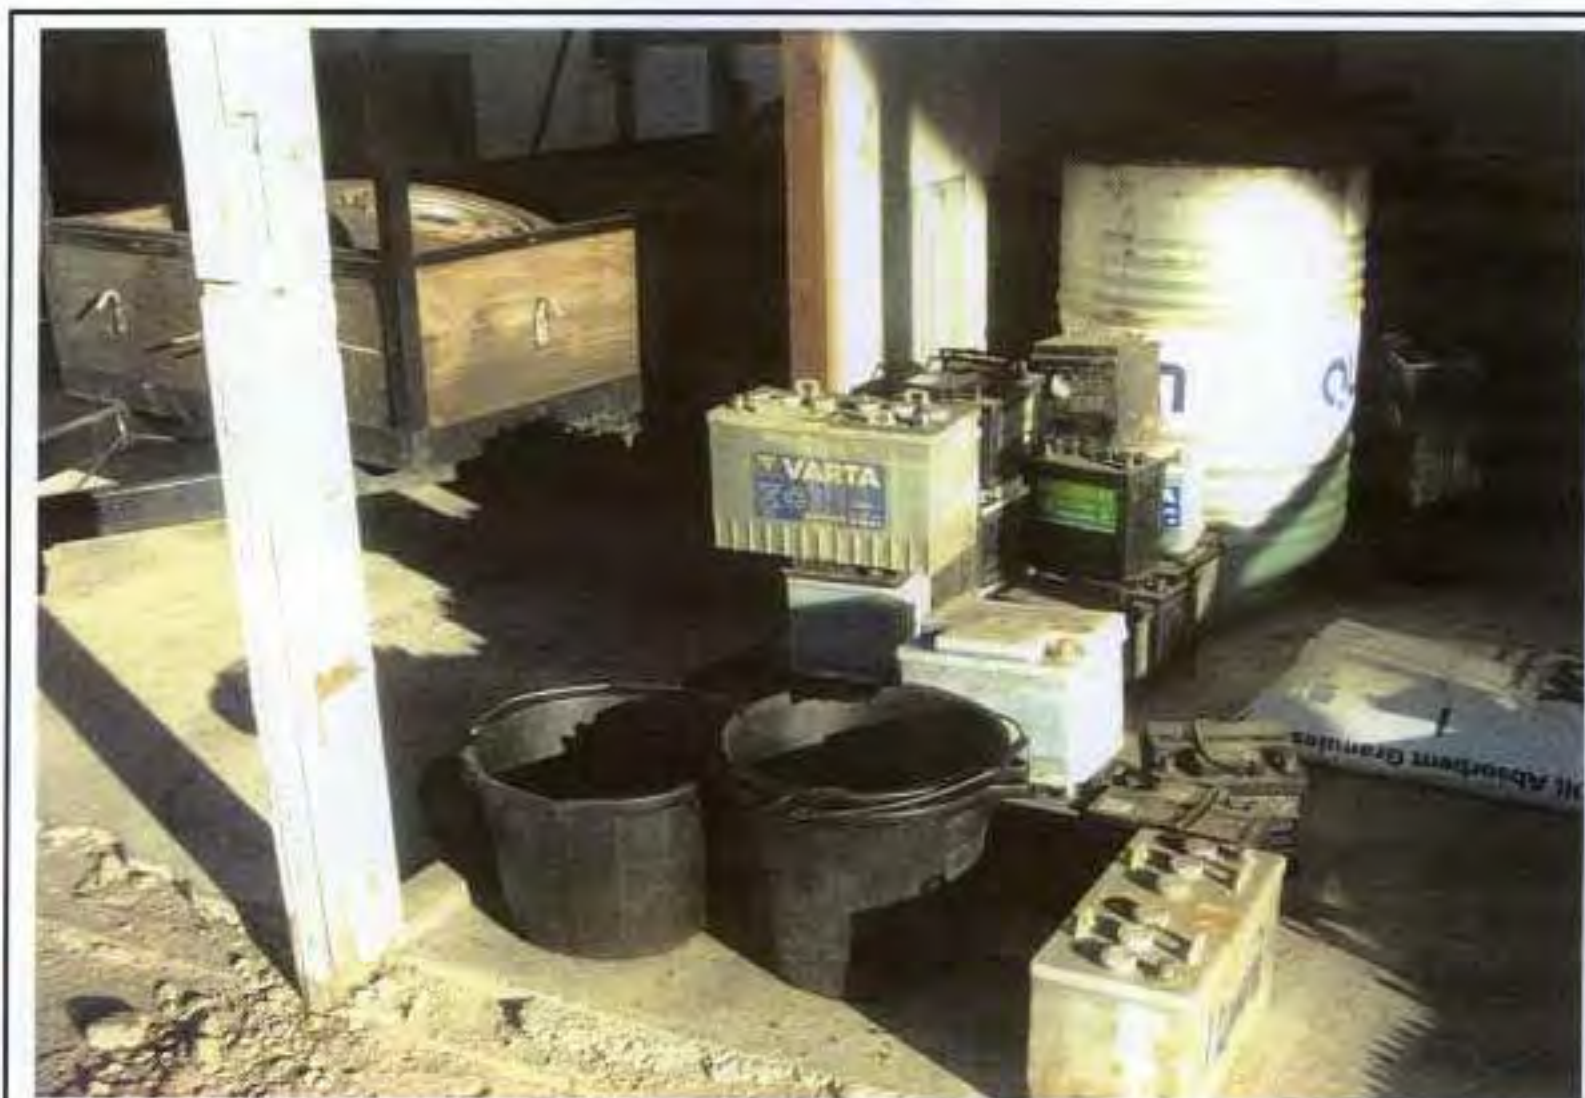
**Photograph 9: Car Battery Store in open fronted workshop building.**

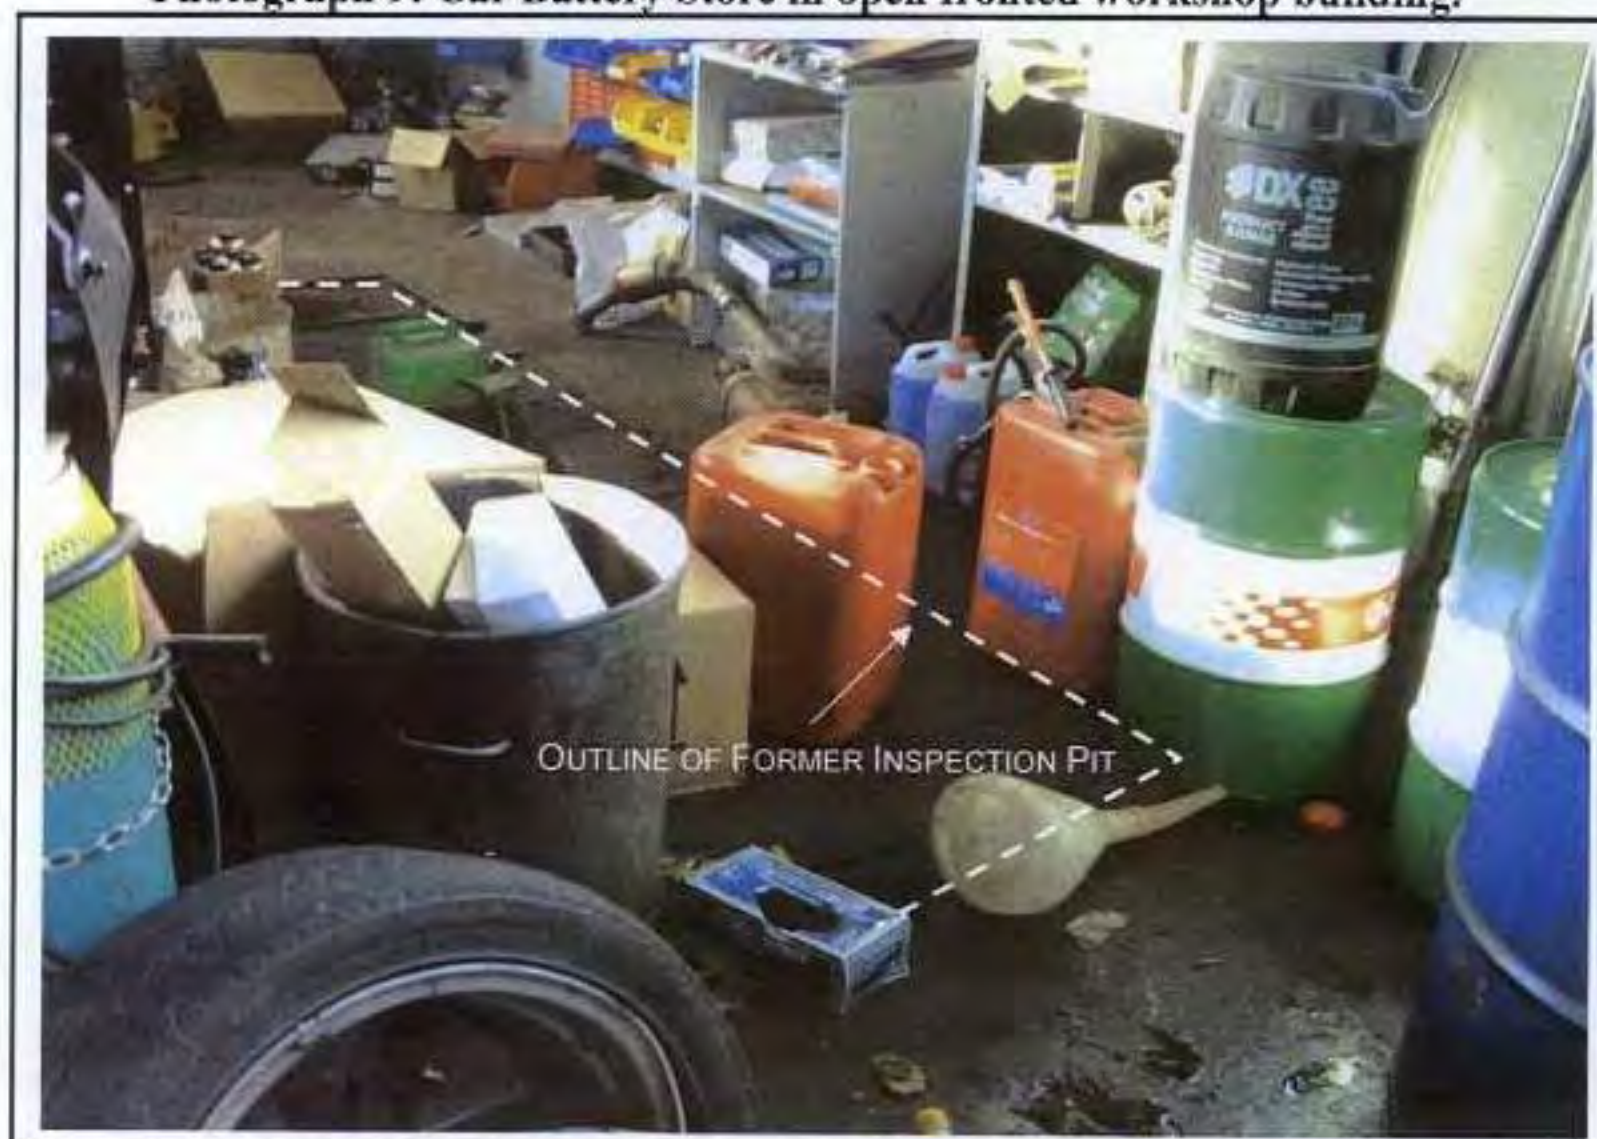
**Photograph 10: Boarded Inspection Pit within Garage Building.**
