Project:
Grafton Bank
Grafton Lane
Hereford HR2 8BL

Drawing Title:
First & Second Floor Plan
Plaster Repairs / Timber Repairs
Listed Building Works

Drawing No.	223174/ LB011	Rev.	~
Scale @ A1	1:50	Drawn	PW
Status	LB	Checked	GD
		Design	GSP

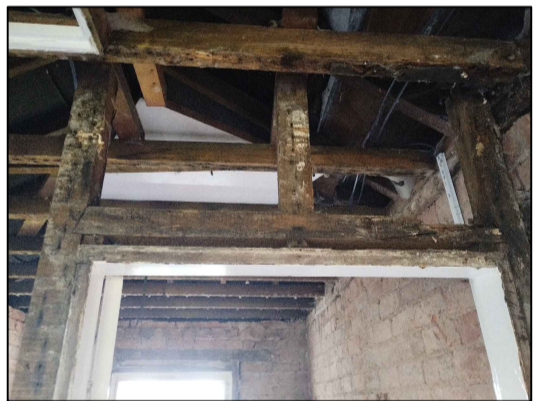
Existing Timber Stud Partition affected by Dry Rot and to be carefully removed and replaced and reformed with new treated timbers to match existing timbers in size and position. Upon completion of installation of new timber stud partition. (Refer to Photo 01 indicating current condition of defective timber partition affected with Dry Rot).

Photo 01 - Timber Partition
(Timber Partition to Storeroom affected by Dry Rot to be repaired)
