**Whitwick Manor,
Yarkhill,
Hereford
Tree Constraints Report**

Report Ref: 118/R/100

January 2024

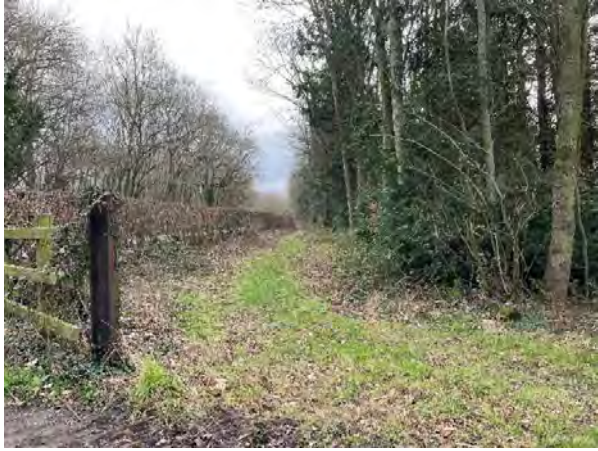
G1-B2 and H1

Several trees within G1-B2 and G2-B2 have fallen or are leaning, with several hung up within other trees. It is recommended that where these trees are within falling distance of the A417 road, that the trees are either removed or cut down to a 4m high snag / pole, so that some habitat value can be retained for wood decay fungi, birds and invertebrates. Timber arisings could be cut and used to form habitat piles.

- A woodland management strategy for groups G1-B2 and G2-B2 is recommended to ensure the longevity of the shelterbelt. There are opportunities to thin and underplant the groups to gradually reduce non-native species and underplant with native scrub and hazel to vary the understorey for the benefit of biodiversity, landscape and visual amenity and to enhance the shelterbelt structure.

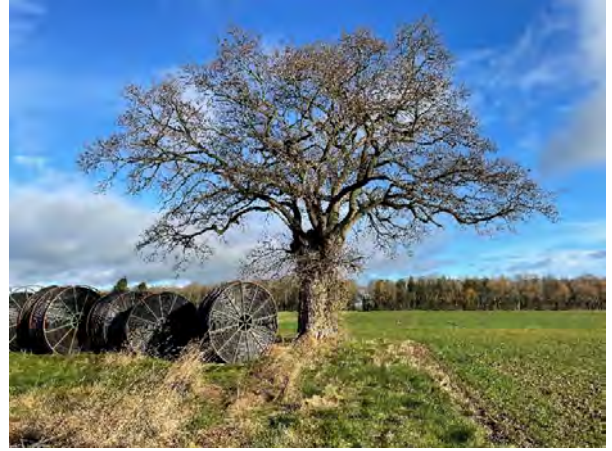
T10-A2,A3

T8	Betula pendula (silver birch)	6	200	4	0 2.5	0	5	Semi-mature	Fair	Narrow, upright growth with high asymmetric crown	C2	2.4		10-20 years
T9	Quercus robur (English oak)	6	120	4	0 3	0	5	Young	Fair	Narrow, upright growth with high asymmetric crown	C2	1.44		10-20 years
T10	Quercus robur (English oak)	8	990	7	7.2 6.4	8	1	Over mature	Good	Significant tree with hollow stem; cavity to base; historic damage to base; epicormic growth to stem and pruning sites; possible previous pollard; tree of high importance in the landscape and habitat value; potential to develop into early stage veteran tree	A2, A3	11.88		40 years +
T11	Quercus robur (English oak)	12	1080	8.7	10.5 7.6	10.5	3	Over mature	Good	Significant tree with extensive ivy growth and roots girdling base of tree; lower branch tear out to west; cavities present; tree of high importance in the landscape and habitat value; potential to develop into early stage veteran tree	A2, A3	12.96		40 years +

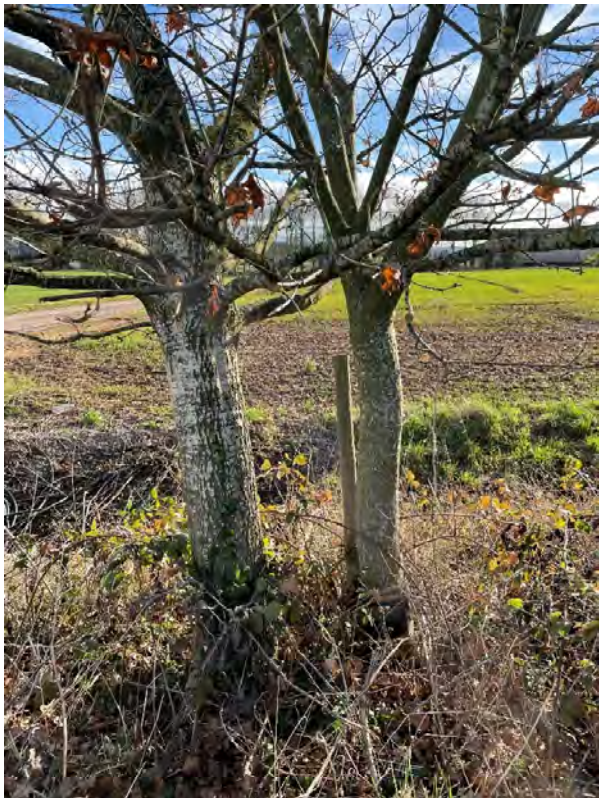
T12-C2 and T13-C2

T12	Quercus robur (English oak)	5	240	2.5	4 1	4.5	1	Semi-mature	Good	Low branching structure and suppressed to south; minor broken branches; tree of low value in the landscape	C2	2.88	T12 and T13 likely to impede each others growth and one likely to require removal in future years	10-20 years
T13	Acer capillipes (Red snake-bark maple)	5	160	2.8	1 3.2	3	1	Semi-mature	Good	Low branching structure and suppressed to north; no apical dominance; tree of low value in the landscape	C2	1.92	T12 and T13 likely to impede each others growth and one likely to require removal in future years	10-20 years
T14	Quercus robur (English oak)	5	290	3.4	3.4 3.8	5.4	2.5	Semi-mature	Good	No apical dominance, damage and loss of leader; tree of low value in the landscape	C2	3.48		10-20 years

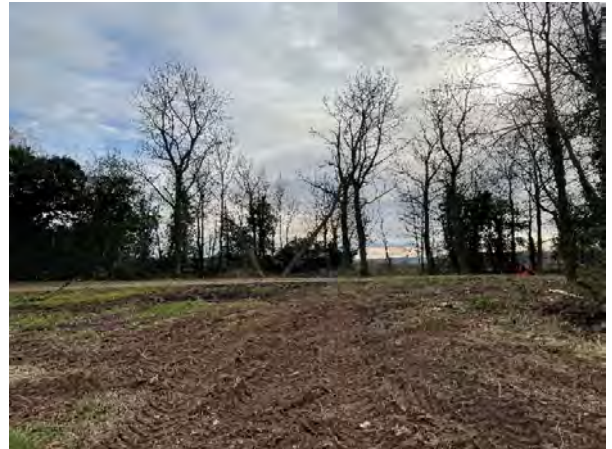
Trees within the survey area have been identified within categories A, B and C. No category U trees were recorded individually, however two trees were noted in G5-B2 as unsuitable for retention. The tree population has a moderate to high amenity and landscape value overall with woodland and individual trees of high landscape or habitat value. Woodland W1 and trees T10, T11, T20, T22, T23, T25-T19, T30-T32, T35, T41, T42, T52 and group G7 are considered to be of high landscape and/or habitat value with the potential to have an estimated life expectancy beyond 40 years due to location, current condition and species. W1 is of particular value having green infrastructure connections to the ancient and semi-natural woodland of Ash Coppice to the south, beyond the survey area and wider conservation benefit.

Fallen willow present in G5-B2 is recommended for removal due to potential risk of damage to existing trees. It is recommended that the cut timber is retained for habitat piles within the group.

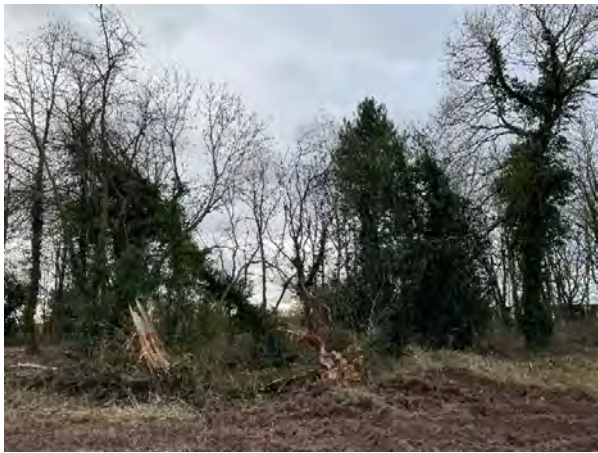
G5-B2 fallen tree

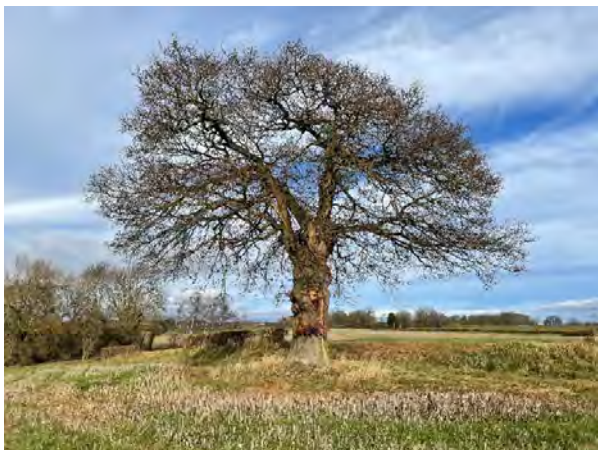
T22-A2,A3

T21b	Fraxinus excelsior (ash)	14	280					Semi-mature	Fair	Crown within spread of willow; basal damage to ash	C2	3.36		10-20 years
T22	Quercus robur (English oak)	14	1310	8	8 8.7	6.6	2	Over mature	Good	Significant tree; branch tears to south and east one major tear 2.5m long to base with hollowing to trunk evident; broken branches, dead wood; epicormic growth with further cavities in branches; crown in good health; self-pruning tree of high importance in the landscape and habitat value; potential to develop into early stage veteran tree	A2, A3	15.72		40 years +
T23	Fraxinus excelsior (ash)	16	1600	9.5	9 9.5	10.7	within group	Over mature	Veteran	over 1600 basal diameter; significant tree with spreading crown and hollows to trunk; multi-stemmed at 1m with 7 stems arising; potential veteran tree; tree of high value in the landscape and high habitat value	A2, A3	19.2		40 years +
T24	Salix fragilis (crack willow)	16	620	5	5.56	9.2	within group	Mature	Good	Open spreading crown; minor dead wood and broken branches; canopy edge to field flailed to a height of 3m; tree of moderate value in the landscape	B2	7.44		20-40 years
