# Asbestos Pre-Demolition Survey Report

## Former Broadlands Primary School, Prospect Walk, HR1 1NZ

**Title:** Full Demolition of property , **Including:** All properties on site

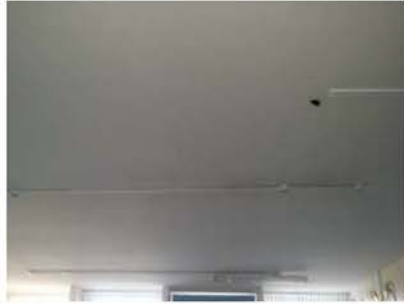
Former Broadlands Primary School - Infant Block	0	006/ classroom	Ceiling	256902-40	Asbestos-containing textured coating	Chrysotile	3	60 Sqm	R3	Remove

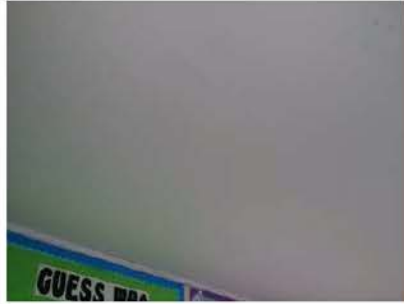
Former Broadlands Primary School - Infant Block	0	009/ lobby including timber cupboards	Ceiling	256902-40	Asbestos-containing textured coating	Chrysotile	3	30 Sqm	R3	Remove

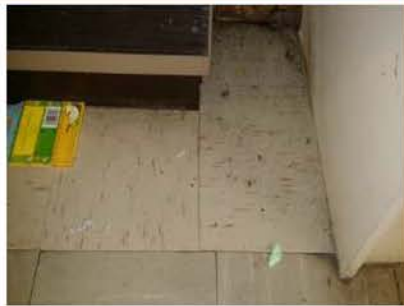
Former Broadlands Primary School - Infant Block	0	011/ classroom	Floor covering	256902-44	Asbestos-containing floor tile with bitumen adhesive	Chrysotile	3	40 Sqm	R3	Remove

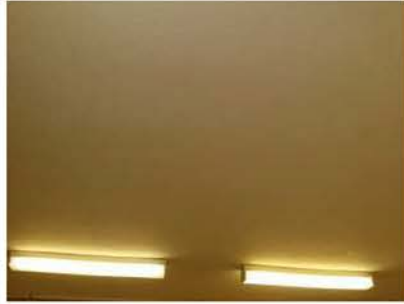
Former Broadlands Primary School - Infant Block	0	011/ classroom	Ceiling	256902-40	Asbestos-containing textured coating	Chrysotile	3	60 Sqm	R3	Remove

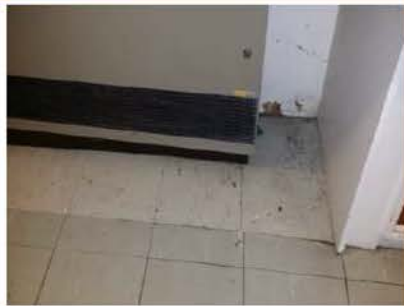
Former Broadlands Primary School - Infant Block	0	012/ classroom	Floor covering	256902-44	Asbestos-containing floor tile with bitumen adhesive	Chrysotile	3	40 Sqm	R3	Remove

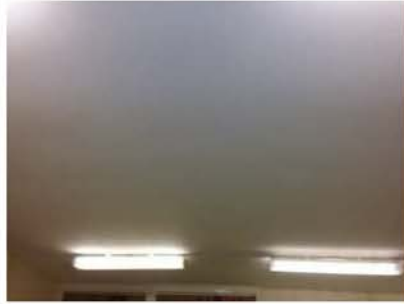
Former Broadlands Primary School - Infant Block	0	012/ classroom	Ceiling	256902-40	Asbestos-containing textured coating	Chrysotile	3	60 Sqm	R3	Remove

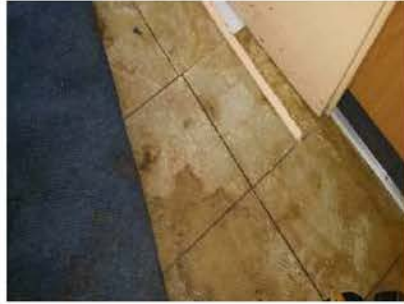
Former Broadlands Primary School - Infant Block	0	015/ classroom	Floor covering	256902-44	Asbestos-containing floor tile with bitumen adhesive	Chrysotile	3	40 Sqm	R3	Remove

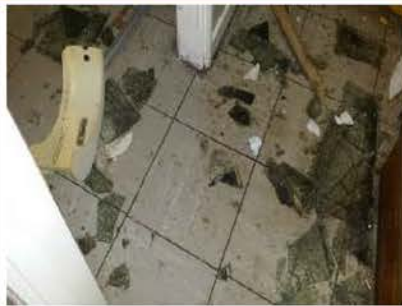
Former Broadlands Primary School - Infant Block	0	019/ toilet	Toilet cistern	256902-52	Asbestos-containing composite	Amosite	4	1 No	R3	Remove

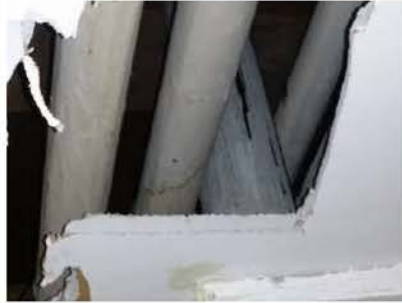
Former Broadlands Primary School - Infant Block	0	019/ toilet	Pipe within ceiling void	256902-54	Asbestos-containing cement	Chrysotile, Amosite	5	1 Lm	R3	Remove

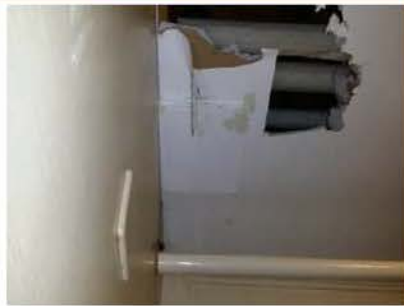
Former Broadlands Primary School - Infant Block	0	019/ toilet	Floor covering	256902-44	Asbestos-containing floor tile with bitumen adhesive	Chrysotile	3	2 Sqm	R3	Remove

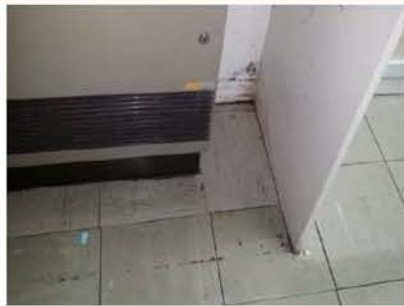
Former Broadlands Primary School - Infant Block	0	030/ classroom	Floor covering	256902-44	Asbestos-containing floor tile with bitumen adhesive	Chrysotile	3	40 Sqm	R3	Remove

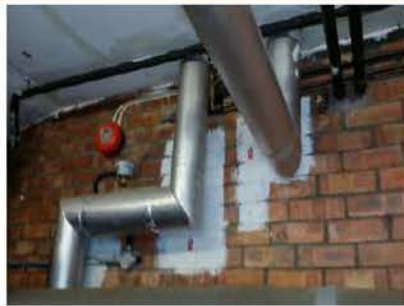
Former Broadlands Primary School - Infant Block	0	043/ boiler room	Gaskets to pipework	256902-66	Asbestos-containing gaskets	Chrysotile	4	Throughout Location	R3	Remove

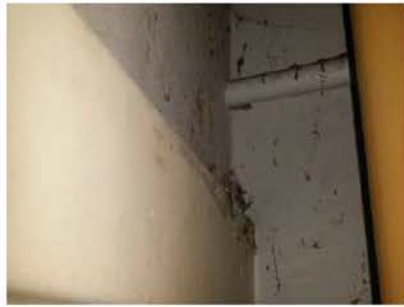
Former Broadlands Primary School - Infant Block	0	044/ gas meter room	Door header	256902-68	Asbestos-containing insulating board	Chrysotile, Amosite	7	2 Sqm	R3	Remove

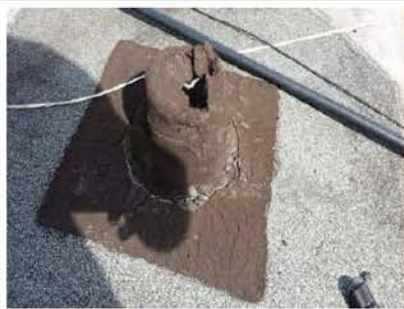
Former Broadlands Primary School - Infant Block	9	999/externals	Sealant to boiler flue	256902-72	Asbestos-containing putty	Chrysotile	3	Small Quantity Observed	R3	Remove

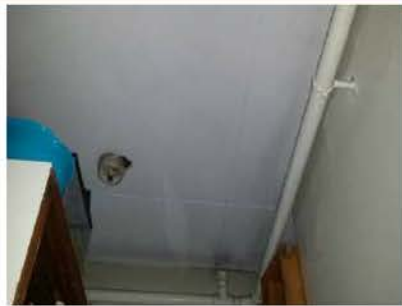
Former Broadlands Primary School - Junior Block	0	024/ nursery store	Sealant to polystyrene tiles	256902-3	Asbestos-containing mastic	Chrysotile	3	Throughout Location	R3	Remove

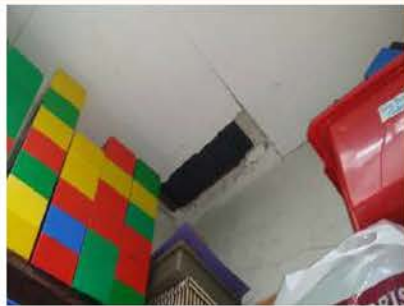
Former Broadlands Primary School - Junior Block	0	027/ nursery toilets	Sealant to timber framework within ceiling void	256902-3	Asbestos-containing mastic	Chrysotile	3	Throughout Location	R3	Remove

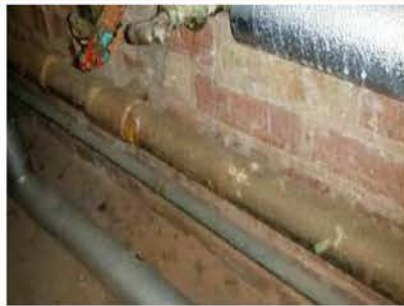
Former Broadlands Primary School - Junior Block	0	051/ boiler room	Ceiling including fascia panels	256902-26	Asbestos-containing insulating board	Amosite, Chrysotile	6	40 Sqm	R3	Remove	 
Former Broadlands Primary School - Junior Block	0	051/ boiler room	Floor duct	256902-31	Asbestos-containing debris	Amosite, Chrysotile	11	Throughout Location	R1	Remove

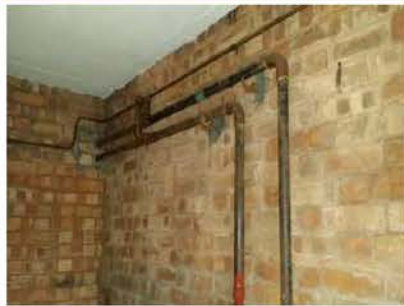
Former Broadlands Primary School - Junior Block	0	053/ gas store	Gaskets to pipework	256902-33	Asbestos-containing gasket	Chrysotile	4	Small Quantity Observed	R3	Remove
