Key GeoSolutions Ltd

Ref: 20-215-L-001

re: John Kyle High School – Environmental Health Consultee Comments

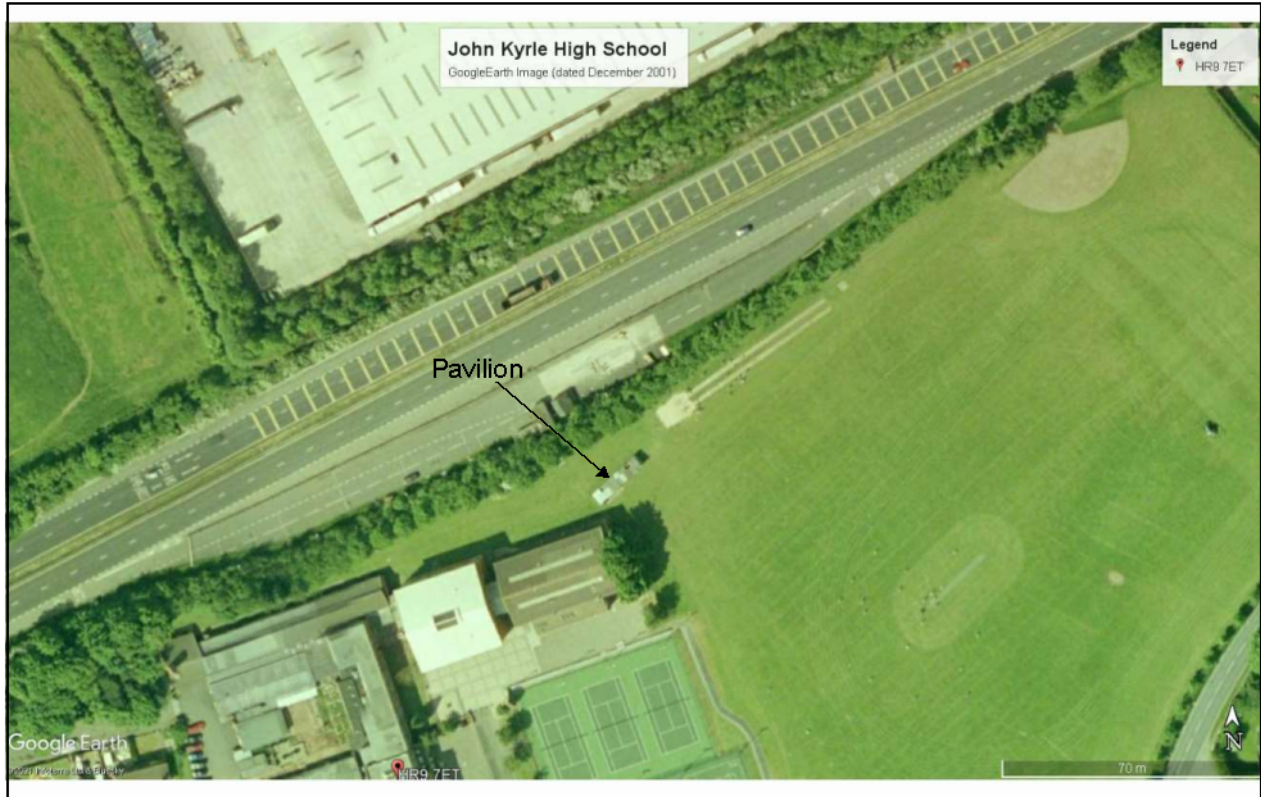
Trial Pit 3 was excavated at the eastern end of a building which on the OS Maps is identified as a pavilion, at the time of the 2012 investigation the building was a brick built store with a corrugated steel roof and wooden extension (Photographs 5 and 7). The school, including the pavilion was constructed between 1964 and 1968. From the construction of the roof on the brick section it is likely that the roof has been replaced at some point, possibly between 2001 and 2006 as the appearance of the roof changes on GoogleEarth images (see Photographs 1 to 4).

Photo 1. GoogleEarth aerial image dated December 2001. Showing “pavilion” roof as a patchwork of light grey and white sections.

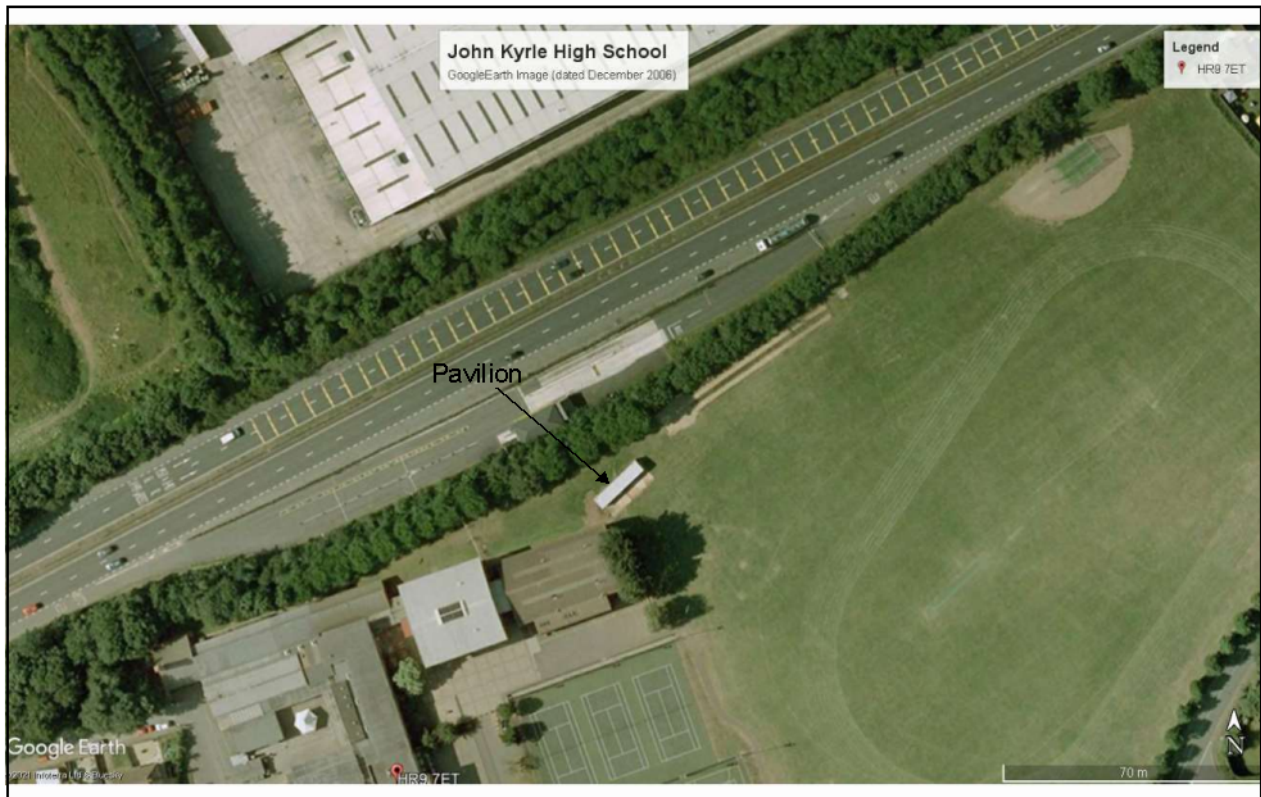
Photo 2. GoogleEarth aerial image dated December 2006. Showing “pavilion” roof as uniformly white.

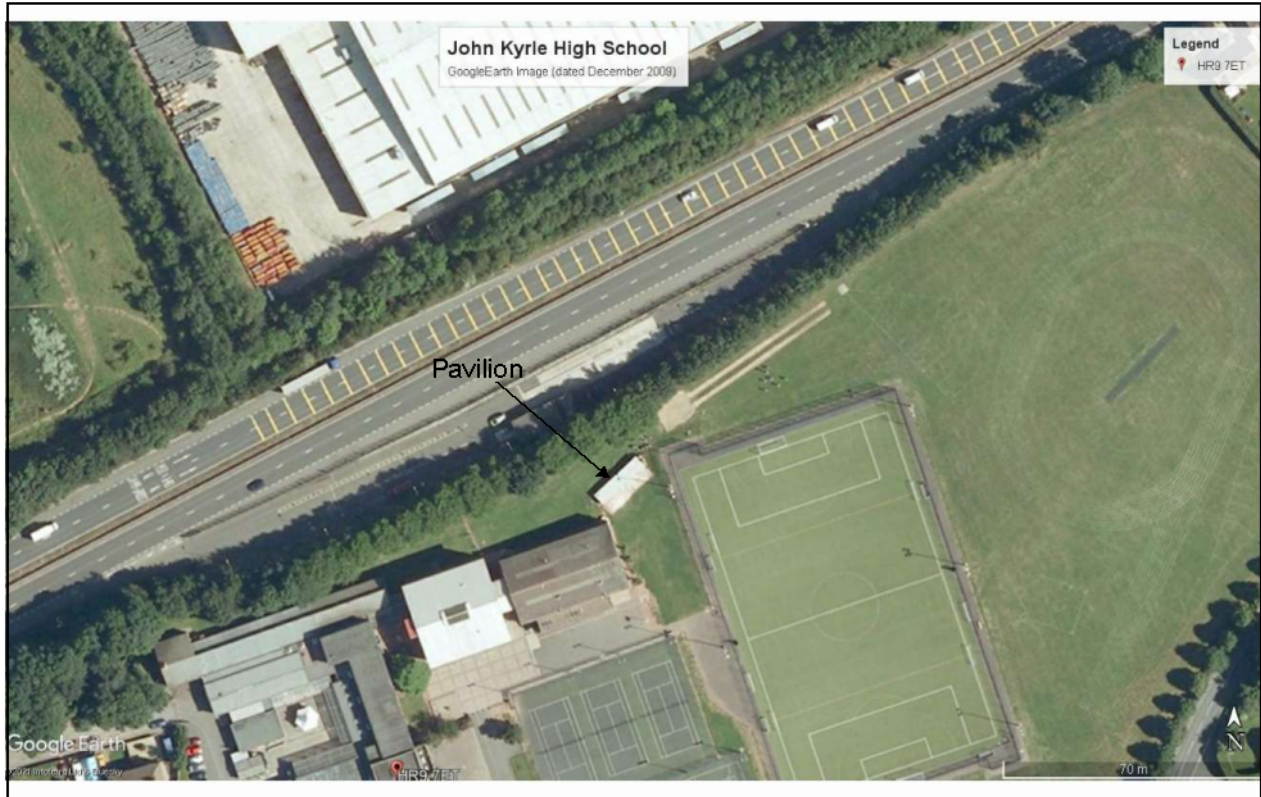
Photo 3. GoogleEarth aerial image dated December 2009. Showing “pavilion” roof as uniformly white.

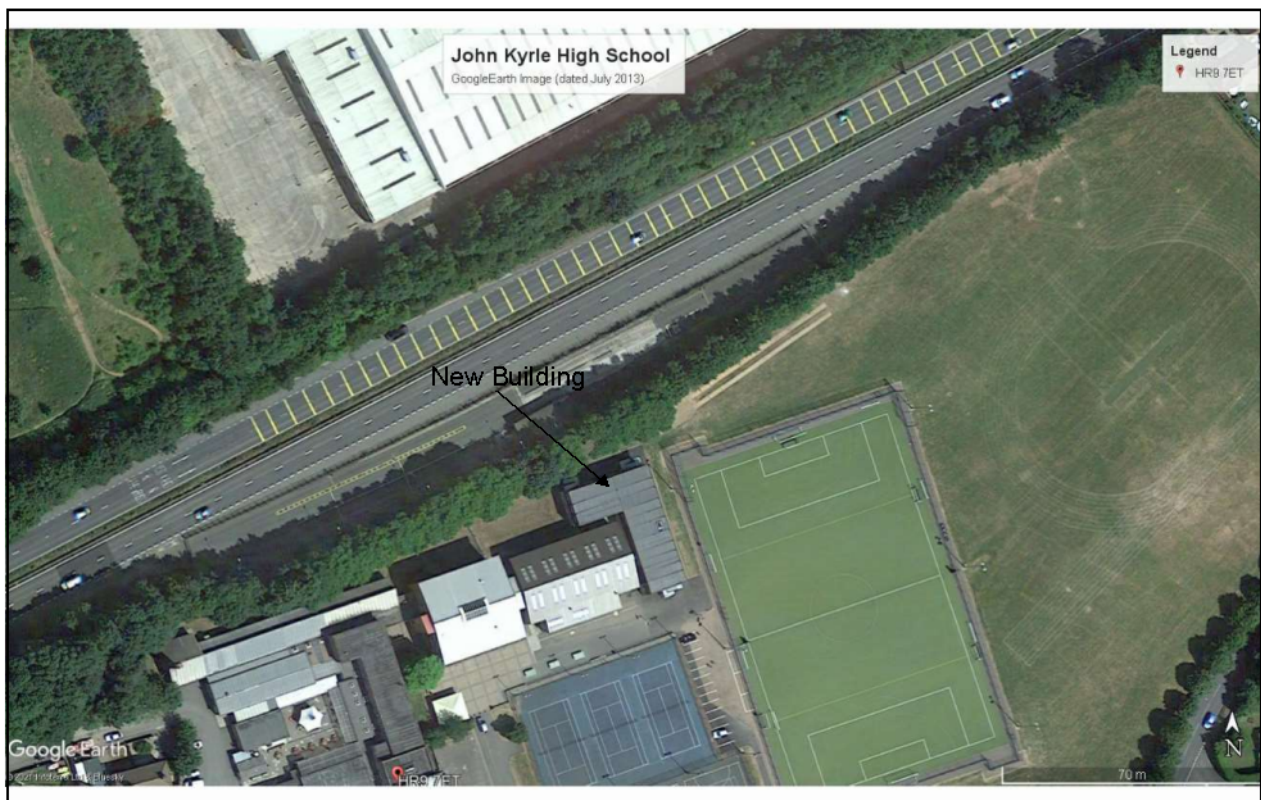
The pavilion was demolished in 2012 to make way for the construction of the new L-shaped classroom block at the north-western corner of the MUGA (Photograph 4), hence the location of Trial Pit 3 and the pavilion is now beneath the new classroom block.

Photo 4. GoogleEarth aerial image dated July 2013. Showing “pavilion” having been removed and replaces with a new school building.

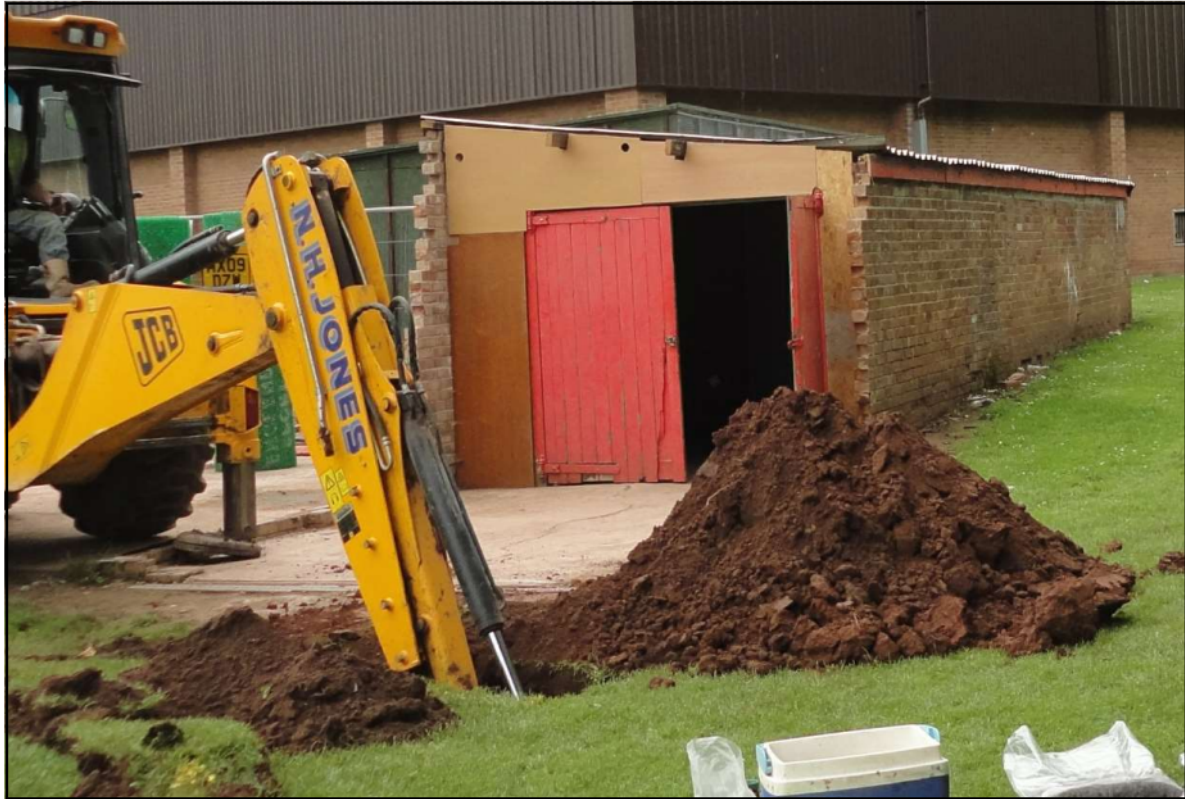
Photo 5. View of “pavilion” from North East at time of July 2012 site investigation. Showing arisings from trial pit TP03 and “pavilion” with corrugated metal roof.

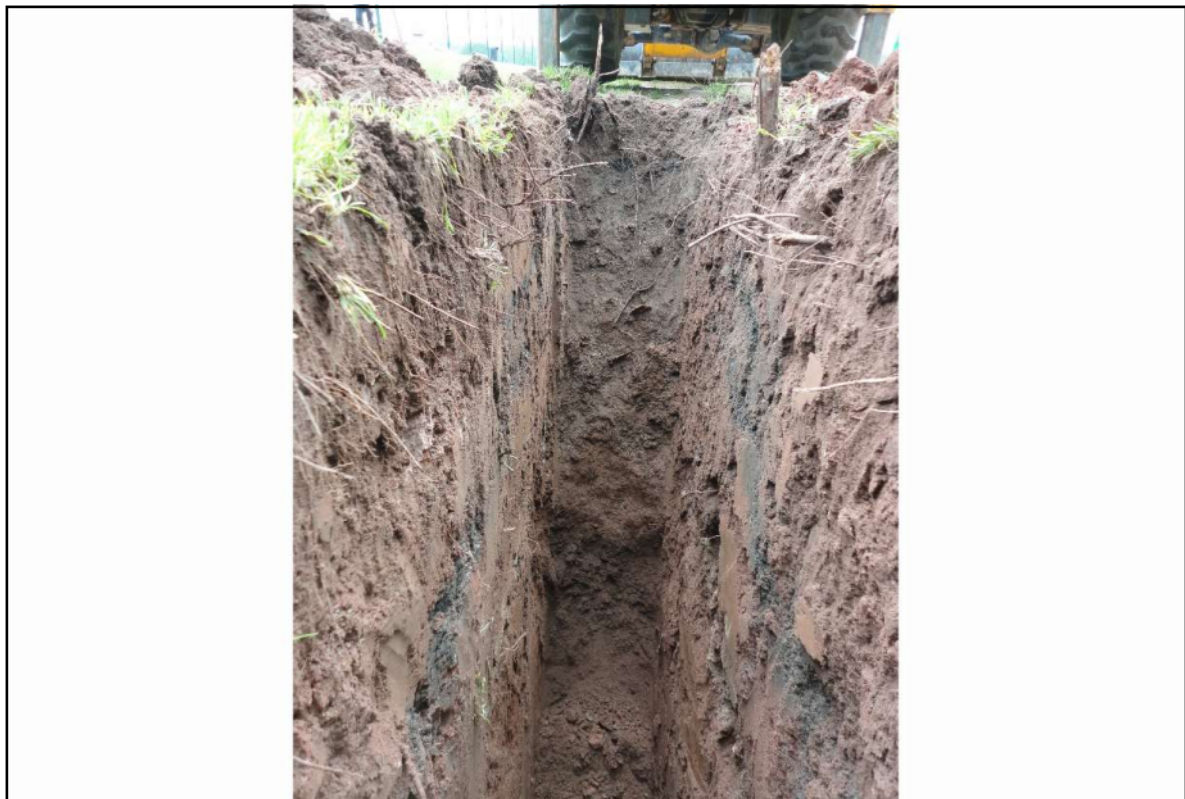
The ground investigation undertaken in 2012 identified loose asbestos fibres in a sample taken for WAC analysis, the sample came from Trial Pit 3. The sample was taken from the lower part of the made ground identified in Trial Pit 3 (log attached). The made ground was a total of 1.0m thick, at 0.8m depth below ground level pieces of cement bound asbestos sheet were encountered in a layer of ash (see trial pit log and Photograph 6).

Prior to construction of the school in the 1960's the site had only previously been in use as agricultural land, hence it is likely that the asbestos sheet is from the replacement of the roof / partial demolition of the brick building.

Photo 6. View of section through trial pit TP03 at time of July 2012 site investigation.

No asbestos was identified in the trial pits excavated in 2020 for the Science Block, a recommendation was made for suitable precautions to be taken by the groundworks contractor to mitigate against the potential presence of asbestos.

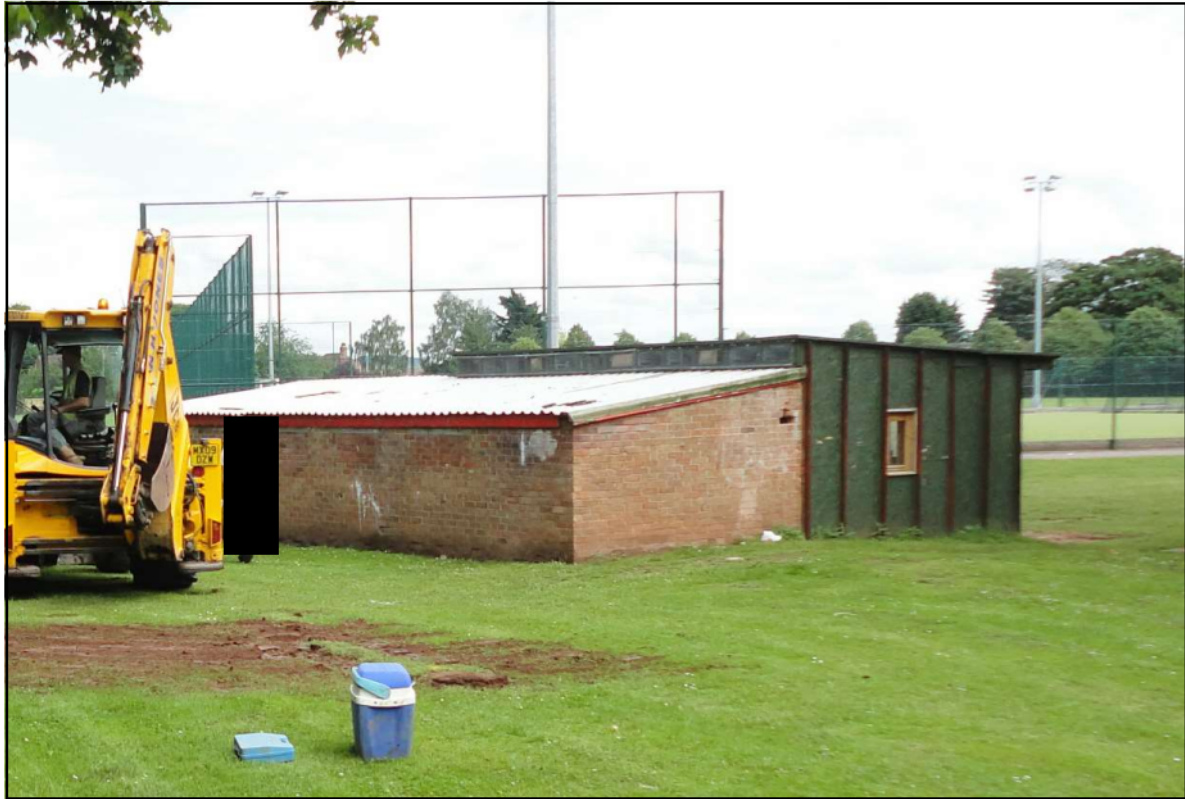
Photo 7. View of “pavilion” from West at time of July 2012 site investigation. Showing “pavilion” with corrugated metal roof and an additional green wooden extension.
