KYTEX LTD

CIVIL AND STRUCTURAL DESIGN CONSULTANTS

UPPER HOUSE FARM

2021063-P1

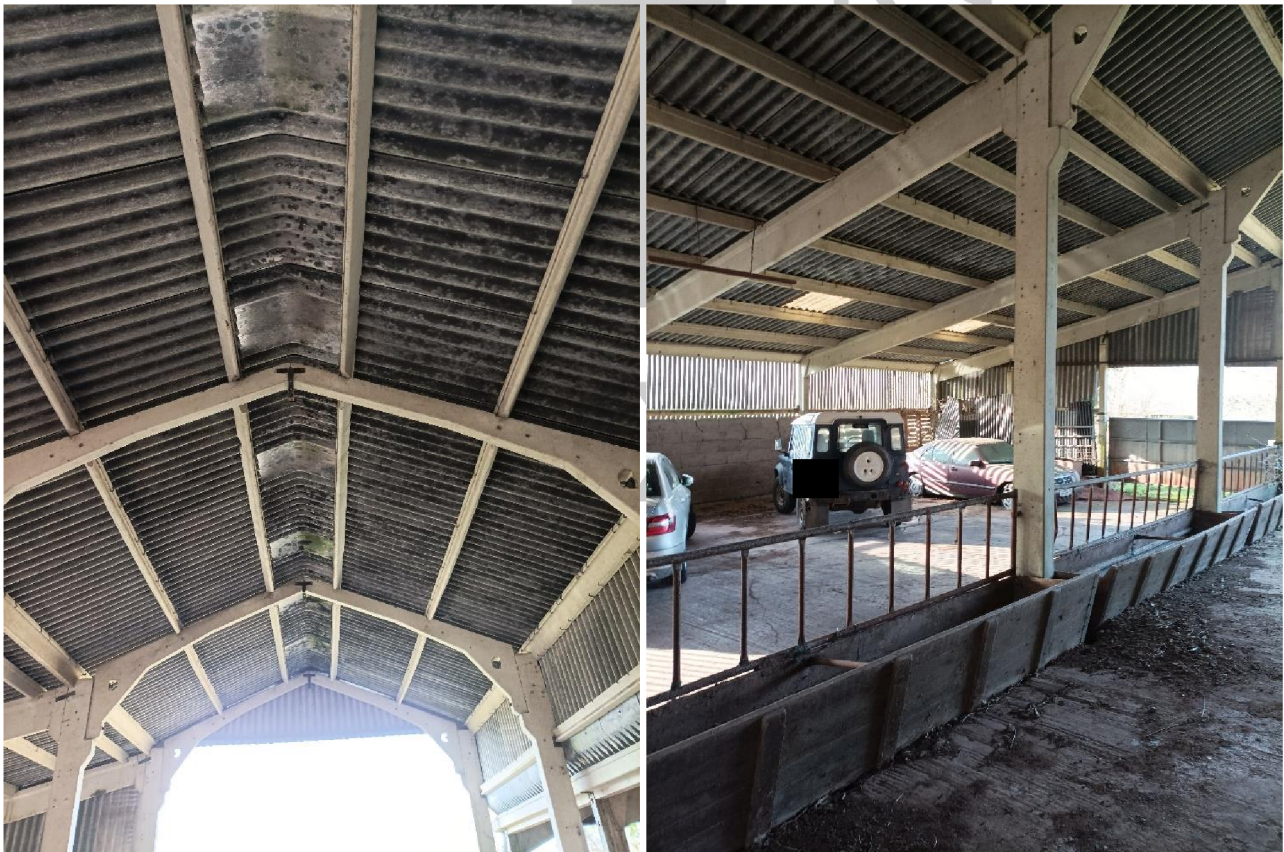
3.2.4 The internal portal frames consist of tapered rafters, approximately 180mm wide x 600mm deep at the haunch reducing to 200mm at the apex.

3.2.5 The lean-to rafters are circa. 450 x 80 'T' beams spanning between columns.

Photo 1: (Left) Portal frame Photo 2 (Right) Lean to

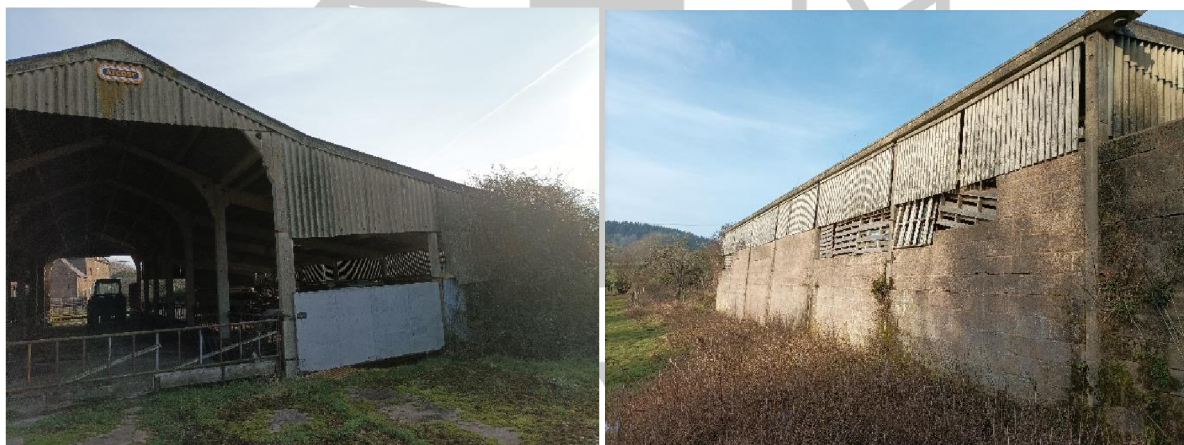
- 3.11 The South elevation is clad with hit and miss vertical timbers from the eaves down to mid height. Below this, a blockwork wall spans down to floor level and continues down to the low ground as part of a retaining wall.

- 3.13 A length of blockwork has been removed and infilled with timbers. This damage to wall is likely to have been due to vehicle or machinery impact.

- 3.14 The West elevation is partly clad from the ridge downwards with profiled fibre sheeting. Part of the gable is fully exposed with a steel gate for access.

*Photo 3 (Left): West elevation, Photo 4 (Right): South elevation*

4.7.2 Repairs to the blockwork wall should be undertaken with consideration to the walls providing stability to the frame unless bracing is added.

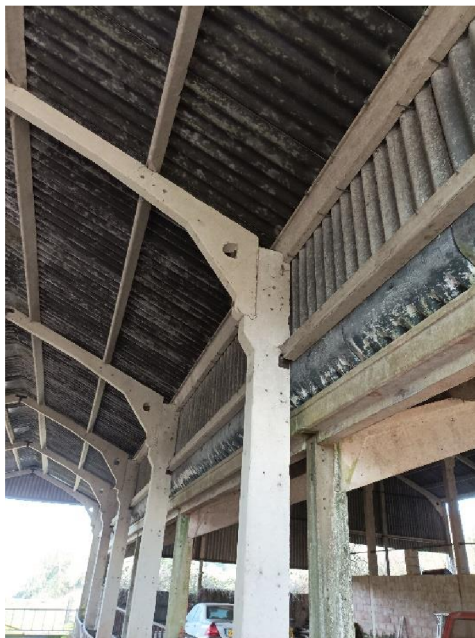
- 3.8 Cladding is present on all sides to varying heights.
- 3.9 The North elevation is partly clad with profiled fibre sheeting, spanning from the eaves down to a valley line formed at the junction with the adjacent shed. Below this, the elevation is fully exposed providing open access to the adjacent shed.

*Photo 5: North boundary (internal)*

4.6.2 Justification for the vertical cantilever action of the columns on the North elevation should be justified or an additional vertical bracing run added.

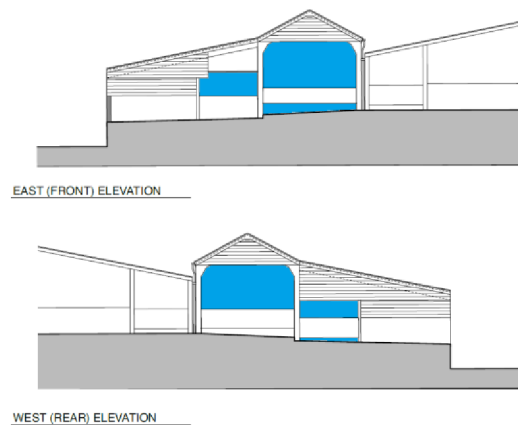
Figure 2: Infill area to the gables in blue

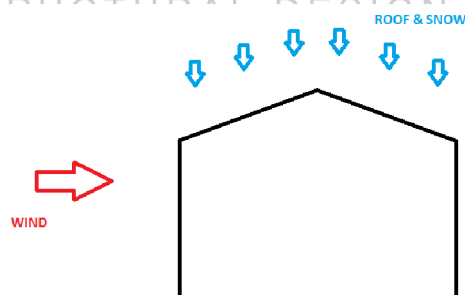
Figure 3: Load to Portal frame (typical section)
