**REPORT on STRUCTURAL CONDITION**

**BARNS 1, 2 and 3 for CONVERSION**

**DOVEHILLS  
BISHOPS FROME  
WORCESTERSHIRE**

**PROJECT NO. MS14101**

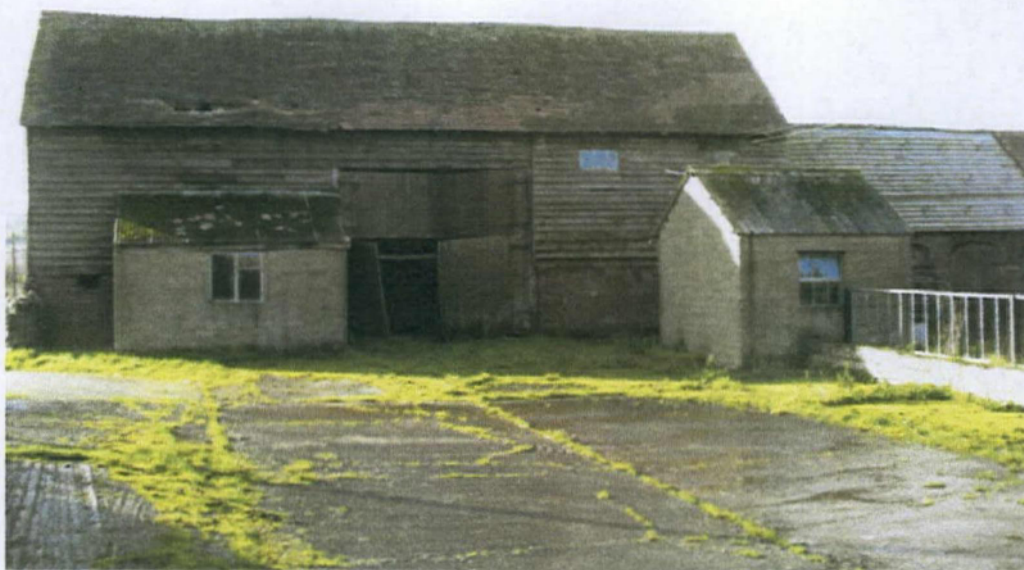
**Photograph 1. General view. Barn 1 and 2. East elevation.**

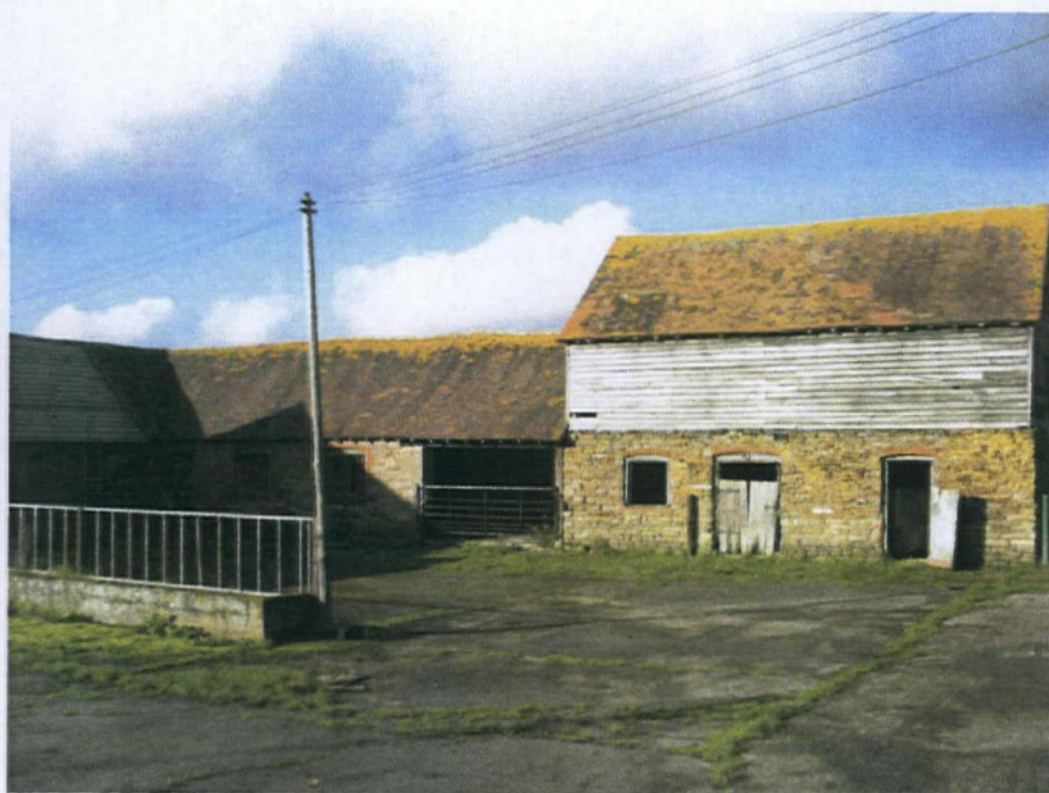
**Photograph 2. General view. Barns 2 and 3. South elevation.**

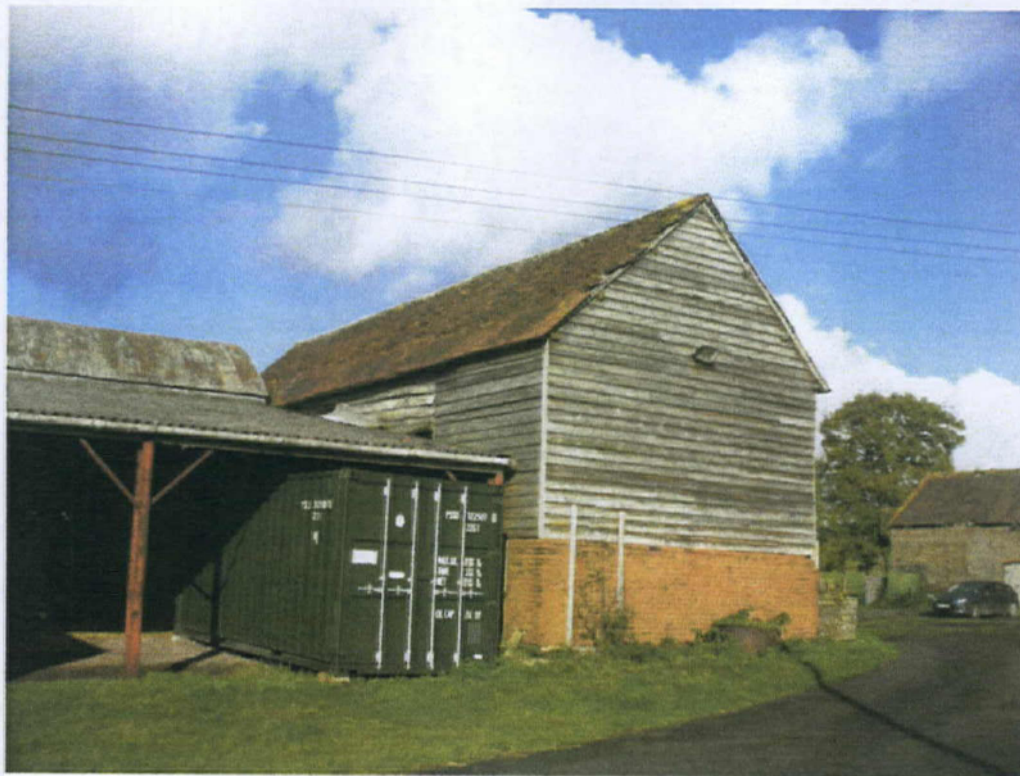
**Photograph 3. General view. Barn1. End, south elevation.**

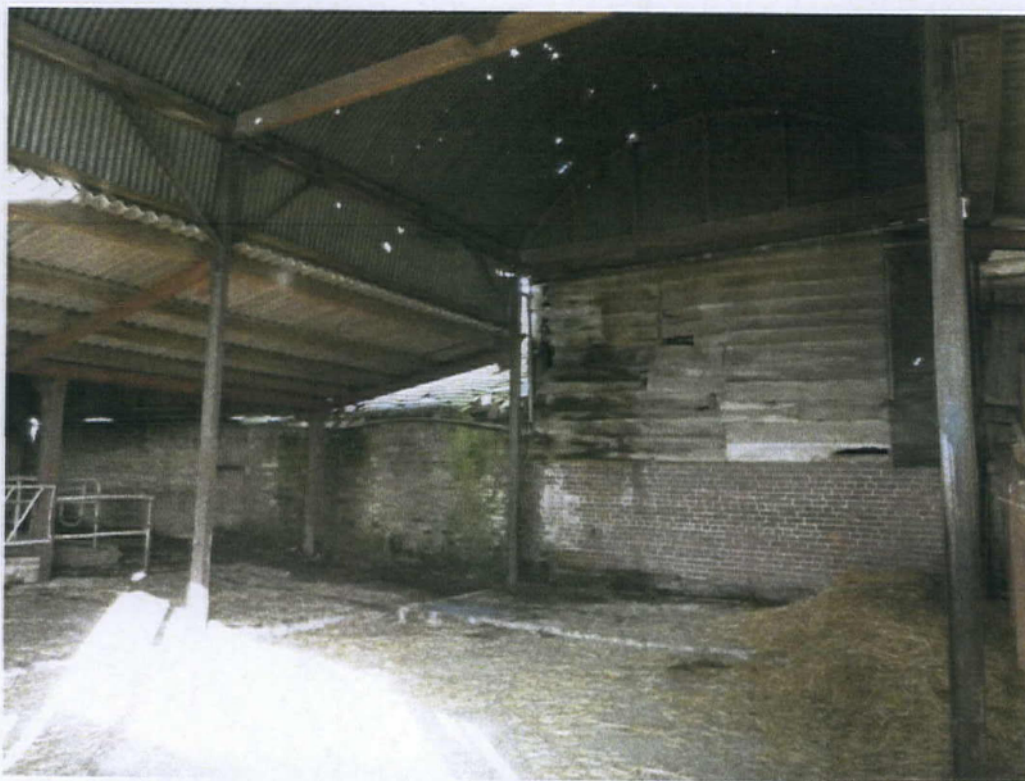
**Photograph 4. General view. Barns 1 and 2. West elevation.**

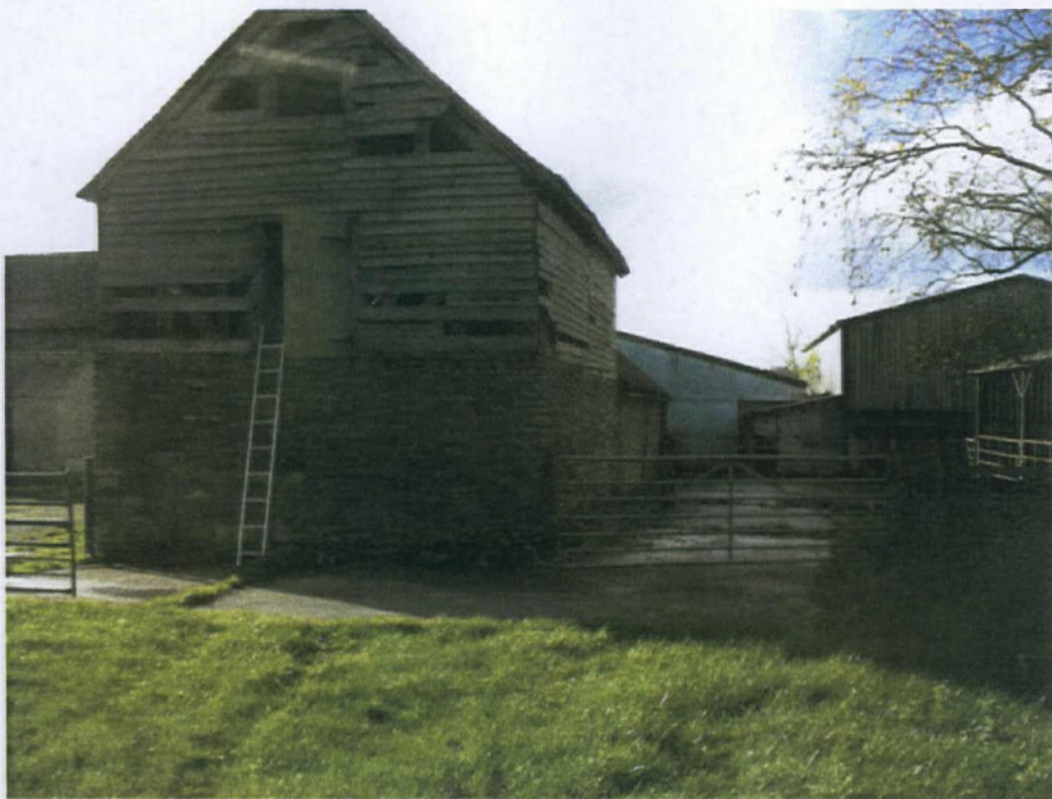
**Photograph 5. General view. Barn 3. End, east elevation.**

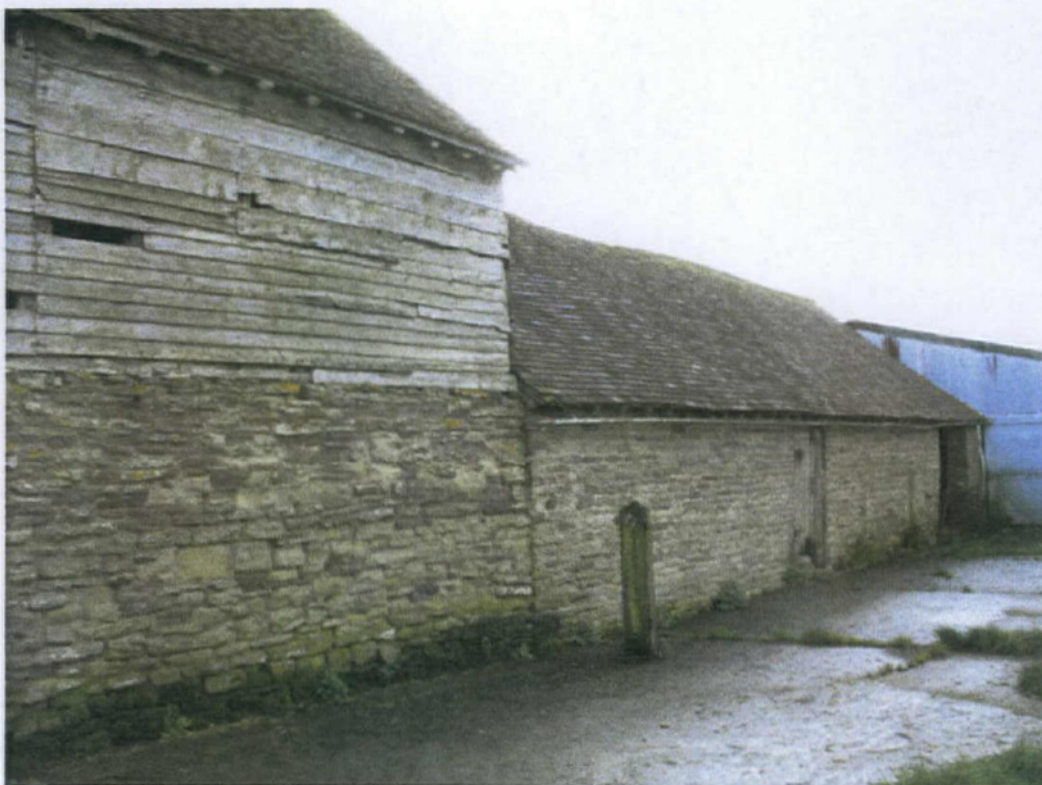
The north (rear) elevation leaned out by up to approximately 60 mm in one metre.

**Photograph 6. General view. Barns 2 and 3. Rear, north elevation.**

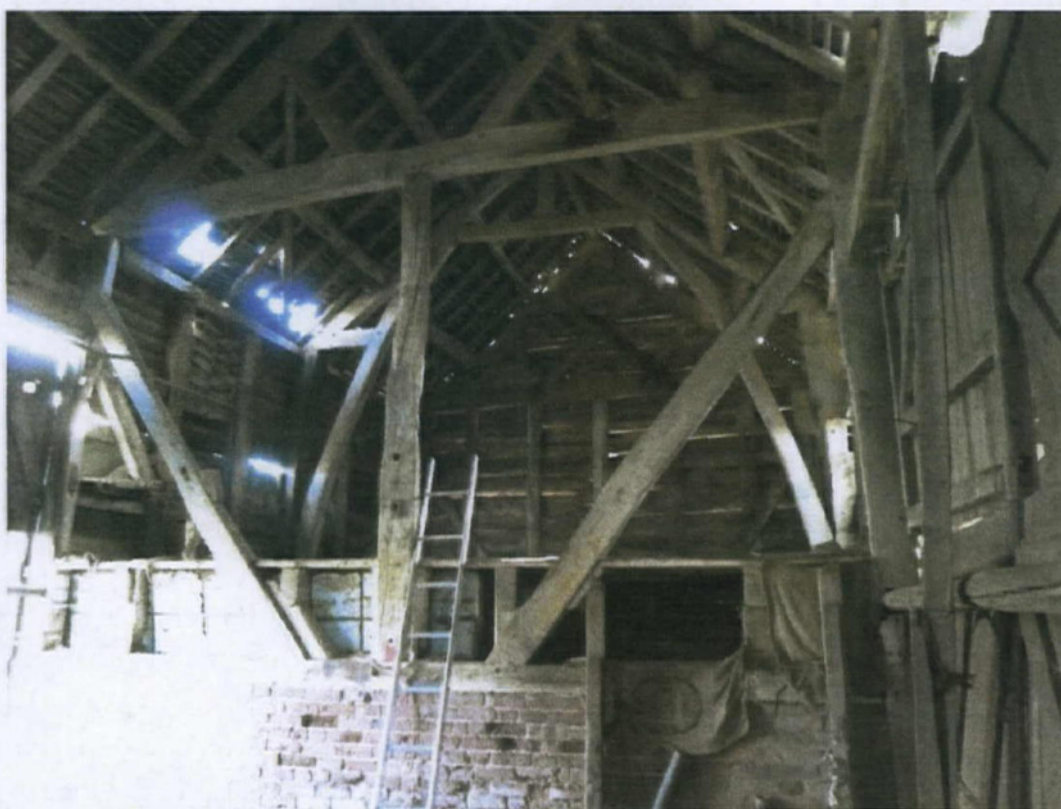
Notwithstanding the above, the rafters, purlins and roof frames appeared to be generally in reasonable condition. The internal south end 'cruck' frame had twisted over to the south, particularly its upper section. The exposed purlin ends at each end of the barn had rotted by varying amounts.

**Photograph 7. Barn 1. Internal view towards south gable wall.**

The other roof frames and 'cruck' frames would appear suitable for re-use. One frame will require some re-alignment.

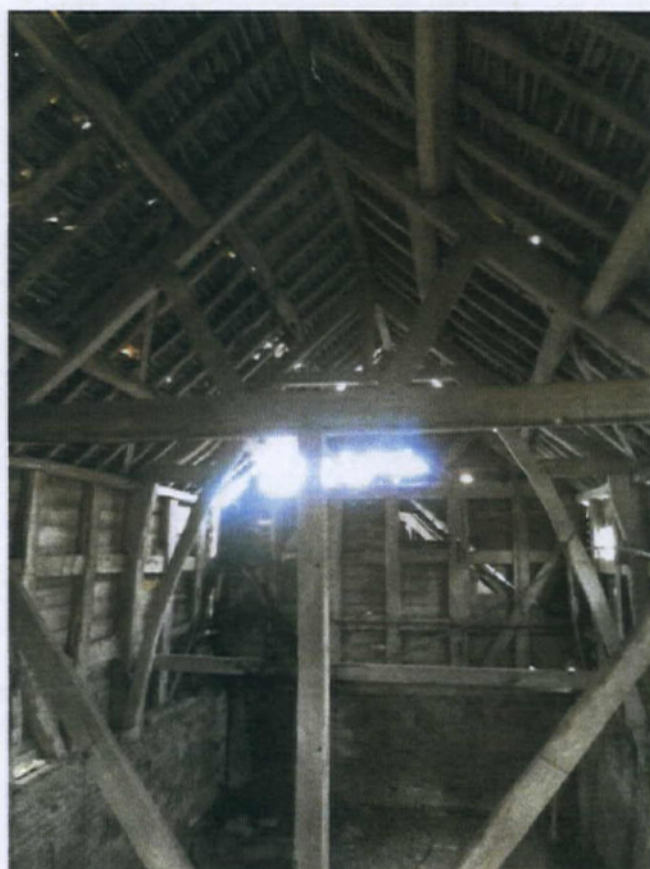
**Photograph 8. Barn 1. Internal view towards north/Barn 2 gable wall.**

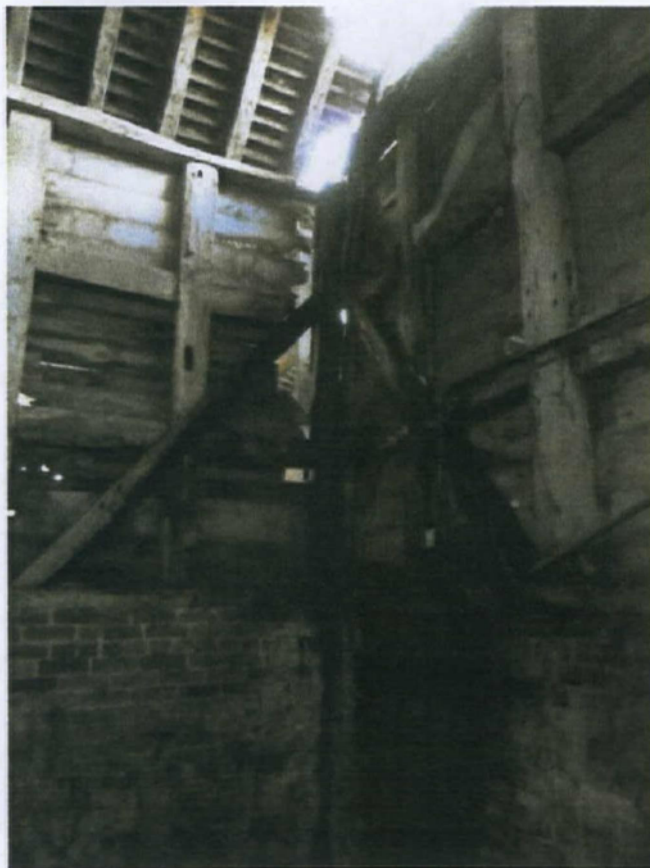
- 3.1.3 There had been significant water ingress into the north-west corner of the barn causing severe rotting of the main north-west corner timber post, adjacent bracing members and roof members. The sole plate supporting the frame onto the low level brickwork was also partially rotten (see photograph 9).

**Photograph 9. Barn 1. North-west corner.  
Significant water penetration and rotten timber members.**

The timber framing supporting the roof and upper cladding on the north-west corner will require some replacement where affected by water ingress.

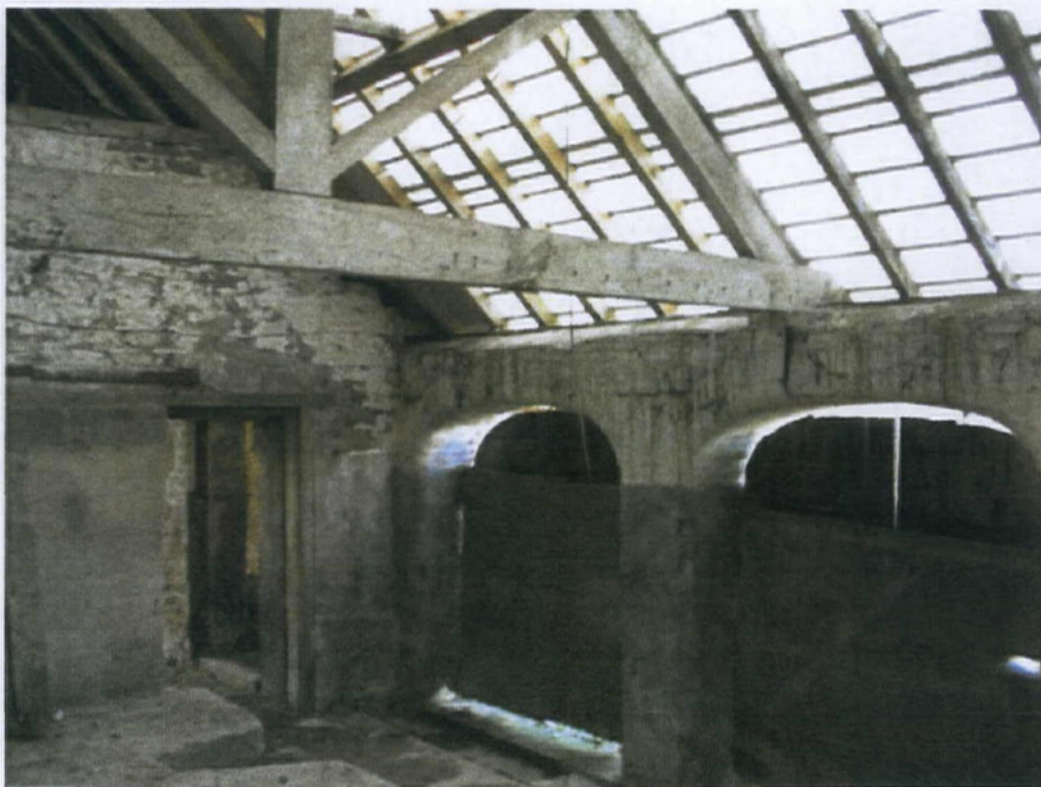
Several purlins, particularly over the northern wing, had deflected significantly.

**Photograph 10. Barn 2. Internal view towards north east.**

- 4.3.1 The timber rafters and purlins were found to be in reasonable condition but may require some supplementing/strengthening subject to justification by calculation. The settlement of the roof over the northern wing will need addressing and may require the replacement of several purlins and rafters to level out the roof as required.

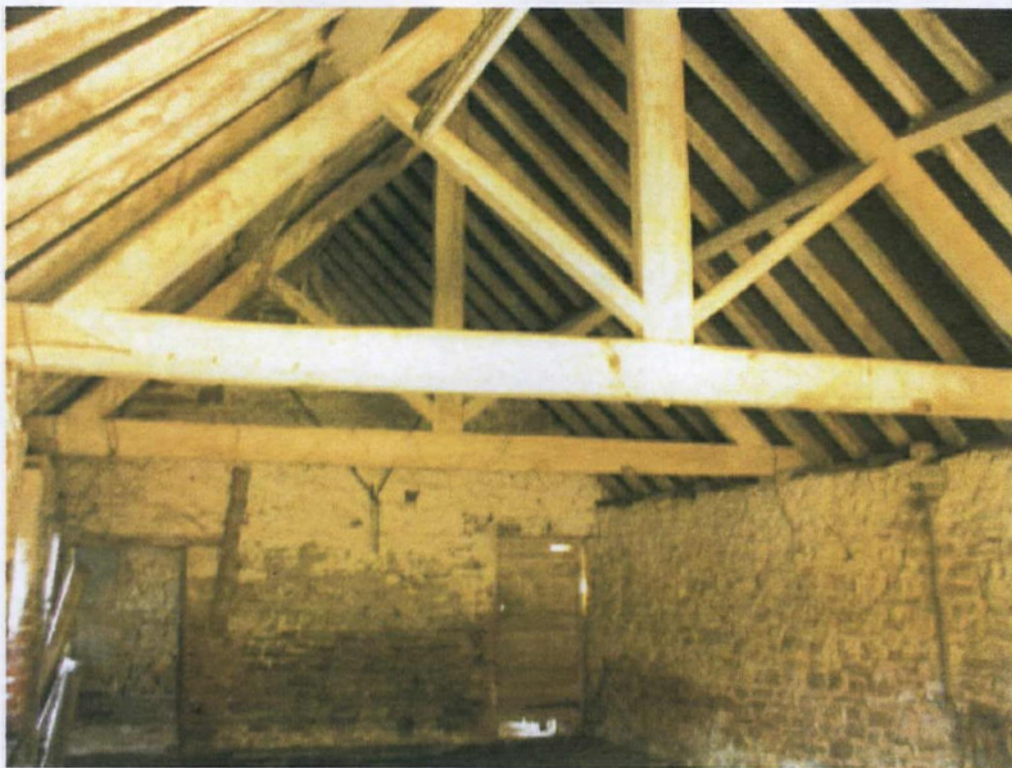
**Photograph 11. Barn 2. Internal view towards west.**

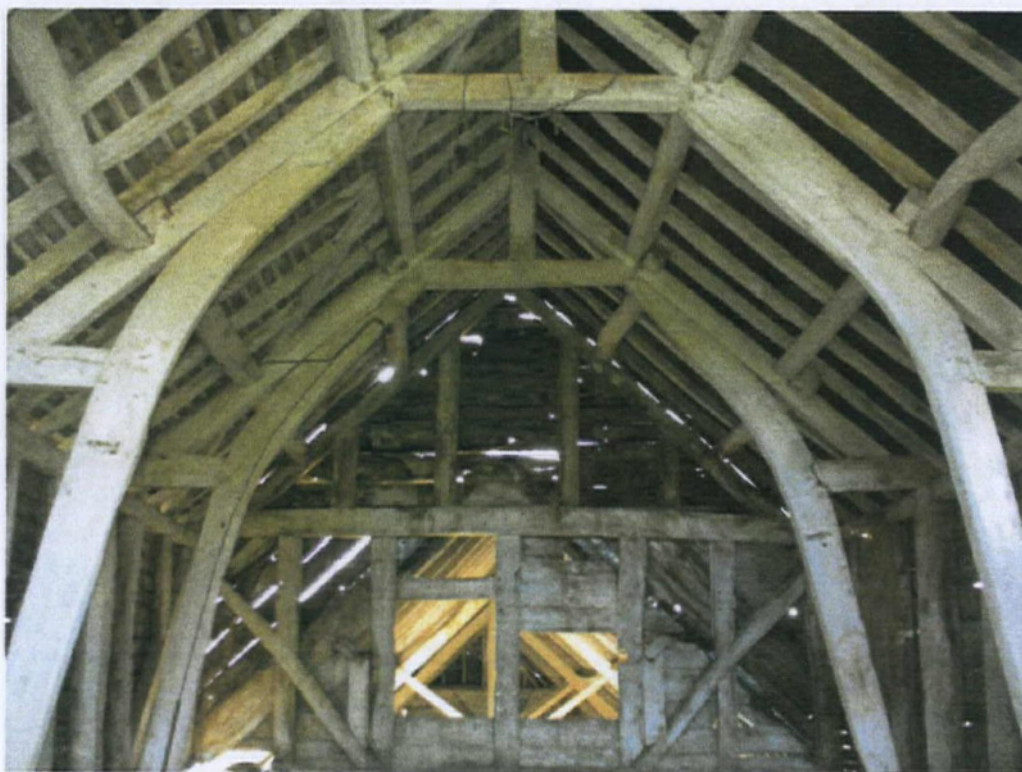
There was evidence of water staining on some of the roof members but they appeared to be generally in reasonable condition.

**Photograph 12. Barn 3. Internal view above first floor level towards Barn 2.**

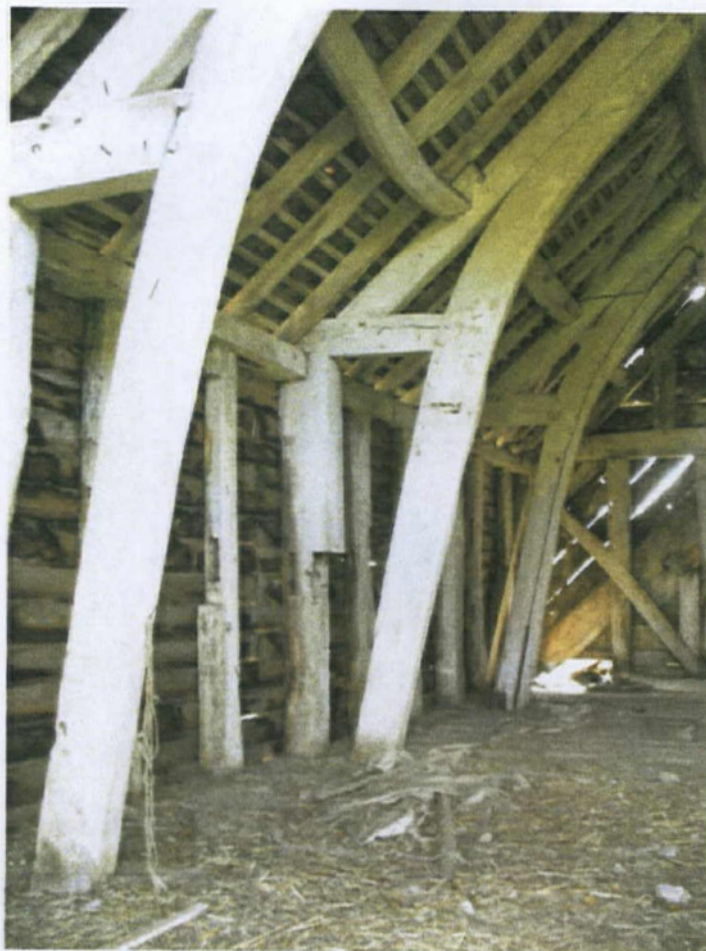
**Photograph 13. Barn 3. Internal view. South elevation above first floor level.**

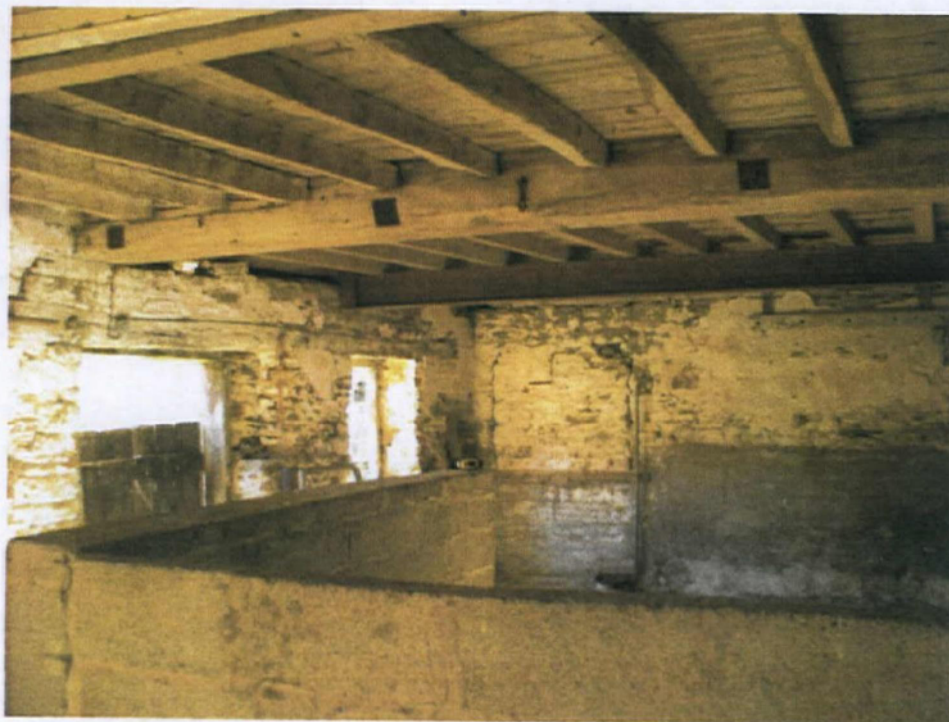
The first floor joists and beams appeared to be in reasonable condition.

**Photograph 14. Barn 3. Internal view below first floor towards Barn 2.**
