# DAMPCURE

## **RE 34 ST MARTINS STREET HEREFORD**

Thank you for your enquiry. Further to your instructions our Surveyor, Gary Edwards, met yourself at the property on the 3<sup>rd</sup> August 2023 in order to inspect the wall indicated in red on the attached survey sheet for the presence of dampness. If there are any omissions or if we have misinterpreted your survey instructions, please let us know at once.

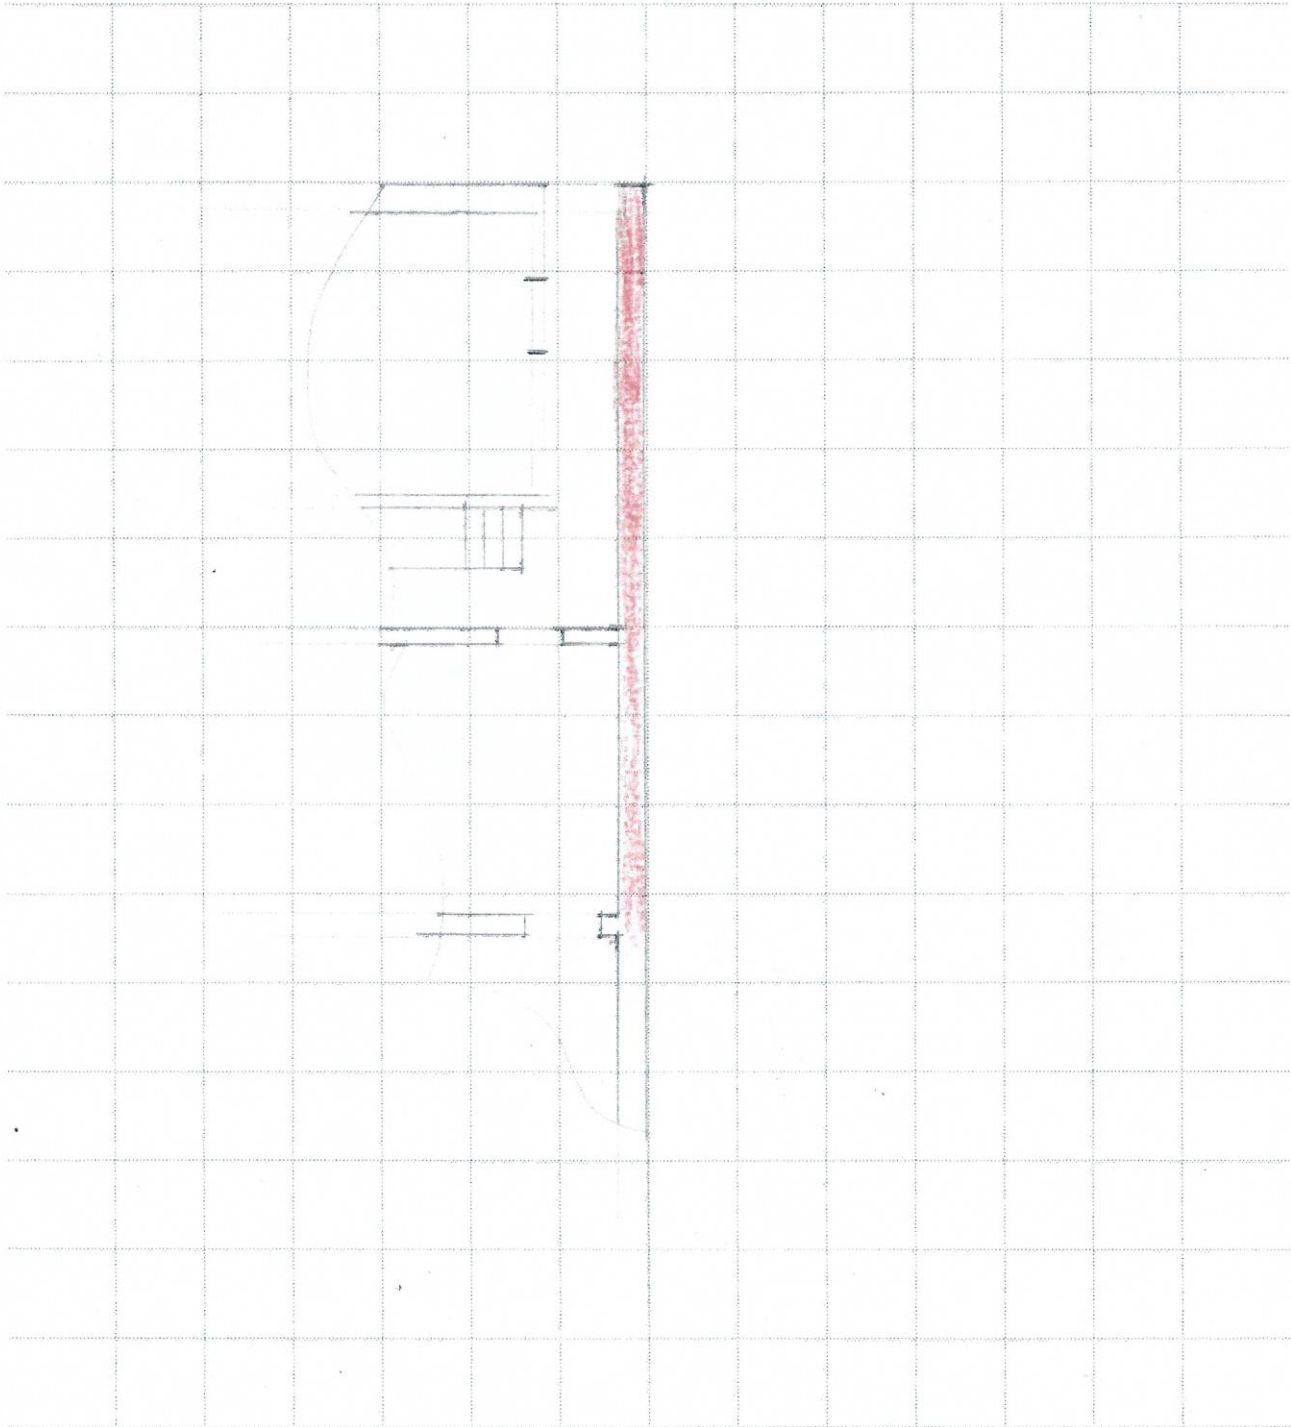
We inspected only the wall indicated in red on the attached survey sheet where to the exterior we noted drill holes indicating that in previous times a chemically injected damp proof course has been installed.

Tests conducted with an electrical moisture meter coupled with a visual inspection suggested the presence of dampness to the base of the wall, up to the height of approximately 1m. This dampness appears to be rising due to the lack of an effective damp proof course but also, possibly, aggravated by salts within the wall attracting moisture from the atmosphere.

1. A Plumber will need to be engaged to remove the radiator upon the wall indicated in red.
2. We will now attend and remove the skirting boards from the base of the wall indicated in red and the plaster up to the height of 1.2m.
3. A Dryzone Cream damp proof course will be installed to the base of the wall indicated in red from the interior of the property only. This work to be carried out to the Property Care Association's Code of Practice and to BS 6576:2005 Code of Practice for the installation of a chemical damp proof course.
4. The walls will now be lined with Dryflex.
5. The walls now to be replastered with Thistle Hard Wall onto the Dryflex membrane and where there is exposed brickwork with Limelite renovating plaster, in accordance with our replastering specification.
6. Skirting boards to be refitted.
