**STRUCTURAL INSPECTION OF  
BARNs AT GANNAH FARM  
BOLSTONE, HOLME LACY  
HEREFORDSHIRE, HR2 6NA**

Project Number: S-15-019  
Originator: Richard Hartshorne

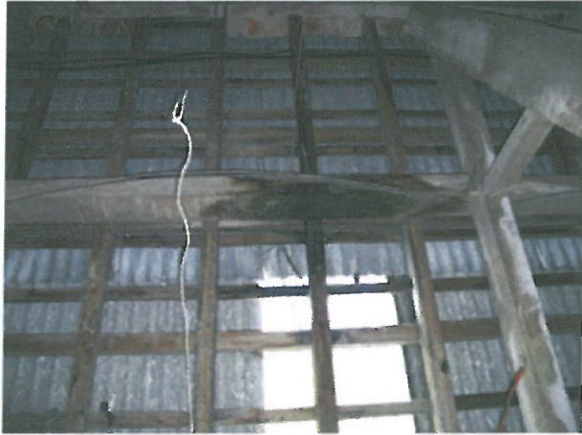
2.3.2 The softwood rafters to the building are generally in good condition with the exception of an area where a rooflight is missing and water has entered the building.

2.3.3 It is likely, as part of the conversion, that the rafters will not be deep enough to accommodate the required depth of insulation, so they may need to be replaced to suit this.

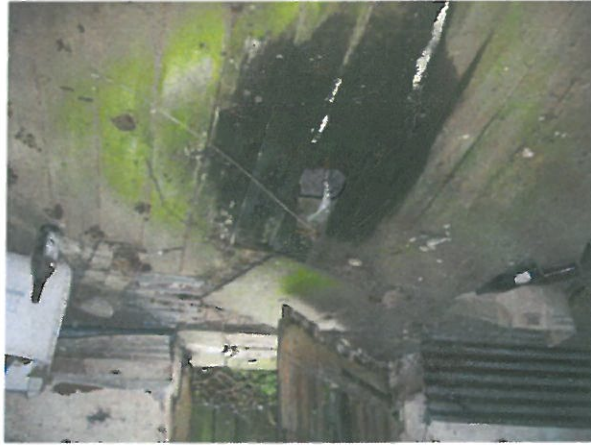
- 2.3.8 The first floor joists are generally in good condition and are suitable to be retained. Floor joists in the local vicinity of the rooflight leak are likely to need to be replaced.

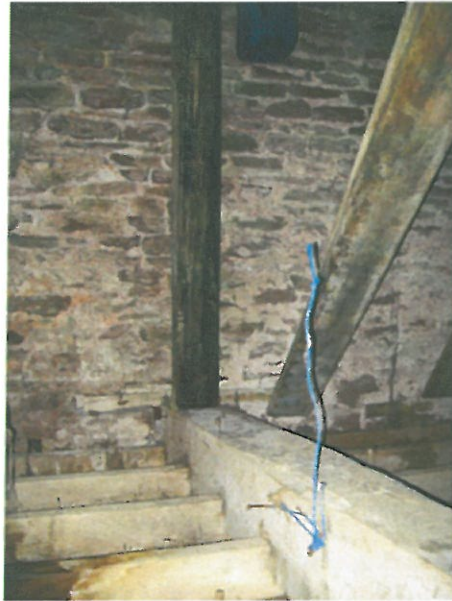
- 2.3.6 The oak truss on the gable end is in very poor condition with extensive decay to the bottom chord, king post and diagonals. Internally the truss top chord has fractured and the roof purlin is no longer in contact with the truss.
- 2.3.5 The internal oak trusses are in good condition and are suitable to be retained.
- 2.3.4 The purlins to the roof are in good condition generally. Adjacent to the missing rooflight a localised repair may be required due to water ingress.

- 2.4.2 The stone steps which provide access to the first floor are heavily worn and are covered in vegetation. It is unclear if these will be re-used in the refurbished building, but will require renovation of the treads if they are due to be retained.
- 2.4.1 The stonework to the external walling is in good condition where it is exposed to view with only minor repointing works required.
- 2.4 External Inspection
- 2.3.10 The ground floor flagstones / concrete flooring is inadequate to be retained and will need to be replaced with a new ground bearing concrete slab.

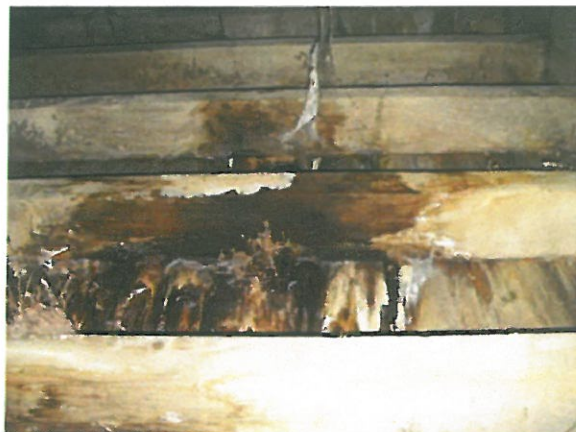
- 2.3.9 One of the main floor beams has decayed at its junction with the East side wall. A new metal shoe to extend the beam into the wall will be required.

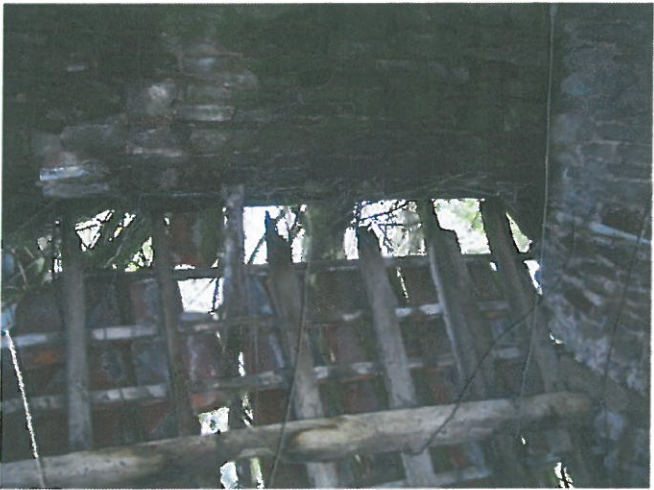
3.4.1 At the West end of the barn, the rear roof slope has lost a significant area of tiling and the rafters and purlins have deteriorated due to rainwater ingress. The rafters, purlins and wallplates to this area will need to be replaced.

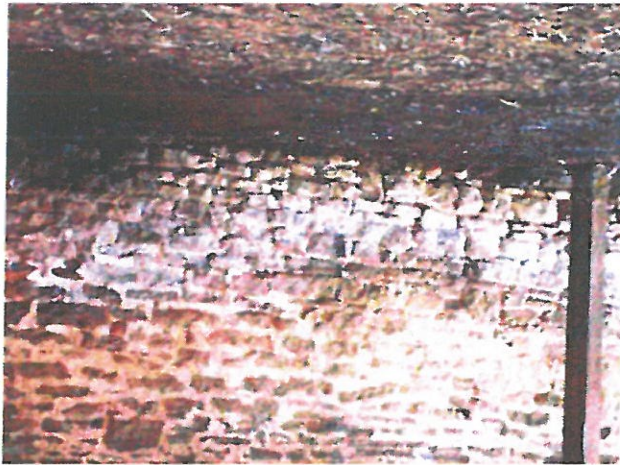
3.4.2 At the East end of the Barn there is a small section of first floor. Again the roof tiles are missing over a large portion of the floor area and the boards and joists have decayed as a result. Whilst some of the timbers may be able to be reused, this area needs to be dismantled and reconstructed.

3.5.1 The external face of the rear wall to the barn, at its interface with the new steel framed barn, is suffering from deeply recessed pointing and damp. The wall will need to be thoroughly cleaned down and repointed.

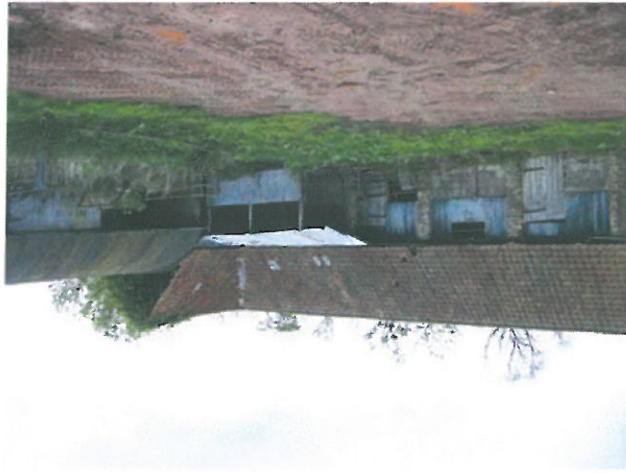
3.5.2 The external finishes to the front of the building comprise grass and bare earth. New finishes will need to be provided as part of the development.
