# **Ecological Survey of Building**

## **Tidnor Mill Lugwardine, Herefordshire**

### **April 2010**

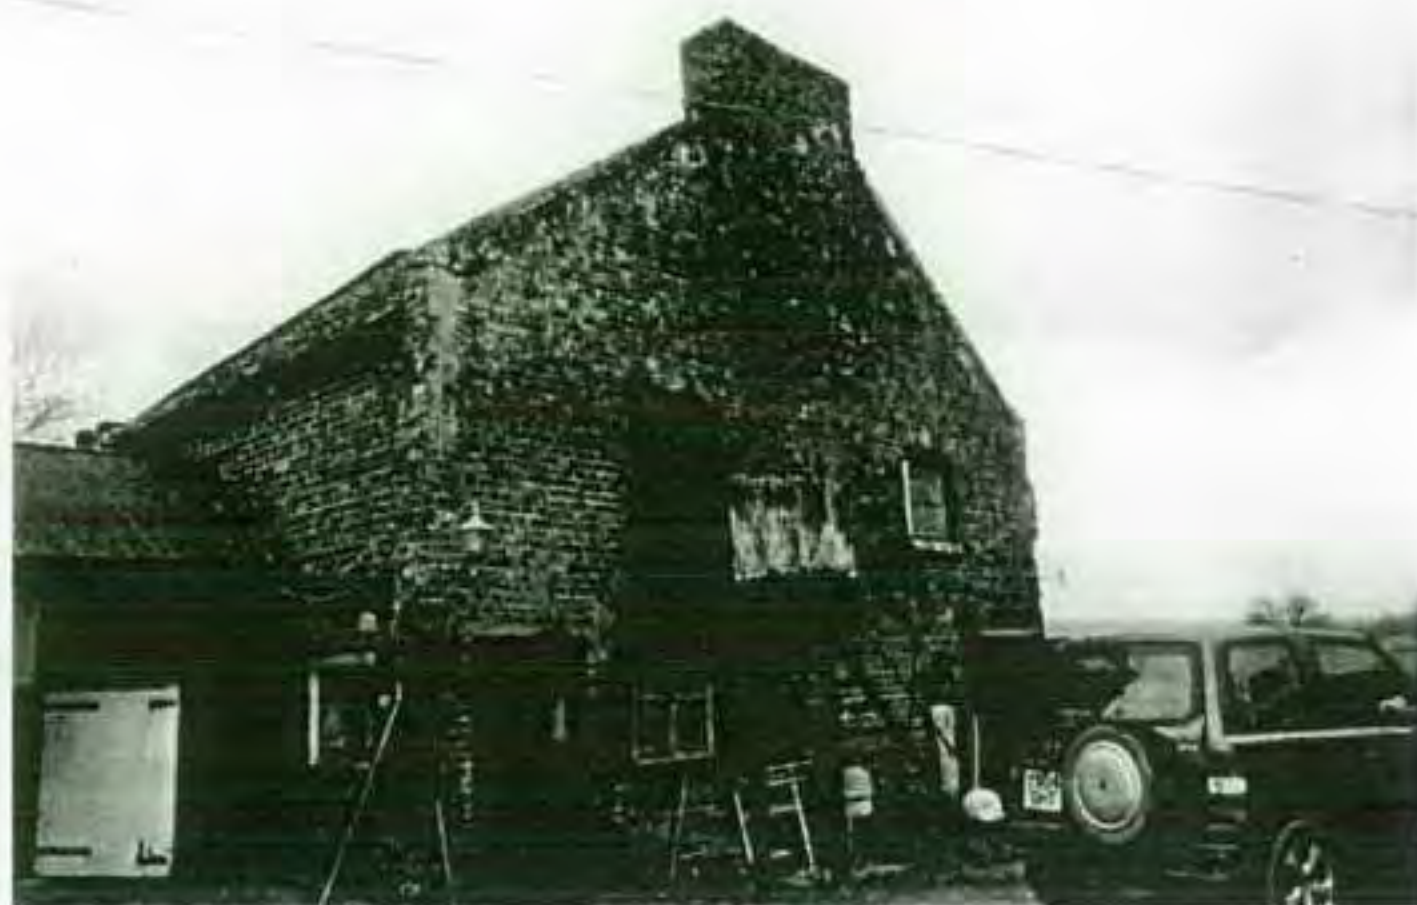
A visual ecological inspection survey of a brick building known at Tidnor Mill, Tidnor Lane, Lugwardine, Herefordshire was undertaken on the 4<sup>th</sup> April 2010. The picture on the front cover of this report shows the building surveyed.

The brick building at Tidnor Mill was checked for visual indicators of bats, owls and other wildlife present on the 4<sup>th</sup> April 2010. The picture on the front cover of this report shows the building surveyed.

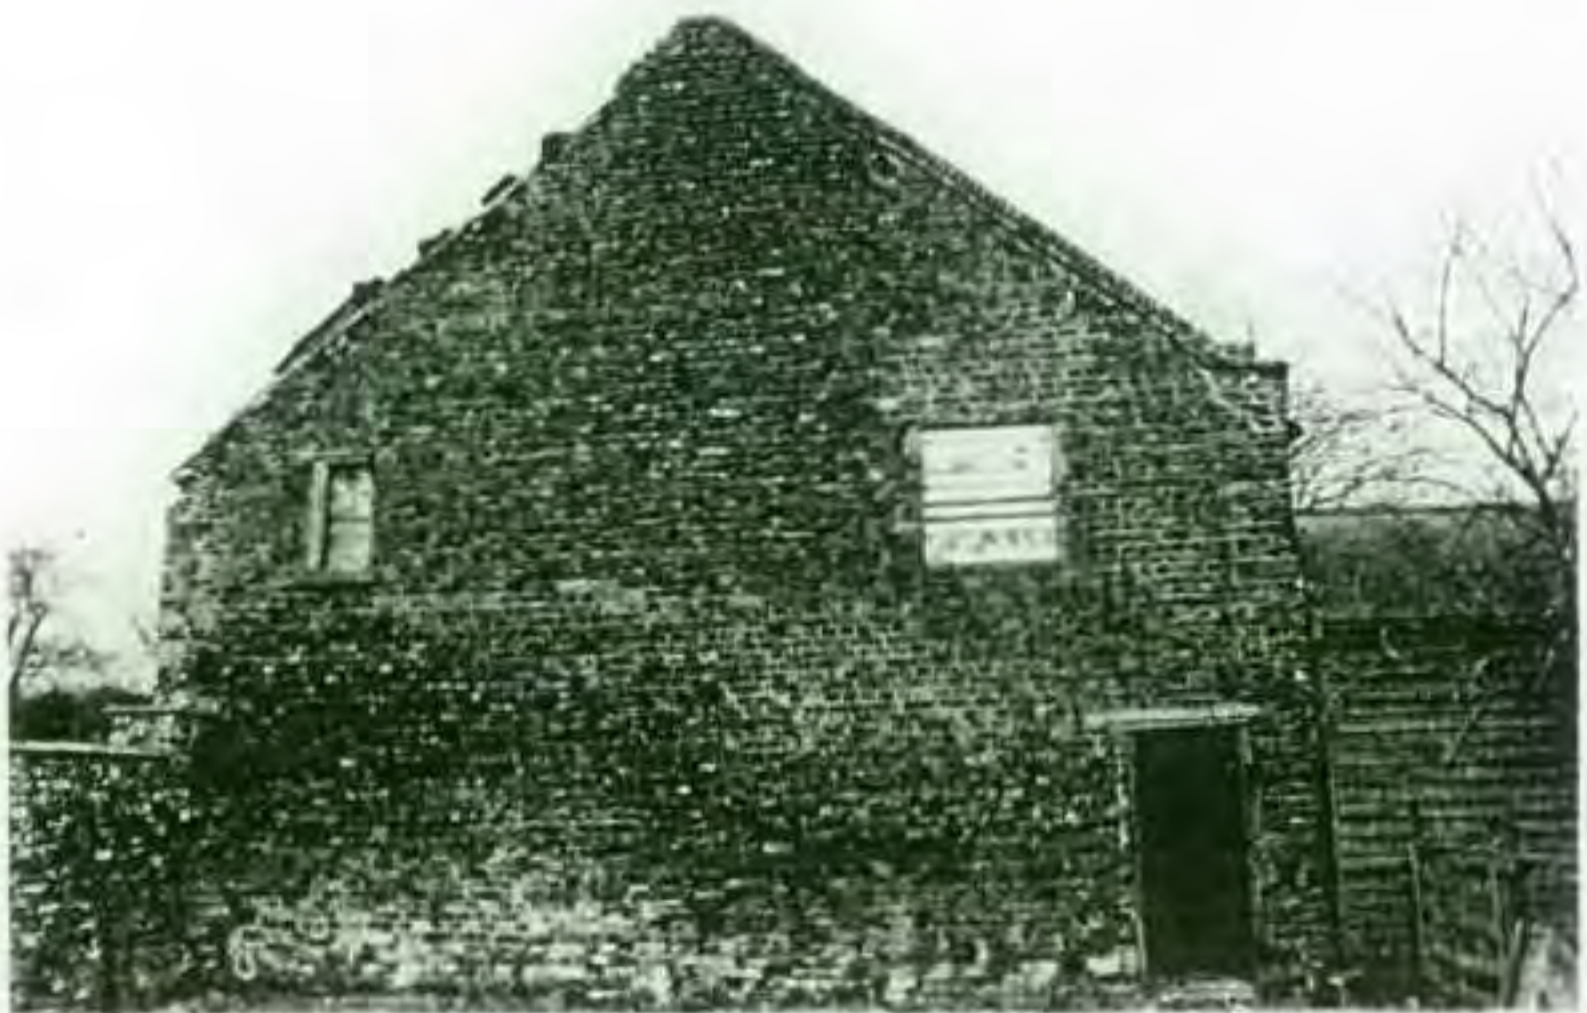
The external walls were constructed from brick, with many cracks, and crevices; providing an ideal sheltering location for bats and nesting birds. Many holes were present in the exterior mortar of the building on the river facing side; the surveyor believes these to be the result of birds pecking the minerals from the mortar over many years.

Rear of the building facing the river

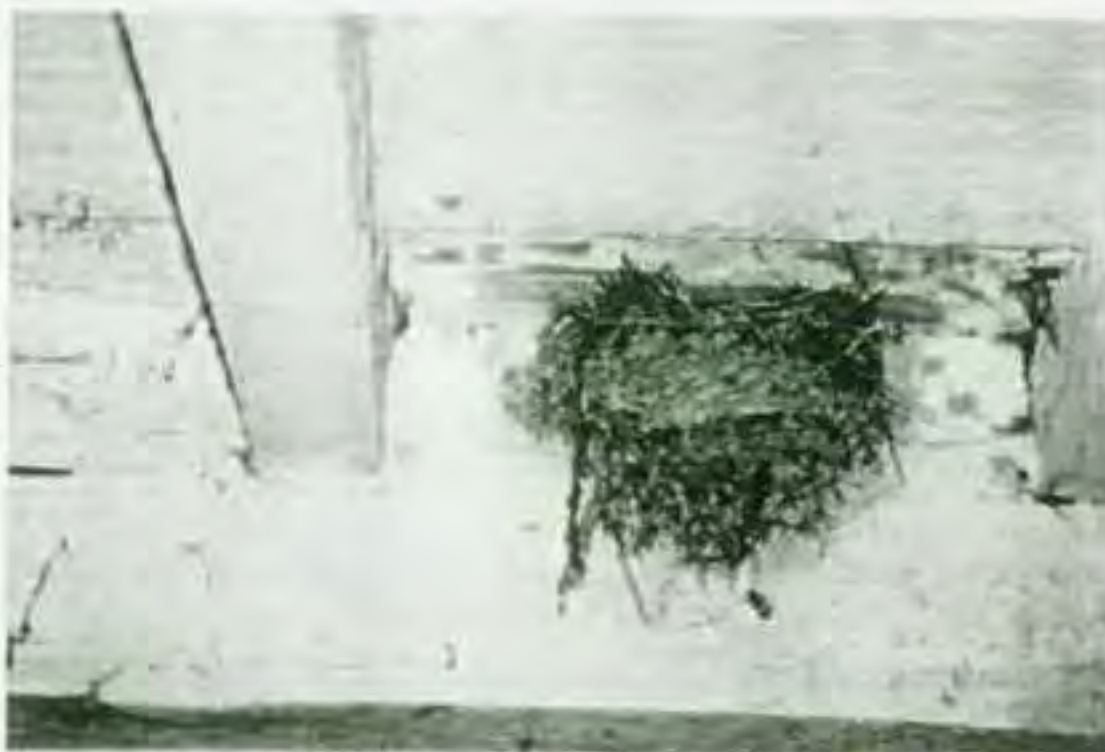
Birds' nests were noted in the internal areas of the building.

Bird's nest inside the building

Two bird boxes, on the east or west face of the building will help to mitigate against the loss of bird nesting habitat. Work should not start between May and August as this may disturb birds nesting in the vicinity.
