**Update 2024**

**Tree survey and Categorisation to BS5837:2012  
Arboricultural impact Assessment and Tree  
Protection Plan.**

**Proposed Development at Peterchurch Primary School, Hereford HR2 0RP.**

**Client: Tilbury Douglas.**

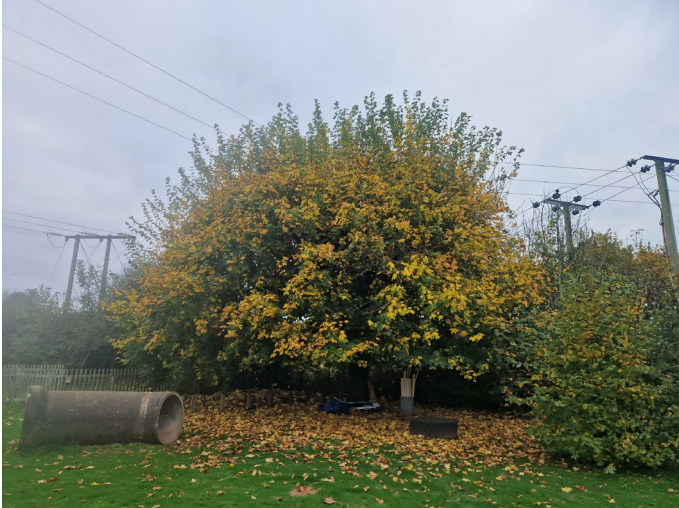
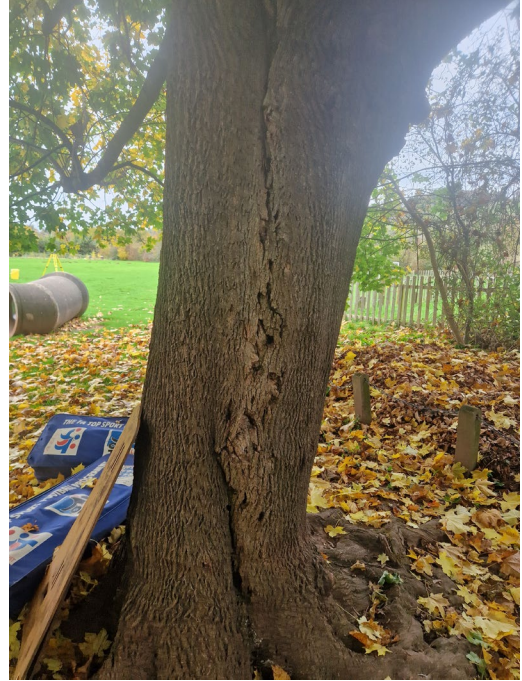
T5 -located under powerlines with structural faults.

To be removed

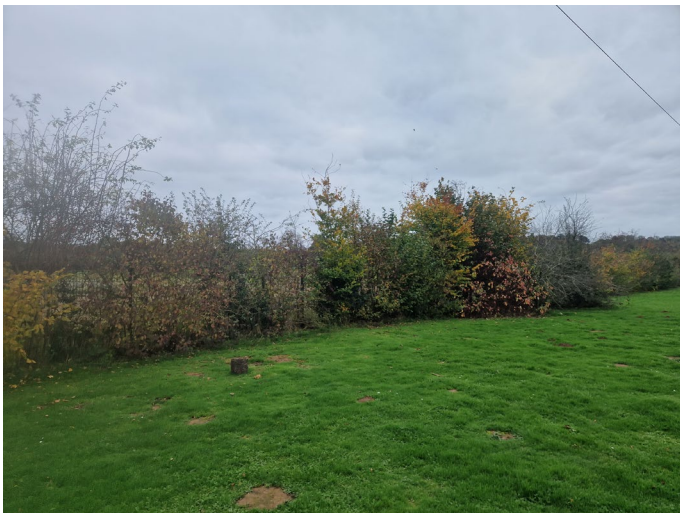
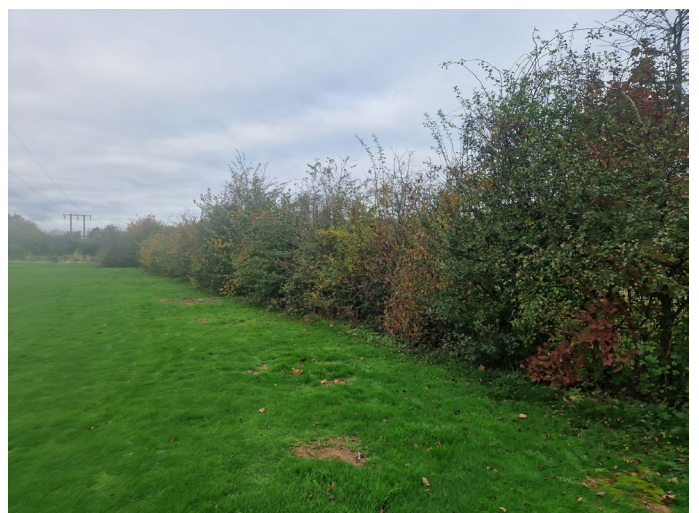
Hedge on external margin to be retained and protected.

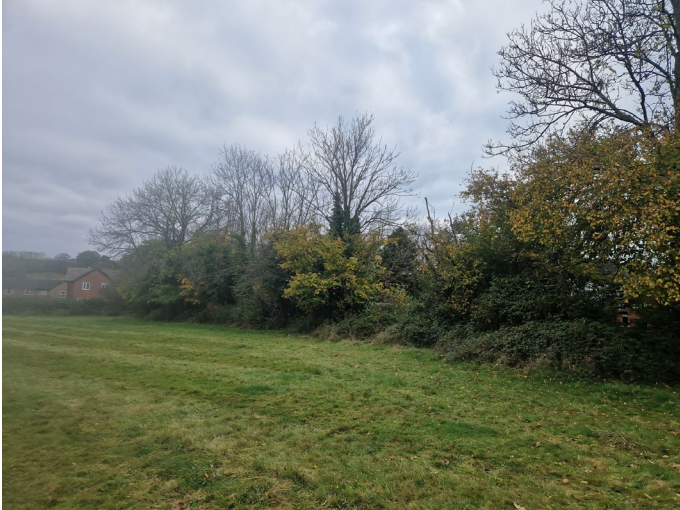
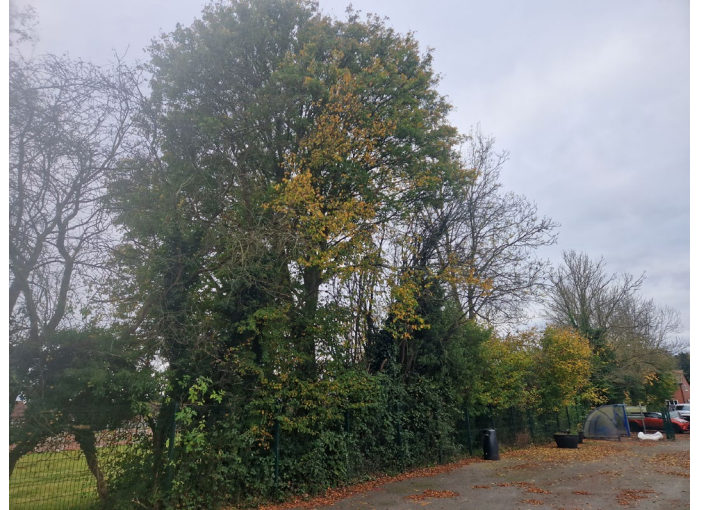
Trees along external southern margin to be removed as part of adjacent planning application

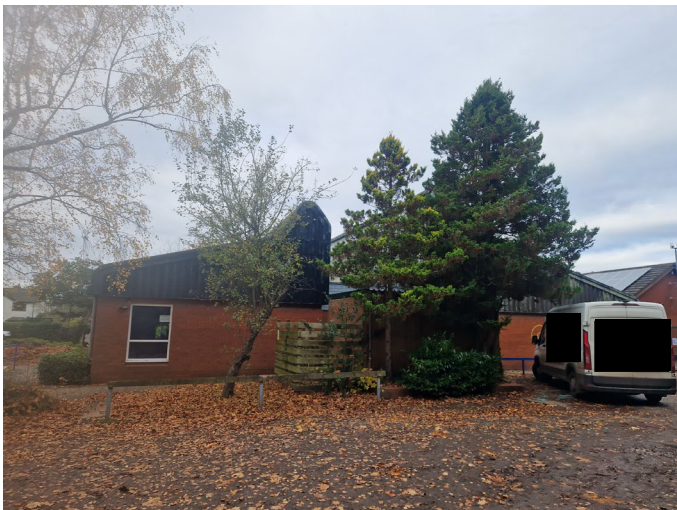
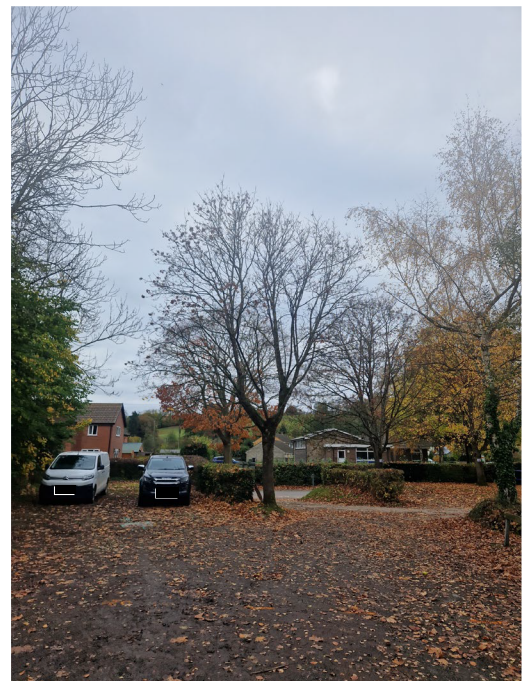
Trees to be removed at site entrance.

Following consultation with Arboricultural consultant, this will include the removal of T5, T18-T22 & T26. Sensitive canopy pruning at site entrance should also be undertaken at same time.

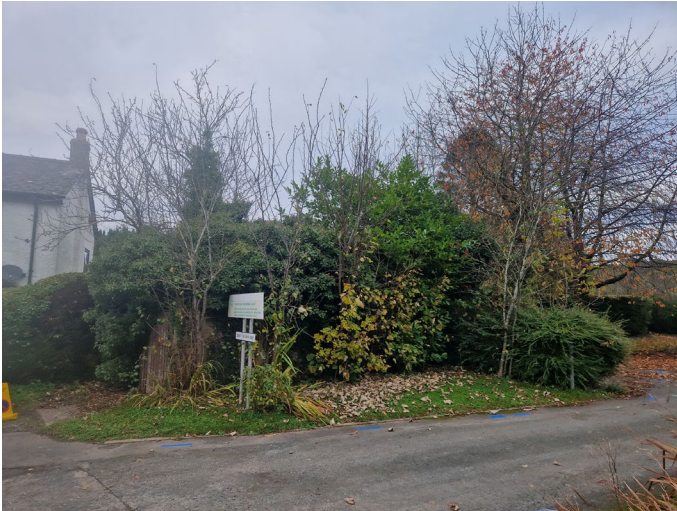
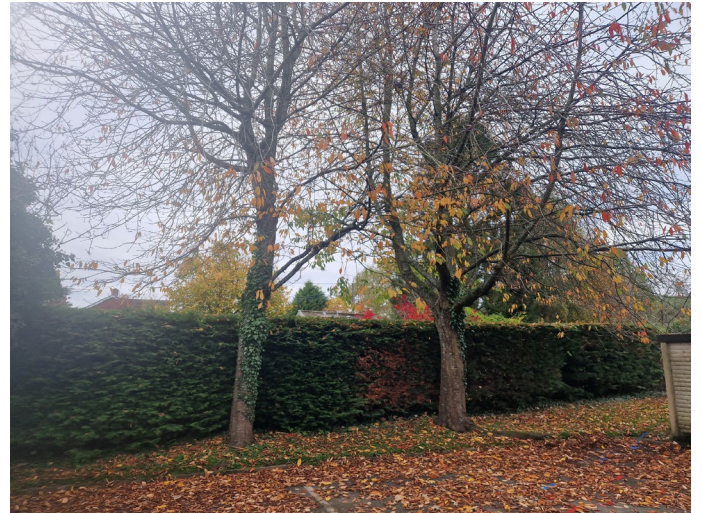
T27-T29 to be retained at site entrance.

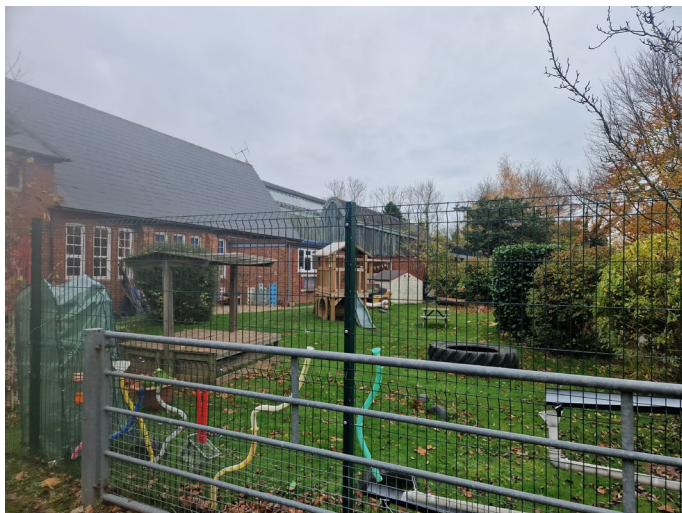
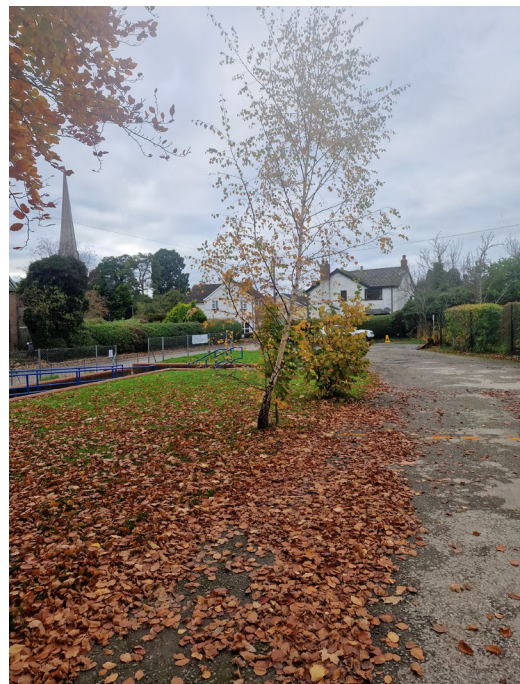
Existing site access and shrubbery
