# OUTLINE ARBORICULTURAL IMPACT ASSESSMENT

Ref: 12259

REGARDING PROPOSED DEVELOPMENT  
WITHIN THE CURTILAGE OF THE  
FORMER HEREFORDSHIRE COUNCIL  
OFFICES, BATH STREET, HEREFORD HR1  
2GY

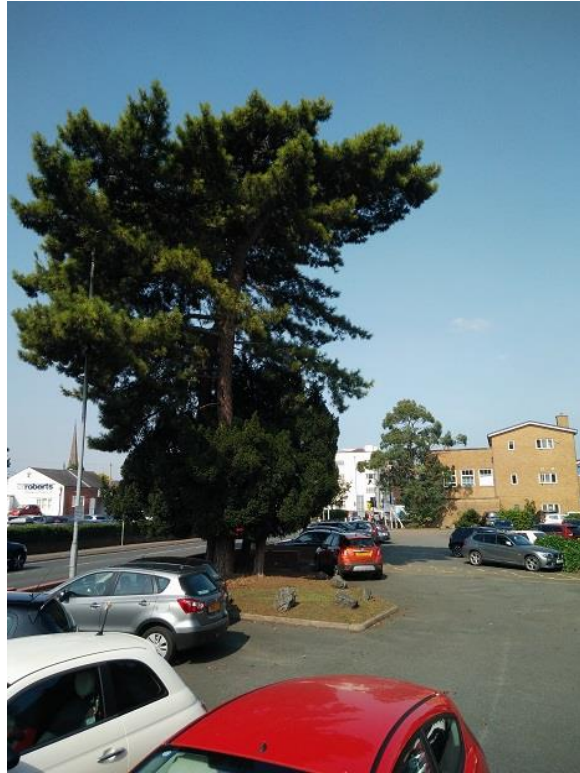
Photograph 1: Western part of application site (G1 visible in foreground)

| Tree ref on plan | Species | Ht (m) | Crown spread (M) NESW | Trunk Dia @ 1.5m (mm) | RPA radius (m) | Ht of lowest branch (M) | Age class | Life expectancy (years) | Physiological and Structural condition. Observations- negative and positive | Preliminary Management Recommendations | Category of retention |
|---|---|---|---|---|---|---|---|---|---|---|---|
| G1 | Yew & Corsican pine | 6 & 14 | 4444 | 300 & 600 | 3.6 & 7.2 | 1 | M | >40 | P = Good<br>S = Good<br>▪ Very prominent group | None | A2 |

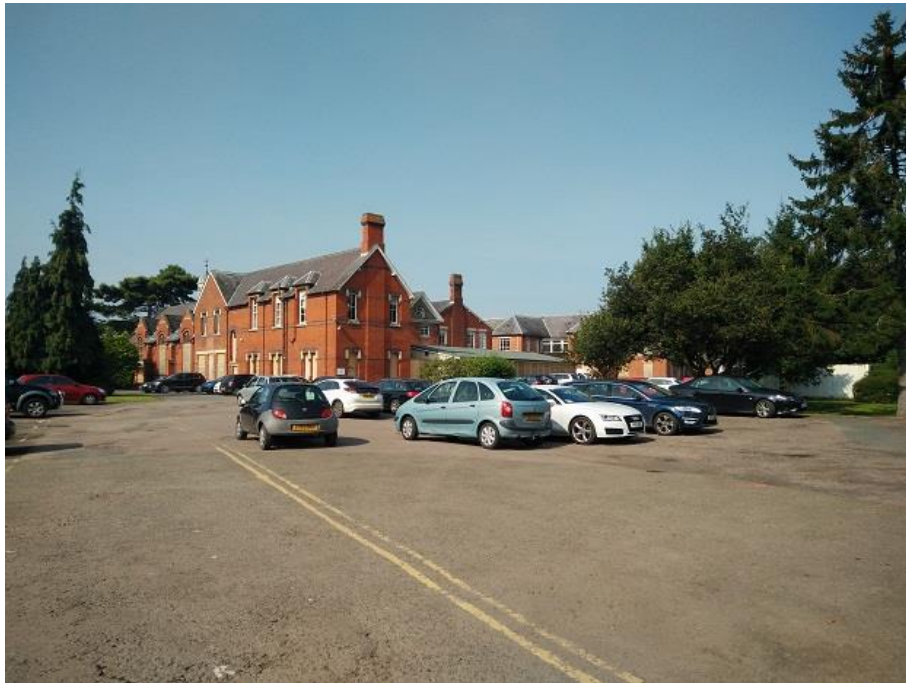
Photograph 2: Eastern part of application site (note extensive hard surfacing)

- 2.3.1 The site comprises a former office building of Herefordshire Council and currently provides a number of pay and display car parking spaces. There is an extensive amount of hard surfacing around the buildings which are located centrally within the site.
- 2.3.2 The site is relatively level throughout.

- 3.3.4 The removal and replacement of the existing tarmac surface within the RPAs of G1, T2, T3 and G4 will however require the use of specialist construction methods whereby the existing surface is carefully broken up using manual power tools, retaining the sub-base in place for the new surface to be laid upon.
- 3.3.5 The provision of the proposed parking spaces within the RPA of the off-site T9 necessitates the use of a no-dig construction method employing a three-dimensional cellular confinement system as a base. No soil stripping can occur to install this and the increased levels (circa 150mm) this entails should be borne in mind during the design process.

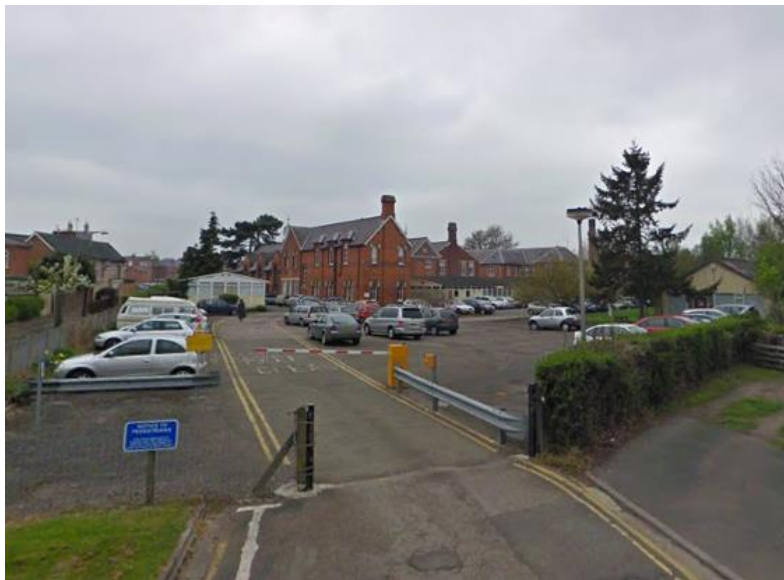
- 3.1.1 It is likely that some tree removal will be necessary to facilitate the development of the site. The indicative site layout I have been provided with (Ref: 8990 SK050) shows that this tree removal is focused within the eastern part of the site, therefore enabling the retention of the most significant trees present.
- 3.1.2 The loss of the low-quality, more internal site trees is assessed as being of low impact to the amenity provided subject to replacement plantings. The impact of their loss is also lessened by the presence of the mature limes along Central Avenue which dominate the treescape of the area.

Photograph 3: View of site from Central Avenue showing lack of tree visibility  
(Source: Google Maps)

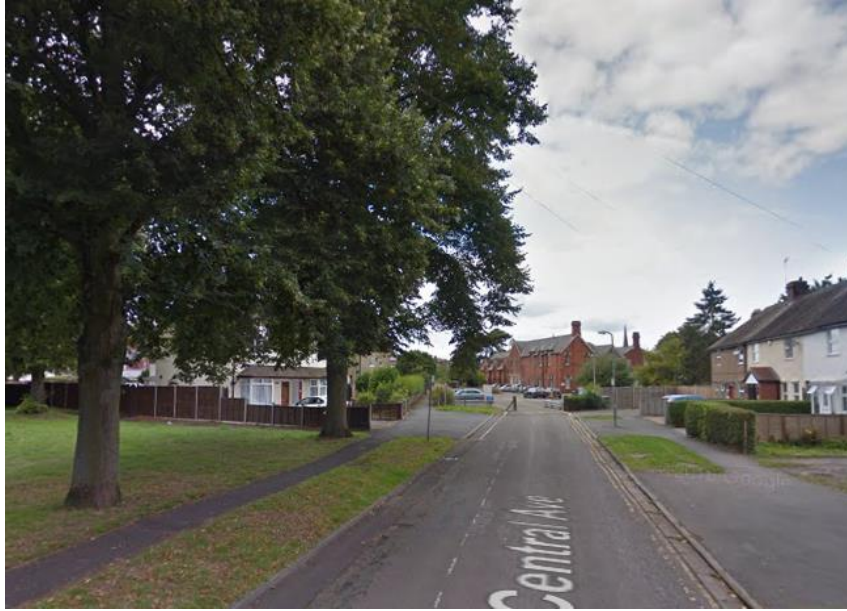
Photograph 4: View of site from further east on Central Avenue  
(Source: Google Maps)
