Wolf Business Park

Gloucester Road, Ross-on-Wye

Tree Survey and
Arboricultural Constraints Report

Revision 6 *(Trees all reassessed, December 2019)*

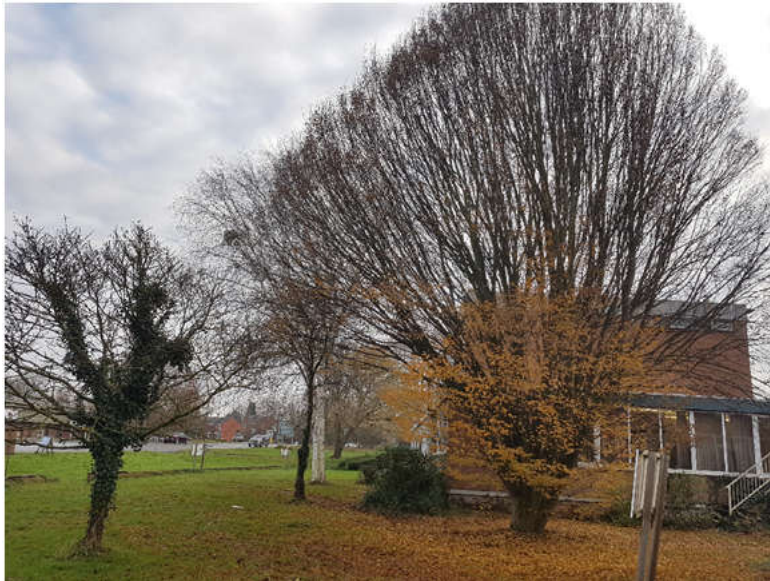
Tree 1 (T2- Hornbeam)
with tree 2 (T3 Sycamore)
December 2019

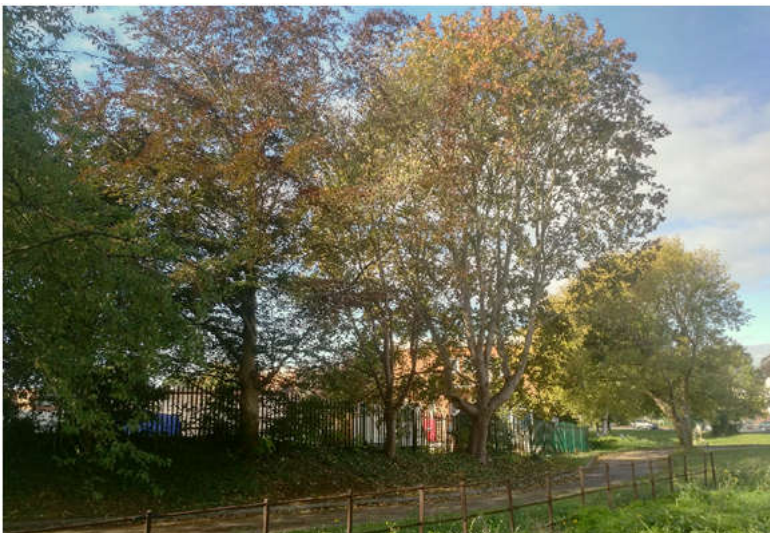
Trees 7, 8 & 9 (R to L);
outside site boundary
October 2018

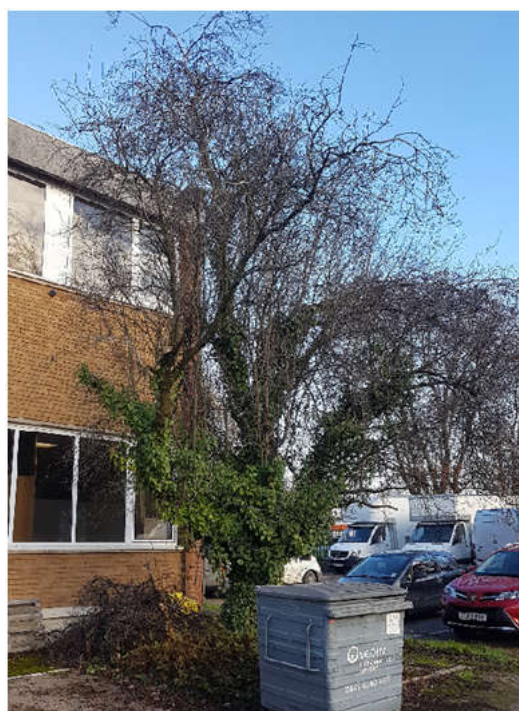
Tree 11
(Purple-leaved maple)
December 2019

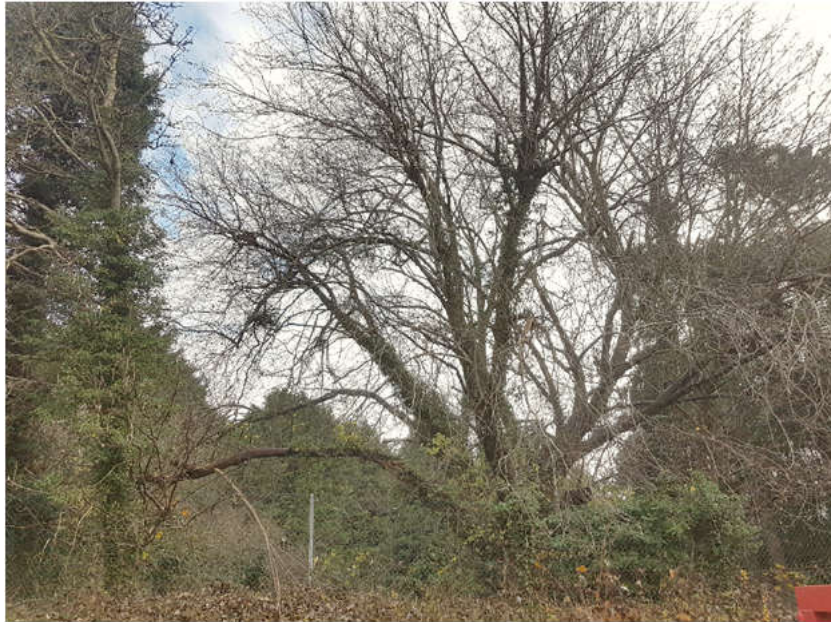
Tree 15 (Silver Maple)
with tree 14 (Walnut)
on left

(Part of TPO G1)

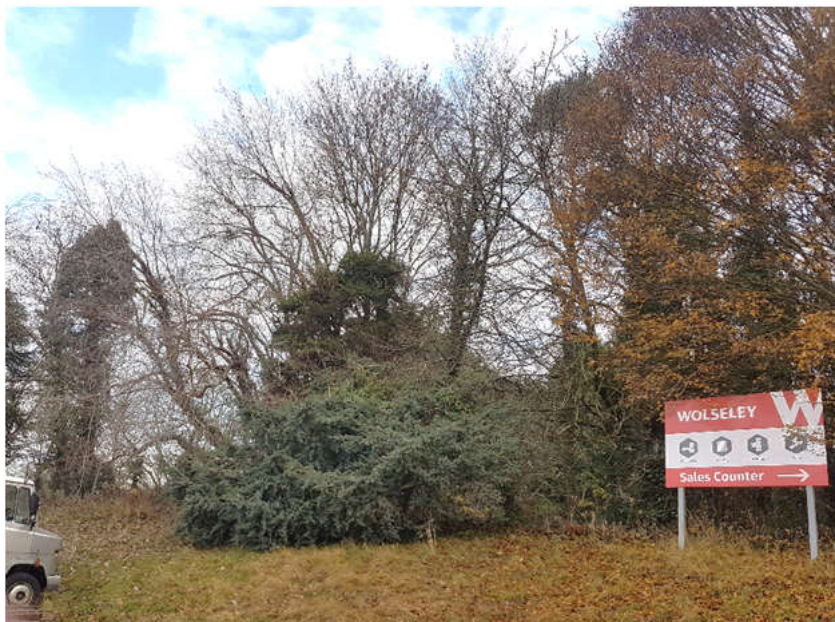
Tree 19 (Juniper) with
tree 15 behind and tree
13 (pencil cedar) far left

(Part of TPO G1)

ID no.	Species	Notes on current condition	Cat.	Proposals & justification
19	Meyer's Blue Juniper	Bare on the east side with broad, low canopy confined almost entirely to the west where it spreads down the existing bank: grossly asymmetric in form, but evidently healthy and acceptable as viewed from within the site, from where it provides some screening.	C+	Remove: <i>Conflicts with proposed layout, with nearly all of its existing crown extending beyond the proposed site wall.</i>
21	Horse Chestnut	Generally good, although with one branch that arches over to the west, hanging low and extending disproportionately wide towards the site	B-	Retain, but tip back branches extending widely towards and over the site
28	Larch	Very tall and slender; ivy. Negligible	C	Retain, but reassess on completion of other works.
29	Fastigate Hornbeam	Numerous low branches with ascending form but spreading widely (compare with tree 2). No significant defects and generally acceptable	C+	Monitor (removal likely to be required): <i>Moderately wide encroachment into RPA, but wide-spreading crown likely to require excessive cut-back, greatly diminishing any amenity value</i>

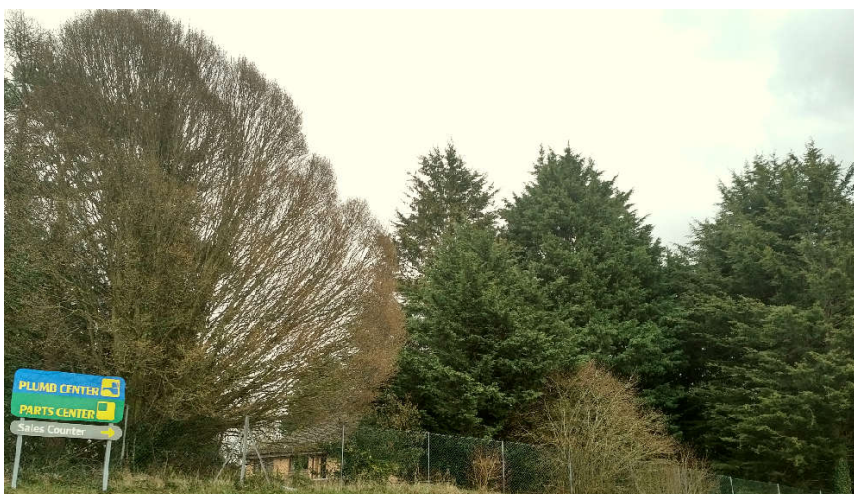
Fastigate Hornbeam
(tree 29: Part of TPO G1)
with Leyland Cypress,
Report group G1 on right

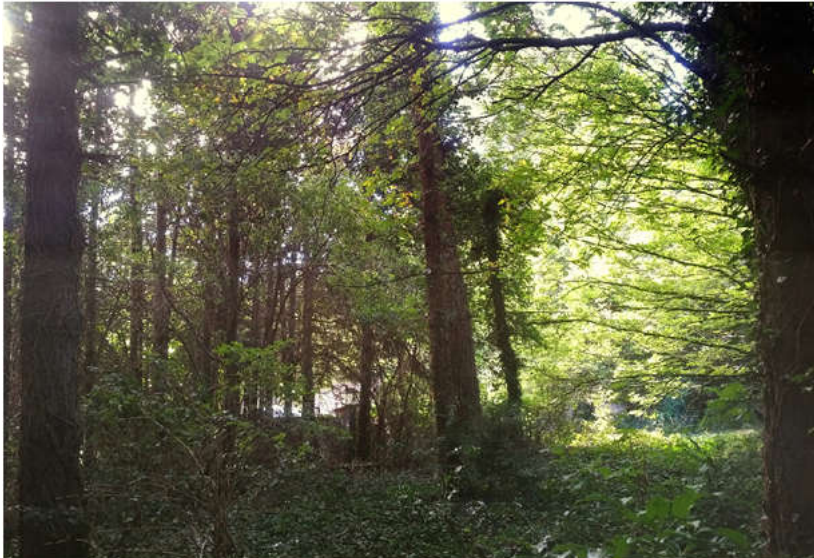
Interior of woodland area, from north, Sep. 2018. (Slender trees on LHS are on adjoining land)

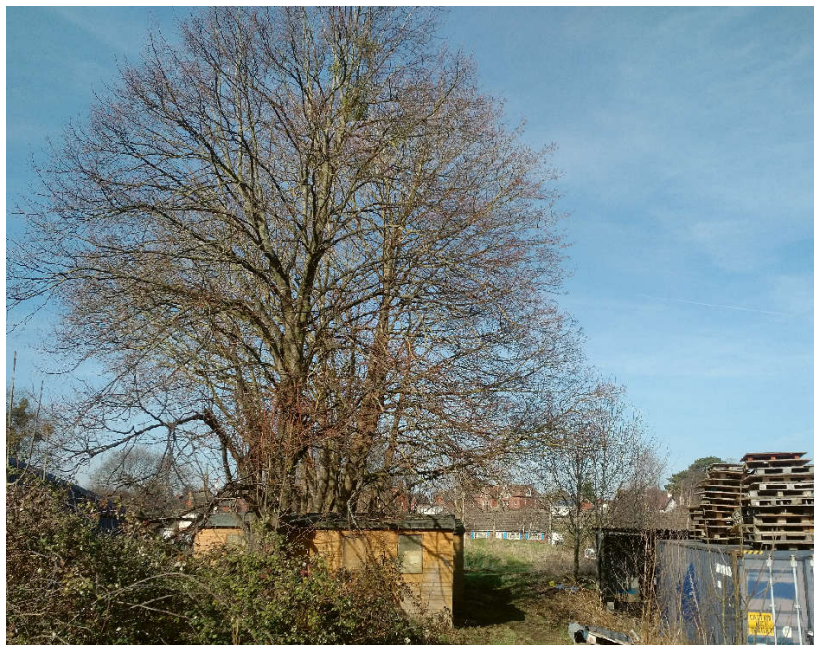
Trees 34 to 36

35	Norway Maple	Multistemmed from base; some minor dead wood; acceptable	B	Remove: <i>Conflicts with proposed layout (Removal would benefit tree 34)</i>
36	Norway Maple	Somewhat congested multi-stemmed structure but no significant defects observed from this inspection	B	Remove: <i>Conflicts with proposed layout</i>
37, 38 & 39	X2 Ash & X1 Norway Maple	Three trees, all small, evidently self-set and negligible	C	Remove: <i>Conflicts with proposed layout</i>
40	Sycamore	Dense ivy; fair, but lacking vigour	B	Remove: <i>Conflicts with proposed layout</i>
41	Sycamore	Fair but not exceptional; somewhat lacking in vigour	B	Remove: <i>Conflicts with proposed layout</i>

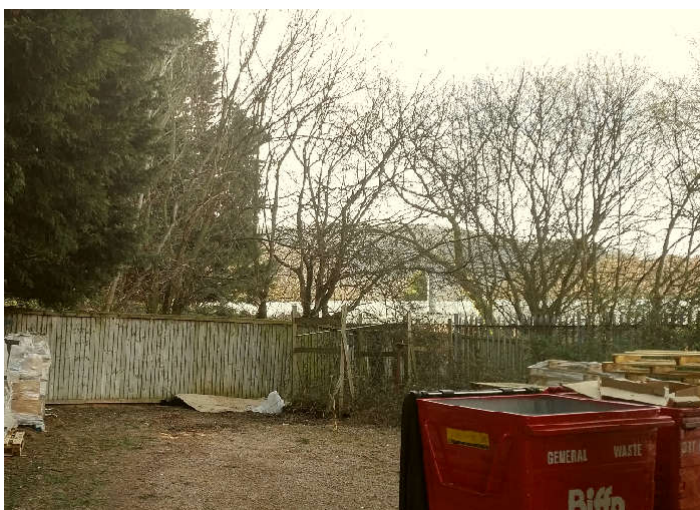
Goat Willows: group G2

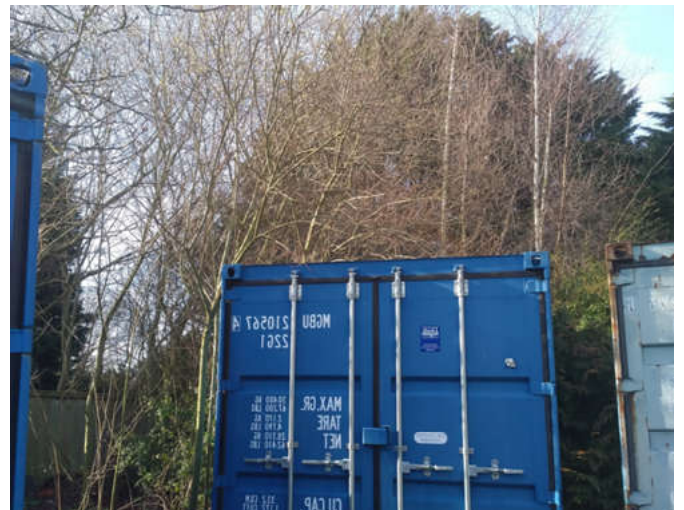
Self-set 'weed' trees, Group G3
