Subject: Fwd: FW: FW: FW: 222006 & 222007 - Lower Daffaluke

In response to below I've reached out to the contractor who installed our PTP last year, Kettle Civils Ltd, for further information. For ease, I've taken a copy of the email response from Kettle Civils Ltd - if this is not clear please let me know and I can forward the original. I can also confirm that the discharge pipe to the watercourse is within our boundary.

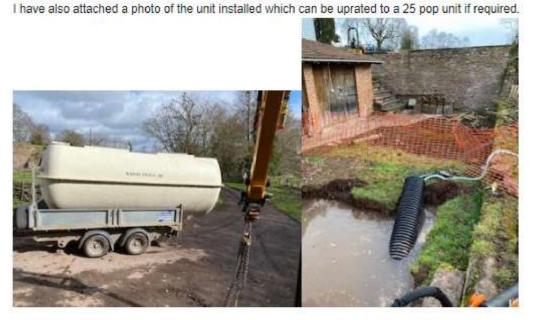
Lawrence has advised it was not necessary/possible to carry out percolation tests due to the height of the water underground - the photo below shows the water level when digging out for PTP installation. He also re-iterates that the installation was inspected and signed off by Building Control, therefore to revisit this now undermines that sign off.

Please see attached photos of the excavation which shows the height the water reached overnight. Therefore no percola in fact we had to raise the plant a little to insure it still works correctly when the stream floods the driveway.

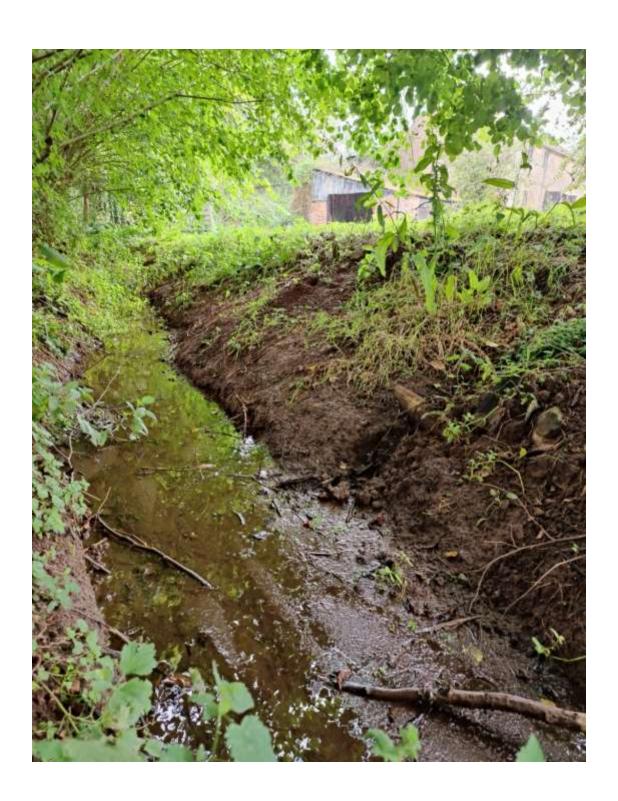
In addition, I've attached the proof requested that it is a running stream. Note, the level is the lowest we've ever known it due to the unprecedented dry spell, but it's still running.
