Re: Barn at Traphouse Nurseries, Allensmore, Hereford HR2 9BP

Application No: S122006/F

Barn at Trap House Nursery, Cobhall Common

Inspection/meeting 21st June 2013

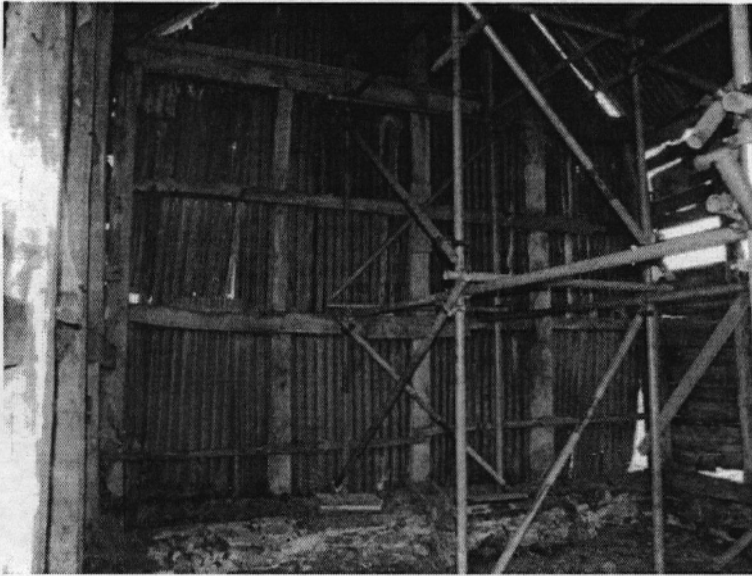
Internal view of the right gable and the internal scaffold.

Note the planted on timbers inside the original timbers.

12. Planted on timbers to the gables are to be removed.

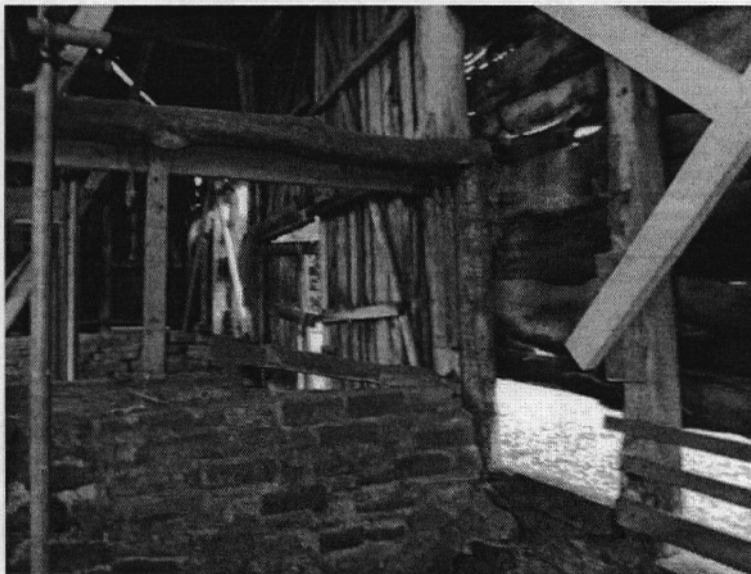
Front wall - the remains of the 1st floor supporting timbers are to be removed.

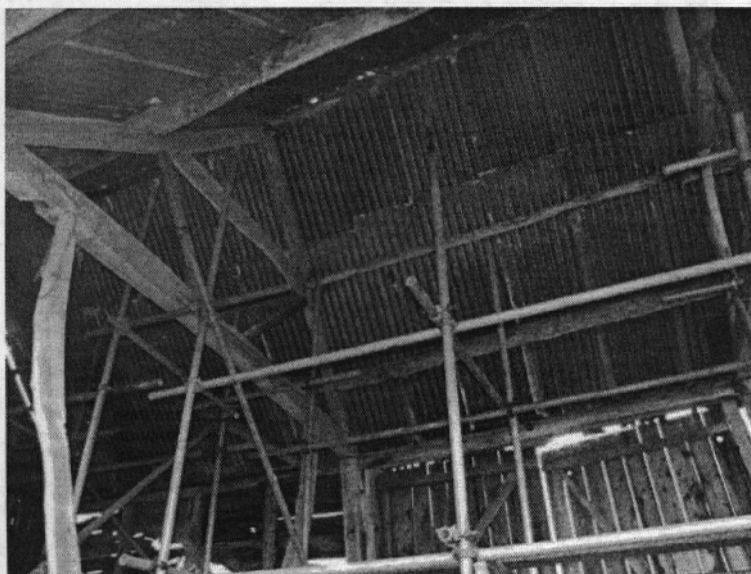
Roof and truss. Truss to be retained.
Timber braces to be retained.

New purlins.

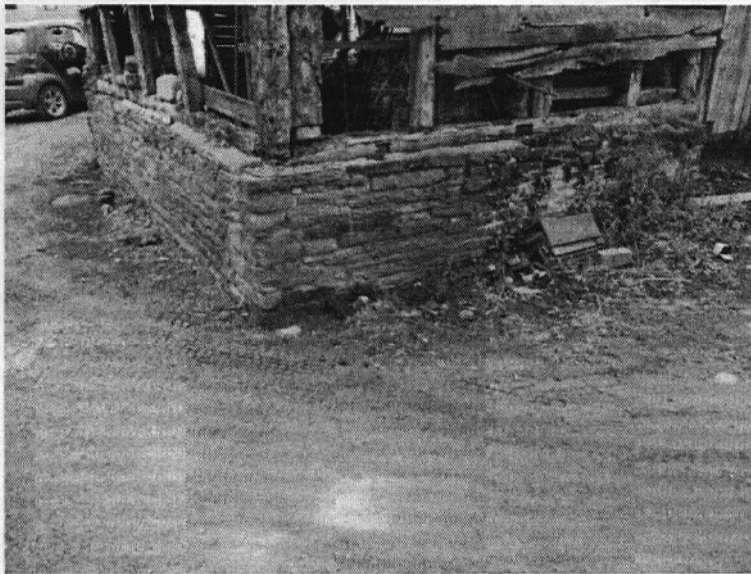
Trial pits on the gable shows that there is little masonry below ground level. Underpinning is required.

The gable wall plinth wall stonework is to be retained.

Note that there is an issue concerning the first 1.5m on the front wall return which is in reasonable condition and has to be retained but the proposal for re-building has the stone face out from the existing.

Issue to be resolved.

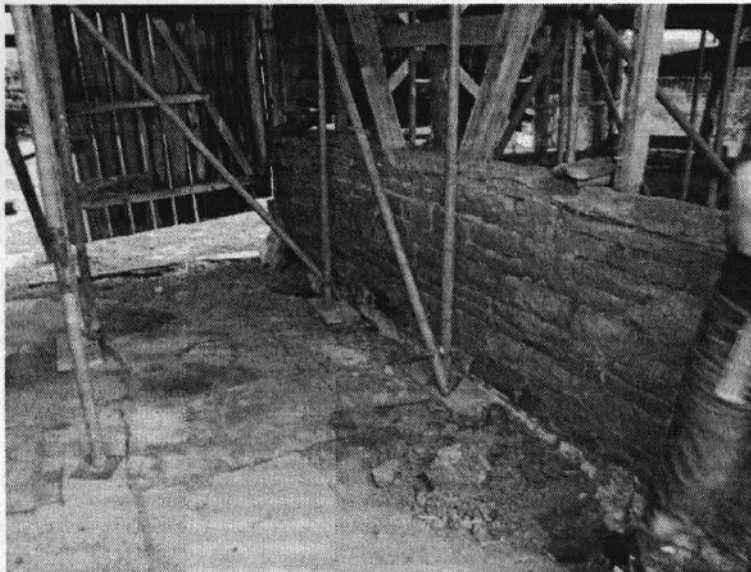
Walls either side of the cartway. Both lean into the cartway, one worse than the other. Both are to be retained, if possible - procedure to be agreed.
