FIGURES 1 - 5

HEREFORDSHIRE COUNCIL PLANNING SERVICES DEVELOPMENT CONTROL	
20 MAY 2013	
To:	
Ack'd:	File:

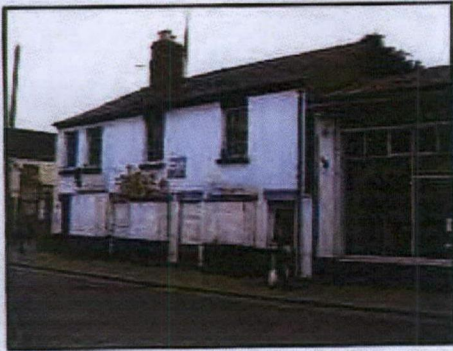
Figure 1

The derelict house and adjoining car sales room are located on the main high street.

No evidence of bats was found in these areas.

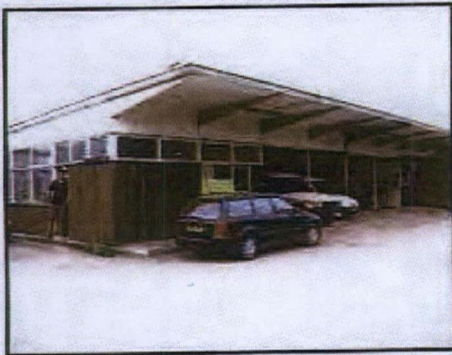
Figure 2

The car workshop is a prefabricated structure that lacks bat roosting opportunities.

It is illuminated at night.

No evidence of bats was found in this area.

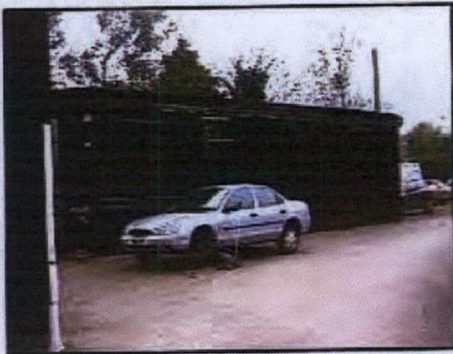
Figure 3

Corrugated iron sheds are used as car servicing areas.

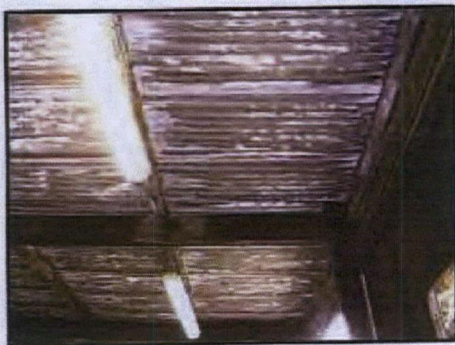
Figure 4

The corrugated iron sheds lack bat roosting opportunities.

No evidence of bats was found in these areas.

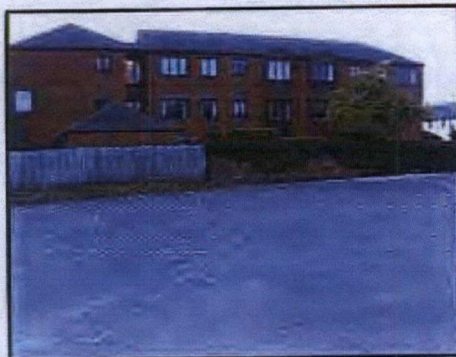
Figure 5

The proposed development site is surrounded on all sides by existing development. The local area lacks any significant vegetation and is well illuminated by security and street lighting.

No bats were observed anywhere in the local area during evening survey work despite ideal weather conditions.
