# **Preliminary Structural Appraisal**

- Project: Lower Barns St Michaels Tenbury Wells
- Client: Mr & Mrs Yapp
- Ref: 17168
- Date: May 2017

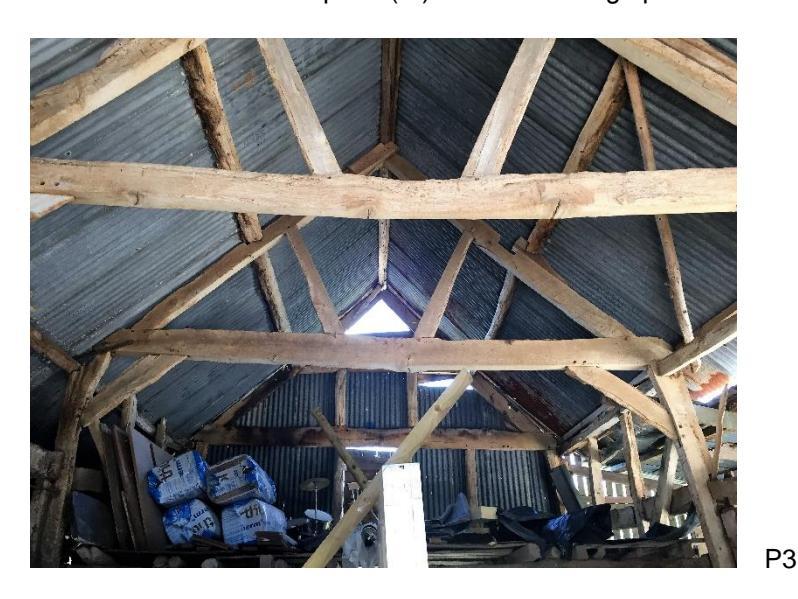
<u>Side purlins:</u> Dual pitched roof is supported on one row of side purlins per slope. Approximate section size is 175mm square (7") in section. Ridge purlin: 125mm square.

- <u>Comment:</u> Current purlins are softwood, probably not contemporary with original framing. Material condition appears adequate however, section size may prove insufficient in terms of strength to support increased loads imposed by required domestic standard construction i.e. plaster, insulation, tiled/slated covering.
- <u>Cross Frame:</u> Triangular truss frame spanning the width of the building supported by large storey posts supporting purlins, member configuration, joints. Tie beam fractures with some displacement noted.

In the case of the sole plate it is usual practise to replace the member with some splicing/repairs to vertical members in contact. Side purlins will need to be replaced.

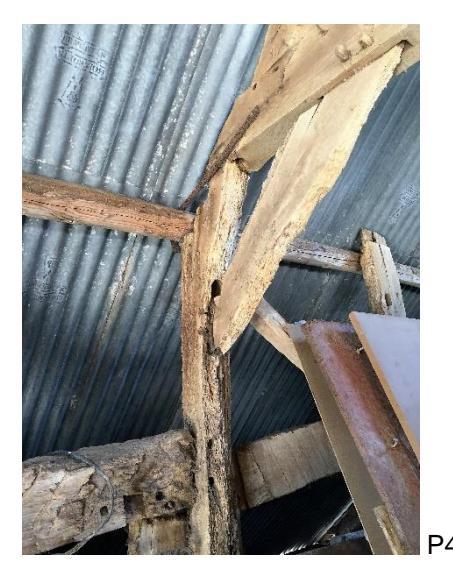
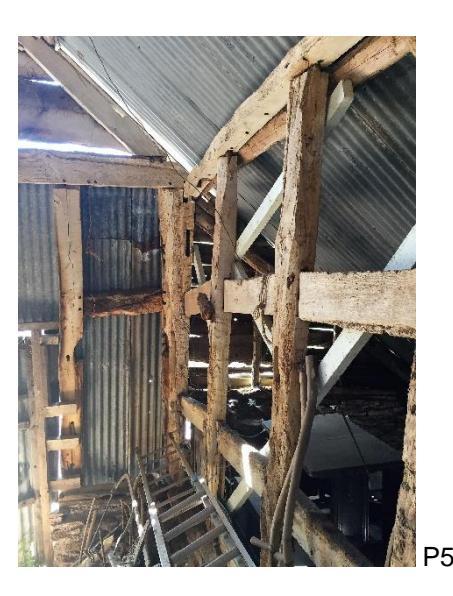
<u>Comment:</u> Material condition and section size appear adequate, localised repairs required.

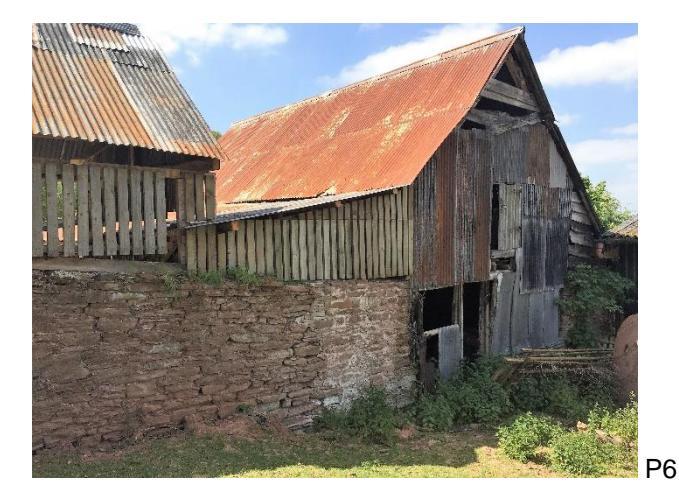
Section of wall (P6) leans outwards with loss of bond/cohesion.

<u>Comment:</u> Like the barn, the stone is in adequate condition, it lacks an effective mortar to bond the construction. Masonry walling requires careful consolidation and repairs. Some section may need to be taken and rebuilt.
