Design & Access and Heritage Statement

Newton Farm, Stoke Lacy, Bromyard, HR7 4QY

Repairs and alterations to existing farm buildings

August 2022

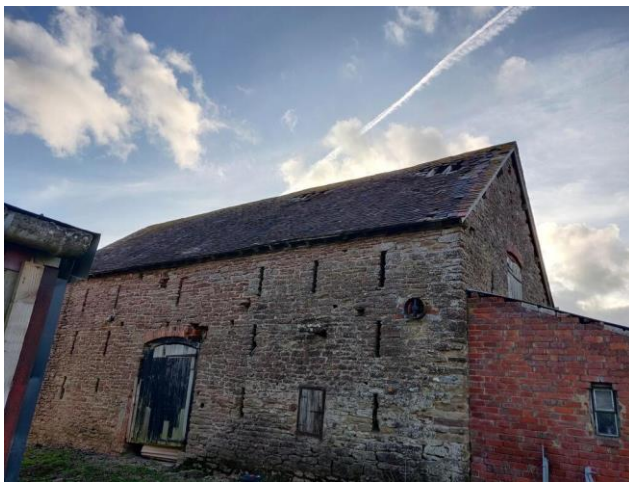
The clay tiles to the combination barn are slipping in large sections as a result of the current batten nails rusting causing the battens to fail under the weight of the tiles. This is now leaving large gaps in the roof covering for the weather to enter and cause further decay.

Tile slippage leaving holes in the roof

The roof coverings will be removed, set aside and any damaged or missing tiles replaced to match.

To improve usability of the barn and to future proof its use, it is proposed to incorporate insulation and roof windows into the roof slopes. The roof will be recovered in the salvaged tiles.

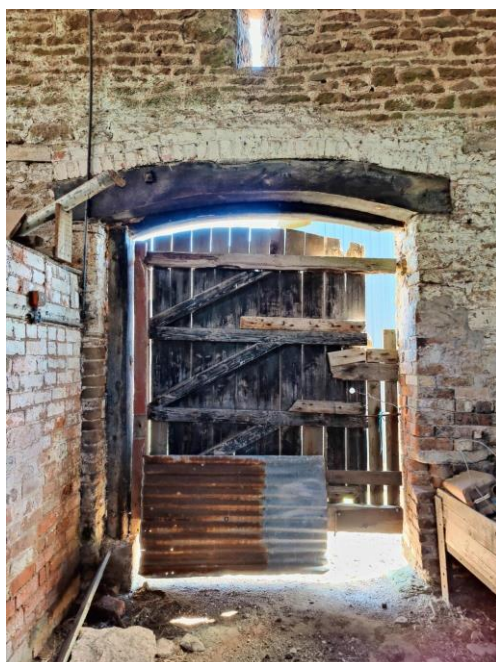
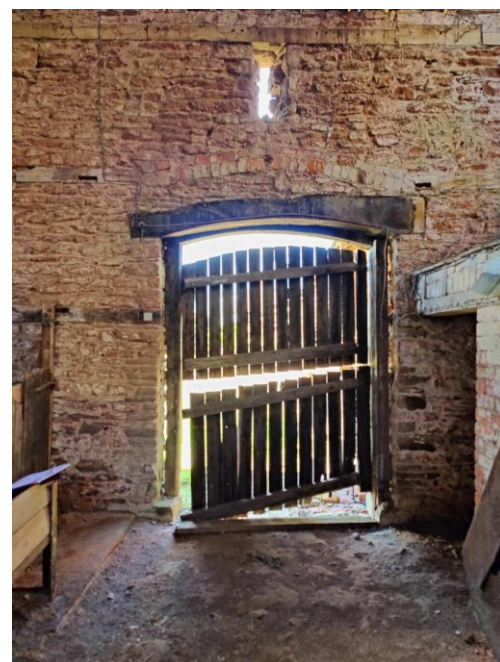
The wagon doors are in poor condition and are not secure. The frames can be repaired and new traditional timber doors installed.

Decay in the wagon doors front and rear.

The wagon door frames will be repaired and the doors replaced with traditional timber joinery.

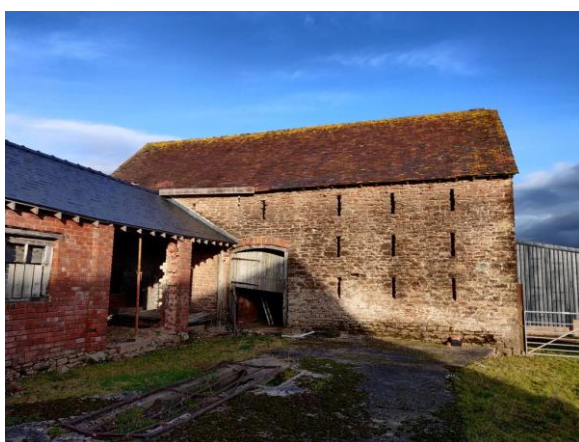
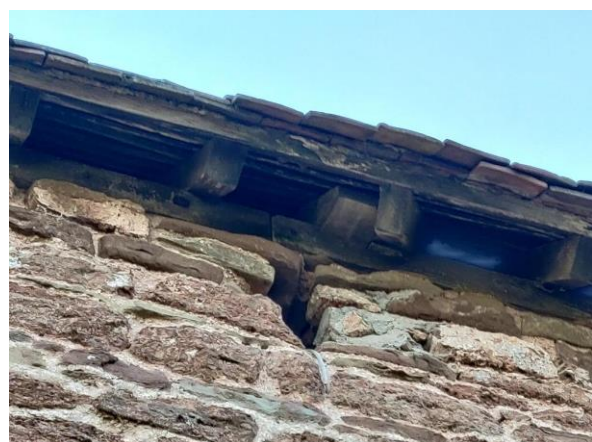
The barn currently has no guttering and water discharging from the roof is causing further decay to the external walls particularly at low levels.

Lack of guttering causing erosion to wall and ground around the building

New gutters and downpipes are proposed to allow effective management of water run-off and protect the walls.

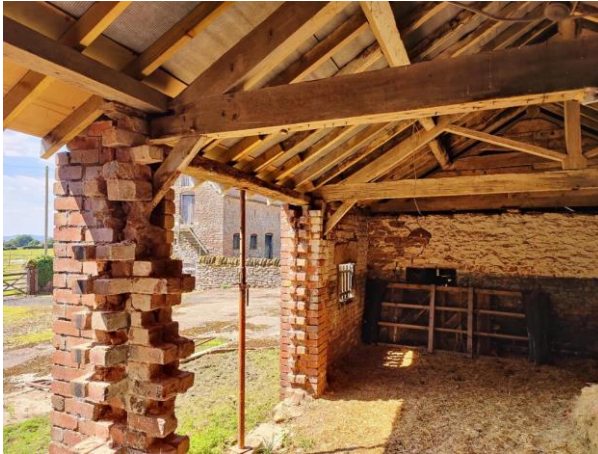
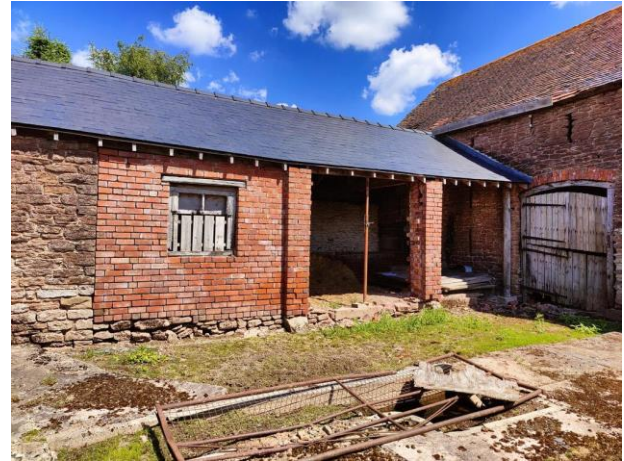
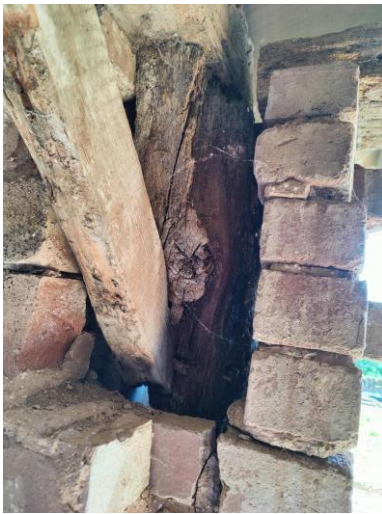
The open fronted livestock barn with a shelter end has been partly infilled with brick and the original posts encapsulated in brickwork causing significant decay in the original timber. A section of wall plate is missing with a temporary beam and post put in place to support the roof structure.

Brick infill and brick encapsulation of the original posts

In this case, the significance of the much later (and poor quality) brick infill and encasement of the original posts, is low. Indeed, it has a negative impact due to the fact

that the later brickwork is causing a loss of historic fabric and limits our understanding of the important historical relationship between the open fronted end to the fold yard.

The existing later brick infill and brick casings to the posts will be removed. The rotten oak posts will be replaced in oak to match the original detail.

The stone threshold and post stones will be repaired.

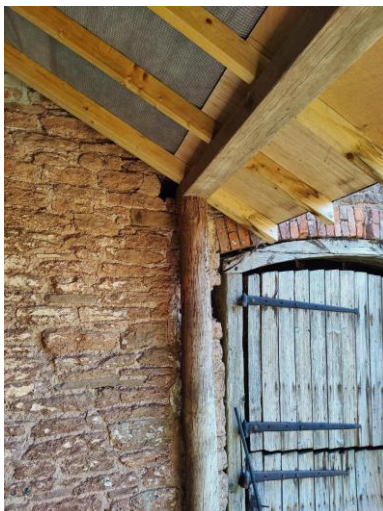
Missing wall plate and temporary repairs

The temporary post and roof support beam will be removed and a new oak wall plate inserted to match the original detail.
