# Arboricultural Impact Assessment & Tree Protection Plan

### Merton Meadows Flood Alleviation, Hereford

Site address	Merton Meadows, Hereford, HR4	Report ref:	15429
Client	Herefordshire Council	Date:	24.04.25
Inspected & prepared by	Tom Luck M.Sc, B.Sc, FD.Sc, MArborA	Version:	01.2

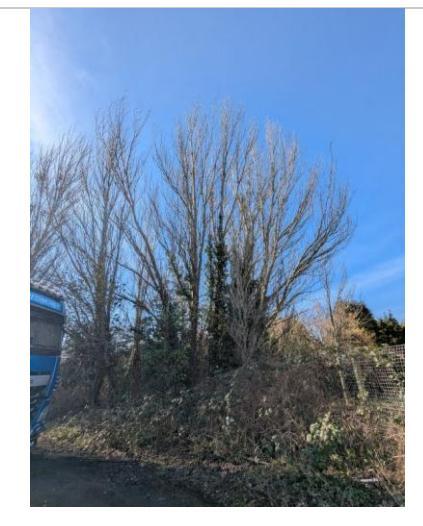
The flood attenuation areas require the removal of 1 Category A tree (T15), 1 category B group (G1), 1 category B tree (G9-T31), 8 Category C trees (T8, T9, T50, T51, T52, T66, T69, T70) and 1 Category U tree (T10). This is discussed in more detail in section 4.4.

Tree/Group No.	Description
	G1, T15	A group of 8 early mature, and a distinct Lombardy poplar situated west of site 1a. The water attenuation proposed in the centre of this site requires an inlet at a suitable point along the existing brook. Soil excavation will be required to lower land in this area to create flow between the existing brook at the proposed flood attenuation.
noval	Т8, Т9	Category C trees in fair condition. Soil excavation is required in this area to create the flood attention and outlet into the brook.
ified for rer	T10	A category U lime tree with advanced canopy dieback and poor vitality. This should be removed on safety grounds, regardless of the proposed development.
Trees ident	T50, T51, T52	These Category C trees are situated on the northern bank of Site 4. Excavation and regrading area required within the RPA of these trees to create suitable water attenuation volumes.

Figure 3 -Site 1: G1, T15- Looking south

Tree works	Tree/group ref	Notes
Fell and grind out stumps	G1, G9-031, T8, T9, T10, T15, T50, T51, T52, T66, T69, T70	
Re-pollard to 3-4m above ground level	T3, T5, T6, T11, T12, T13, T16, T17, T18, T65	These lapsed pollards are beginning to fail due to the weight on the pollard unions.
Coppice	T56	Tree is collapsing at base and leaning on neighbouring building.

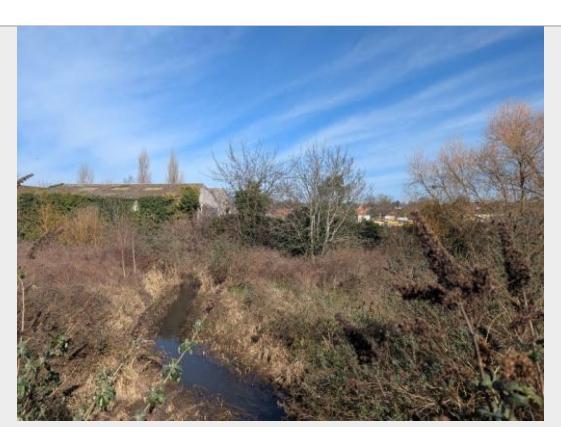
Figure 5 - Site 4: T49-T50 on left - looking north.

T049	Bird cherry (Prunus padus)	Tree	Height (m): 10 Stem Diam(mm): 250 Spread (m): 4N, 4E, 4S, 4W Crown Clearance (m): 1 Lowest Branch (m): 1 Life Stage: Early Mature Rem. Contrib.: 20+ Years	Radius: 3.0m. Area: 28 sq m.	Site inaccessible - measurements and tree position estimated. Dense ivy present.	C1	Other Reference: Physiological Condition: Fair Structural Condition: Fair Public Amenity Value: Low Inspection Limitations: Access Bat Habitat: Unknown

Ref.	Species	Full Structure	Measurements	RPA	Survey Notes	Retention Category	Condition	Recommendations	Photo	Photo	Photo
T050	Common ash (Fraxinus excelsior)	Tree 6 stems	Height (m): 10 6 stems, avg.(mm): 160 Spread (m): 4N, 4E, 4S, 4W Crown Clearance (m): 1 Lowest Branch (m): 1 Life Stage: Early Mature Rem. Contrib.: 20+ Years	Radius: 4.7m. Area: 69 sq m.	Site inaccessible - measurements and tree position estimated. Dense ivy present. Multistem	C1	Other Reference: Physiological Condition: Fair Structural Condition: Fair Public Amenity Value: Low Inspection Limitations: Access Bat Habitat: Unknown				
T051	Crack willow (Salix fragilis)	Tree 3 stems	Height (m): 10 3 stems, avg.(mm): 190 Spread (m): 4N, 2E, 4S, 4W Crown Clearance (m): 1 Lowest Branch (m): 1 Life Stage: Early Mature Rem. Contrib.: 20+ Years	Radius: 3.9m. Area: 48 sq m.	Site inaccessible - measurements and tree position estimated. Assessment of trunk not possible. Dense ivy present.	C1	Other Reference: Physiological Condition: Fair Structural Condition: Fair Public Amenity Value: Low Inspection Limitations: Access Bat Habitat: Unknown

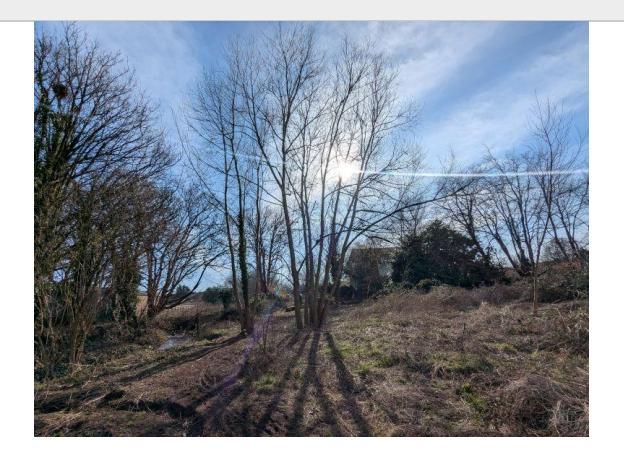
Figure 7 - Site 5: T66, G09-T31 in centre - looking south.

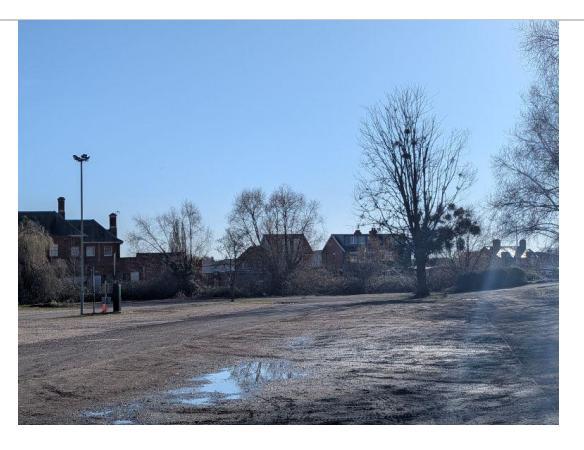
Figure 4 -Site 1: T10 on right. Looking east

T010	European lime (Tilia x europaea)	Tree	Height (m): 13 Stem Diam(mm): 790 Spread (m): 5N, 5E, 5S, 5W Crown Clearance (m): 1 Lowest Branch (m): 1(M) Life Stage: Mature Rem. Contrib.: <10 years	Radius: 9.5m. Area: 284 sq m.	Advanced canopy dieback Mistletoe Poor vitality.	U	Other Reference: Physiological Condition: Diseased Structural Condition: Fair Public Amenity Value: Moderate Inspection Limitations: None Bat Habitat: Low				
T011	Crack willow (Salix fragilis)	Pollard	Height (m): 13 Stem Diam(mm): 1400 Spread (m): 9N, 8E, 9S, 9W Crown Clearance (m): 1 Lowest Branch (m): 2(M) Life Stage: Over Mature Rem. Contrib.: 20+ Years	Radius: 15.0m. Area: 707 sq m.	Lapsed pollard. Reactive growth. Good vigour Prolific ivy - trunk not visible. NE limb contains decay at 2m Primary limbs contain decay with good reaction wood.	A1,2,3	Other Reference: Physiological Condition: Good Structural Condition: Fair Public Amenity Value: Good Inspection Limitations: Vines Bat Habitat: Medium	Re-pollard to reduce weight on trunk/primary limbs.

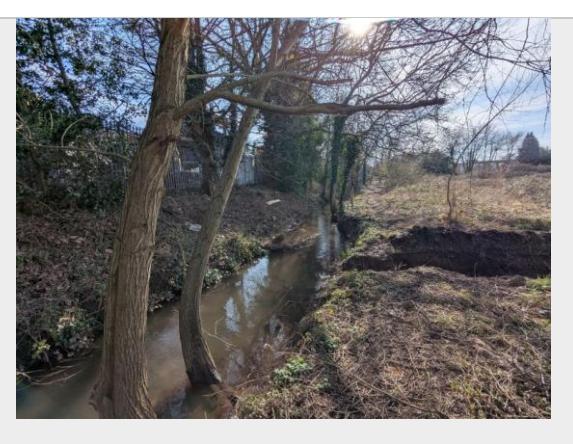
Figure 6 - Site 5: G9-T1 on left. Looking south.

G009 - T001	Crack willow (Salix fragilis)	Tree 2 stems	Height (m): 9 2 stems (mm): 190,290 Spread (m): 2N, 2.5E, 4S, 4W Crown Clearance (m): 2 Lowest Branch (m): 3(W) Life Stage: Semi Mature Rem. Contrib.: 10+ Years	Radius: 4.2m. Area: 55 sq m.	Trunk with sweep and corrected lean due to competition Growing out of base of brook Unstable root plate.	СЗ	Other Reference: Physiological Condition: Good Structural Condition: Poor Public Amenity Value: Low Inspection Limitations: None Bat Habitat: None				
G009 - T002	Common holly (Ilex aquifolium)	Tree 3 stems	Height (m): 5 3 stems (mm): 90,110,100 Spread (m): 2N, 2E, 2S, 2W Crown Clearance (m): 0 Lowest Branch (m): 1(W) Life Stage: Semi Mature Rem. Contrib.: 20+ Years	Radius: 2.1m. Area: 14 sq m.	Growing close to neighbouring fence	C3	Other Reference: Physiological Condition: Good Structural Condition: Fair Public Amenity Value: Low Inspection Limitations: None Bat Habitat: None

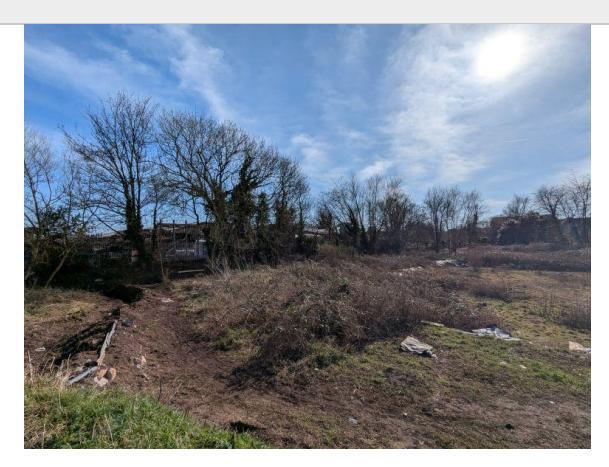
Figure 8 - G9 - looking east

Ref.	Species	Full Structure	Measurements	RPA	Survey Notes	Retention Category	Condition	Recommendations	Photo	Photo	Photo
G009	Common ash x3 (Fraxinus excelsior) Sycamore x20 (Acer pseudoplatanus) Elder x10 (Sambucus nigra) Crack willow x2 (Salix fragilis) Common holly x3 (Ilex aquifolium) Common holly x3 (Crataegus monogyna) Goat willow x2 (Salix caprea)	Group 45 trees	Height (m): 13 45 stems, avg.(mm): 400 Spread (m): 2N, 2E, 2S, 2W Crown Clearance (m): 2 Lowest Branch (m): 2(M) Life Stage: Mature Rem. Contrib.: 20+ Years	Area: 2037 sq m.	A cohesive group immediately east and west of the brook. Dense ivy throughout - sever ivy then resurvey tree condition. Low branches (3m) obstruct pedestrian access.	B1,2,3	Other Reference: Physiological Condition: Good Structural Condition: Fair Public Amenity Value: Low Inspection Limitations: Vines Bat Habitat:	Pre construction: Sever ivy at base of trees. Post construction: Conduct a tree condition and risk assessment.
