# ARBORICULTURAL IMPACT ASSESSMENT

Cholstrey Road,  
Leominster

September 2019

| Summary table | | |
|---|---|---|
| Project reference: | C.3258 | |

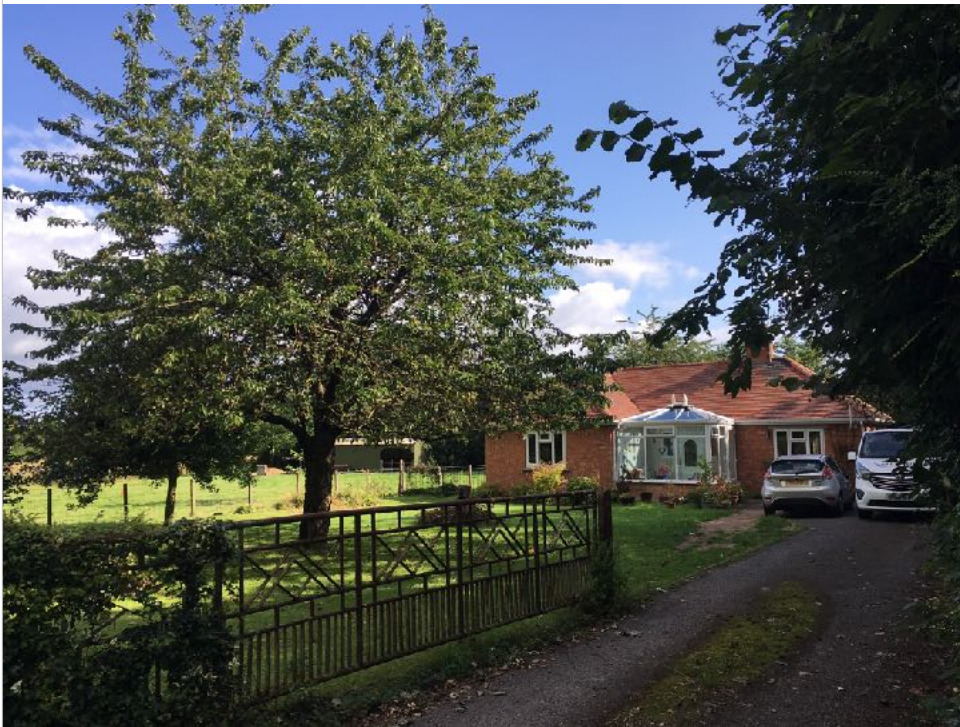
- 3.2. T1 cherry (C1) is a prominent tree within the front garden on West Winds. It is in a poor state of health and has an advanced infection of Bacterial Canker of Cherry (*Pseudomonas syringas* pv. *morsprunorum*). The disease is disfiguring and debilitating and will significantly reduce the tree's useful life expectancy.

5.3. The removal of cherry tree T1 (C1) for Plot 6 is acceptable because of its poor state of health and declining amenity value. The tree has extensive gum exudate over its bole and branches and wilted attached foliage tips. These symptoms indicate severe Spur Blight (*Monilinia laxa*) and/or Bacterial Canker of Cherry (*Pseudomonas syringas* pv. *morsprunorum*) infections. The trees have poor foliar density and vigour, indicating the tree's health is being weakened by the disease(s).

PHOTO 1: View from the entrance to West Winds looking north-east. Cherry T1 is within the lawn to the left, with H5 to the right of the driveway.

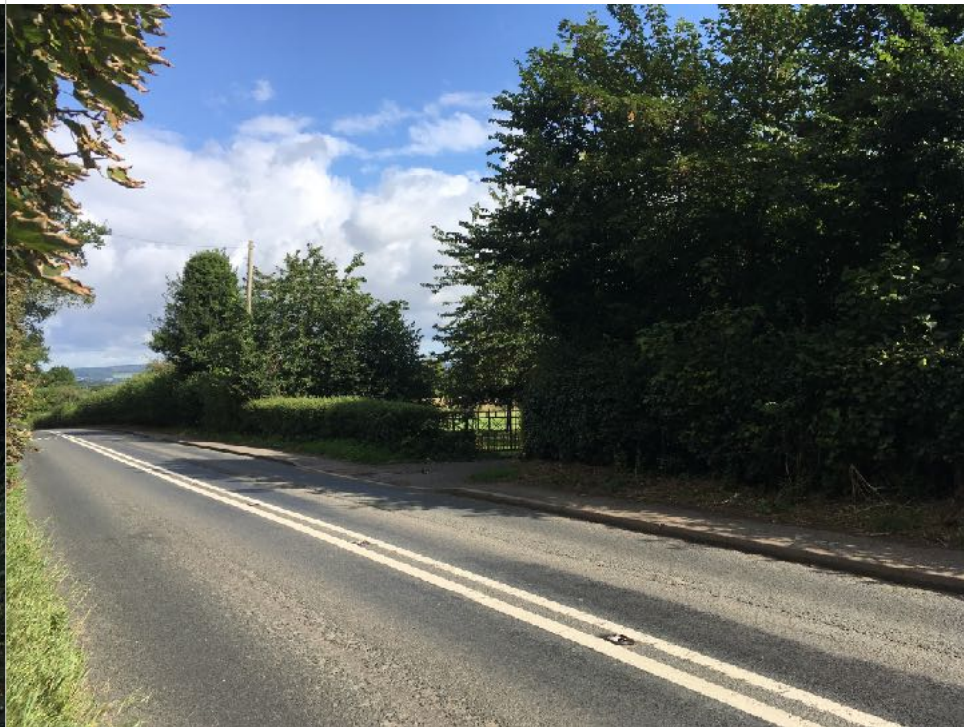
PHOTO 2: View looking north along Cholstrey Road. H1 and G2 are to the right of the paddock gate, with T16, H6 and G3 visible to the left of it.

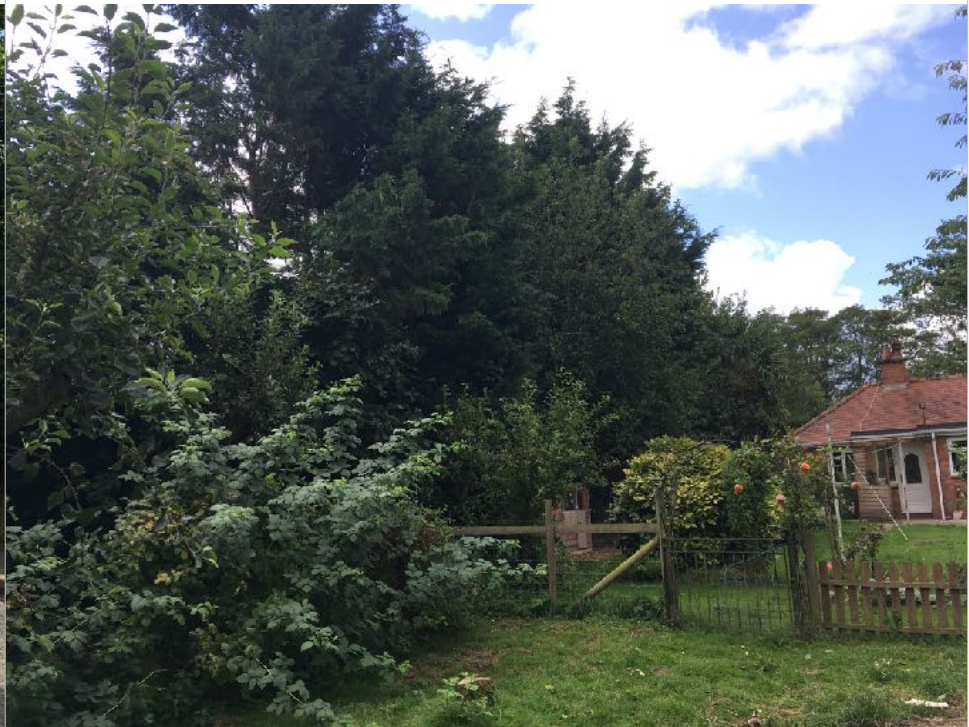
- 3.7. H2, H3, H4 and H5 form a linear boundary feature with adjoining open space. H2 and H4 include Leyland and Lawson cypress trees which have been historically topped at a low level, then allowed to regrow. Two or three individuals have grown to a much larger size and have suppressed their neighbouring trees. The upright stem regrowth is capable of exerting significant force on the unions in high winds, and future stem break-outs are likely to occur. This poor form, with limited options to manage the hedgerows down to a

lower height, means they are of quality category C2. Hedgerows H3 and H5 are still capable of being managed through height reduction, and so achieve quality category B2. The ownership of these hedgerows is unclear. If a decision over the retention/management of H2 and H4 is in the client's gift, their removal and replacement with new mixed native species hedgerow should be considered.

PHOTO 3: View in the ear garden of West Winds looking south. The Leyland Cypress conifers are within H4.

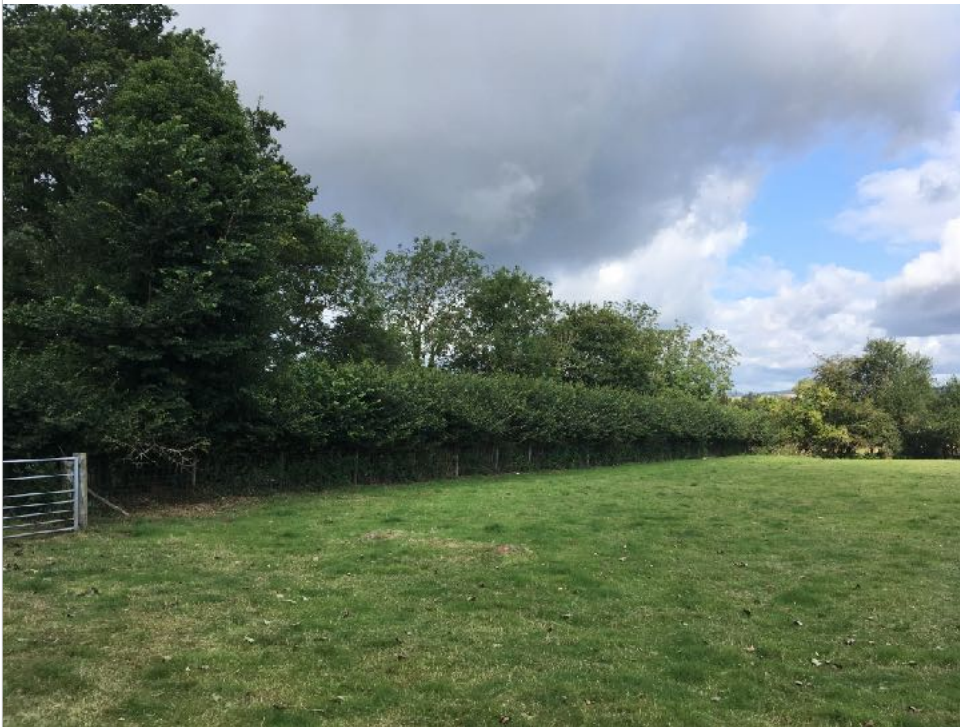
5.2. The location of the proposed new site access from Cholstrey Road will require the removal of an approximately 15-metre section of hedgerow H6 (B2). Hawthorn, elder and blackthorn group G3 (C1) can be successfully retained between the access road and Plot 58, but some of the smaller sucker shrubs would be removed and the group generally trimmed back and brought into a tighter form. These removals and pruning are acceptable from an arboricultural perspective.

5.10. No building foundations are proposed within the RPAs of retained trees or hedgerows. There is an incursion into the RPA of holly T16 (B1) by a Plot 5 car parking space and hard surfacing. The tree is an out-grown hedgerow tree. The hard surfacing could be installed using either a no-dig cellular confinement system or

PHOTO 4: View from within the paddock looking west towards T16 (left) and hedgerow H6 through which the proposed new access will pass.

hand excavation and root pruning. The former option would be more technically complex and might produce a less satisfactory finish. The latter option would have no more impact than the ploughing of fields which takes place near to hedgerows and hedgerow trees in fields and would produce a more satisfactory finish. Both options are feasible.

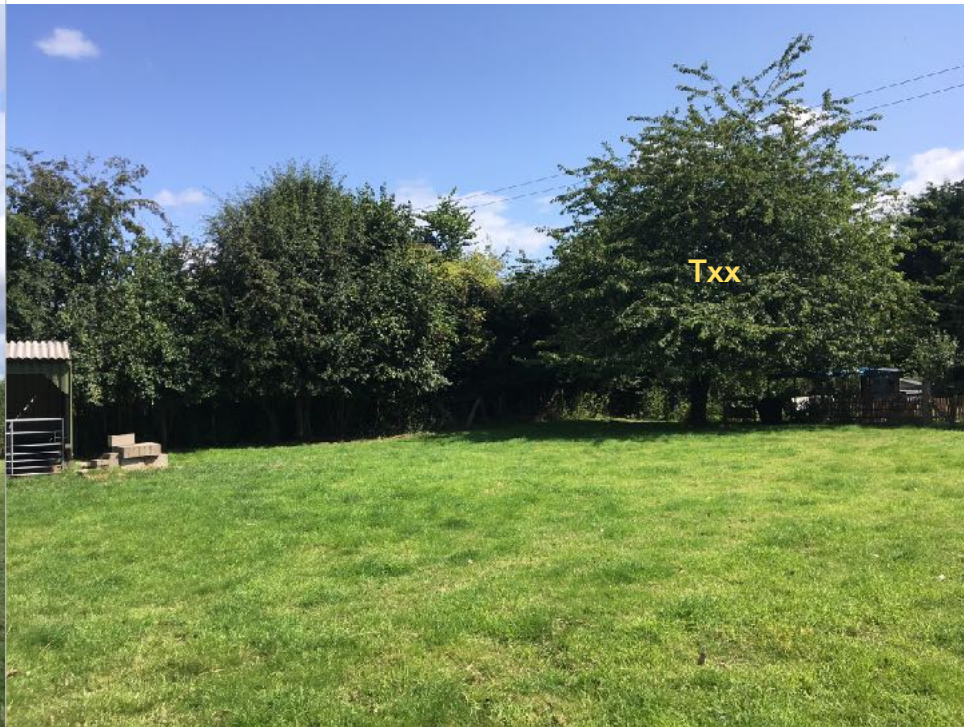
5.4. Plots 10 and 11 require the removal of cherry T19 (B1); a loss of moderate significance for the site. The removal of contorted hazel T3 and wild cherry T4 (B1) are of lower impact because of their smaller size. Purple Norway maple T6 (C1) and orchard apple T7 (B1) can be retained within the garden. Although fruit trees T8 to T12 (C1) are shown as retained, they are small and unattractive trees which are likely to be removed by a new property owner and this would be of no consequence.

5.5. Hedgerow H7 (B2) is a mature hedgerow of Hawthorn, hazel, damson, elder, common ash, and English elm. The hedgerow stems located tightly along the boundary line, or further to the north, but the canopies overhang the site. The wider canopy within the garden of Plot 11 is predominantly of low blackthorn stems which have subsided out into the garden and rested on the ground. The removal of these and the trimming back of the canopies to provide clearance from the building of Plot 11 would have no significant impact on amenity or hedgerow longevity.

PHOTO 5: View from within the paddock looking east towards cherry tree T19, with mature hedgerow H7 running behind it.

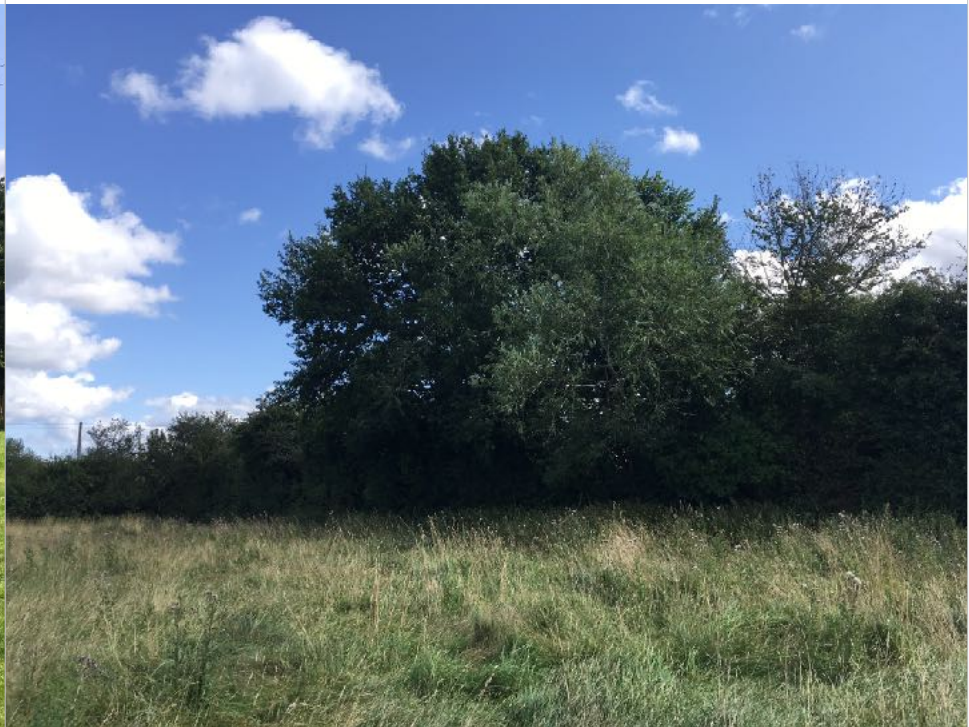
- 3.5. T22 crack willow (U) is immediately next to the English oak tree. It has the serious irremediable defect of cracked bark-included unions at its base and failed stems. Three stems towards the site have split basal unions and decay, and the likelihood of failure into the site is significantly increased. Removal of the stems at the boundary line would reduce this likelihood, but ultimately it would be preferable for the tree owner to fell the tree.

5.7. Crack willow T22 (U) is an off-site coppice-origin tree with cracked bark-included unions at its base and failed stems. Three stems towards the site have split basal unions and decay. Its canopy overhangs the proposed rear gardens of Plots 29 and 30. Although removal of the tree is not within the gift of the applicants or future property owners, the canopy over the rear gardens would be removed entirely up to the boundary line. This would effectively remove the risk of further stem failure into the site, and regrowth could be managed in the future in the same way.

| Ref | Species | Height (m) | No. of Stems | Est diam? | Calc. / Actual Stem Dia. (mm) | Crown radii (m) N-E-S-W | Avg. Canopy Height (m) | 1st branch ht (m) | 1st branch dir. | Life Stage | Special importance | General Observations | Health & vitality | Struct. cond. | Estimated Remaining Contribution (Years) | BS5837 Category | RPA Radius (m) | RPA m² |
|---|---|---|---|---|---|---|---|---|---|---|---|---|---|---|---|---|---|---|
| T22 | Crack willow | 10.0 | 5 | # | 430 | 7-6-8-8 | 2.5 | 1.5 | W | EM | None | Off-site coppice-origin tree with cracked bark-included unions at base and failed stems. Three stems towards site have split basal unions and decay. Stem removal wounds on site side. | Good | Poor | <10 | U | 5.2 | 84 |

PHOTO 6: View from within the field looking east at English oak T21, with poor quality crack willow T22 to its right and hedgerow H13 running along the boundary.
