UPPER BLAEN FARM, LLANVEYNOE, HEREFORD

Tree Survey Report

Our Ref: JSL3124_770

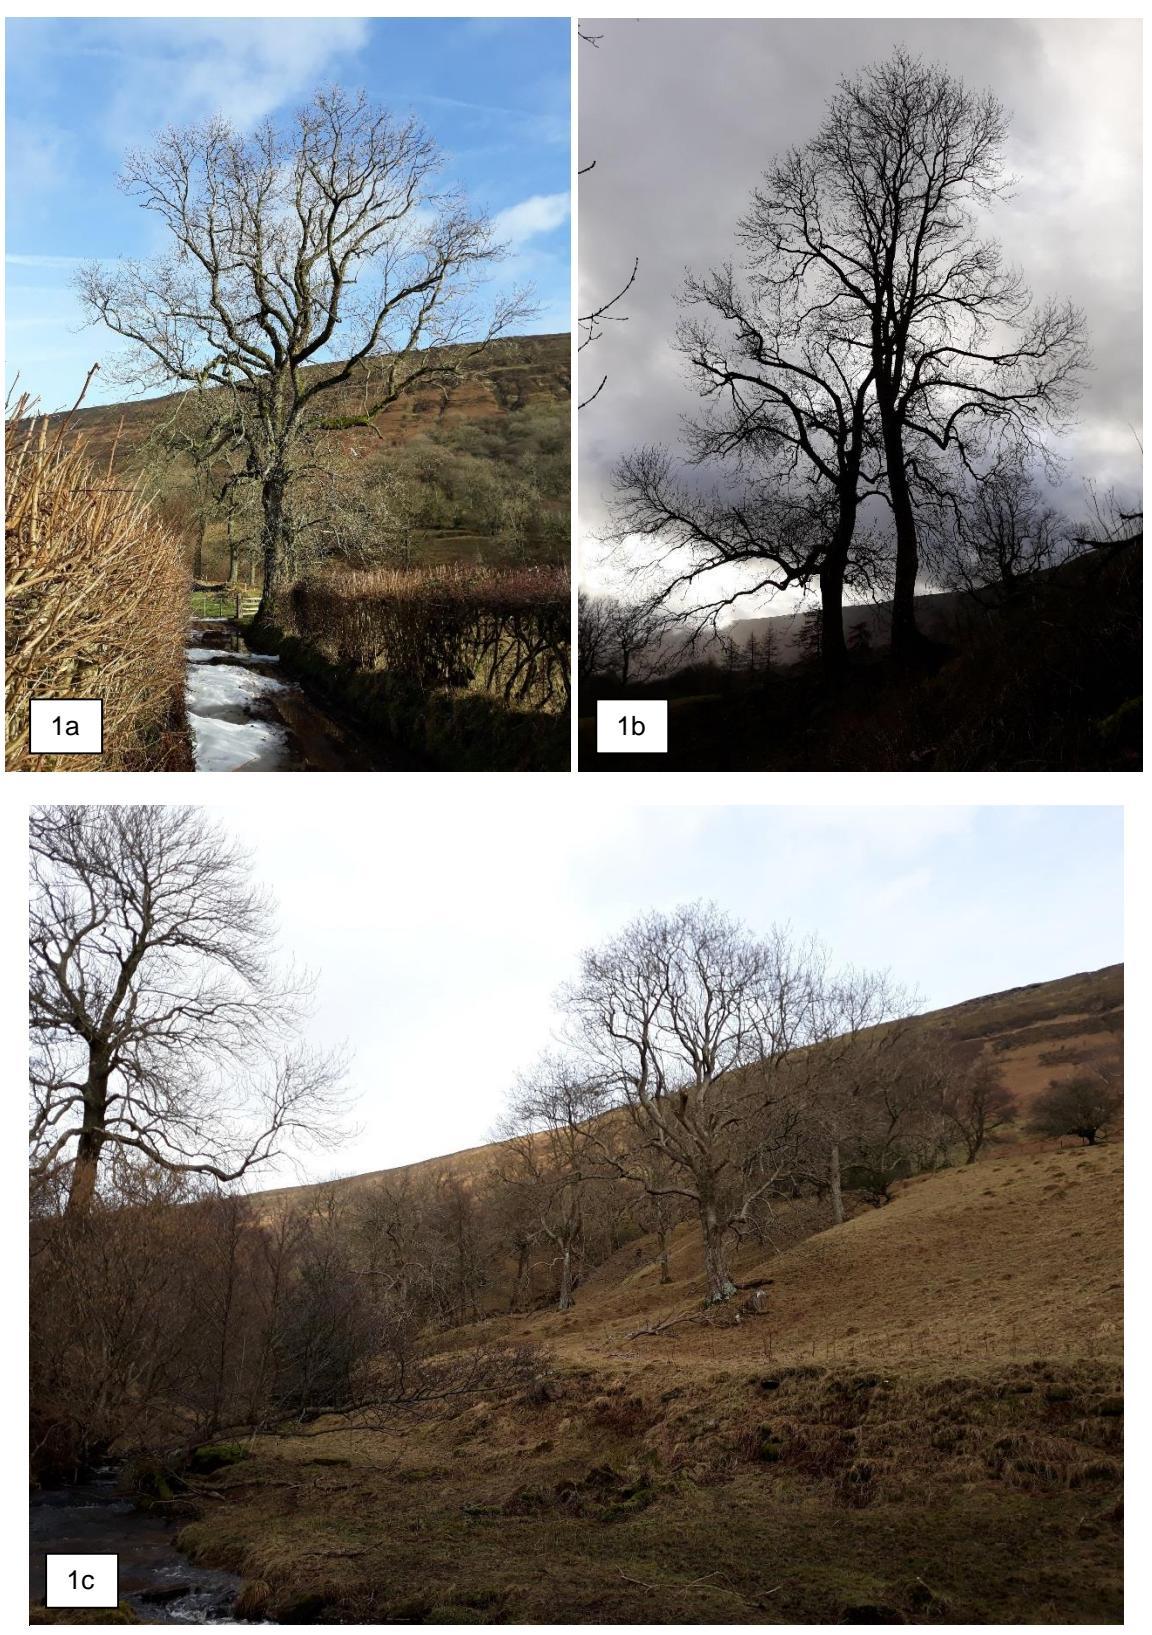
Figures 1a-1c: Mature ash trees formed an integral part of the landscape character, both within the site and in the wider area.

- 4.3 High value, mature ash trees (T3, T4, T5, T12, T13#, T14, T23) were the most prominent trees noted during the survey and contributed significantly to the treed character of the area. These were between category A ('high value') and category B ('moderate value') of the BS5837:2012 tree grading criteria, with estimated lifetimes of 40+ years (see section on Ash dieback below) and a stage of maturity not replaceable with new planting. As such, these trees should be regarded as assets to the site and their retention planned for in the design phase of any potential development; see design and layout considerations. See figures 1a-1c.

1a- A large and prominent category A ash tree at the site entrance. 1b- T3 and T4, a pair of category A ash trees which complemented each other. 1c- Ash trees in the wider landscape beyond the north-east site boundary.

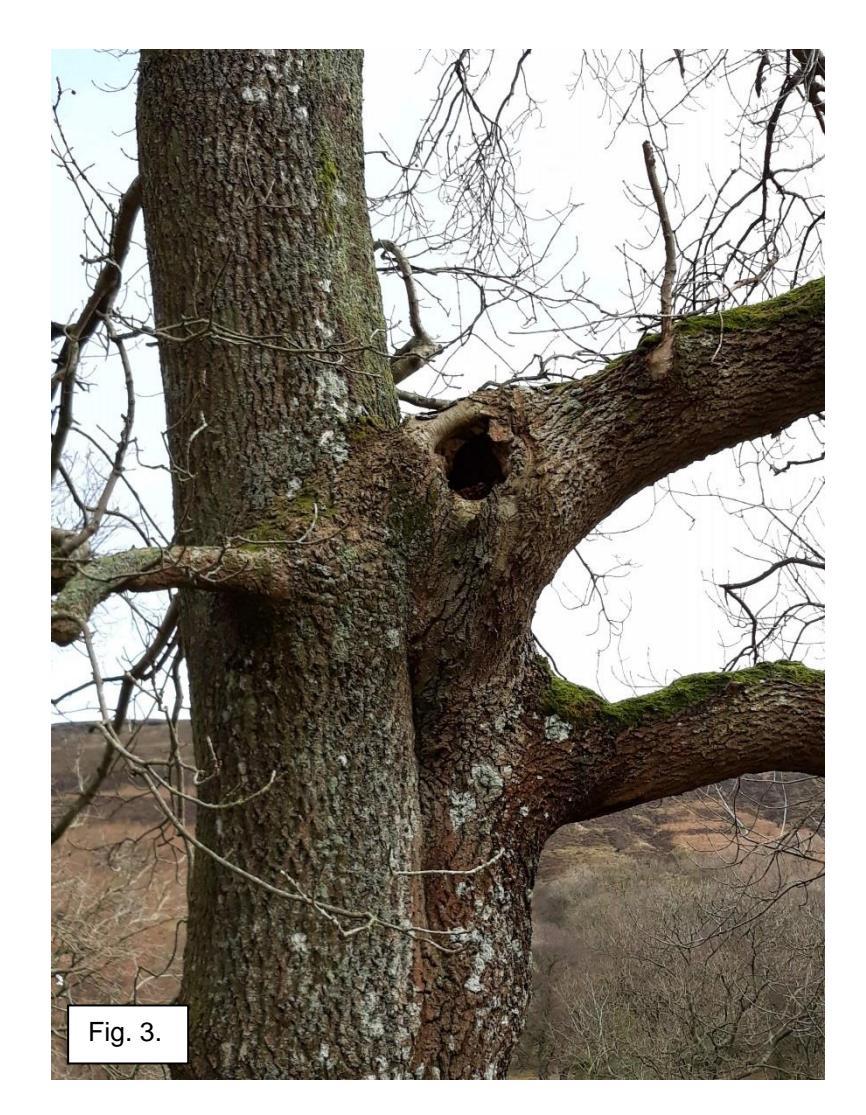
- 4.8 This survey is not intended as a comprehensive hazard assessment and should not be used as such. However, some significant defects (i.e. large sizes of defective parts, relatively high target area) were noted and are described in the following paragraphs which are earmarked to assist future identification.
- 4.9 **T3-** A rot pocket from a previous pruning wound or branch failure was noted at the base of a major limb which may compromise branch strength (See figure 2). The rot pocket itself may have habitat potential (seek advice from an ecologist). Branch reduction may be necessary in the future if the cavity extends. Recommend further monitoring of woundwood occlusion.

4.10 **T4-** A basal stem cavity was noted on the south west stem. Cursory probing with a sounding hammer suggested sufficient reaction wound was present, however it is recommended the condition of this tree is further monitored and the extent of the cavity measured in a tree hazard assessment.
