Warryfield Farm
Conversion of Outbuildings

Window Repair Details

scheme	1843
drwg no.	T(420)
revision	
scale	1:5@ A3
date first drawn	Jan 21
drawn	PL

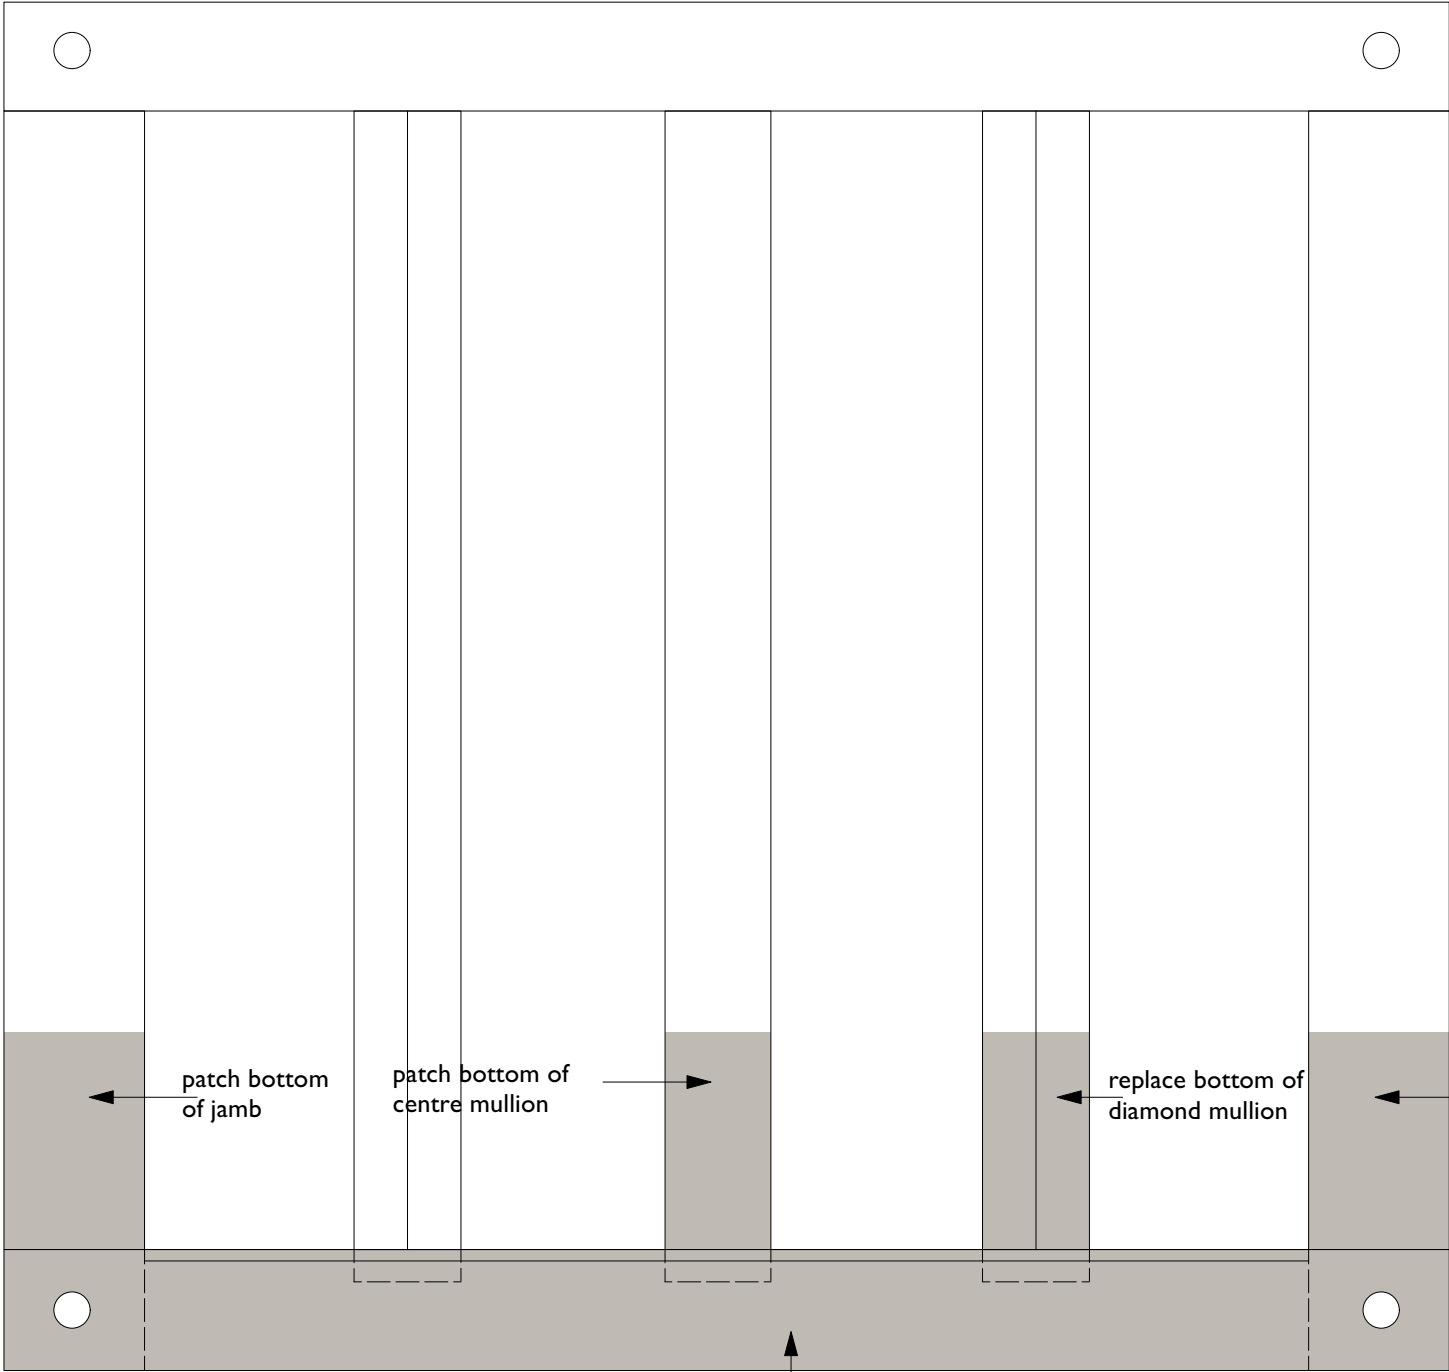
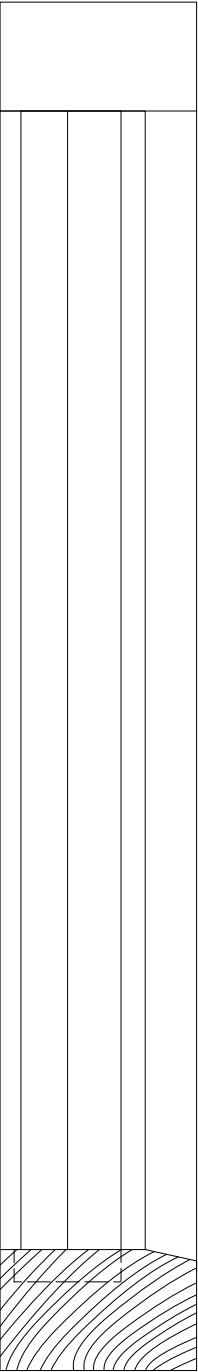
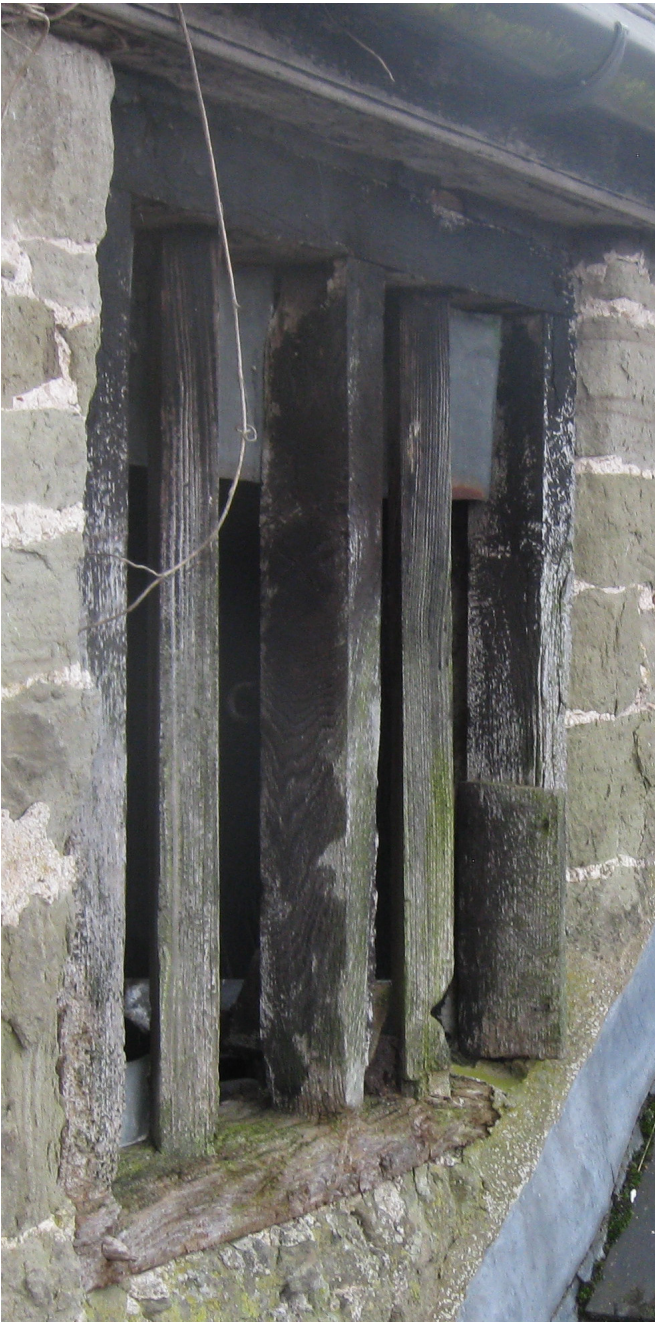
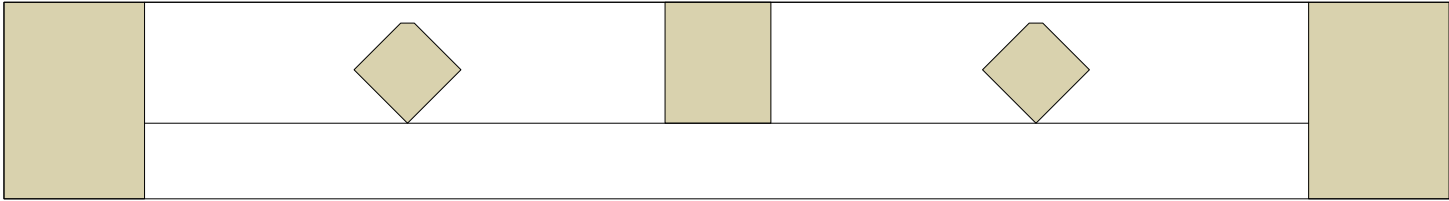
Existing Window to be Repaired

Existing Window with Diamond Mullions

Replace cill with kiln dried oak.
Renew oak pegs at joints with
jambs
