5.4 Proposed Demolitions

Photographs and Description of elements

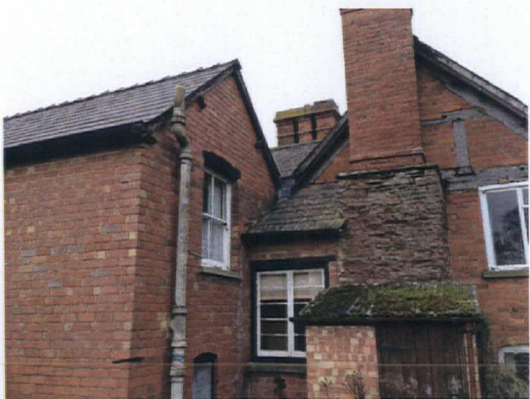
Image 44 shows the confused junction of various later extensions and alterations. The original timber frame property with stone chimney connects with a later single skin brick tower that is home to the staircase and a lean to WC block, also single skin brickwork and post war. To the side and connected to the staircase lean to is the Edwardian two storey extension in red brickwork.

Removal to the lean to staircase tower, the lean to wc block and the Edwardian extension are proposed to reinstate an historic form.

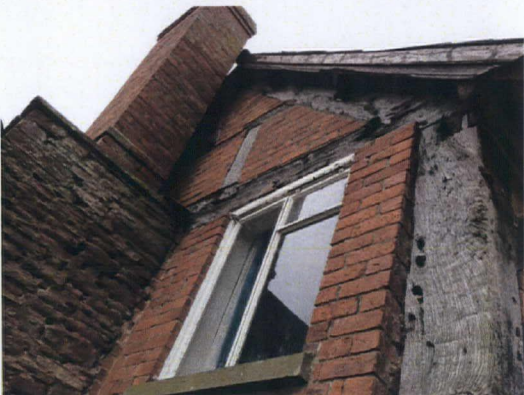
Image 45 shows a first floor crittall window and modern brickwork infill. Proposed replacement and repairs.

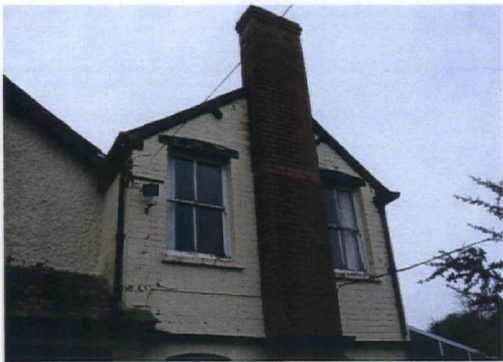
46

Images 46, 47 and 48 show the later 20th Century extensions and poor junctions to the historic building together with UPVC windows and cement, roughcast render facade treatment. All are proposed to be removed and the oak frame substructure repaired. Windows replaced with traditional oak casement windows and joinery.
