Conservation Area Application for Tree Work

St Mary's Churchyard
Church Row
Ross on Wye
HR9 5HN

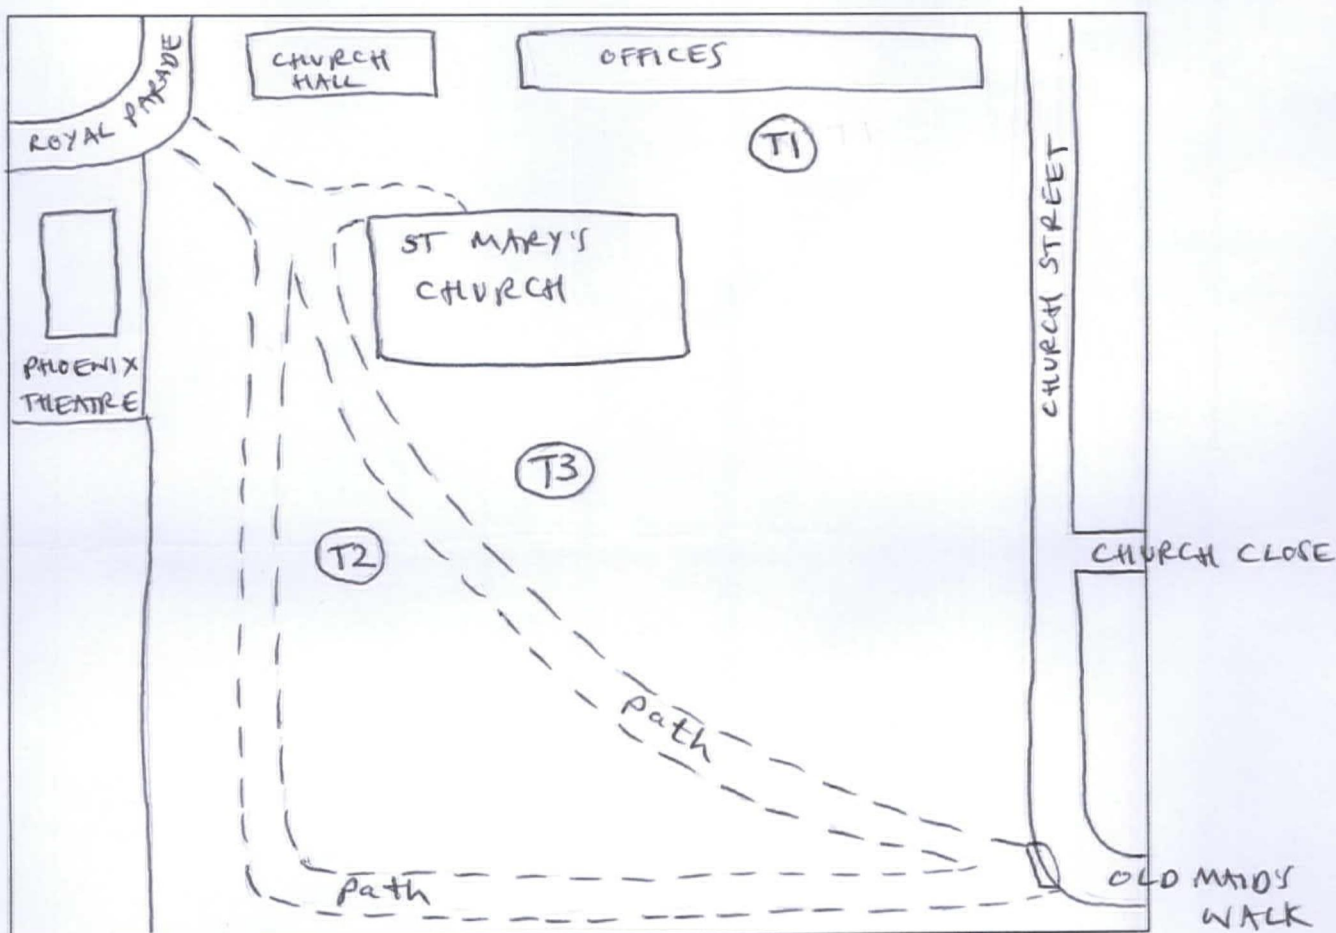
Sketch map to show trees:

Remove Conifer in churchyard by Okells Solicitors and grind out stump. This small Conifer has collapsed and is unsightly and will be replaced. Pollard 2 Irish Yews on opposite side of church where branches have bent over from snow damage. They need pollarding back to 8ft as the branches are now overextended and top heavy and there is no structure in the tree.

T1 – Conifer to be removed. T2 & T3 – Yews that need pollarding due to snow damage.
