Tree Survey Report Arboricultural Impact Assessment and Arboricultural Method Statement

Martins Way Ledbury

Fed3

January 2019

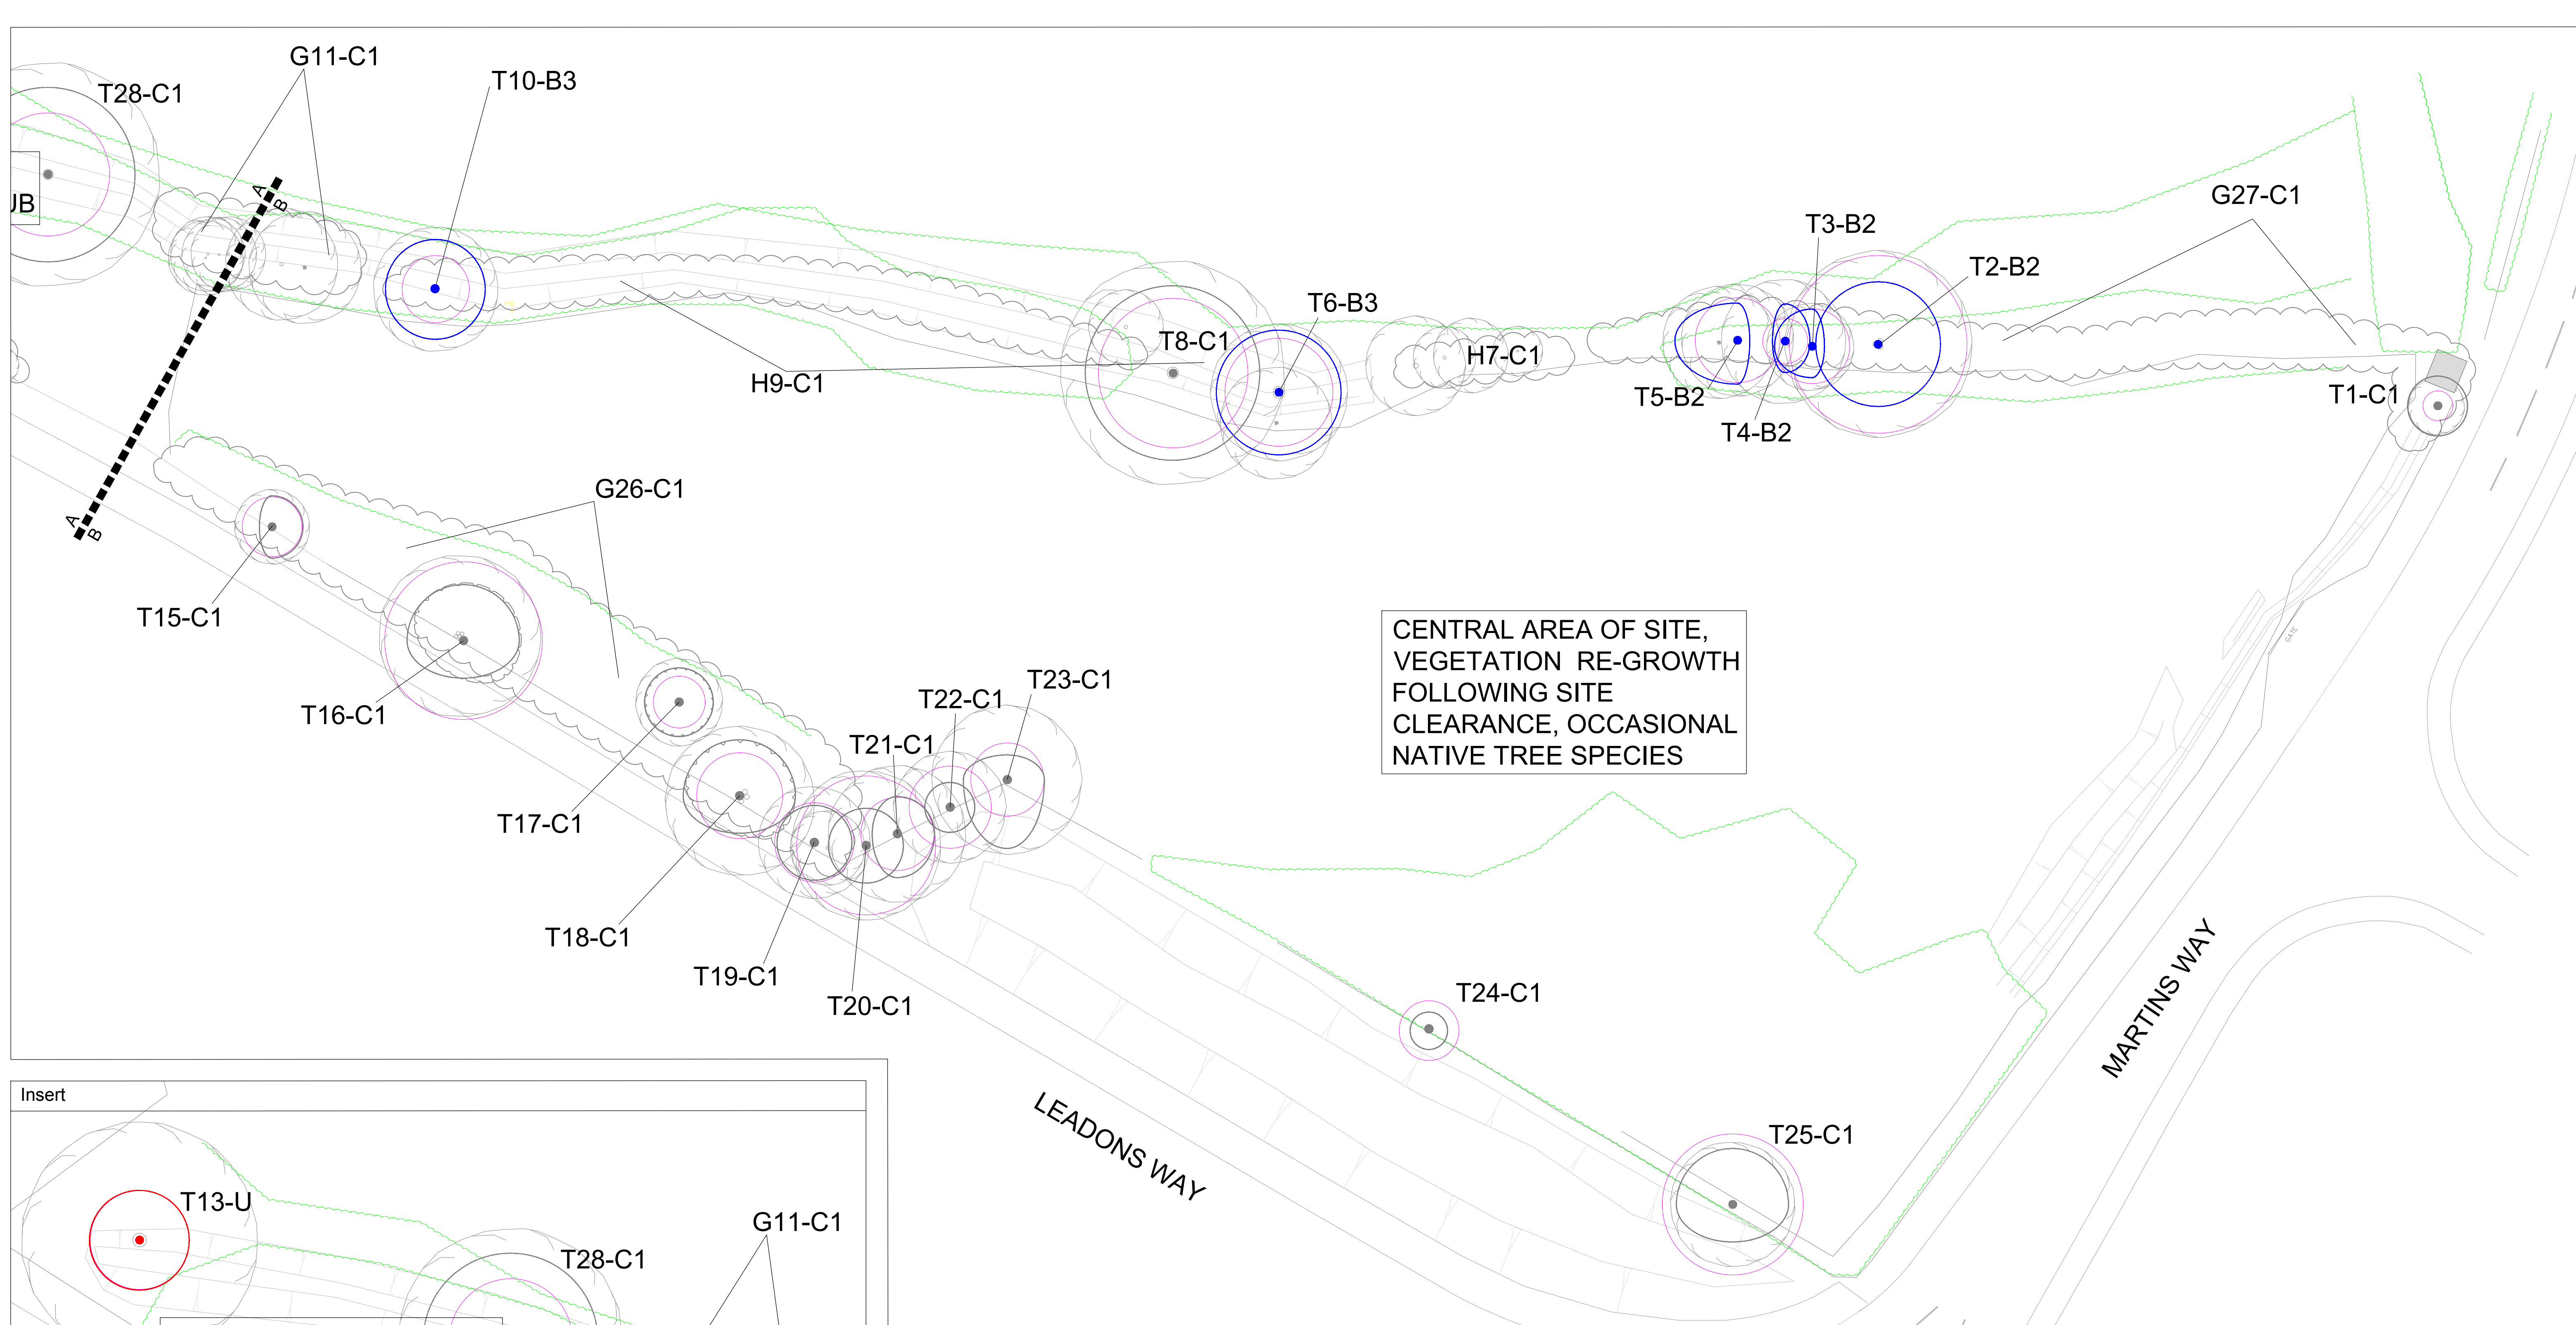
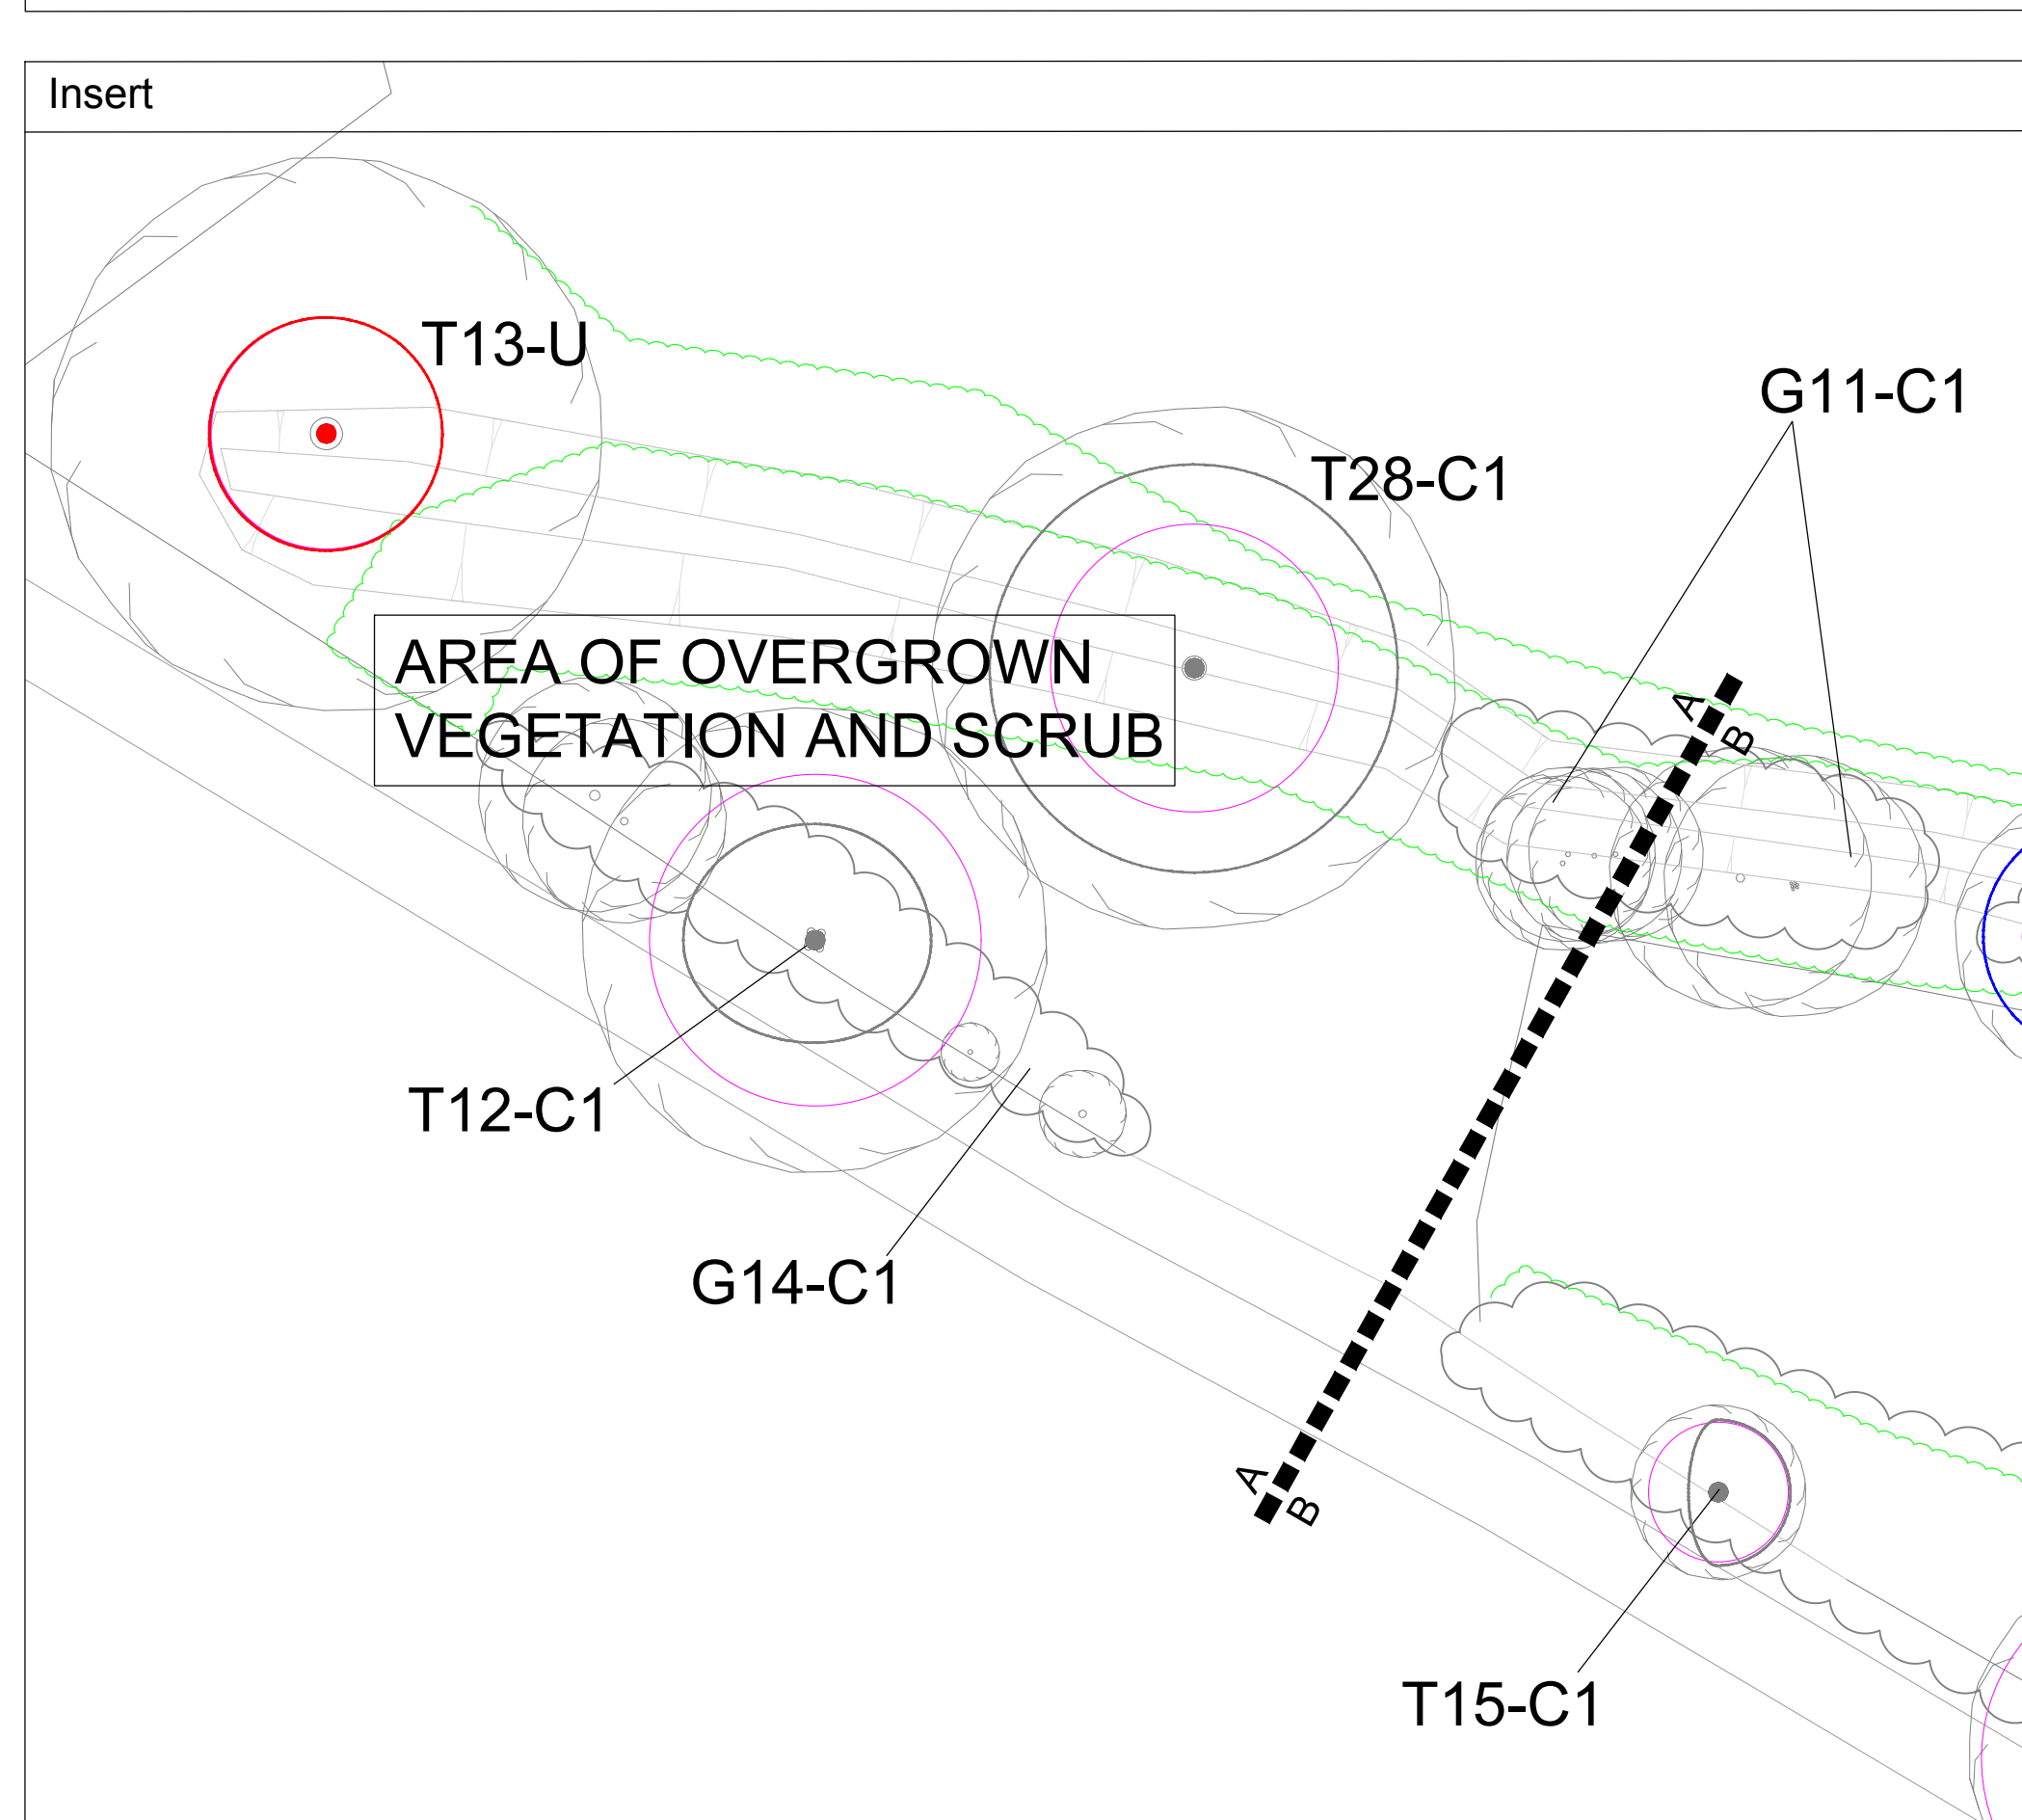
T13 White Willow	Dead tree adjacent to offsite footpath, check ownership before carrying out work
------------------	--

T1 Cherry Plum	To enable the proposed pumping station and access
T24 Goat Willow	To enable the proposed landscaping
T25 Goat Willow	To enable the proposed retaining wall
G26 Various Native species	To enable the proposed landscaping

T2 Field Maple	Proposed parking bay construction
T3 Field Maple	Proposed parking bay construction
T5 Field Maple	Proposed parking bay construction

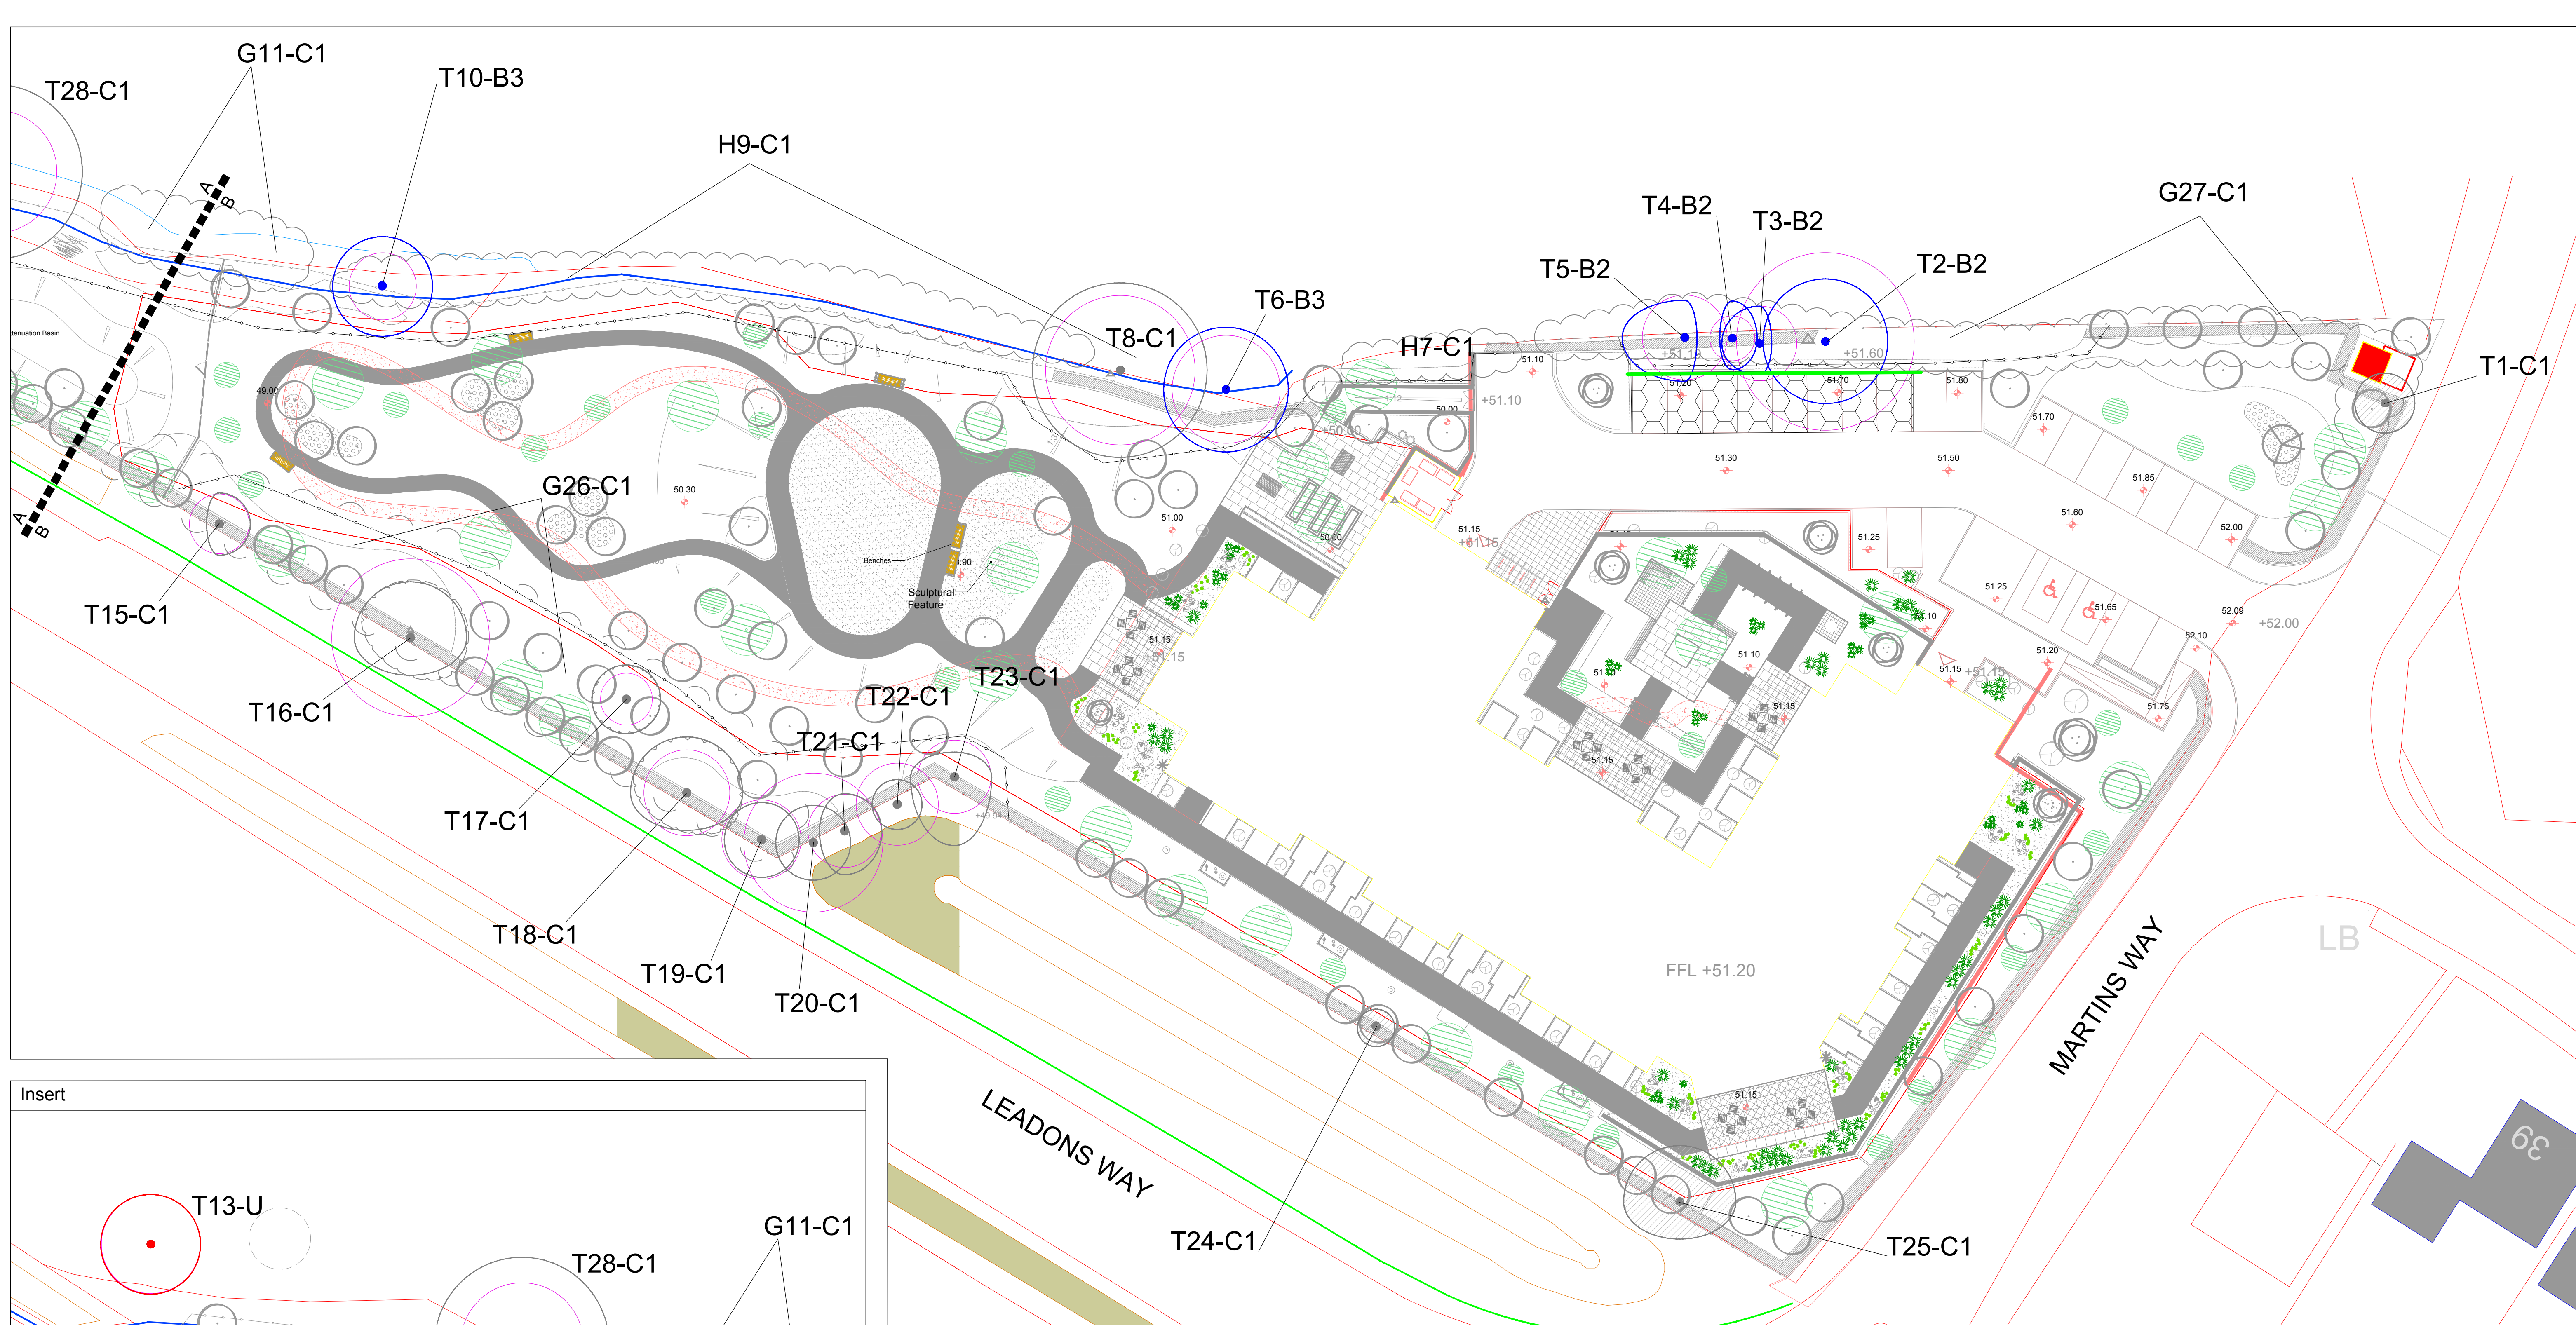
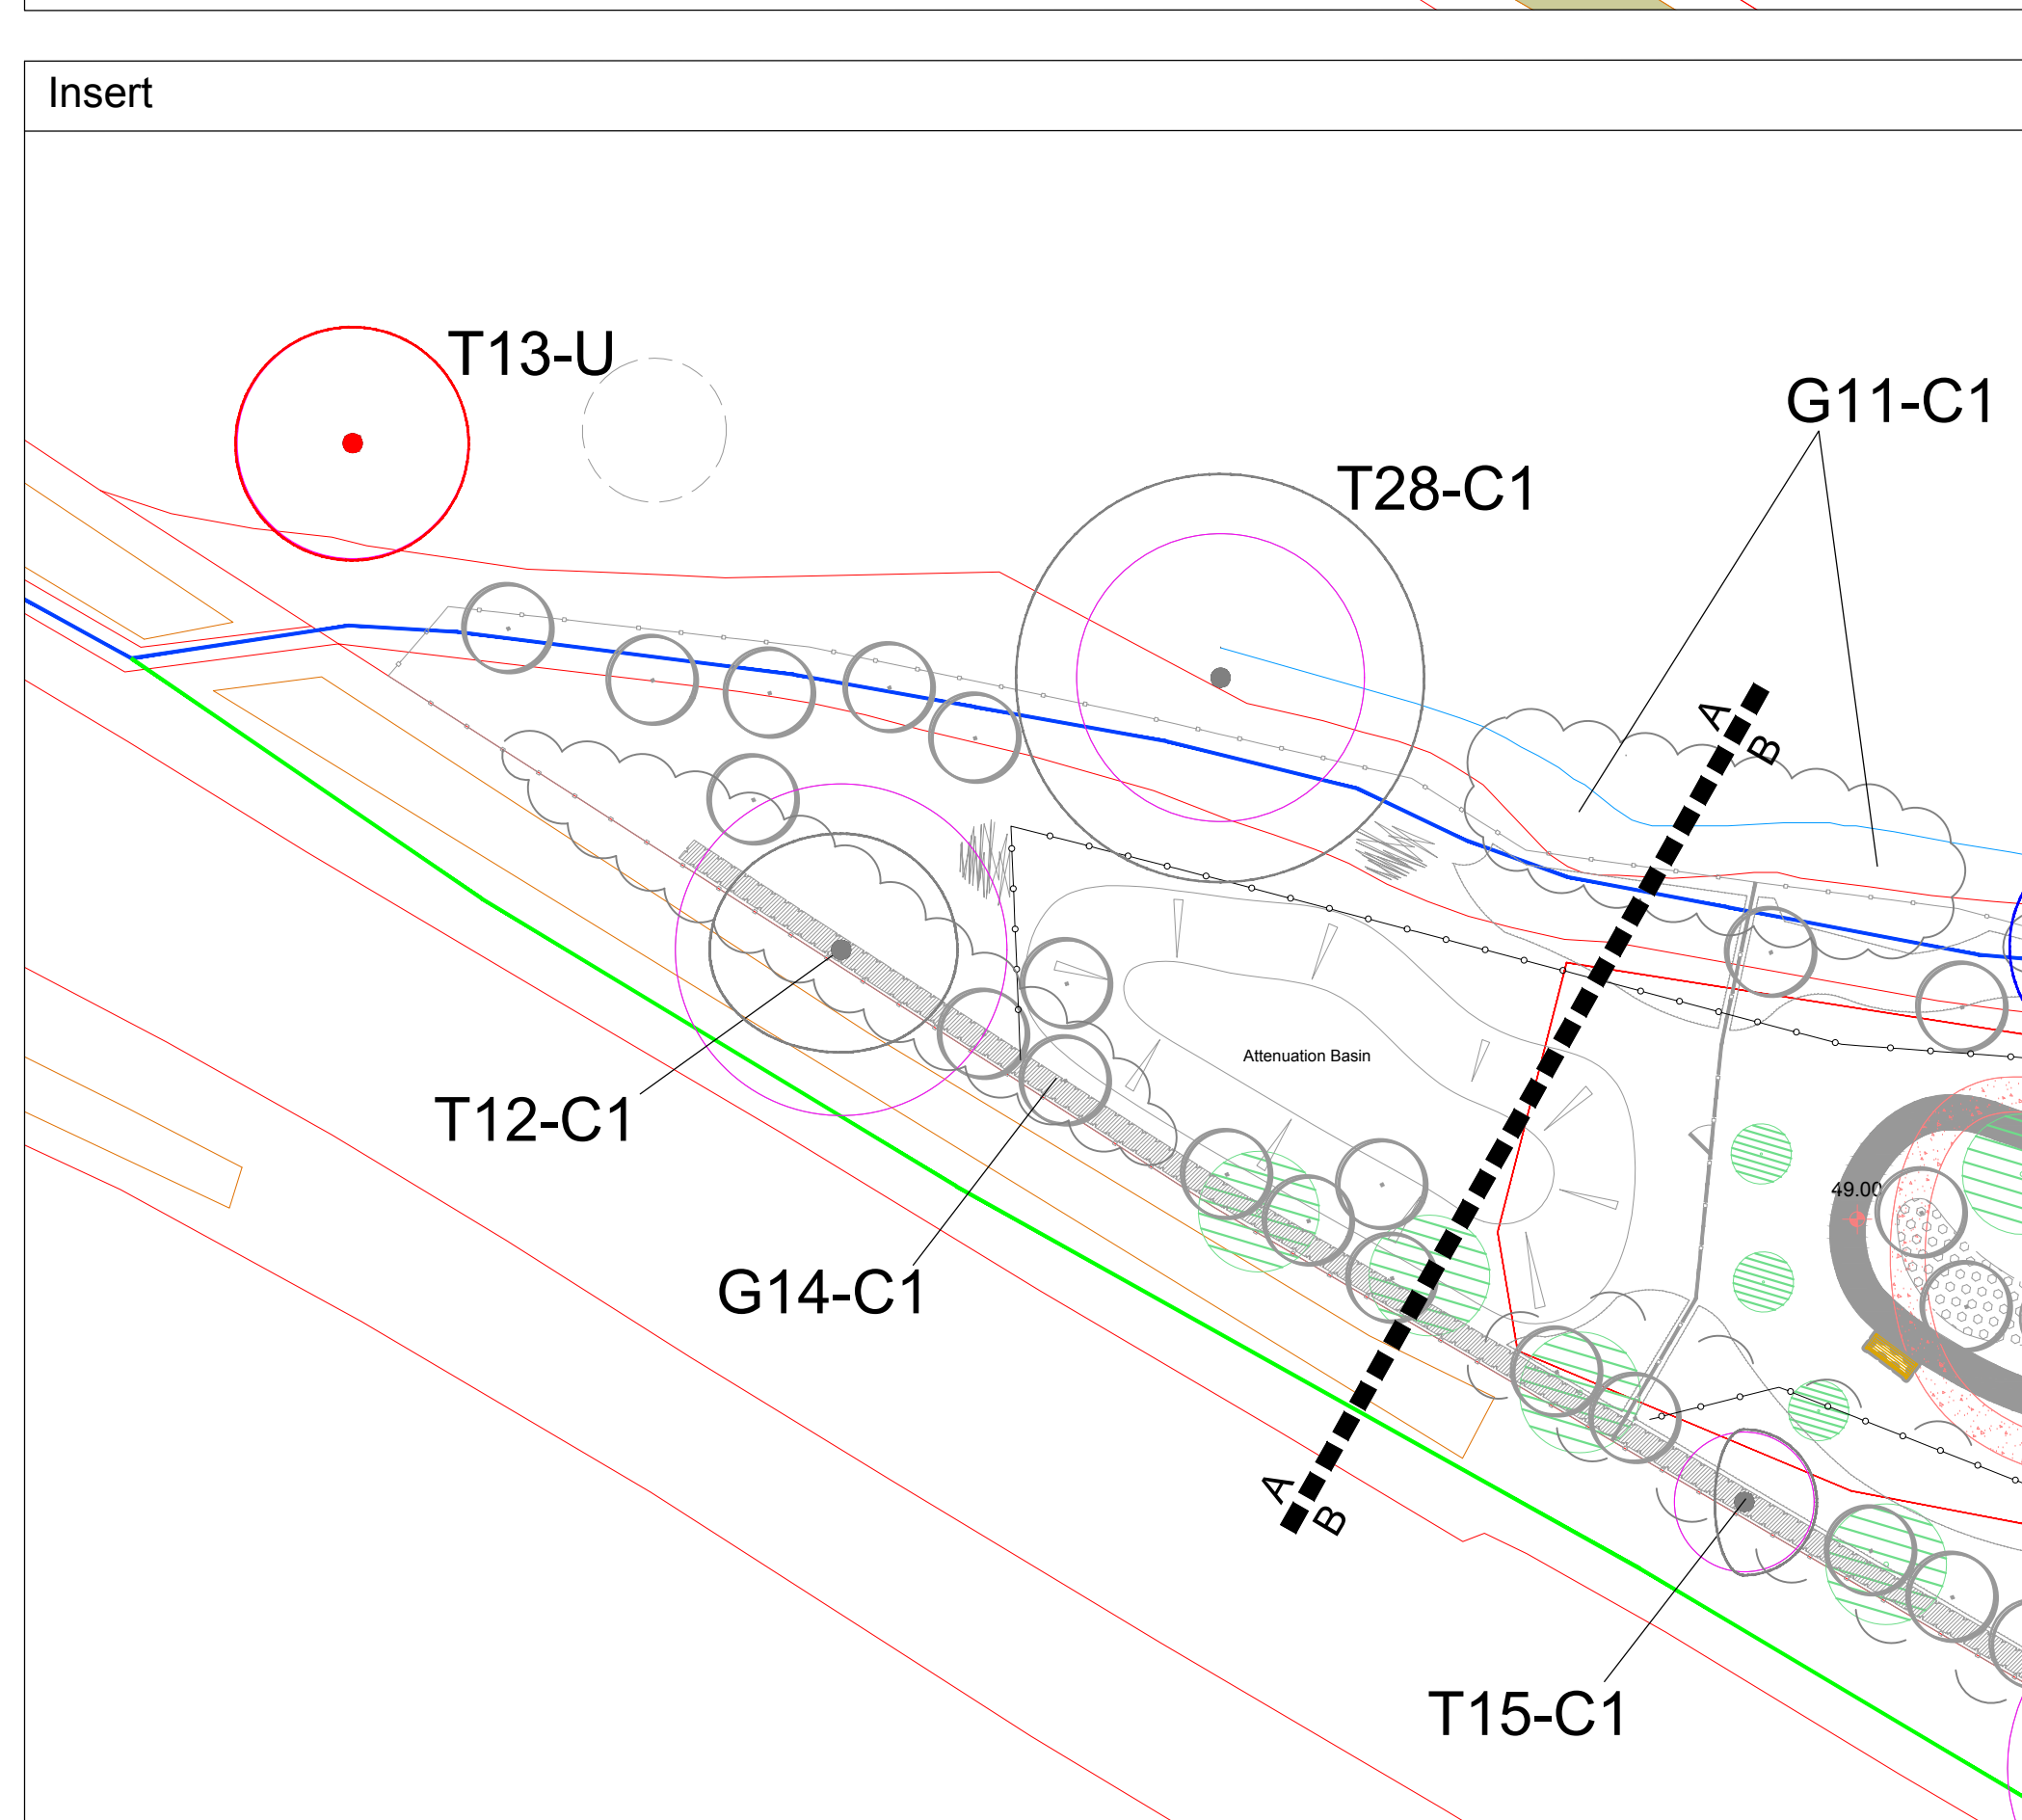
8.3 **Parking bay construction** will be carried out by employing a "no dig" form of construction as illustrated in the document at appendix 3. The edges of the parking bay construction will be made up using topsoil which tapers to the existing soil levels before it reaches the affected retained tree.

8.1 The proposed development requires the clearance of recent scrub growth within the body of the site. This work should be carried out in conjunction with the erection of the tree protection barrier before the construction phase of the development commences. Soil stripping will be limited to areas outside the tree protection which excludes construction activity within the root protection areas of retained trees. The exception to this is an area of parking which is within the root protection area of T2, T3 and T5. This area will also be excluded from soil stripping operations as the construction of the parking bays is to be "no dig" to prevent tree root loss and damage.

- 10.1 Trees retained in close proximity to the construction area of the site will be protected by the use of a tree protection barrier erected in the location shown on the accompanying AIA AMS Plan Number B18058-TLP-602. The fence will consist of "Heras" type panels or similar braced at appropriate intervals and secured to keep in place. The tree protection barrier will be erected prior to the site clearance phase of the development and remain in situ for the duration of the development and will only be removed once construction work has been completed and landscape work begins.
