The Furlongs, Brockhampton, Herefordshire

Bat Report

Report Ref: 1421 / 01

Date: 01.07. 2016

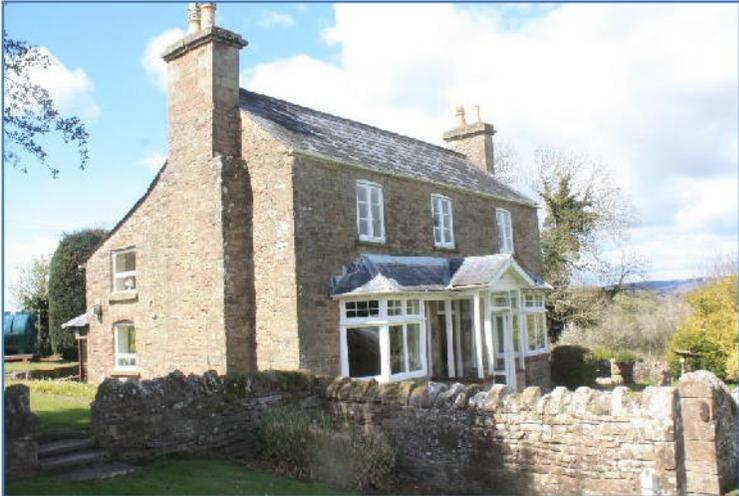
Photograph 1. The front (south-eastern) and south-western aspects of the Iding viewed from the south.

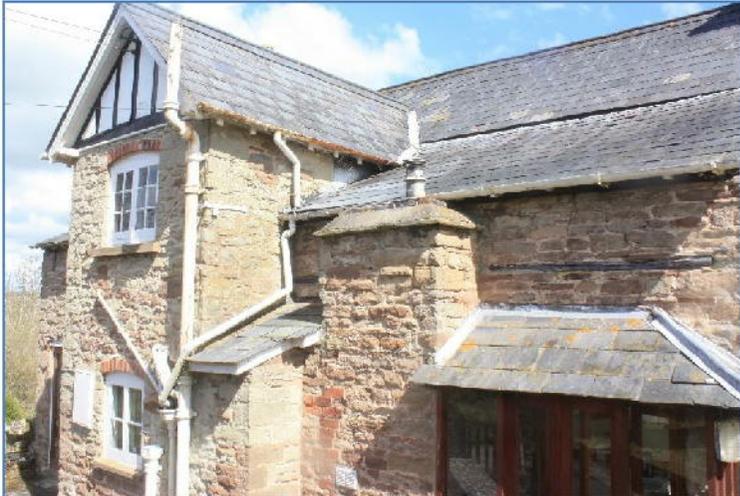
Photograph 2. The rear (north-western) aspect viewed from the south-west.

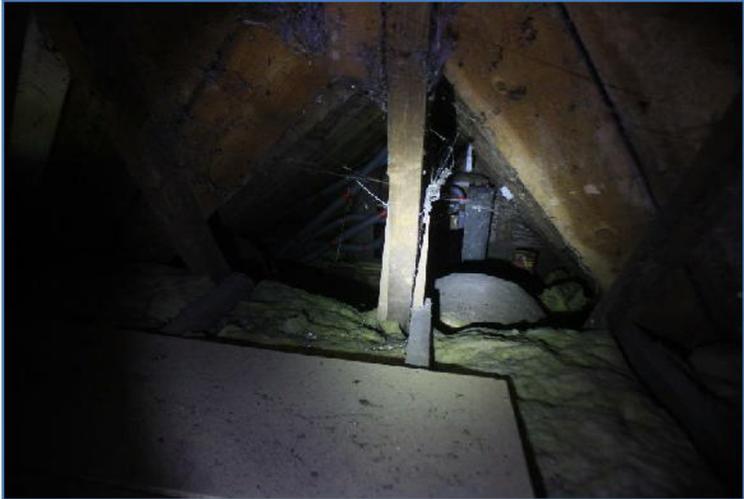
- 3.14 The connected cross gable loft void is approximately 1.2m to the apex and again spans the full length of the rear section of the house. The roof is of a simple cut and pitch structure and lined with bitumen felt which is in excellent condition. The rear (north western) gable end is of lathe and plaster, which is also in good condition. No bat droppings were recorded. Abundant mice droppings were present throughout the void.

Photograph 3. The small and cluttered rear loft.

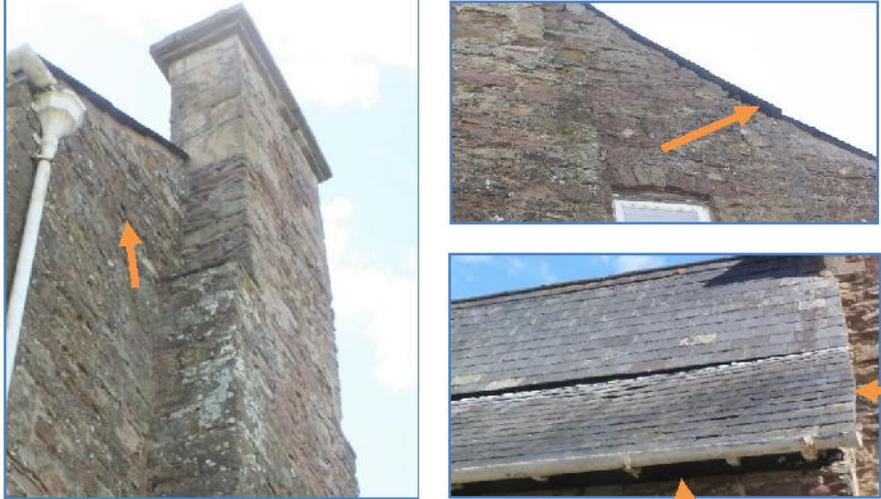
- 3.19 A low level of bat activity was recorded throughout the survey, with the majority of passes by common pipistrelle bats, a few soprano pipistrelle bats and a single myotid species.
- 3.20 At 04:20 a common pipistrelle bat entered a small hole to the right of the drainpipe near the chimney on the north eastern gable end (see **Appendix 1 – Photograph 4**).
- 3.21 At 04:22 an unidentified pipistrelle bat entered the top of the wall to the right of the chimney on the north eastern gable end (see **Appendix 1 – Photograph 4**).
- 3.22 At 04:27 an unidentified pipistrelle entered beneath a tile (at the verge) along the north eastern gable end (see **Appendix 1 – Photograph 4**).

- 5.1 There are minor roosts of pipistrelle and *Myotis* species present (totalling four individuals) within the Building, including (all locations shown on **Plan 1**):

- Minor roost of a single common pipistrelle bat in stonework on the north eastern elevation;
 - Minor roost of a single unidentified pipistrelle bat on the wall-top/roof cavity on the north-western (rear) aspect;

- Minor roost of a single unidentified pipistrelle bat at the verge on the north eastern elevation; and
 - Minor roost of a single *Myotis* species considered likely to be a Brandt's or whiskered bat on the wall-top/roof cavity on the north western (rear) aspect (exited on the south-western side verge).

Photograph 4. The access points to the four recorded minor roosts.

- 5.14 In the event that repairs to the verges of the main roof are required, this must be carried out under supervision of a licensed bat worker. Repair works would likely result in blocking up a large gaps, retaining small access locations in more-or-less like-for-like locations where bats have been recorded. Works would be undertaken in spring or autumn as far as possible to reduce the likelihood of bats being present. A minimum eight gaps (dimensions of 30mm high by 100mm wide) will be retained in total to ensure continued functionality of recorded roost sites. Two of these would be located either side of the chimney on the north-eastern and south-western gable end walls.
