From: info@peterhunt.uk.net <info@peterhunt.uk.net>
Sent: 03 October 2022 16:36
To: 'Allen, Jennifer (02)' <Jennifer.Allen2@balfourbeatty.com>; Bailey, Josh
<Joshua.Bailey@herefordshire.gov.uk>
Subject: FW: Bannut Tree 222922

From: Steven Peters [REDACTED]
Sent: 05 August 2022 15:08
To: PETER HUNT <info@peterhunt.uk.net>
Subject: The Bannutt

We have pleasure in attaching the results of BRE365 and BS6297 tests carried out recently at The Bannutt.

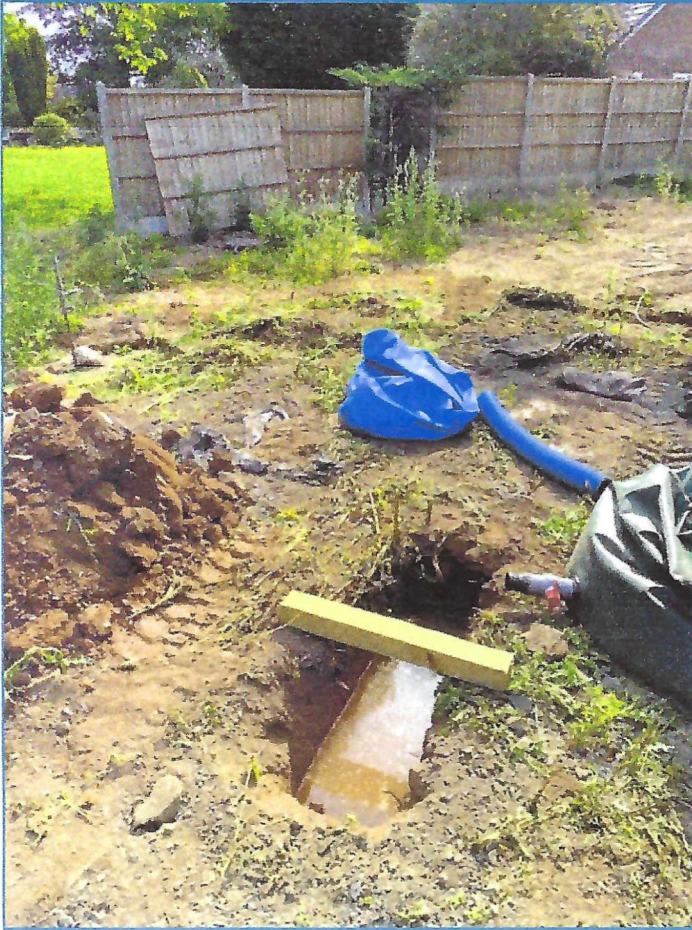
Trial Pit A

As the data illustrates, the BRE365 test only drained 25mm over a period of 6 hours and it was not therefore possible to carry out the test to the required standard.

At the drainage rate achieved it would have taken 240 hrs, that is 4 full days, for the first drainage event to occur.

Trial Pit: A Length: 1100 Width: 400 Depth: 1300 Depth of water (at 100%) 1000

Time	Fall (mm)
09:55 AM	0
10:30 AM	0
11:00 AM	0
11:30 AM	5
12:00 PM	5
01:00 PM	10
02:00 PM	15
03:00 PM	20
04:00 PM	25

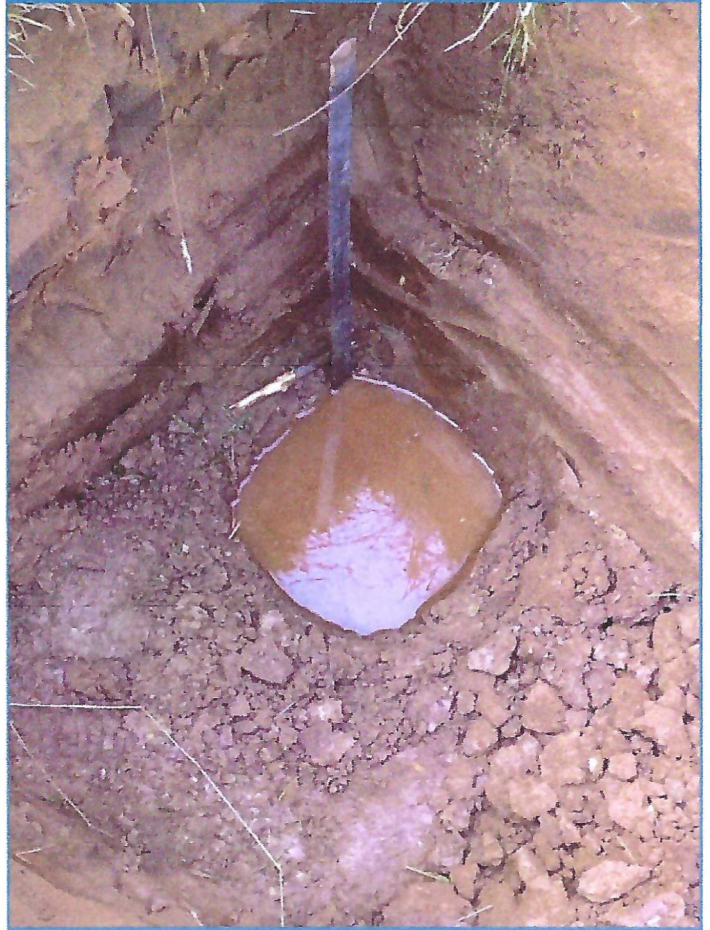
Trial Pit B

The BS6297 tests only drained 15mm and 20mm 5.5hrs and 5.25hrs respectively.

Trial Pit: B Length: 300 Width: 300 Depth: 300 Depth of water (at 100%) 300

Time	Fall (mm)
10:30 AM	0
11:00 AM	0
11:30 AM	5
12:00 PM	5
01:00 PM	10

Time	Fall (mm)
02:00 PM	15
03:00 PM	15
04:00 PM	15

Excavated at 1000mm bgl

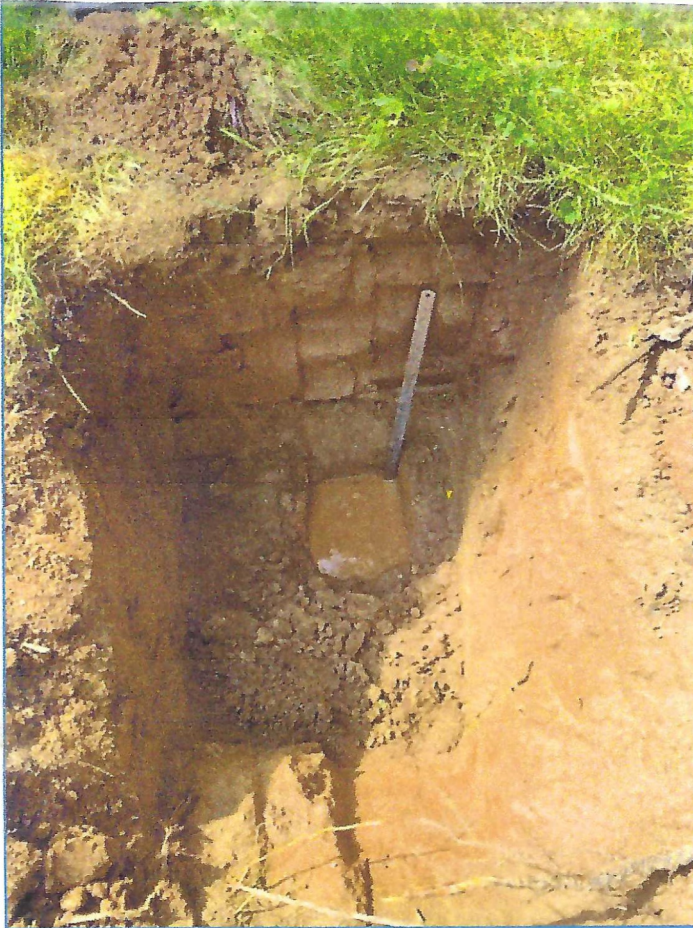
Trial Pit C

Trial Pit:	Length:	Width:	Depth:	Depth of water (at 100%)
C	300	300	300	300

Time	Fall (mm)
10:45 AM	0
11:00 AM	0
11:30 AM	0
12:00 PM	0
01:00 PM	5
02:00 PM	10
03:00 PM	15
04:00 PM	20

Excavated at 1000mm bgl

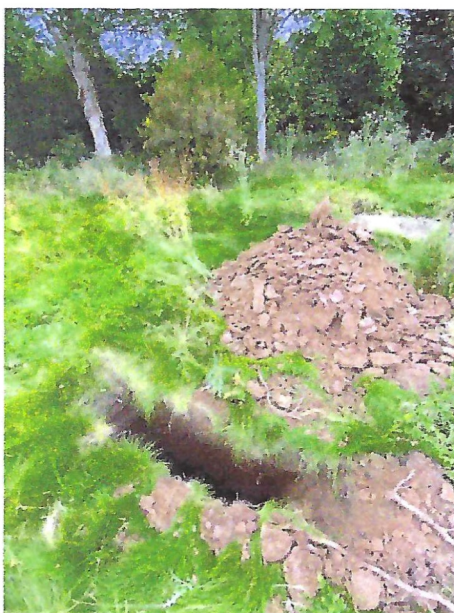
PHOTO

Whilst on site, a deeper trial pit was excavated with the purpose of identifying the ground water table, the pit was left open during the course of the day and the following information was recorded.

Ground Water Encroached	Depth Of Excavation
No	2600
