**HEREFORDSHIRE FWAG**

## BAT SURVEY, JUNE 2009

**Aim:** To survey, and assess the importance of a barn for bats at Lower Llanon Farm, Urishay, near Peterchurch, where development is proposed.

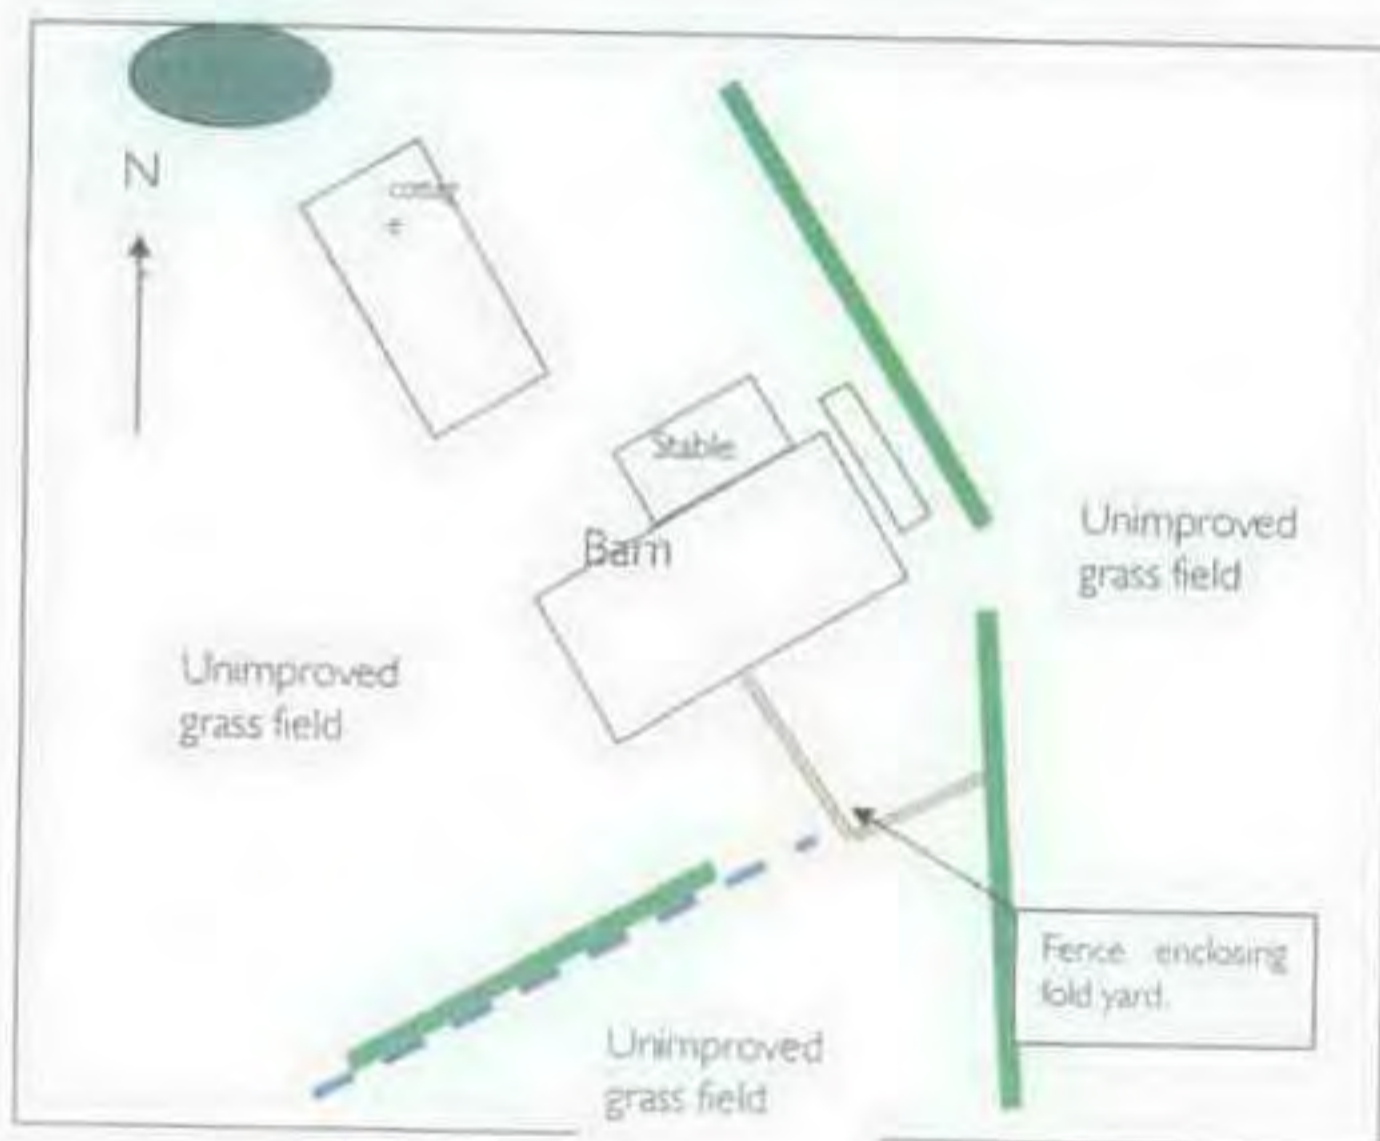
The large threshing/hay barn at Lower Llanon Farm lies close to the original farm cottage. Attached to the barn is a small stable which was included in the survey. There was also a modern breeze block building with sealed roof of modern materials, a few feet north-east of the barn, and parallel with the barn, which was not worthy of survey. See diagram below.

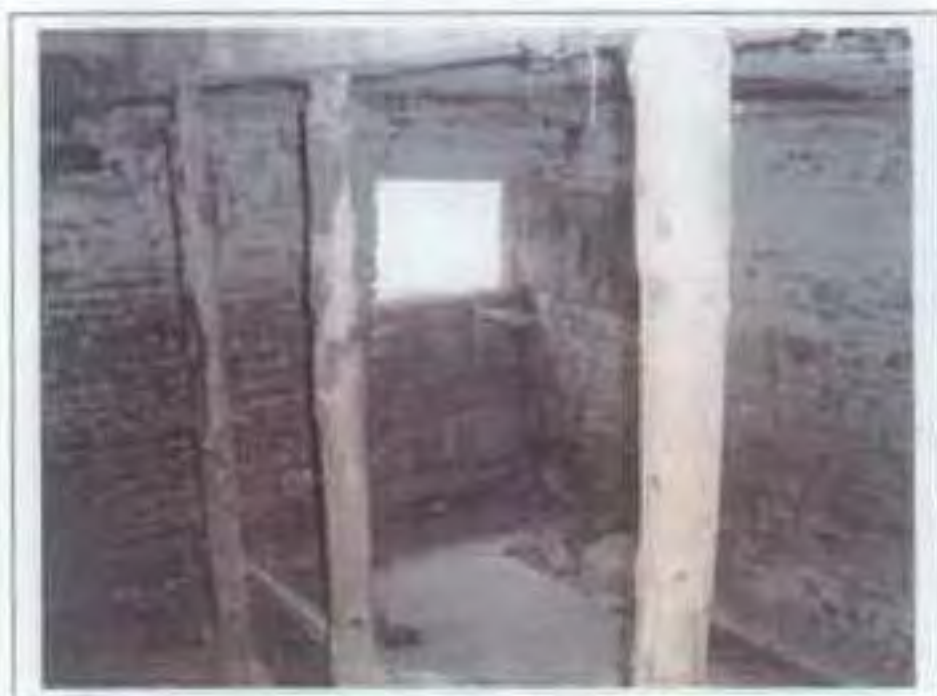
Photo 1: inner room.

Probably in order to accommodate sheep, a wall was built within the barn, and a corrugated tin ceiling (probably at one time wooden) lay on the timbers. This "inner room" is shown in photograph 1 which was taken within the building. The light rendering on walls remains to some degree, inside the inner room. This part of the building had a regular type of door (open) on the east elevation.

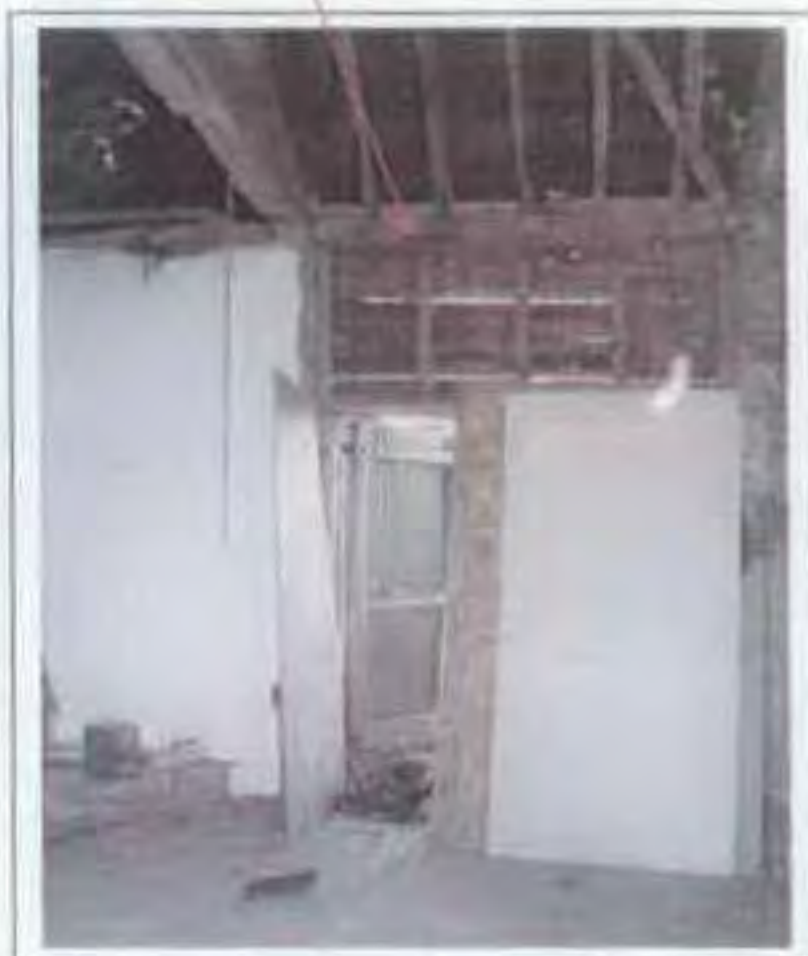
Photo 2: boards above door on north west elevation. Note the original rendered walls (rendering now removed).

The barn had big double doors, in the centre of the south-east and north-west elevations. Wooden boards, with visible gaps formed the wall above the latter. See Photo 2. The doors were kept closed, and the inside of the barn was fairly dark.

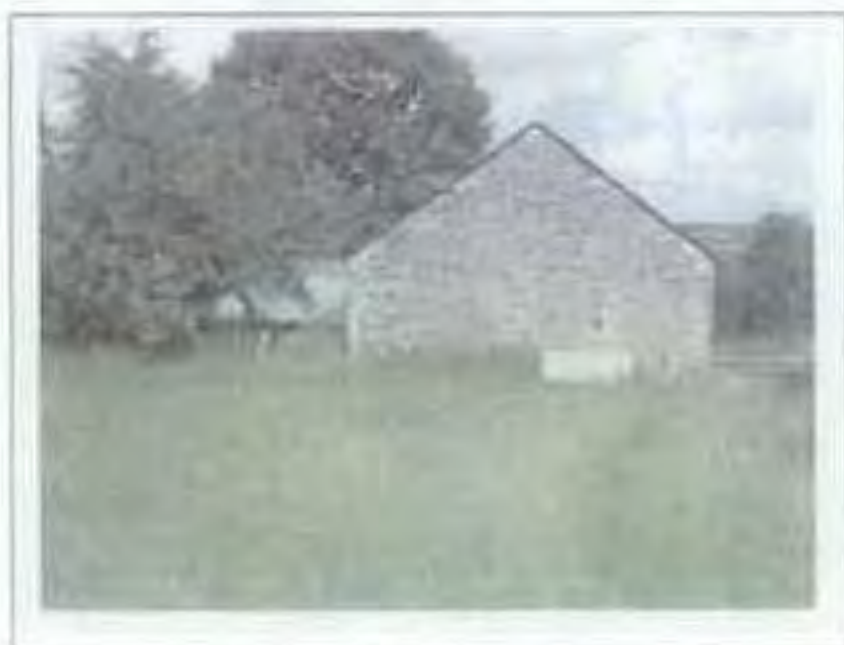
Photo 3: west elevation

The stable (joined to the north-west elevation of the barn) had a tin roof, and was single storey, currently used for storage. See photo 3.

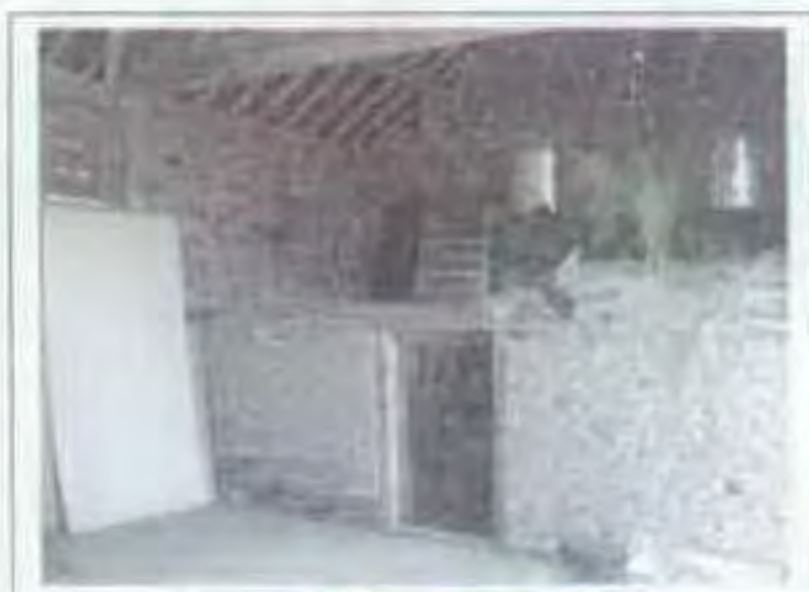
Photo 4: Second storey created by added floor.

The barn and the stable were constructed by local sandstone. The internal walls were rendered, and this covering had only been removed in 2009, so the holes between stones in the inside of the barn have only recently been exposed. The open area within the barn was likely to have been for storage of hay, as the barn has slit windows (west and east elevations), built in barns to provide ventilation for stored hay/straw. It is currently used for general storage.

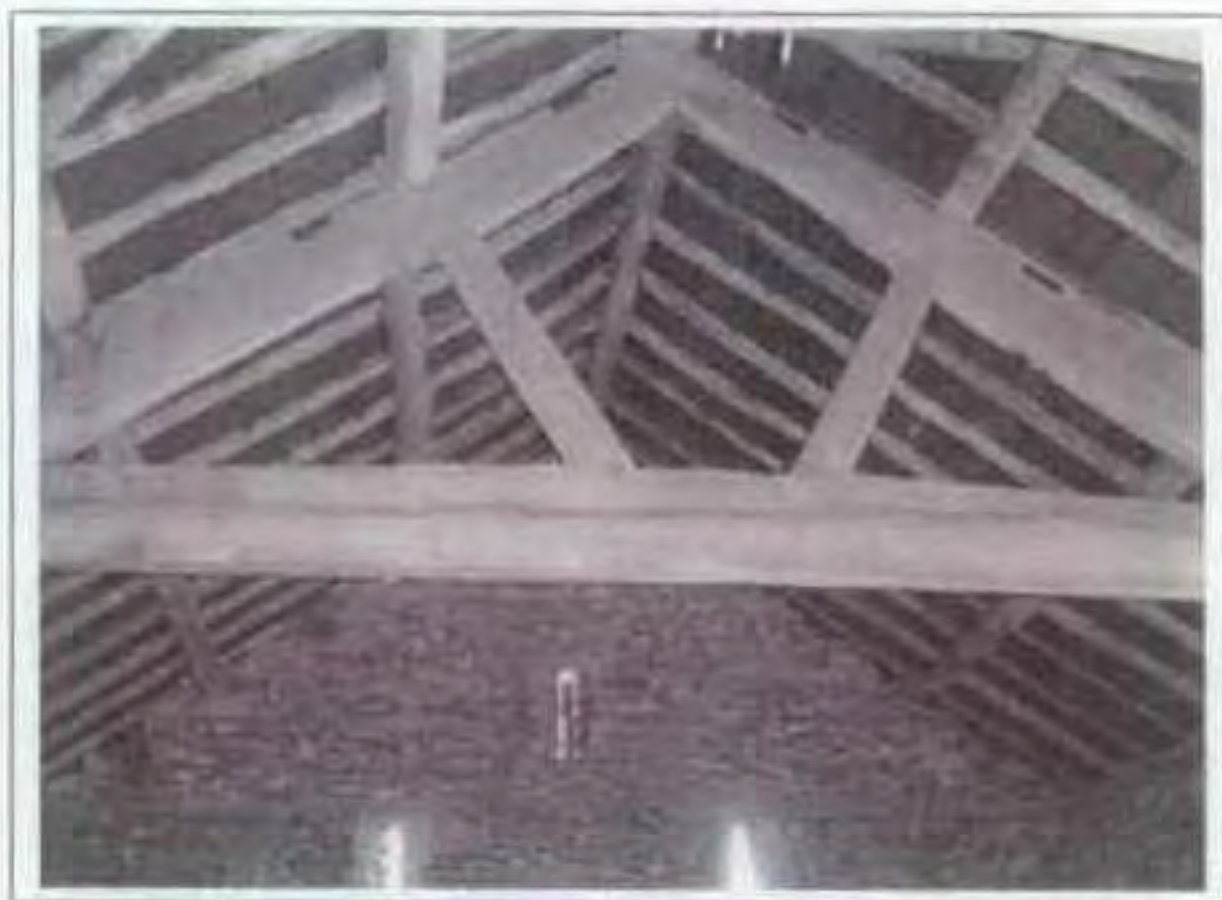
Photo 5: internal roof.

The external walls of the barn had many holes, shown in photographs of the barn. The stone slate roof had been repaired using original materials and was in good condition, and roofing felt had been added. A tin plate over the roof's ridge was replacing original ridge tiles.

The stone slate roof had recently been repaired using original materials and was in good condition, and roofing felt had been added. A tin plate over the roof's ridge was replacing original ridge tiles. This half of the roof which faces south-east was providing roosting habitat for single bats, either in spaces between tiles on the roof, or between tile and roofing felt.

If the roof will be removed during development of the barn, bats could be protected from disturbance, as the law requires, if the work is carried out at a time of year when bats are not present. The roof provides conditions which are warm in summer, but also very likely to fluctuate in winter. It is therefore very unlikely to be providing roosting habitat in winter, so any work to the roof should take place at that time of year. Otherwise, an European Protected Species Licence would be required.

- Ensure that timbers are only treated with approved remedial timber treatments.
- Roof voids with access by bats should have roof felt of the traditional bitumastic with Hessian type, rather than the modern plastic smooth surfaced roof felt.

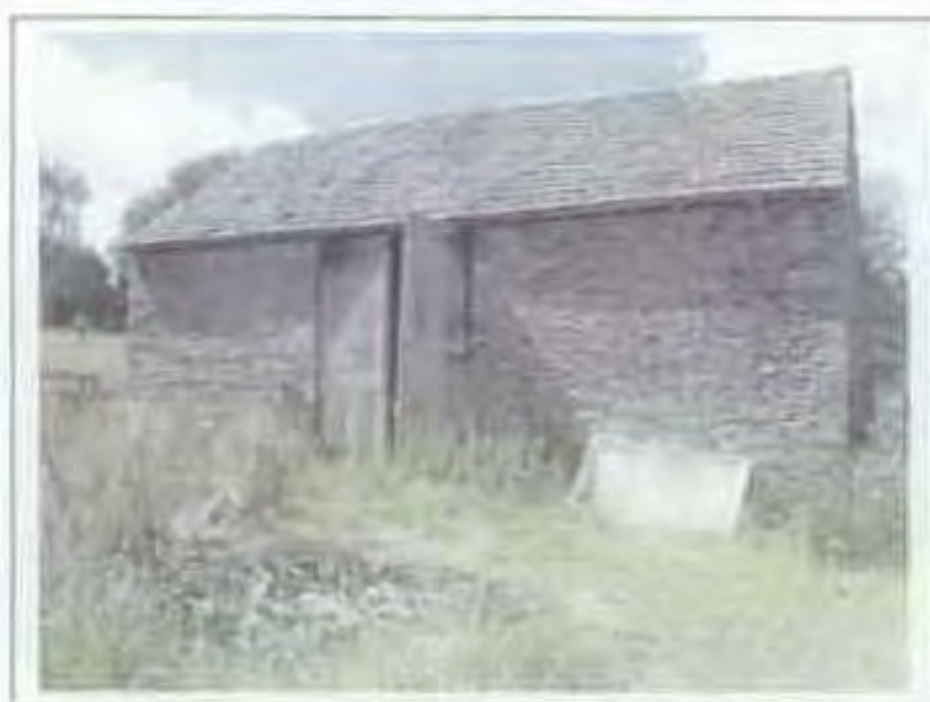
Photo 6: south-east elevation

One or two Pipistrelle bats were seen leaving the building, apparently roosting between roof slates on the south-east half of the barn's roof. No more than one bat appeared from any one point on the roof. There was no evidence of presence of a maternity roost, and as the survey took place at the optimum time for activity for breeding bats, the existence of a maternity roost at least in 2009 is therefore very unlikely.

If any work to the roof takes place, it should take place in winter, to avoid any chance of disturbance to the bats which undoubtedly use the building in summer. The walls of the barn could be providing winter hibernating conditions and this should be taken into consideration if any work to the walls takes place.

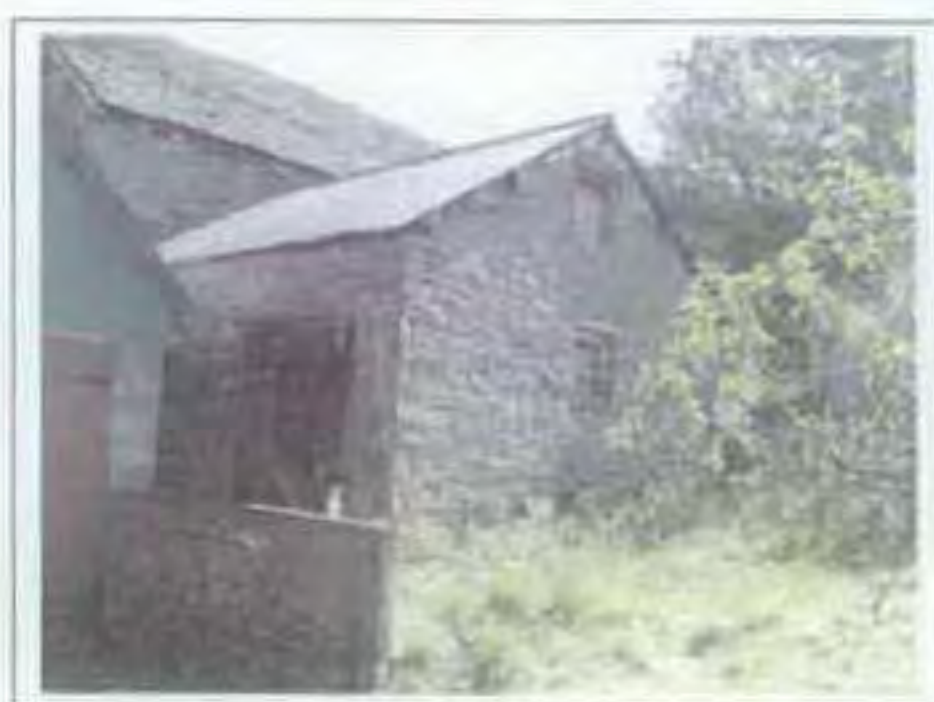
Photo 7: Stable, attached to barn.

The single-storey stable had a low tin roof and walls with 2 metre high eaves, and provided little opportunity for bat roosting, and no signs of bats were seen.
