# ARBORICULTURAL IMPACT ASSESSMENT

Ref: 11918c

REGARDING PROPOSED DEVELOPMENT  
WITHIN THE CURTILAGE OF  
BROCKINGTON, HAFOD ROAD,  
HEREFORD HR1 1SH

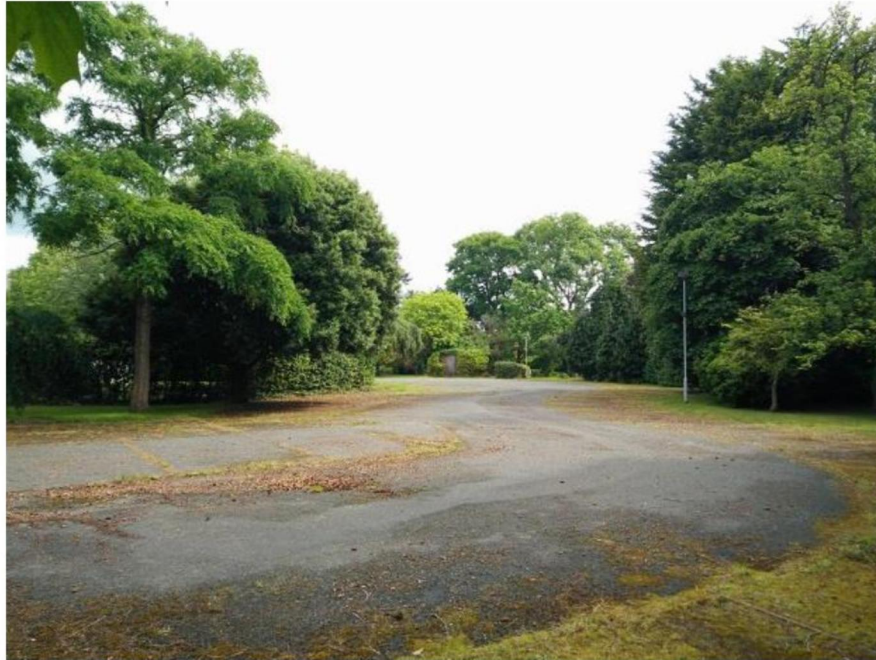
Photograph 1: Application site within curtilage of Brockington, Hafod Road, Hereford HR1 1SH

- 2.3.1 The site comprises former offices of Hereford Council and contains an extensive amount of car parking and hardstanding as well as large expanses of lawn planted with specimen trees. The application site is generally level although the wider site does slope gently to the north-west.
- 2.3.2 It is important to note that the site has been split into 2 parcels, one owned by IE Developments and the other by a third party. This report is wholly concerned with the parcel of land owned by IE Developments.
