129 Hinton Road, Hereford,  
HR2 6BN

for Dean & Emma Wyatt

## BAT SURVEY REPORT

5367 V2

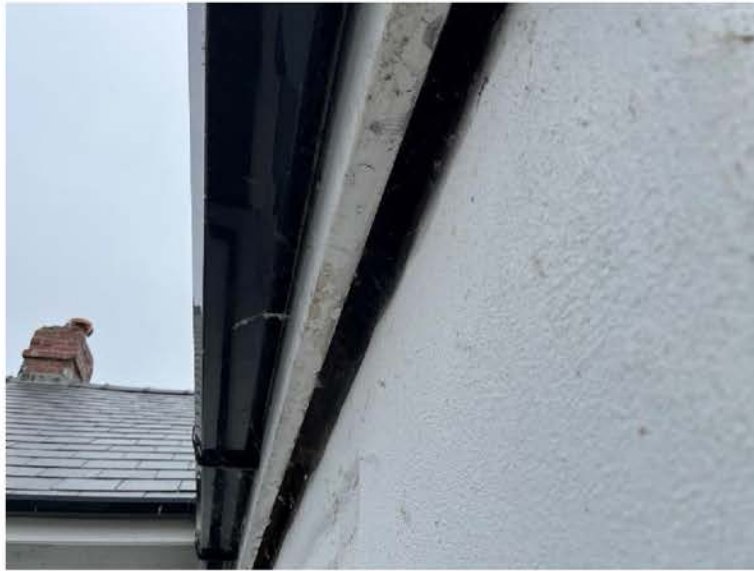
Facia, bargeboards and soffits are PVCu, facia at the southern façade are not finished above flat roofed southern outcrops providing access to the box structure. Facia boards of southern outcrops are set-off from the structure by approximately 2 inches forming crevices 2-3 inch deep.

**Plate 3.** Crevice behind fascia board on southern outcrop extension.

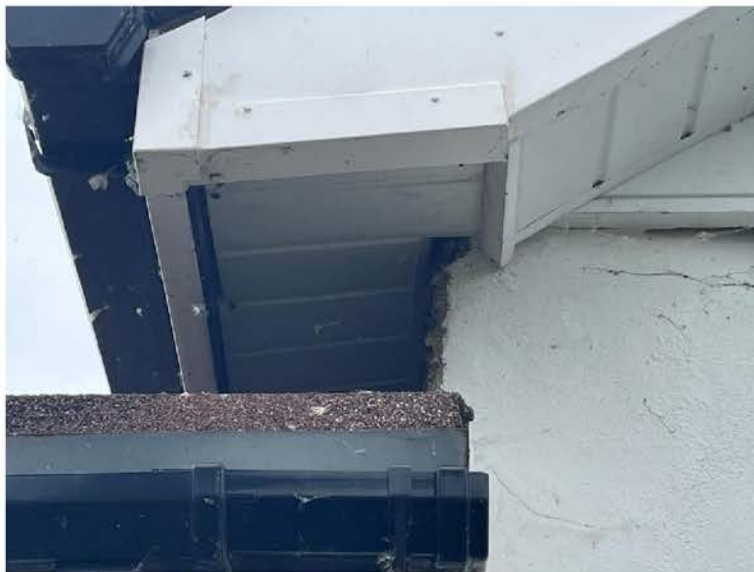
**Plate 4.** Unfinished soffit boards on south-eastern corner.

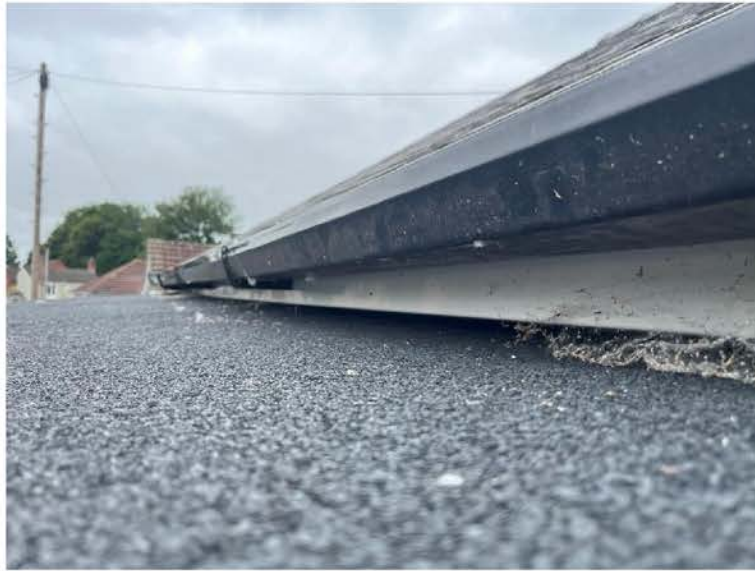
**Plate 5.** Gap between fascia and flat roof on southern aspect, soffits are unfinished in these locations.

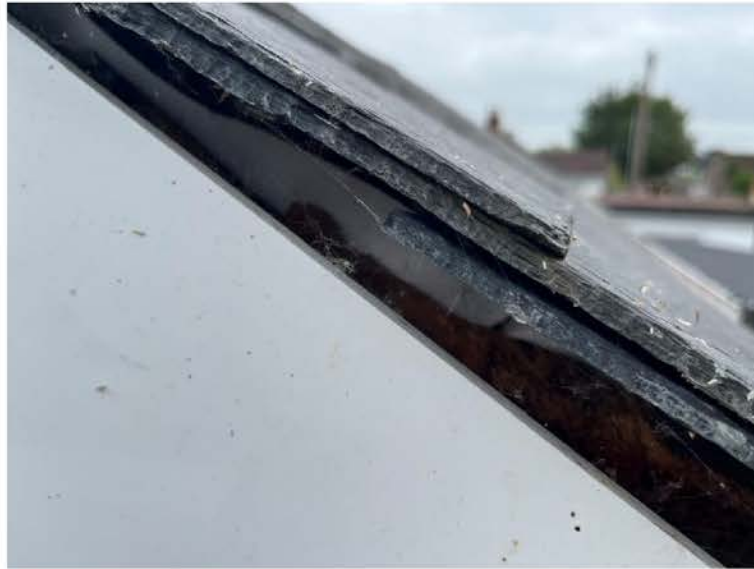
for crevice dwelling bats. Un-pointed verges provide further access for bats to enter beneath the slates on gable ends.

**Plate 7.** Un-pointed gable verges provide access to beneath slates.

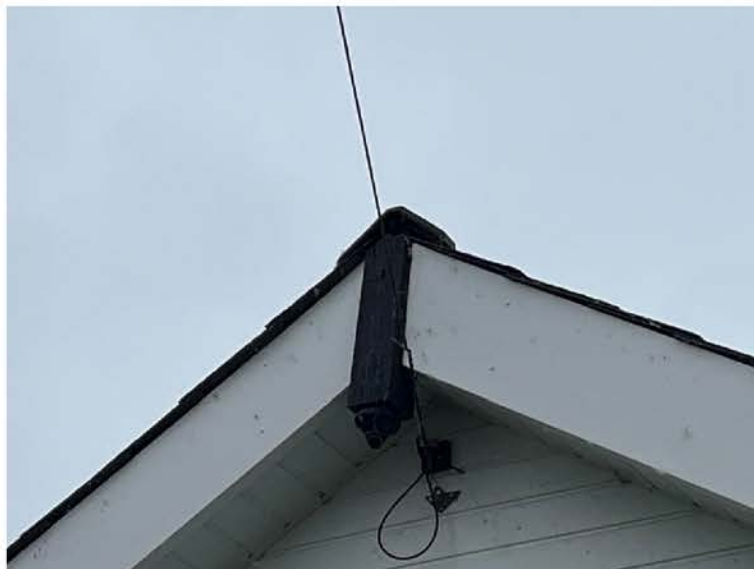
The building features a gable and valley roof that has been recently re-roofed with slate covering, slates are in correspondingly good condition and well seated. Ridge tiles are also slate in good condition and well seated but not pointed on the ends providing access beneath ridge tiles suitable

**Plate 8.** Un-pointed ridge tiles on gable ends provide access to beneath ridge tiles.

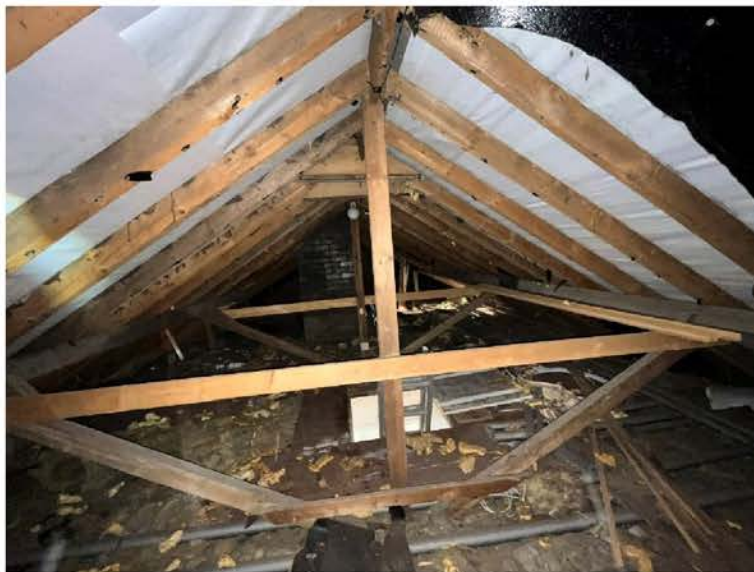
Internally the building features a single large roof void. Slates are fully lined with a modern breathable roofing membrane. Timbers are modern machine-cut rough-sawn in a fan truss arrangement with additional raised tie-beams. Floor of the void is insulated with glass fibre roll and has a low amount of rudimentary boarding.

**Plate 10.** General view of interior roof void, note the use of breathable roofing membrane.

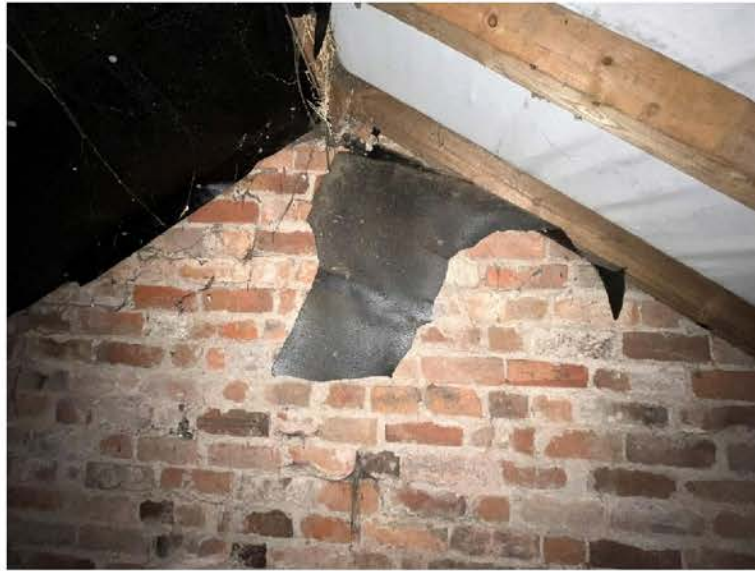
**Plate 11.** Remnants of bituminous felt attached to the underside of rafters.

- The north-eastern aspect has been chosen as the most suitable on this occasion as facing ideal foraging habitats of the River Wye, the south-western façade is illuminated by street lighting making it unsuitable.
- Areas provided for bat roosting shall use traditional bituminous felt (Formerly type 1F), no breathable roofing membranes shall be permitted where access is available for bats.
- Timber battens shall be used to restrict roosting to areas of bituminous felt.

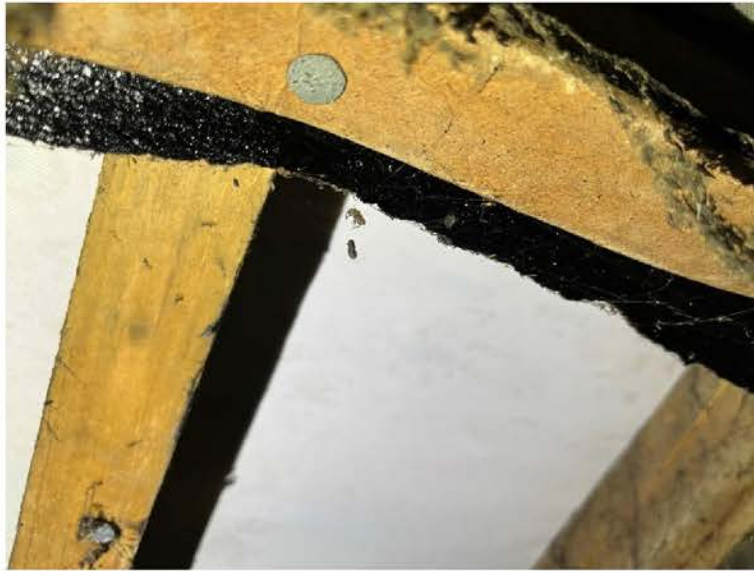
All accessible interior and exterior surfaces were inspected for evidence of bat activity including bats live or dead, faeces, oil and urine staining, scratch marks, feeding remains etc. a low number of bat droppings were identified hung in cobwebs at the northern and eastern ends of the void.

**Plate 13.** Bat dropping hung in cobwebs at northern end of the void.

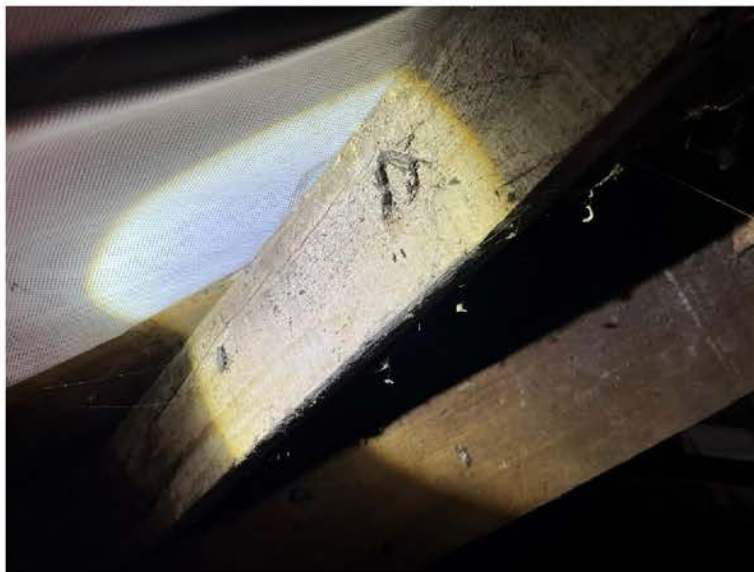
**Plate 14.** Bat dropping hung in cobwebs at eastern end of the void.
