Forty's Pitch

Gorsley

***Road Safety Audit Response Report***

**Stage 1 Road Safety Audit**

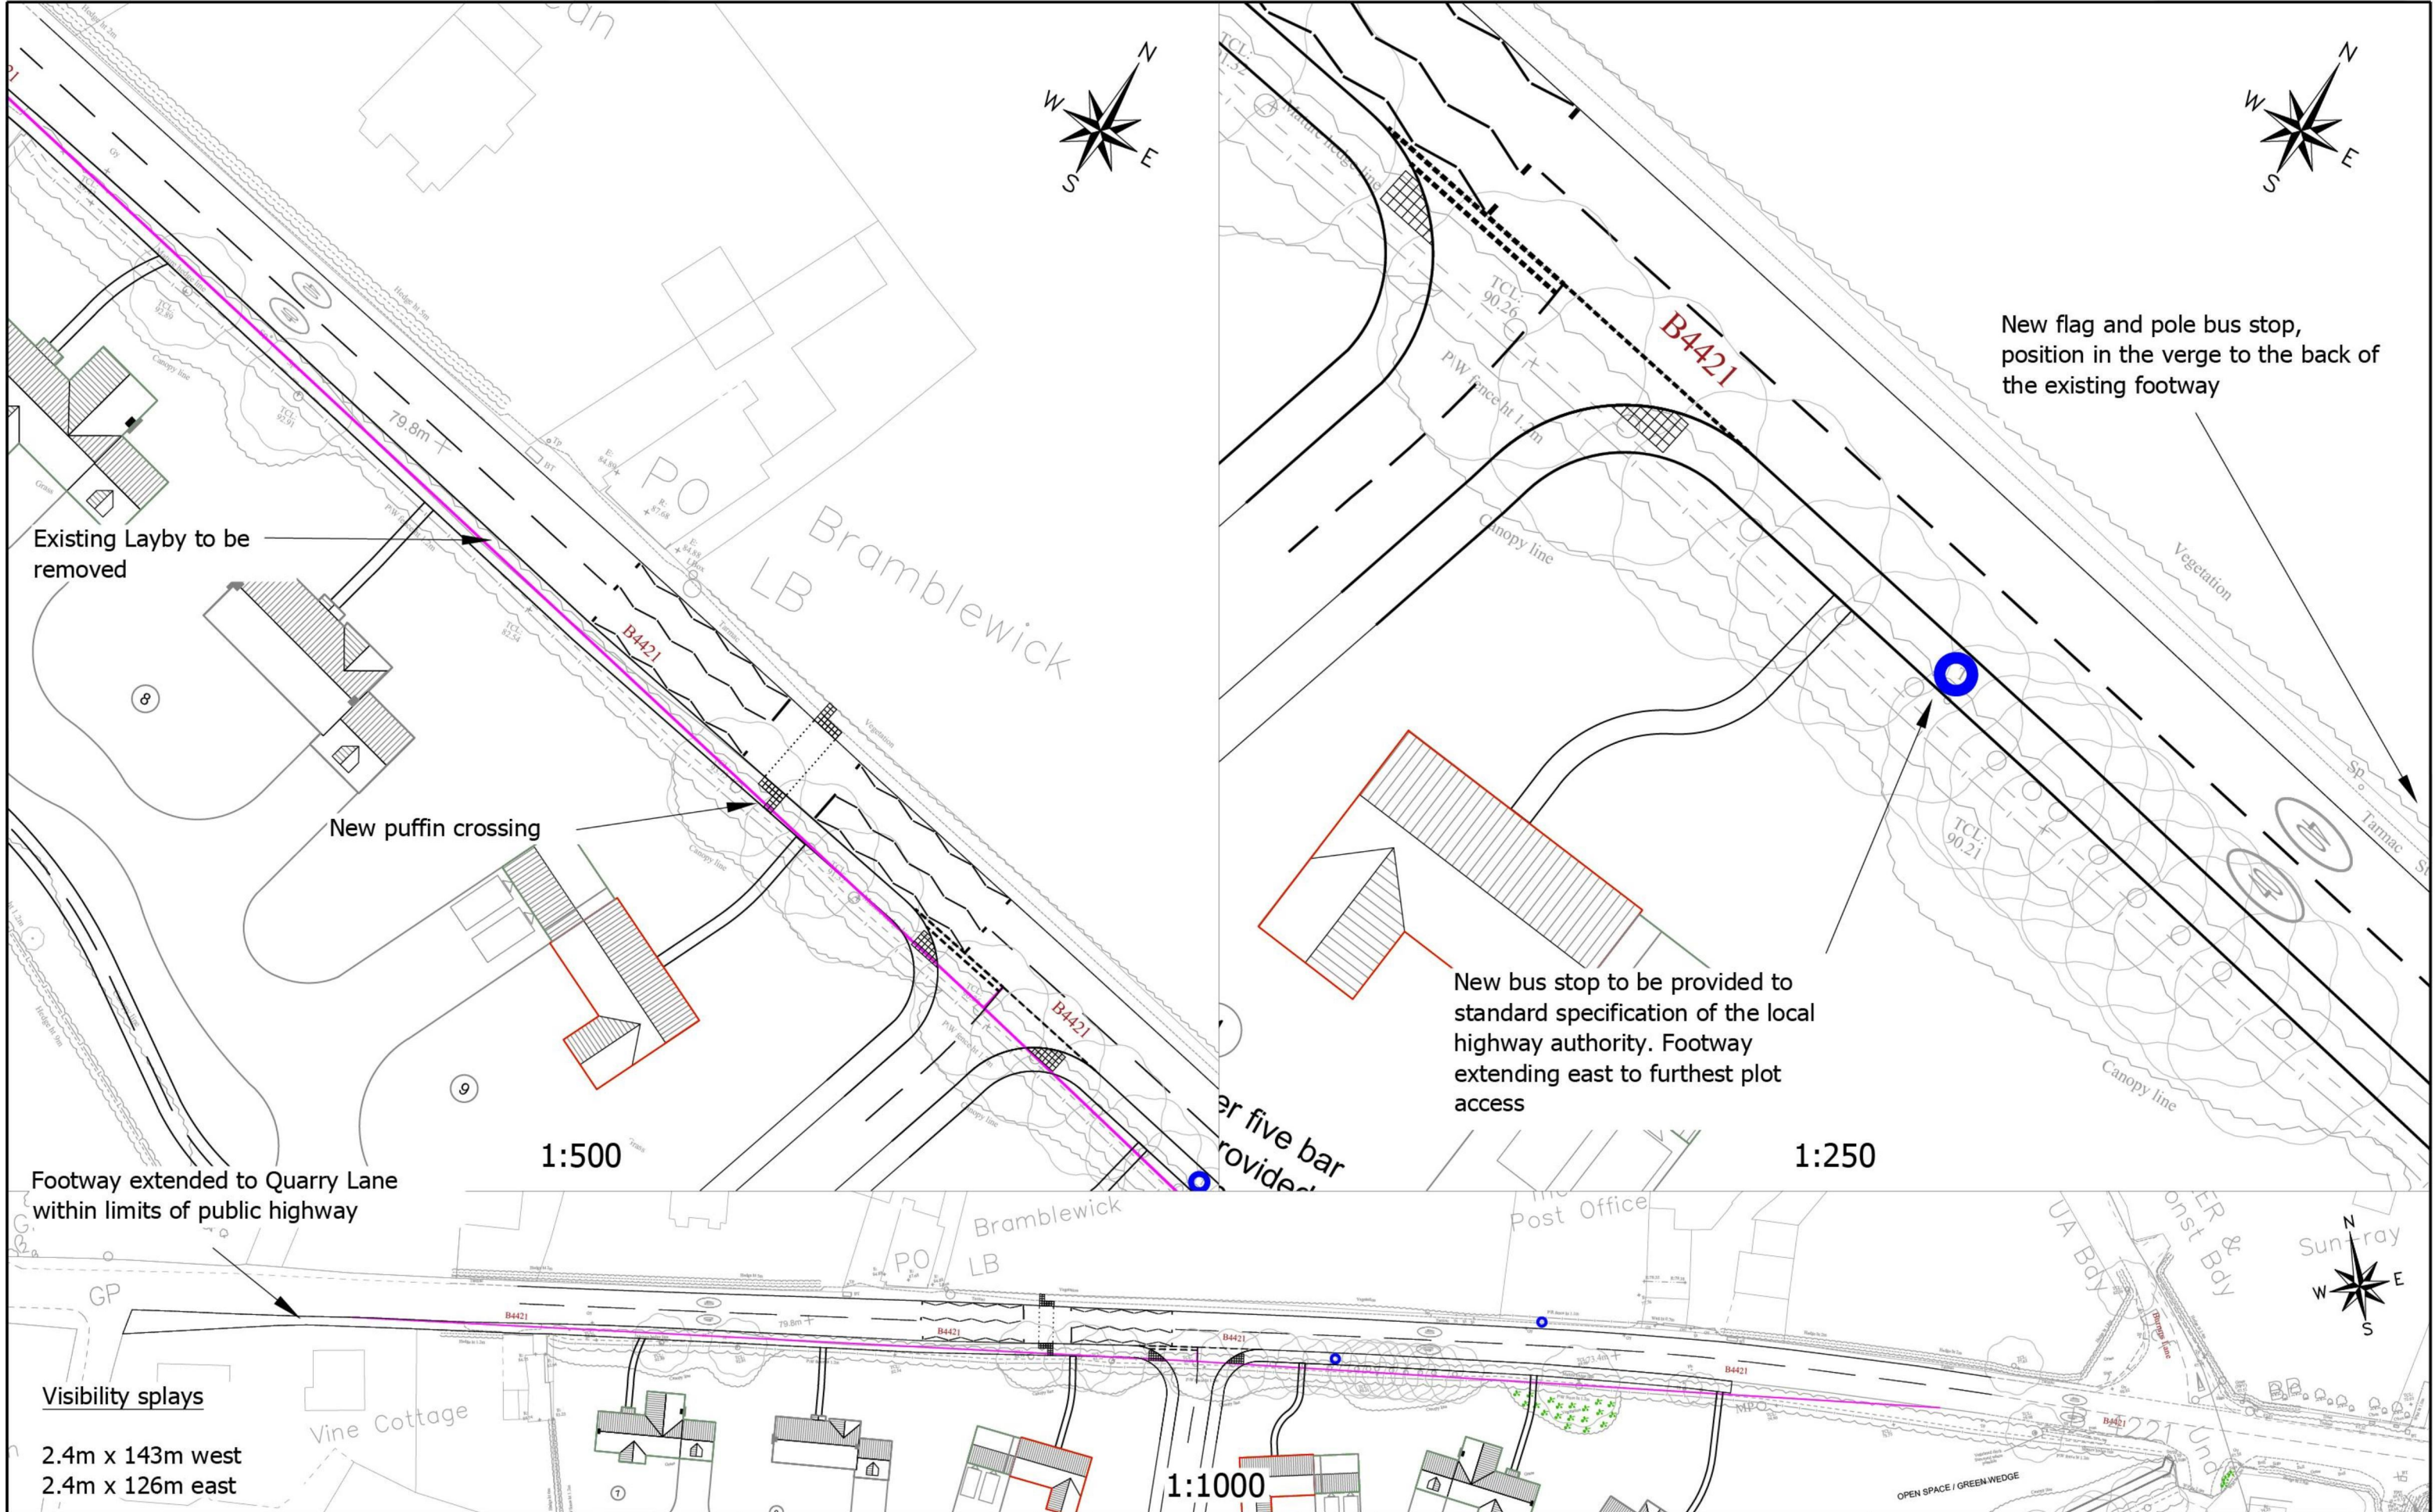
*The southbound bus stop has been relocated to change the stagger with an approximate separation distance of 35m. This is shown on **Drawing 16251-11b**.*

***Drawing 16251-11b** shows tactile dropped kerb crossing facilities across the site access junction.*

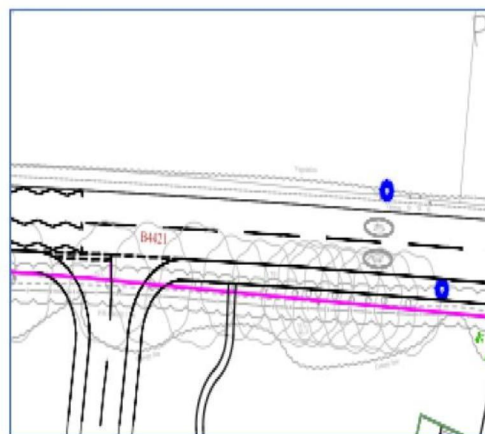
Location: On Forty's Pitch

Summary: Pedestrian to vehicle collisions

Two bus stops are proposed, to the east of the proposed development access. Pedestrians are unlikely to use the signalled crossing, away from the direct pedestrian desire line, to access these stops. Pedestrians may be vulnerable to being struck by vehicles as they attempt to cross on the likely desire line.

*The bus stops are located at a point equidistant between the existing stops on the B4221, which has been agreed in principle with the operator. The crossing has been located on the crest of the hill to maximise the visibility for approaching drivers, it is therefore, not recommended that the crossing be relocated.*

*A simple dropped kerb crossing could also be provided to assist with crossing the road. See response to 2.6 below for appropriateness of a simple crossing.*

It is recommended that the bus stops are relocated to maximise the use of the proposed crossing.

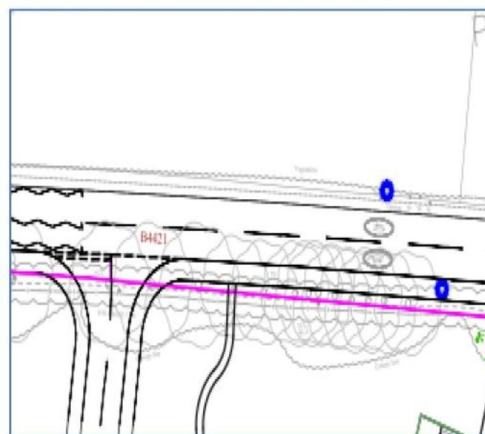
Location: On Forty's Pitch

Summary: Vehicle to vehicle collisions

Two bus stops are proposed, to the east of the proposed development access. The orientation of the bus stops may lead to the carriageway being blocked, should buses occupy opposing stops at the same time; this may lead to late braking nose to tail collisions.

It is recommended that the bus stops are relocated to maximise the use of the proposed crossing – tail to tail configurations are considered conventional, with a separation of three bus lengths.

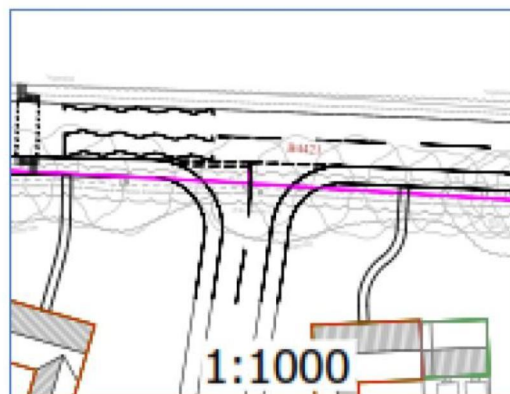
Location: At the development access

Summary: Pedestrian injury

At the development access, no dropped kerb crossing facilities are indicated for pedestrians. Some users may have difficulty negotiating full height kerbs and this may result in pedestrian trips or falls.

It is recommended that appropriate dropped kerb crossing facilities are provided, with tactile paving to highlight the presence of flush kerbing.

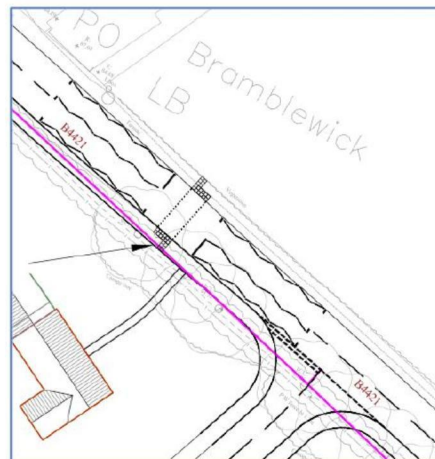
Location: At the signalled pedestrian  
(puffin) crossing

The proposed development consists of only nine residential properties; this level of development is unlikely to generate substantial levels of pedestrian activity and with low levels of existing development there may be a low frequency of operation of the crossing. Regular drivers of Forty's Pitch may not expect the operation of the crossing and this may lead to failure to stop type incidents (reference LTN 1-95 paragraph 4.2.4).

*Information provided to Herefordshire in the form of a PV<sup>2</sup> calculation clearly demonstrates that a formalised crossing facility is not required, either in the form of a puffin or central refuge.*

*Finally, the road is not wide enough to be able to provide a refuge. Therefore, the road would need to be widened to provide a refuge, which could lead to increasing vehicle speeds.*

It is recommended that an assessment of need for the crossing is carried out. Other forms of pedestrian crossings, such as pedestrian refuges may be more appropriate.

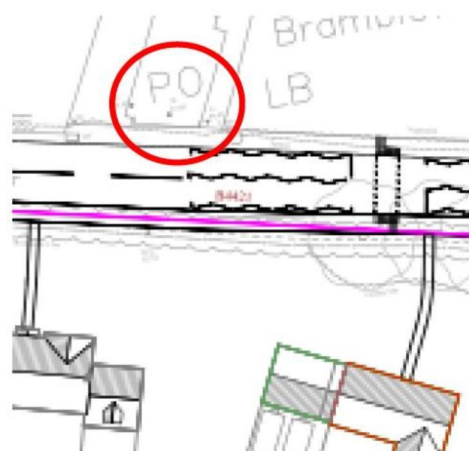
Location: At the signalled pedestrian  
(puffin) crossing

There is a Royal Mail Letter box located on the eastbound approach to the crossing which falls within the controlled area of the pedestrian crossing. This may result in people wishing to use the letter box including the Royal Mail operative to stop on the zig-zag markings, which in turn may encourage other drivers to illegally overtake parked vehicles.

*Discussions will be held with the local highway authority with a view to agreeing whether or not the post box should be relocated and to where.*

It is recommended that the letter box is relocated to the east, away from the crossing.
