An Ecological (Bat Assessment) Survey of proposed Barn Conversions, Upton Court Farm, Upton Bishop, Herefordshire

Ecological Survey of
Proposed conversion of barns at
Upton Court Farm,
Upton Bishop, Herefordshire

Countryside Consultants Ltd
Ecological Surveys

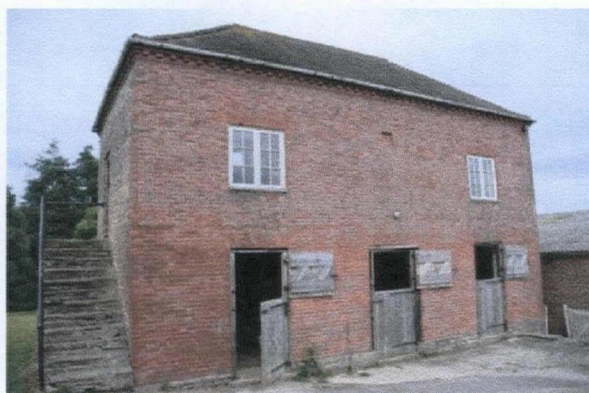
Image 2: south-west elevation of the stable barn — note the number of windows and openings

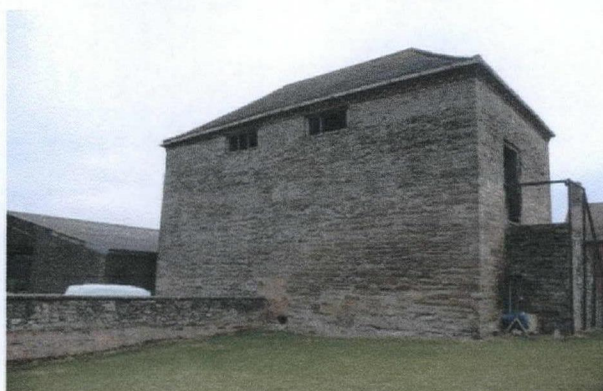
Image 3: north-eastern elevation of the stables showing stone walls

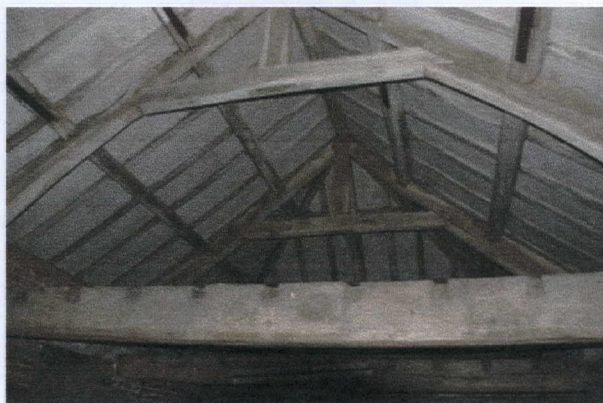
- 3.1.3 Inside, the building is arranged over storeys with large timber floor joists and substantial roof trusses with king posts which were noted to be notched and which probably supported a third floor or mezzanine level. The roof was visibly lined underneath with ceiling boards which were reported as being insulated underneath.

Image 4: inside view of the stables showing hipped roof and trusses with ceiling boards between rafters

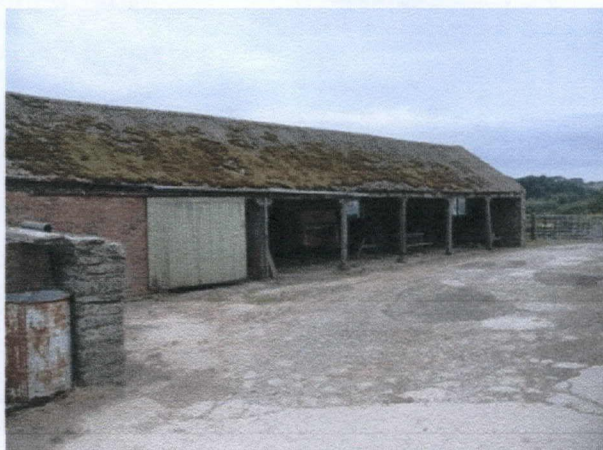
- 3.1.5 The atmosphere within the barn was found to be relatively cool and slightly draughty whilst the building was considered to be in a water-tight and relatively good condition. There was however considered potential for roosting bats beneath the eaves, at the wall plate and within mortise crevices and over timbers.
- 3.1.6 The cart shed is located to the south of the farm complex on the edge of an area of set-aside within an arable field. This single storey building was found to be open to the north-east with timber pillars and the brick / stone walls supporting the roof trusses. The roof was unlined with clay tiles and ridges over.

Image 5: north-east elevation of the cart shed showing open frontage and moderate condition of the roof

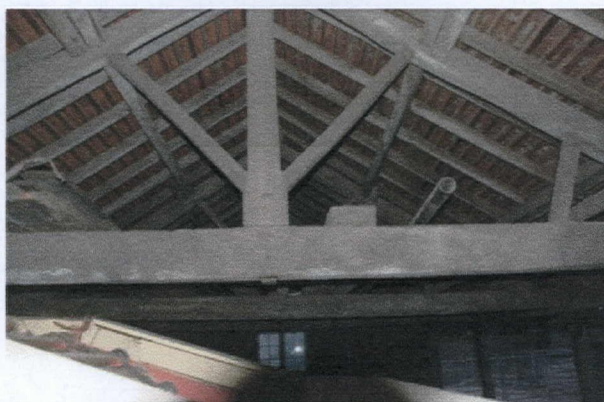
- 3.1.7 The inside of the cart shed was found to be partially divided by internal walls with glazed windows on the south-west, south-east and north-west elevations. The environment inside the cart shed was

found to be notably draughty and cool with some ingress of water through the roof which was in a moderate condition. This building was noted as having some limited roosting potential for bats beneath roof tiles and within stone wall crevices. The ridge line was clear of cobwebs although the draughty conditions are likely to preclude significant summer roosts.

Image 6: inside the cart shed showing roof trusses

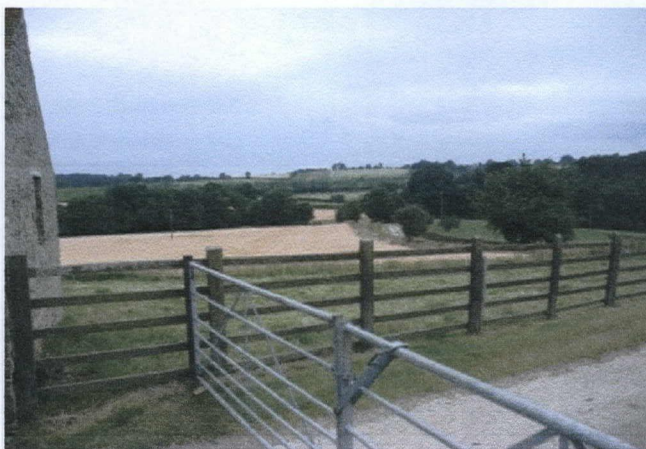
*Image 9: landscape setting with view to the west of the cart shed –
note the absence of a hedgerow close to the building and arable land beyond*
