**Land East of Hereford**

**Archaeology and  
Heritage Assessment**

Prepared by:  
**The Environmental Dimension  
Partnership Ltd**

Report Reference  
**edp6719\_r002c**

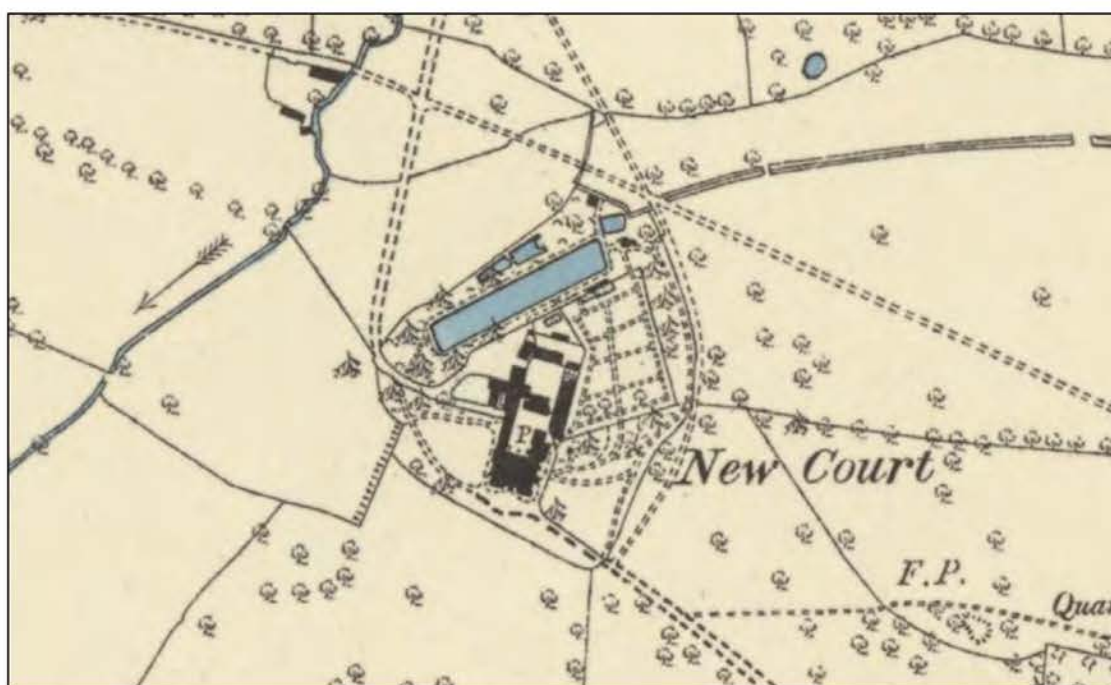
**Image EDP 4.1:** Extract of 1888 1<sup>st</sup> Edition OS Map. New Court and its immediate grounds (NLS 2023). Reproduced with the permission of the National Library of Scotland.

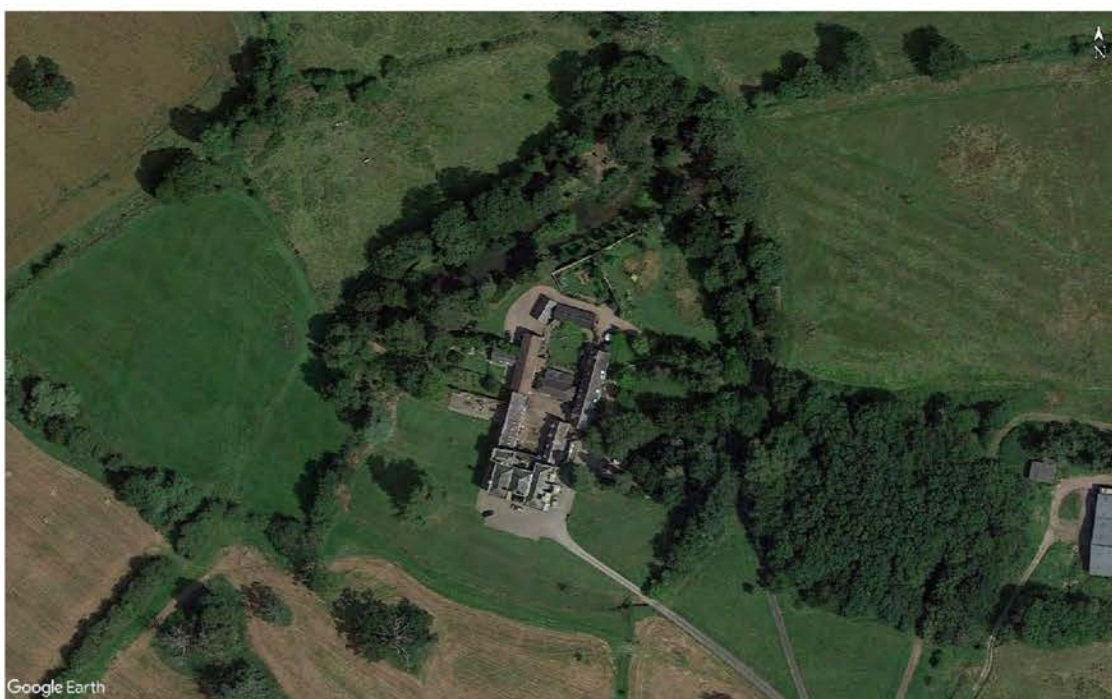
**Image EDP 4.2:** Google Earth 2023 satellite imagery of New Court (Google Earth 2023).

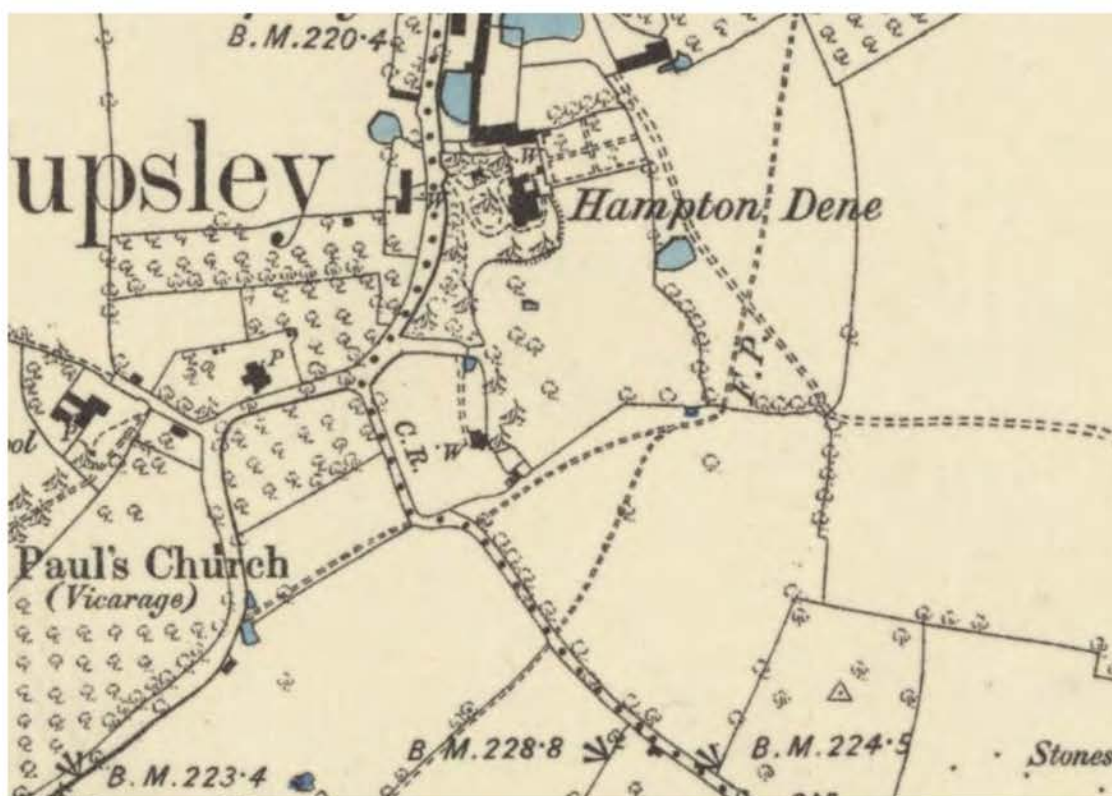
**Image EDP 4.7:** Extract of 1886 1<sup>st</sup> Edition OS Map. Map to show the layout and organisation of Hampton Dene during the late 19<sup>th</sup> century (NLS 2023). Reproduced with the permission of the National Library of Scotland.

4.225 When compared with the later 1886 OS Map, which illustrates the layout of Hampton Dene House's grounds and park in detail (**Image EDP 4.7**), the extent of the gardens are indicated to match that with the HER's record (see **Image EDP 4.6**). As such, plot 243 as shown in

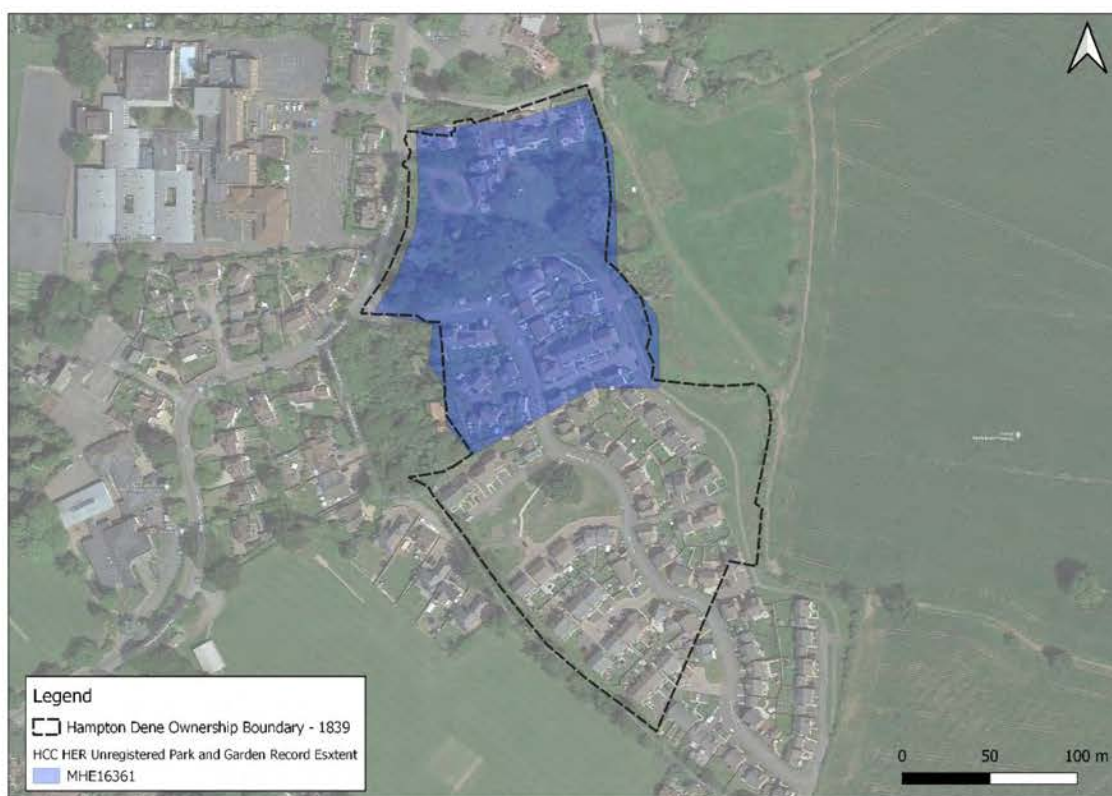
**Image EDP 4.8:** Modern satellite imagery to show present-day conditions of Hampton Dene Landscape Park (**MHE16361**).

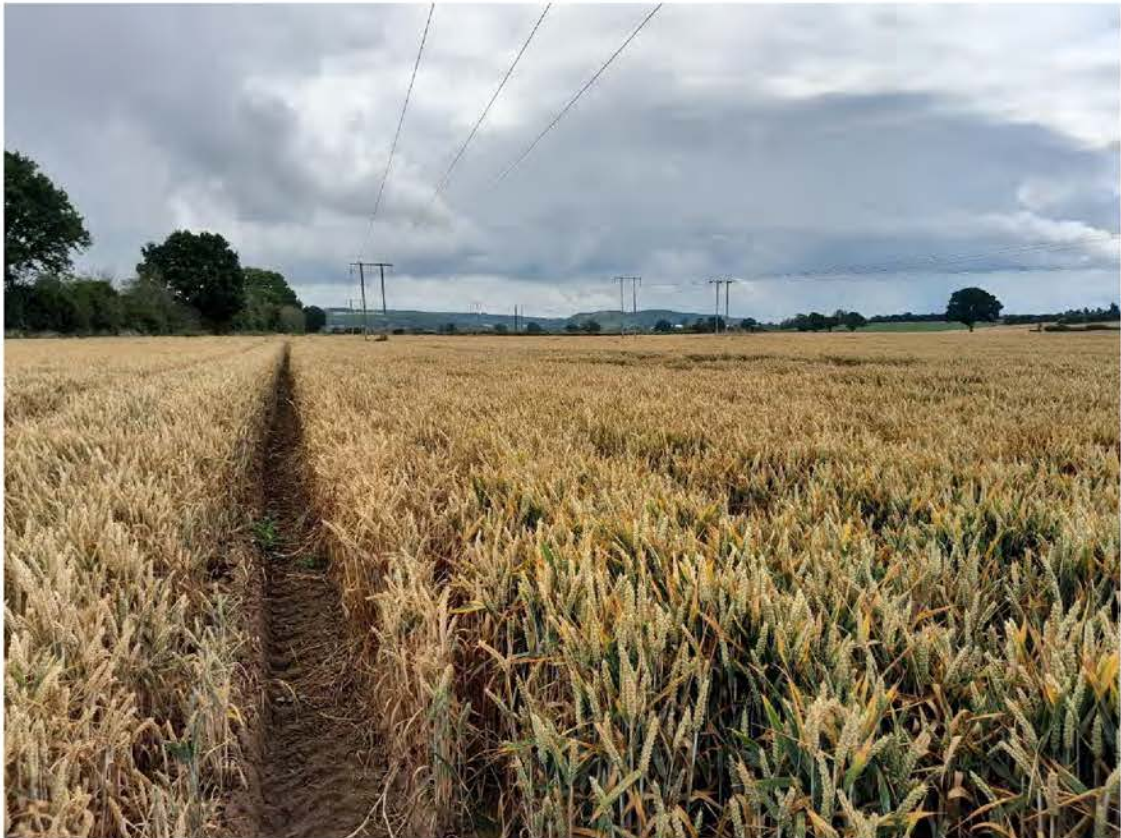
**Image EDP A1.1:** South-east facing view of Scheduled Monument (**1005348**) from the north-west corner of its scheduled area. The scheduled area of the monument is utilised for arable practices. Periodically subject to ploughing, which is reflective of its level field, with no visible earthworks or features of archaeological interest.

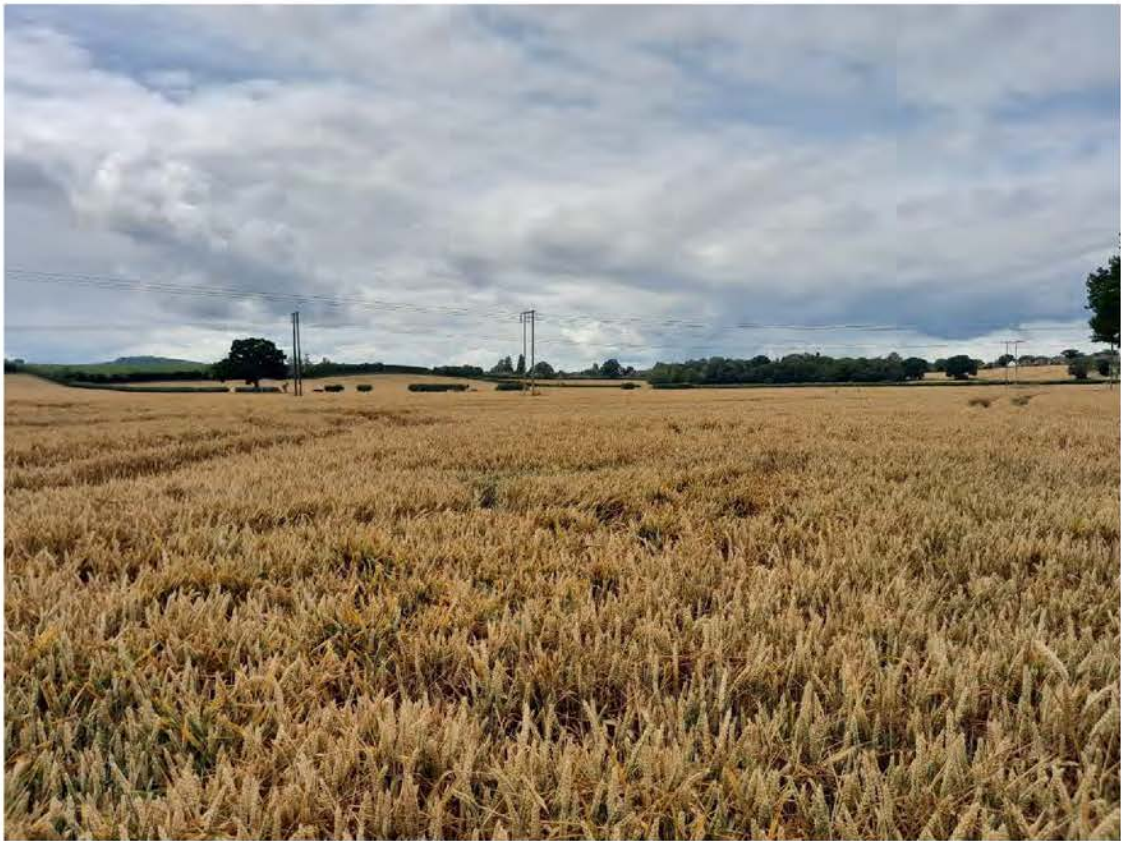
**Image EDP A1.2:** South-west facing view of Scheduled Monument (**1005348**) from the north-east corner of its scheduled area. The scheduled area of the monument is utilised for arable practices. Periodically subject to ploughing, which is reflective of its level field, with no visible earthworks or features of archaeological interest.

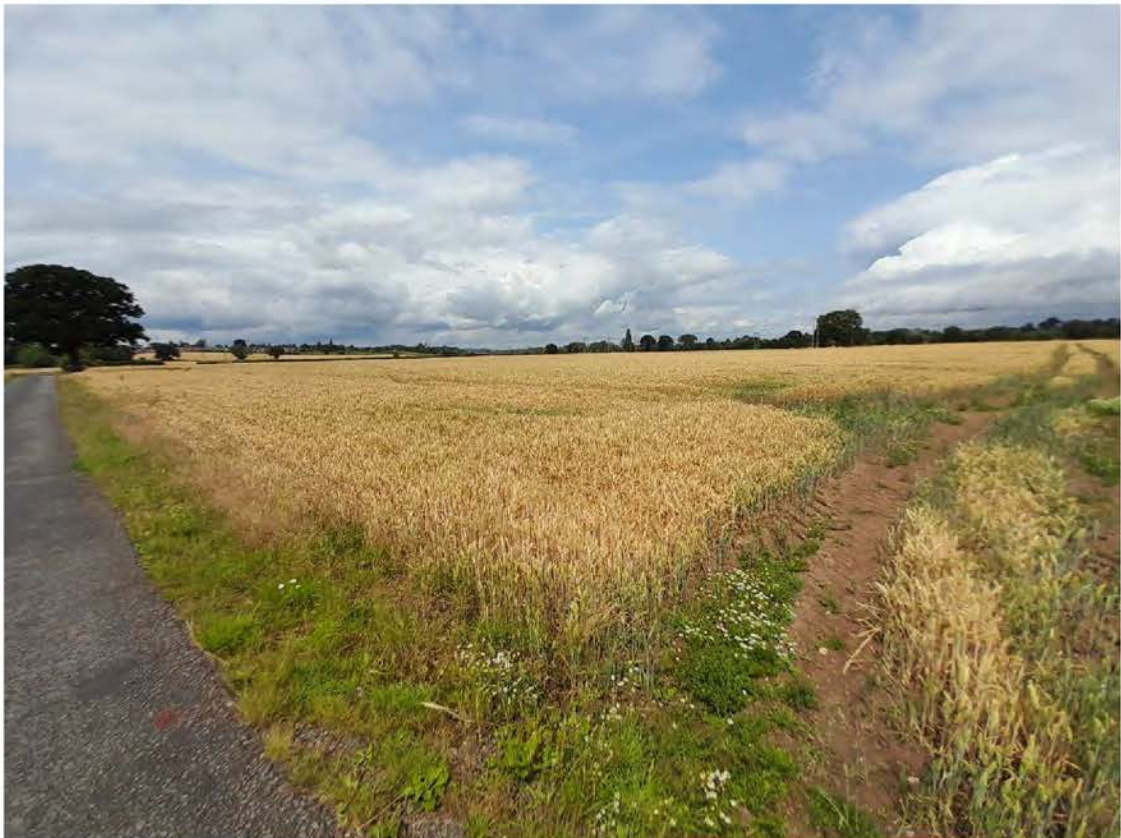
**Image EDP A1.3:** North-west facing view of Scheduled Monument (**1005348**) from the south-east corner of its scheduled area. The scheduled area of the monument is utilised for arable practices. Periodically subject to ploughing, which is reflective of its level field, with no visible earthworks or features of archaeological interest.

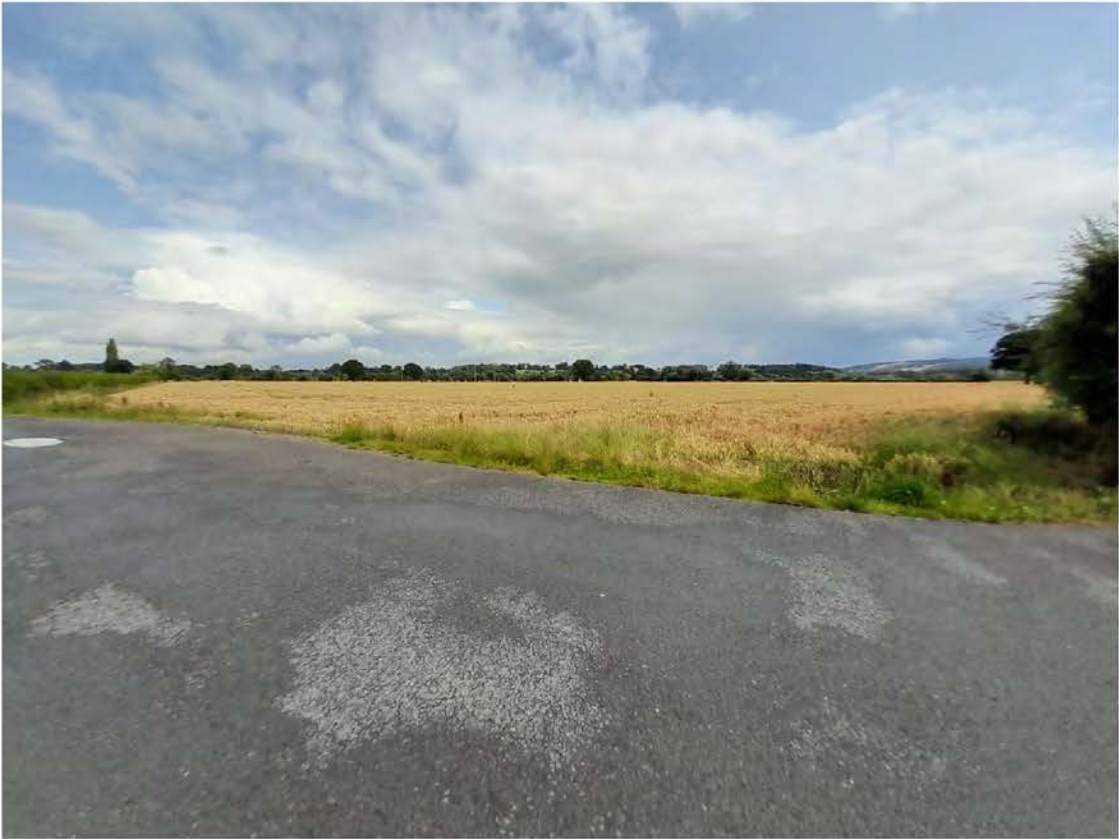
**Image EDP A1.4:** North-east facing view of Scheduled Monument (**1005348**) from the south-west corner of its scheduled area. The scheduled area of the monument is utilised for arable practices. Periodically subject to ploughing, which is reflective of its level field, with no visible earthworks or features of archaeological interest.

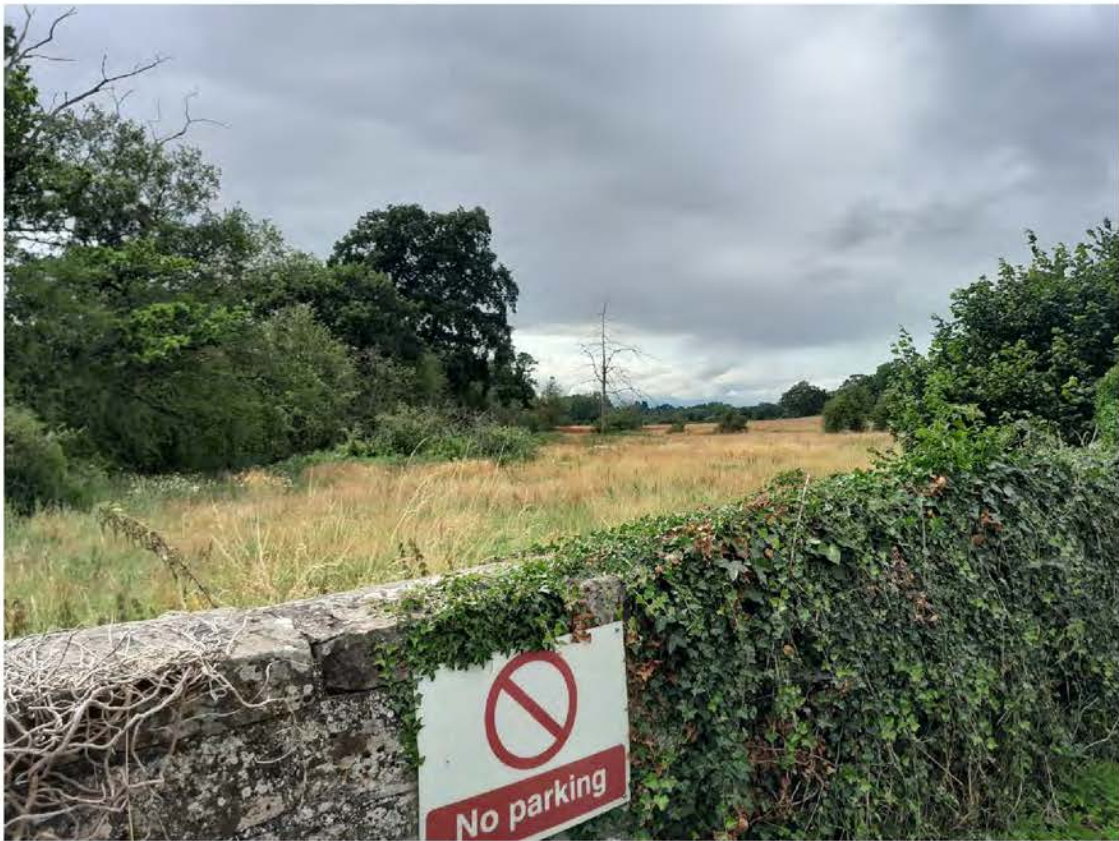
**Image EDP A1.5:** North-west view of floodplain north of River Lugg towards New Court (1099834).

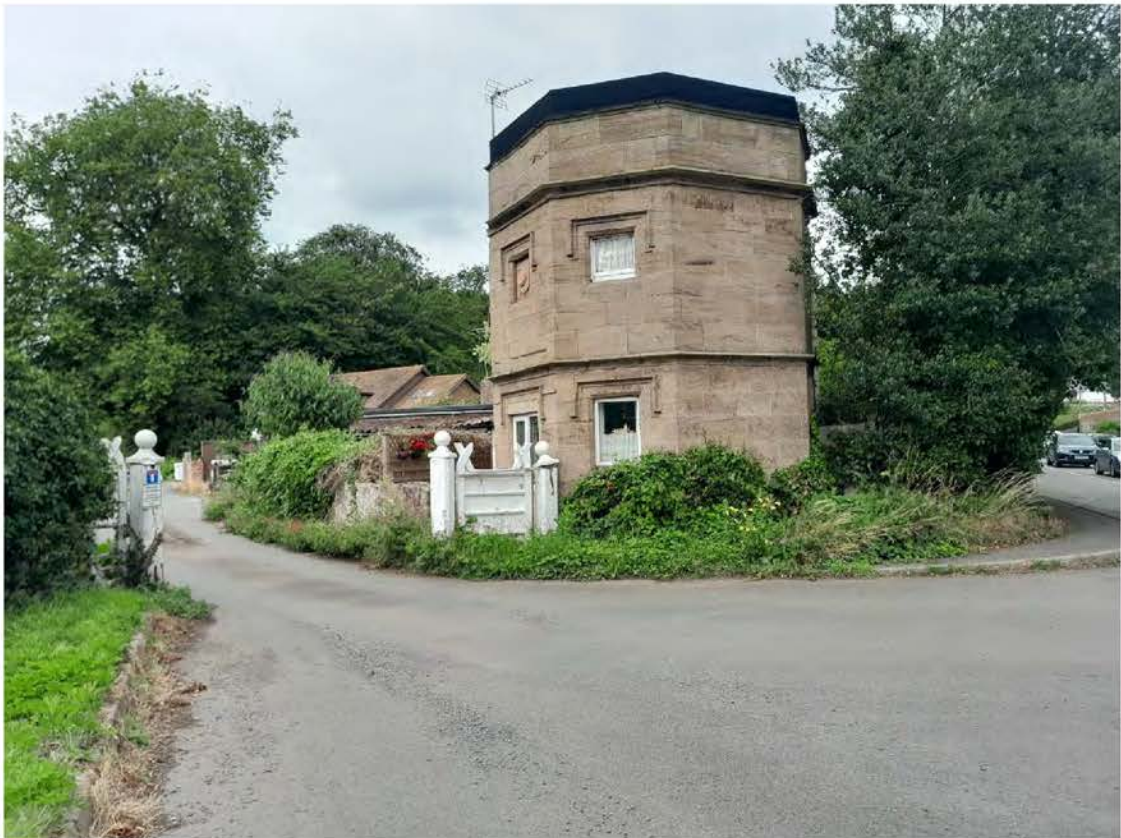
**Image EDP A1.6:** North-east View of Lower Lodge and southern driveway entrance to New Court (1099834), off A438 Ledbury Road at Lugwardine Bridge (1179669).

(Image EDP A1.6), reflects the historic principal approach to the country house through its associated parkland. Views of the heritage asset on approach from the historic southern driveway enable the appreciation of its architectural and historic interest to be experienced. As such, the southern driveway from the Lower Lodge to New Court makes a moderate positive contribution to the significance of the heritage asset.

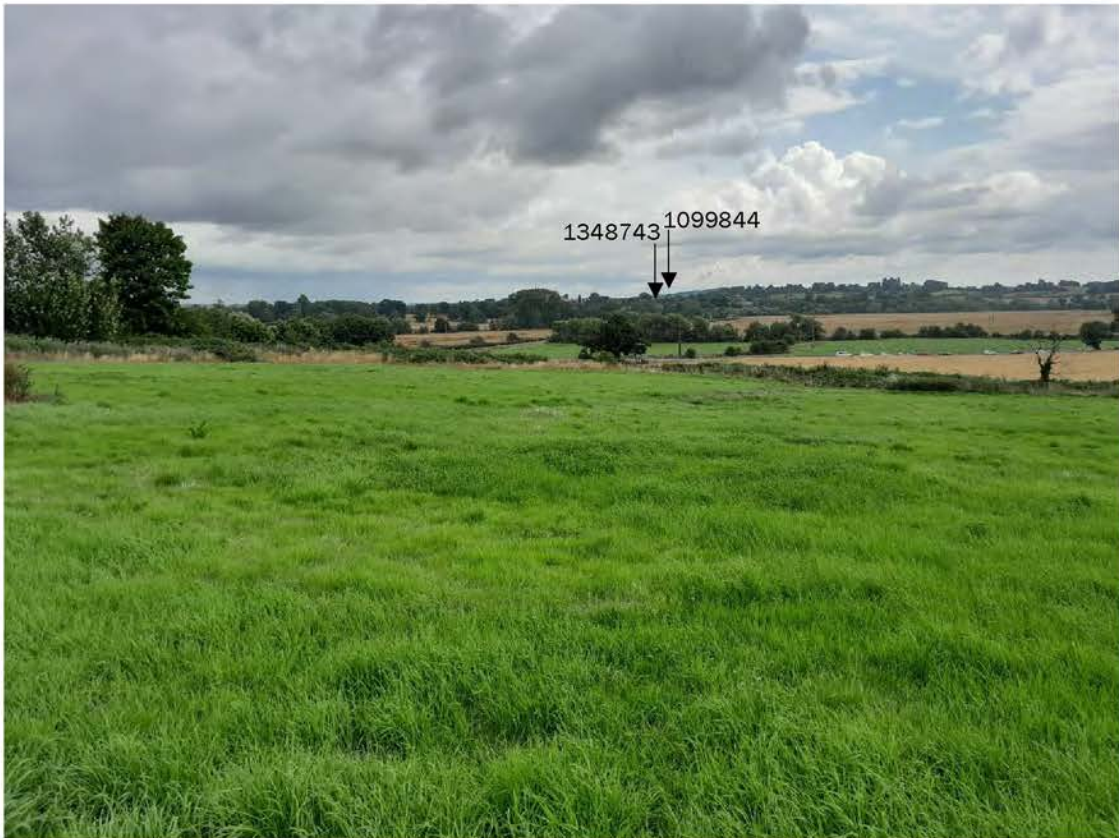
**Image EDP A1.7:** North-east view towards Lugwardine from the north-west corner of the Site. The only designated heritage assets noticeably visible in the distant views are Grade II\* Church of St. Peter (**1099844**) and Grade II Lugwardine Court (**1348743**). New Court (**1099834**) to the left of the two visible heritage assets is screened by intervening vegetation, between Site and heritage asset.

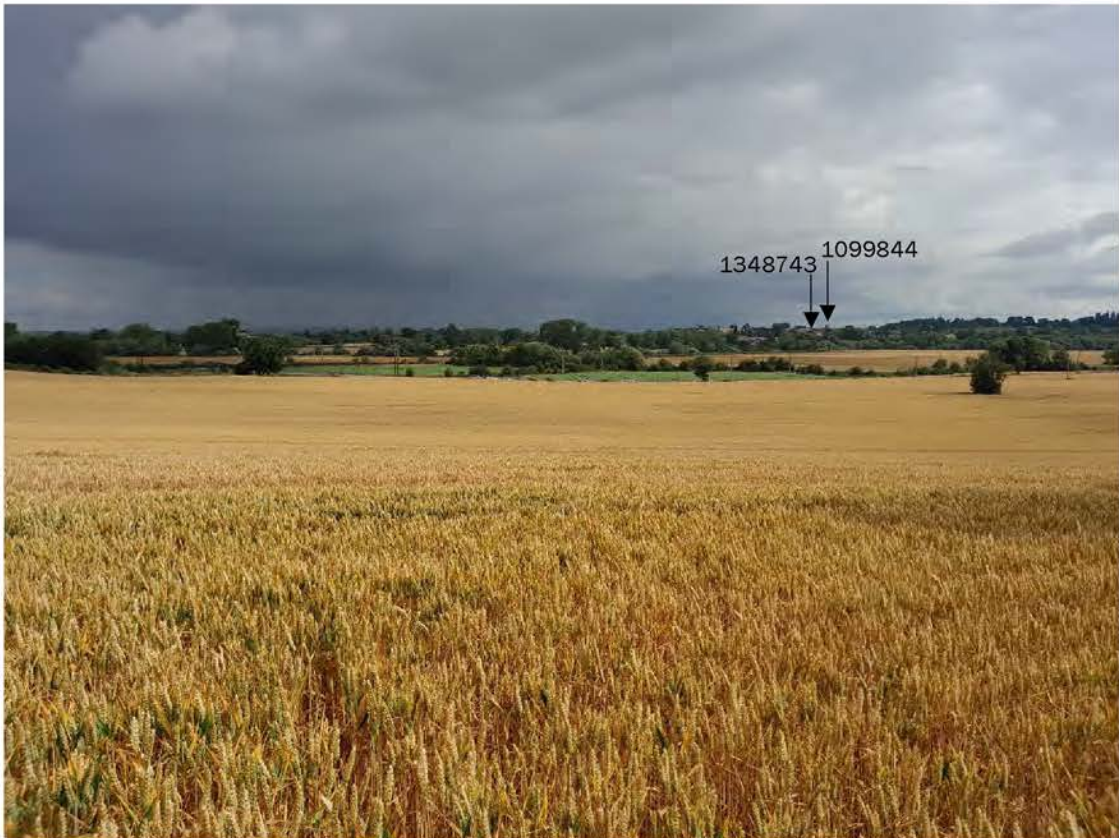
**Image EDP A1.8:** North-east view towards Lugwardine from the centre-west of the Site. The only designated heritage assets noticeably visible in distant views are Grade II\* Church of St. Peter (**1099844**) and Grade II Lugwardine Court (**1348743**). New Court (**1099834**) to the left of the two visible heritage assets is screened by intervening vegetation, between Site and heritage asset.

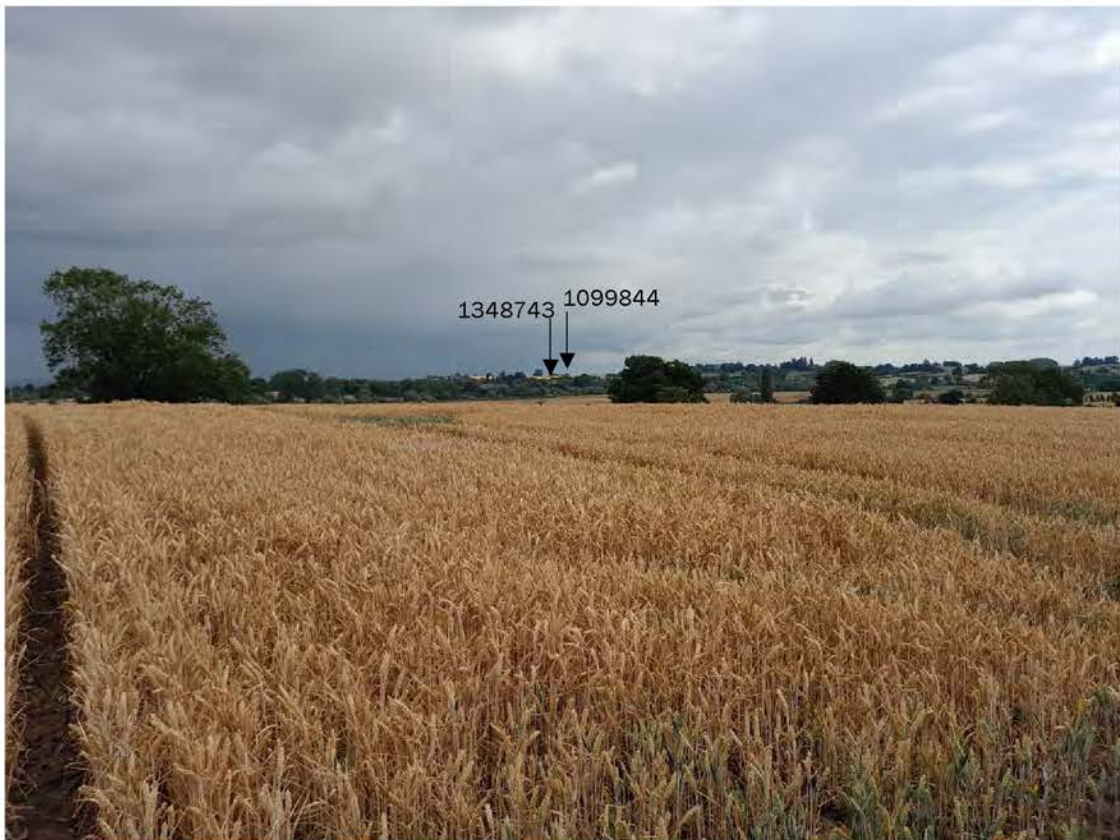
**Image EDP A1.9:** North-east view towards Lugwardine from the south-west corner of the Site. The only designated heritage assets noticeably visible in distant views are Grade II\* Church of St. Peter (**1099844**) and Grade II Lugwardine Court (**1348743**). New Court (**1099834**) to the left of the two visible heritage assets is screened by intervening vegetation, between Site and heritage asset.

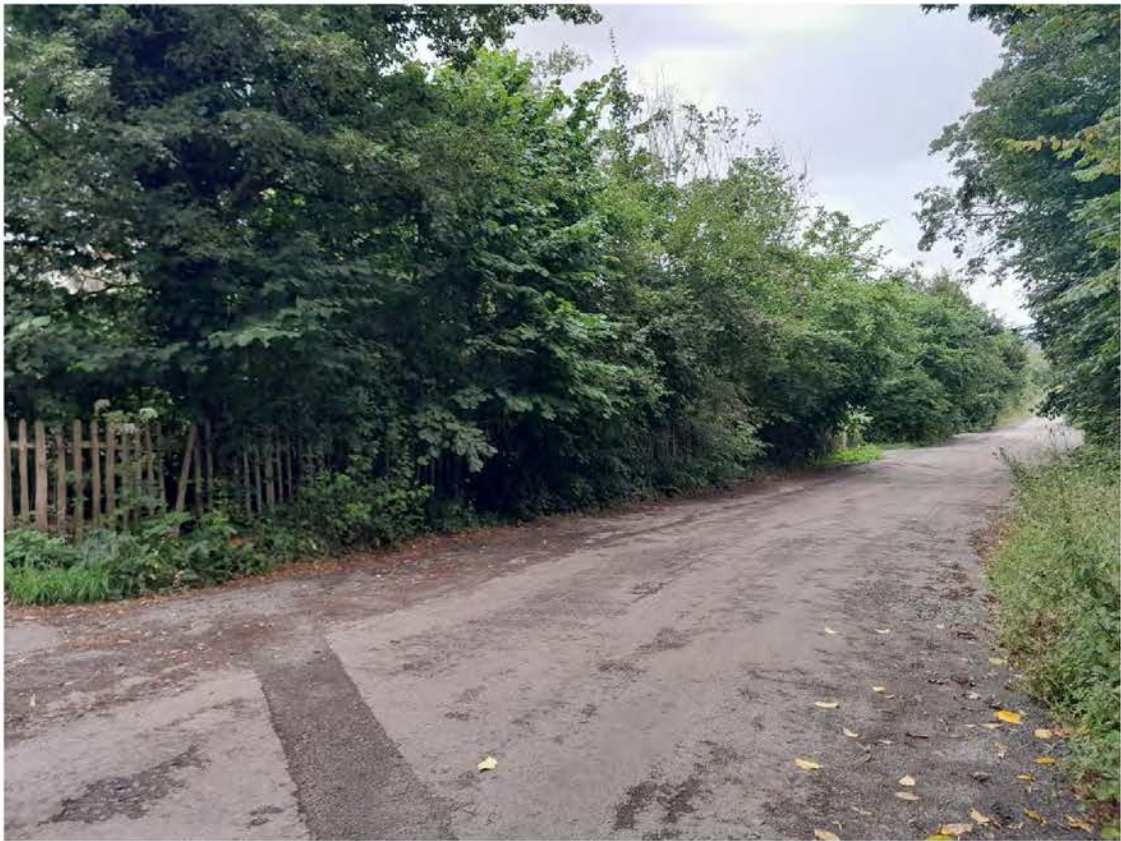
**Image EDP A1.14:** North-east view of former alignment of the A438 Ledbury Road to the south of Lower House Farmhouse (**1250963**). Vegetation screening planted along the perimeter of the garden to the Listed Building.

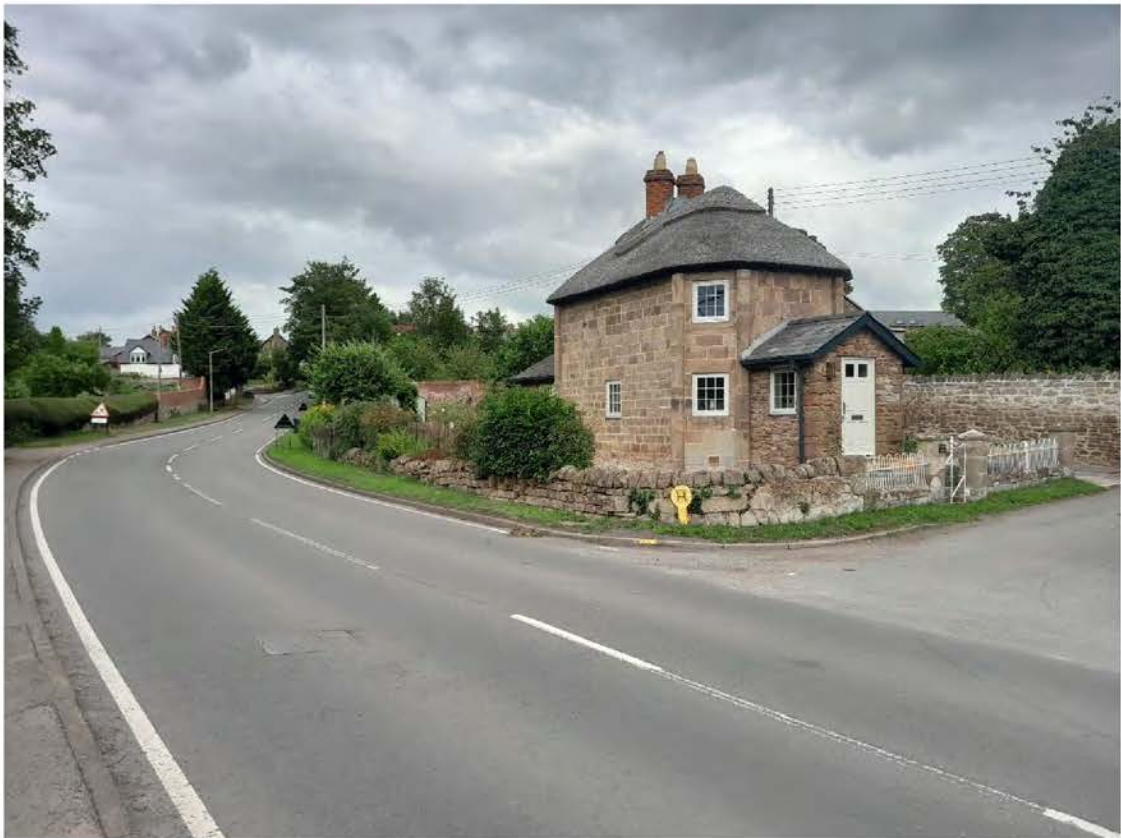
**Image EDP A1.19:** North facing view of Lower Lodge (**1099846**) to Lugwardine Court (**1348743**).

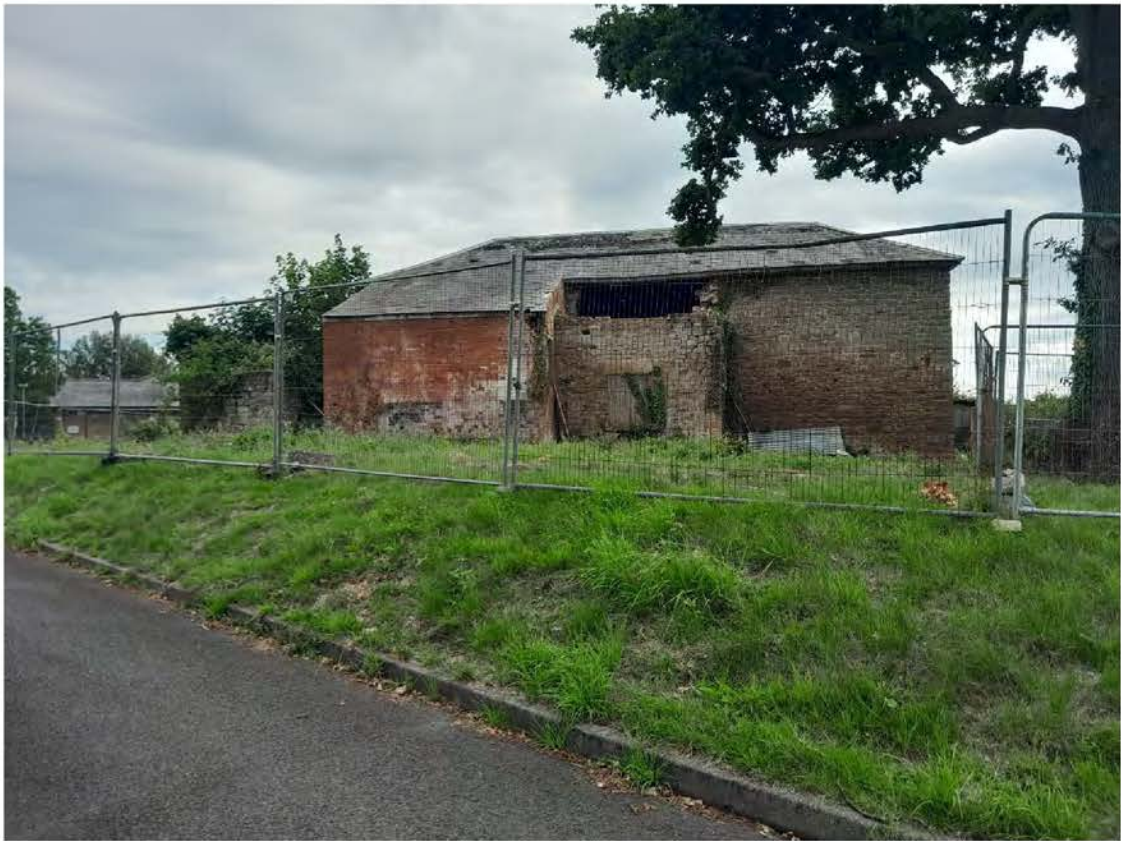
**Image EDP A1.23:** South view of the derelict barn to the rear (north) side of Lugwardine Court (1348743).

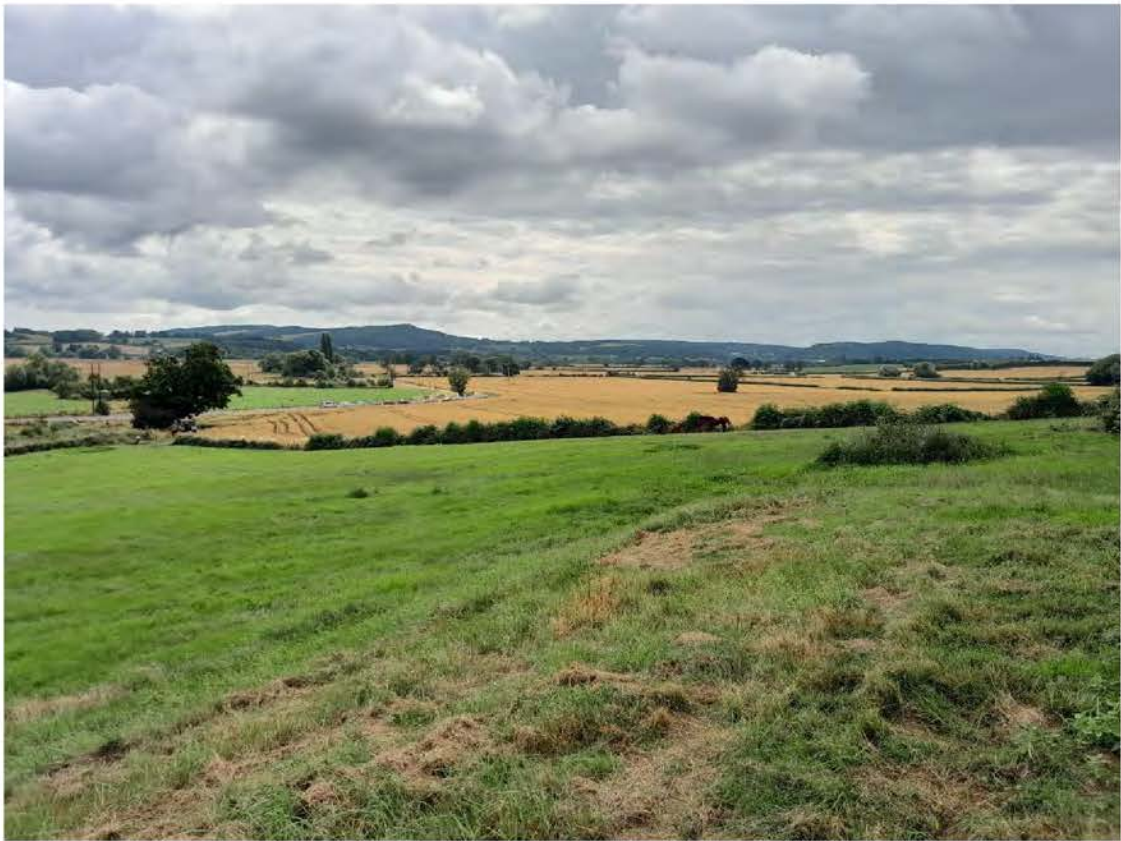
**Image EDP A1.24:** South-east view from the north-west corner of the Site on the ridgeline to the River Lugg floodplain. Hampton Bishop is screened in the distance (centre).

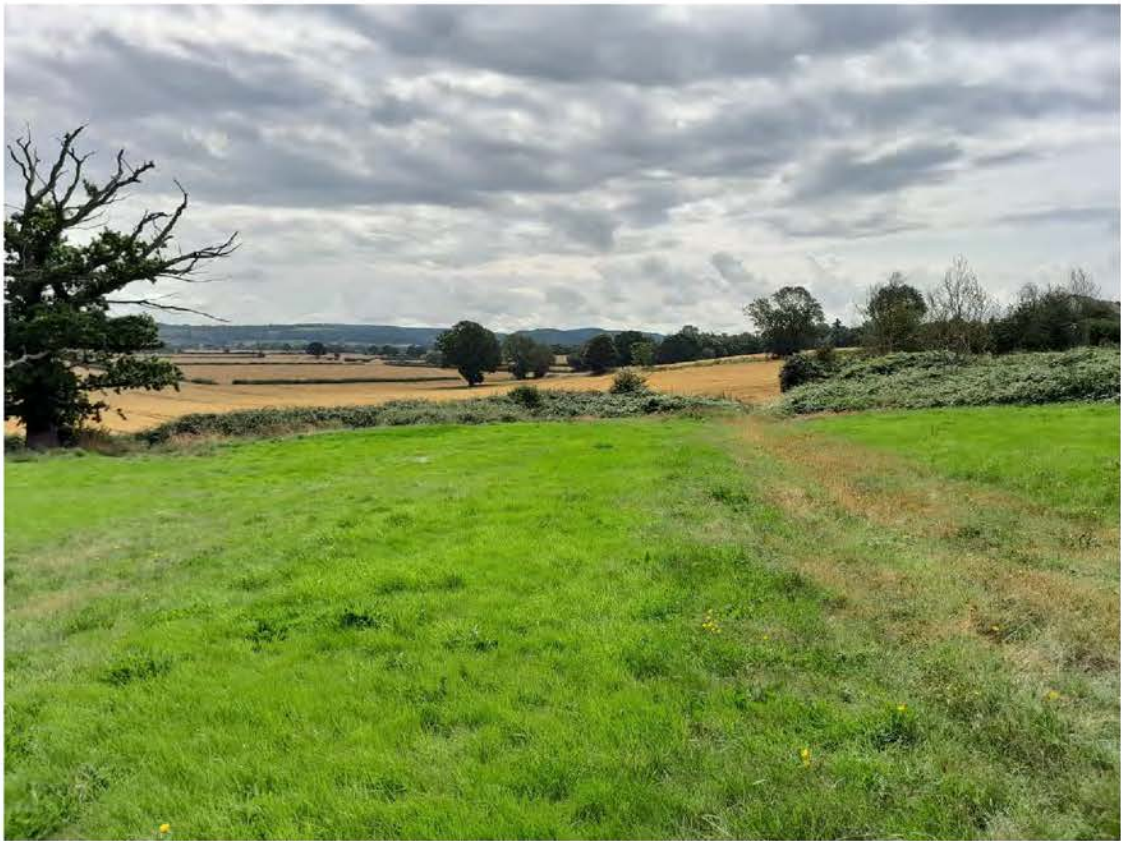
**Image EDP A1.25:** South-east view from centre-west of Site on ridgeline to floodplain. Hampton Bishop is screened in the distance (centre-left).

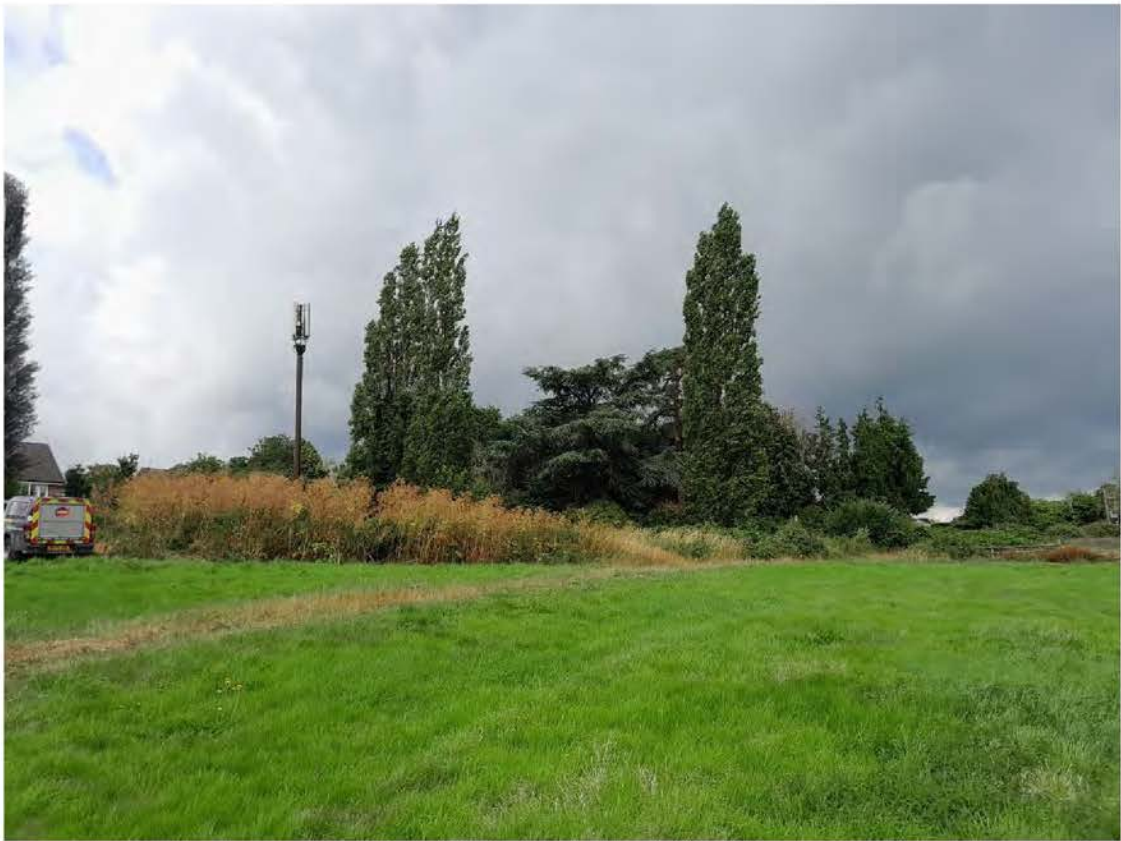
**Image EDP A1.27:** North-west view of the eastern wooded boundary to Hampton Dene landscape park (MHE16361). Image illustrates the absence of any intervisibility with the landscape park beyond its plantation along the eastern boundary of the landscape park.

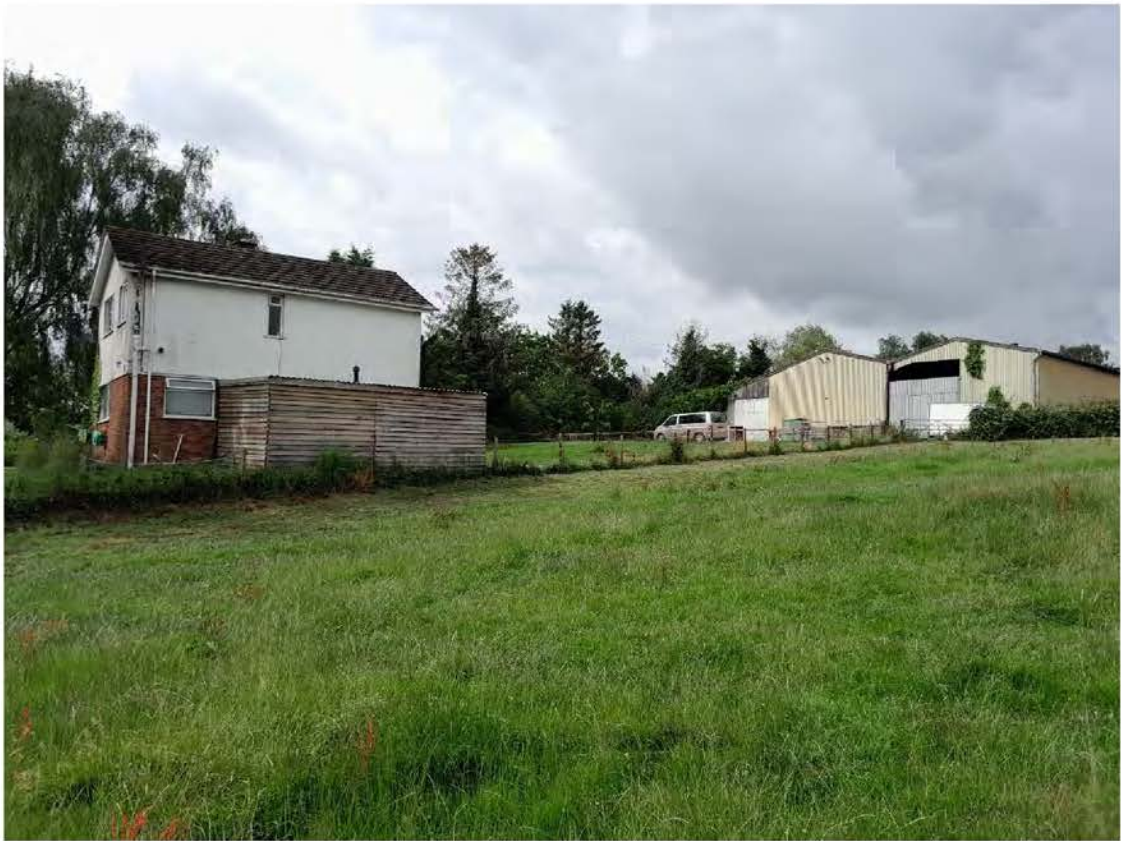
**Image EDP A1.28:** South-west view from the within the north-west corner of the Site. View of the modern 1960s onwards buildings built within the grounds of the former 17<sup>th</sup> century Tupsley Court (MHE4015). The modern 'Tupsley Court Cottage' is shown on the left comprised of red brick, white render and a slate gabled roof. Modern steel corrugated steel sheds/barns are shown on the right.

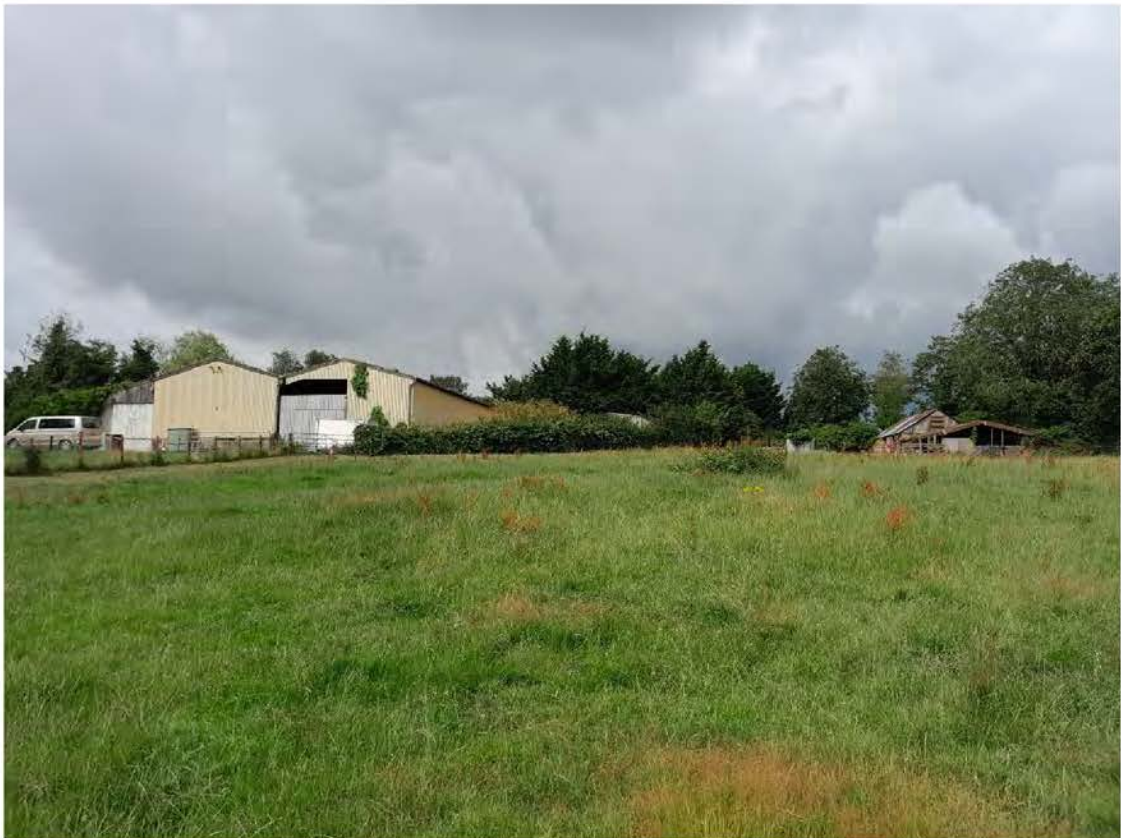
**Image EDP A1.29:** West facing view of modern buildings located within the grounds of the former 17<sup>th</sup> century Tupsley Court (**MHE4015**). Modern steel corrugated sheet sheds/barn on the left and the right.

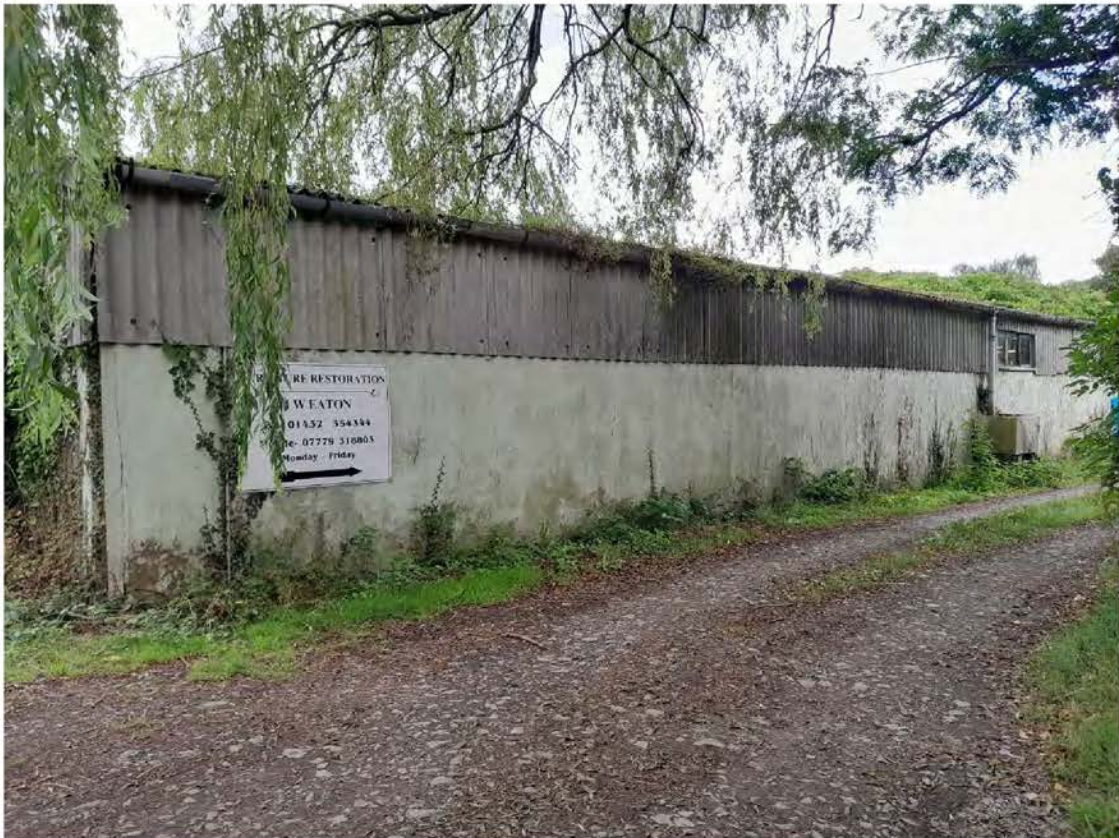
**Image EDP A1.30:** North-east facing view of the south side of the modern sheds/barns within the grounds of the former 17<sup>th</sup> century Tupsley Court (**MHE4015**), comprised of steel corrugated sheet material and concrete walls. Sheds signed as being in use as a furniture restoration business.

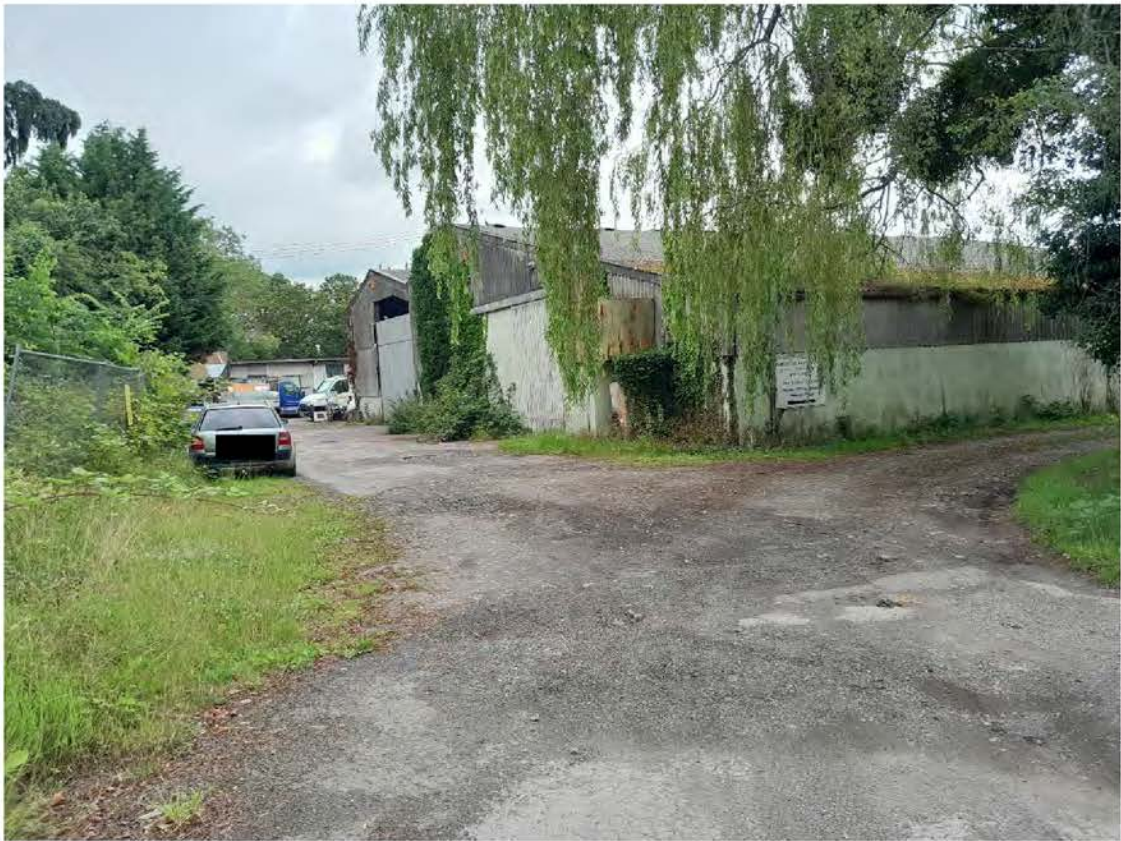
**Image EDP A1.31:** North-east view from the driveway to the present-day Tupsley Court. Sheds used for furniture restoration business withing grounds of former 17<sup>th</sup> century Tupsley Court (**MHE4015**).

- Modern 20<sup>th</sup> century water management area (**MHE21885**).
- 5.32 The former layout of 17<sup>th</sup> century Tupsley Court has been completely demolished during a land clearance and rebuilding event during the 1960s, as discussed above. No above ground remains have been identified on site. The majority of Tupsley Court's buildings are shown on historic maps to be located beyond the Site boundary (**Plan EDP 5-6**). Those that stood within the Site have the potential for associated buried remains to be present. Such remains would likely comprise of building foundations, if present, would be of low value and not merit preservation *in situ*.
