**Land East of Hereford**

**Archaeology and  
Heritage Assessment**

Prepared by:  
**The Environmental Dimension  
Partnership Ltd**

Report Reference  
**edp6719\_r002c**

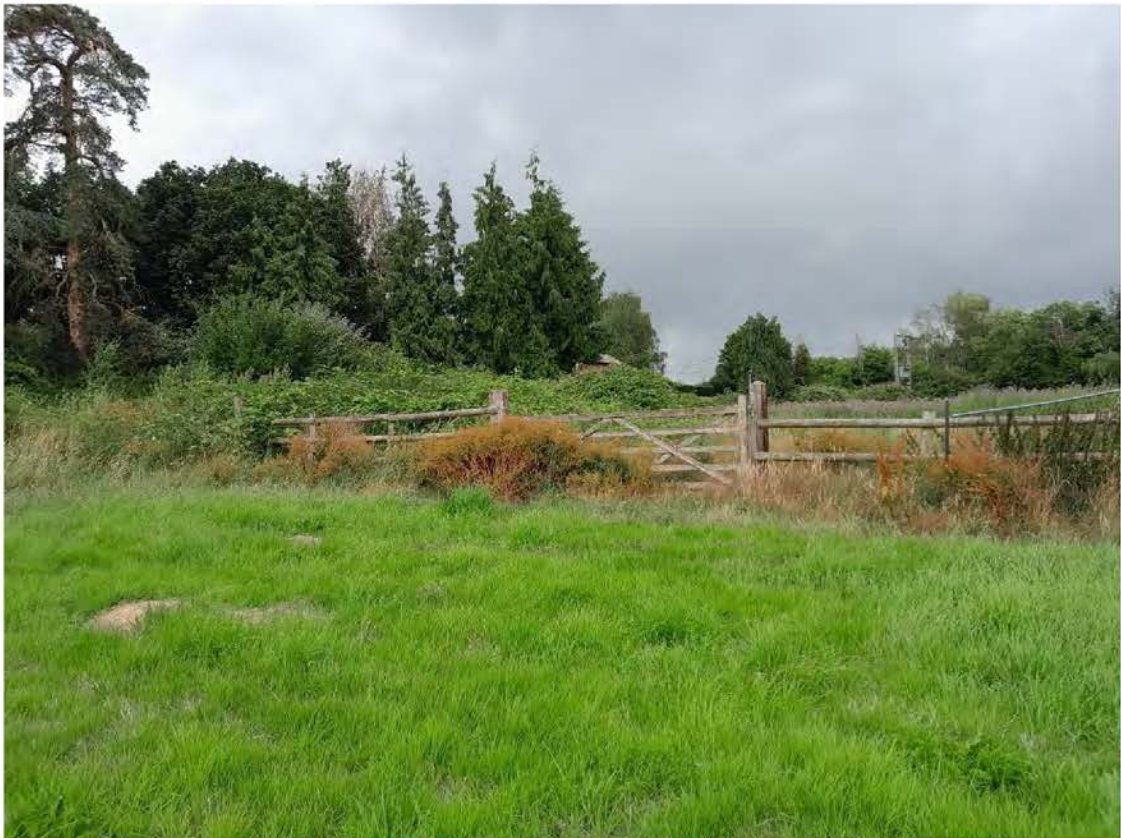
**Image EDP A1.32:** North-west view of the identified modern 2010s fenced enclosure/livestock pen within the west end of the Site, in proximity to Hampton Dene.

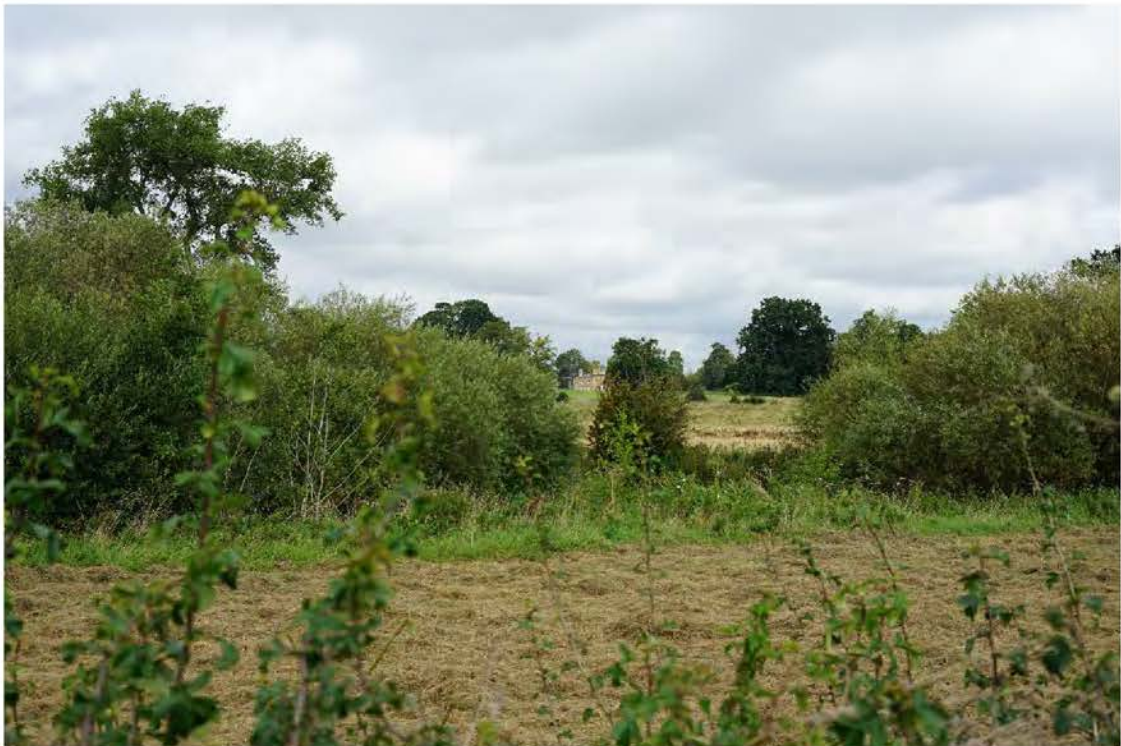
**Image EDP A1.33:** North view of New Court (1099834) from the south side of the River Lugg within Lugg Meadow. The country house is partially visible between existing tree lines/scattered parkland trees.
