**E15241 – Letter report regarding the soakaway investigation at Land adjacent to B4360,  
Cobnash, Leominster HR6 9RA.**

Scope of Works

### Soakaway Test Results

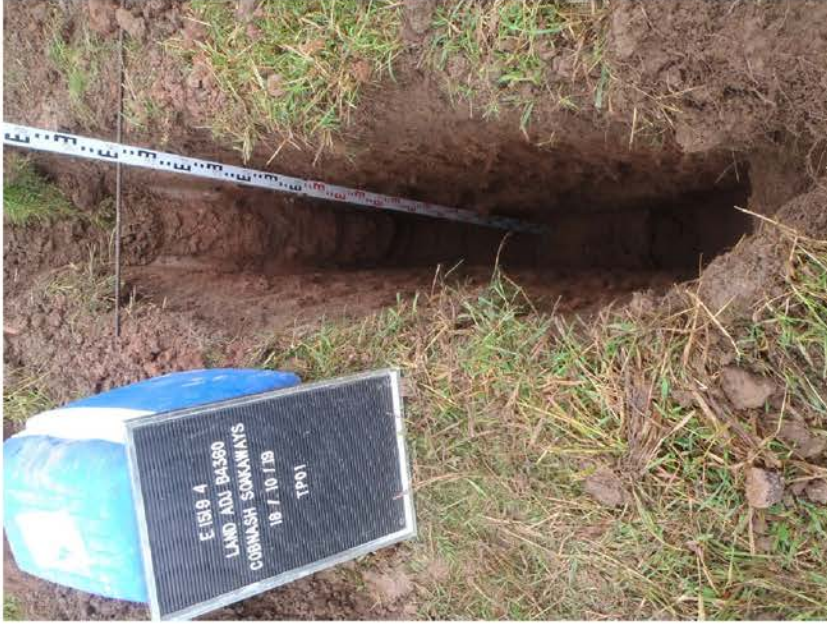
Groundwater was encountered at TP01 at 2.55 m.

(0.35) 2.55	Soft light brown gravelly very sandy CLAY. Gravel is subangular to subrounded fine to coarse sandstone and miceous mudstone. (ALLUVIUM)		
			86.20

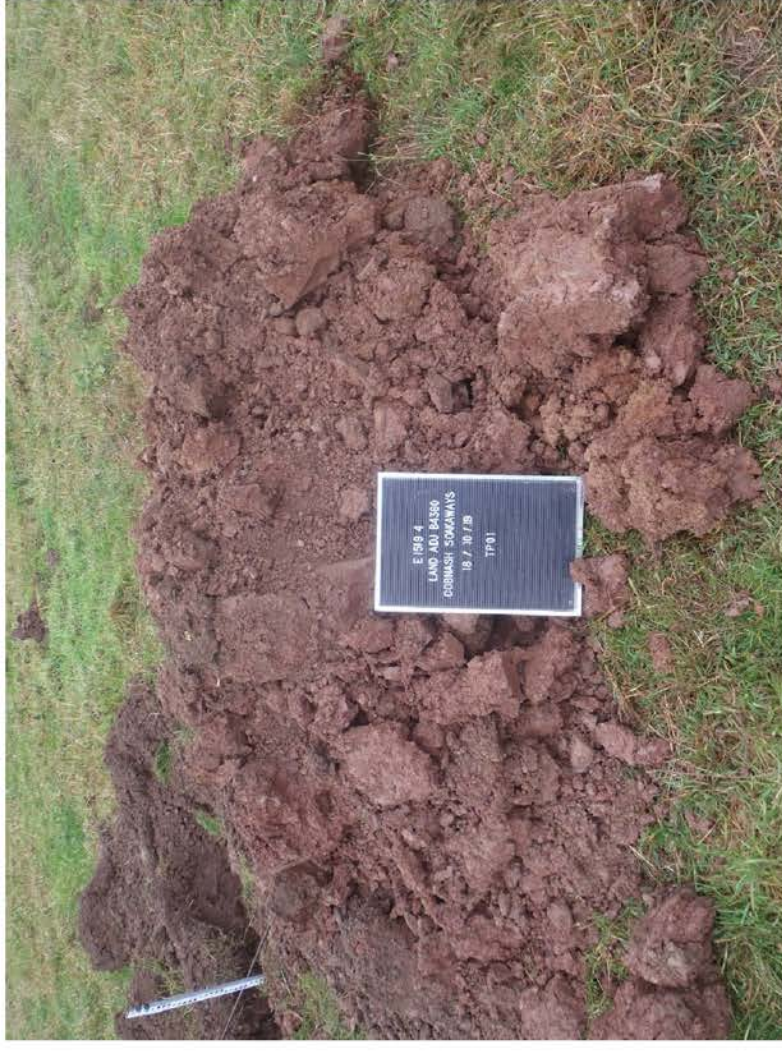
TP01 Arisings

(1.90) 2.20	MADE GROUND. Remoulded soft reddish brown very gravelly clay. Gravel is subangular to subrounded, fine to coarse sandstone and ceramic fragment. Frequent cobbles.

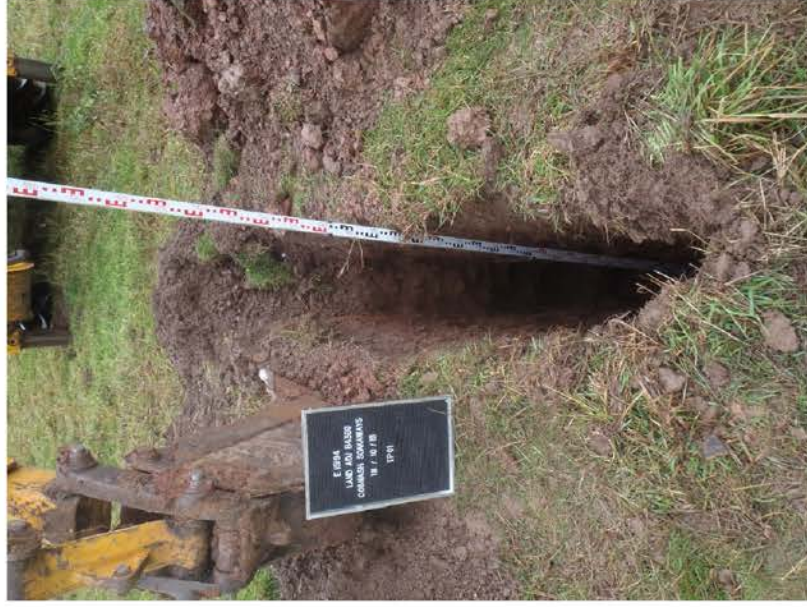
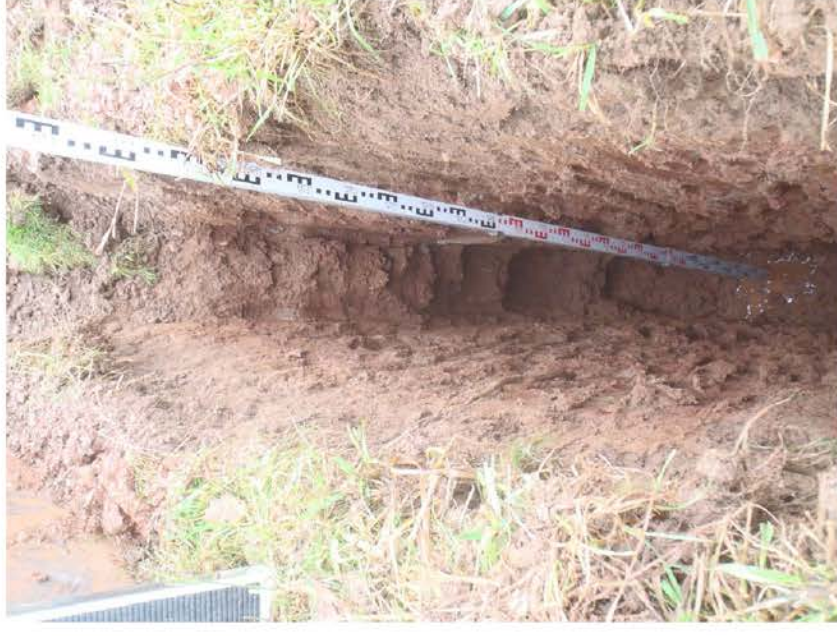
TP01 Extended

(0.25) 2.80	Light brown clayey GRAVEL of angular to subrounded, fine to coarse sandstone and mudstone. (ALLUVIUM)

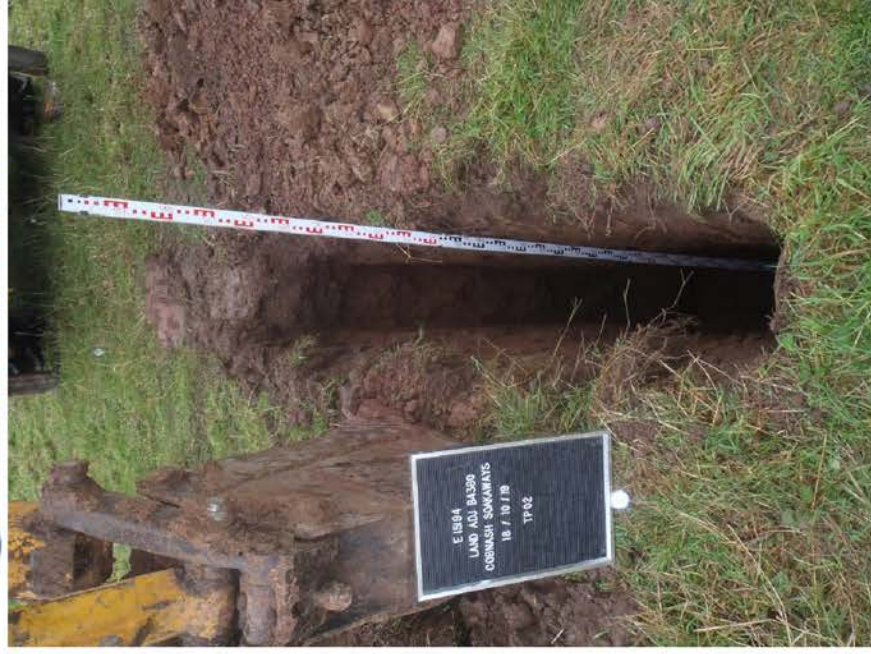
Firm friable gravelly CLAY representing the Raglan Mudstone Formation is present at TP02 between 2.60 m and the extent of the trial pit at 3.00 m.

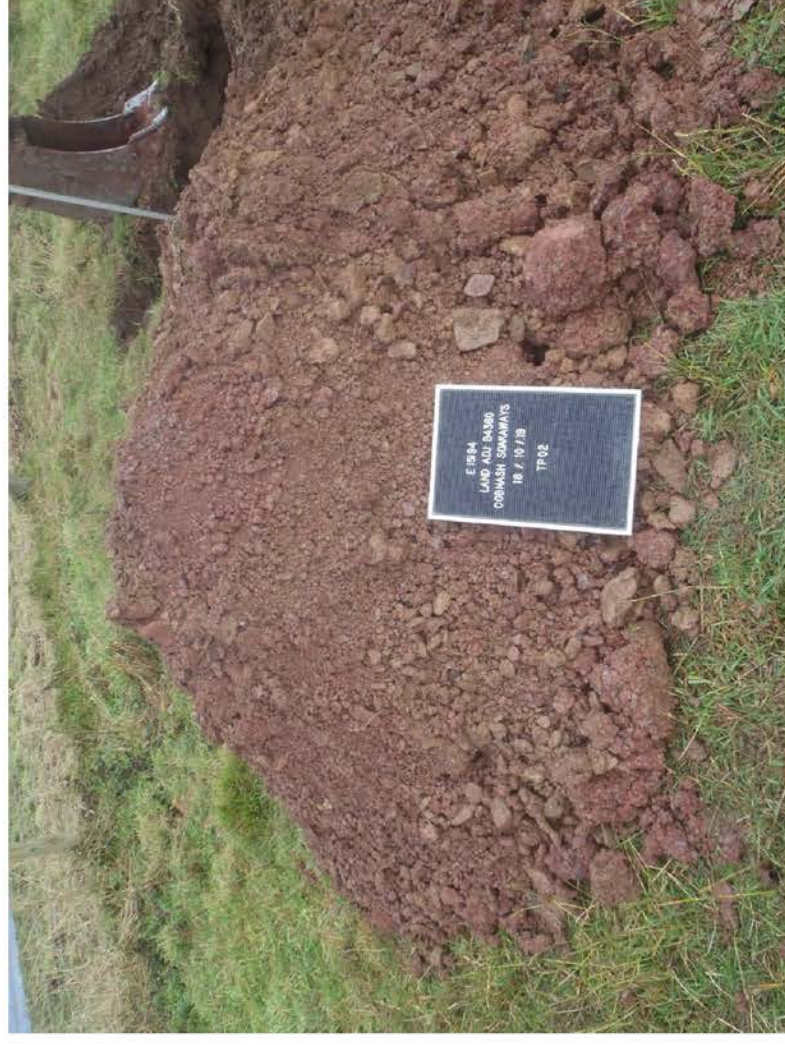
TP02 Arisings

(0.40) 3.00	Firm red very sandy gravelly friable CLAY. Gravel is angular to subrounded, fine to coarse mudstone with occasional cobbles. Grey / green discolouration. (RAGLAN MUDSTONE FORMATION)

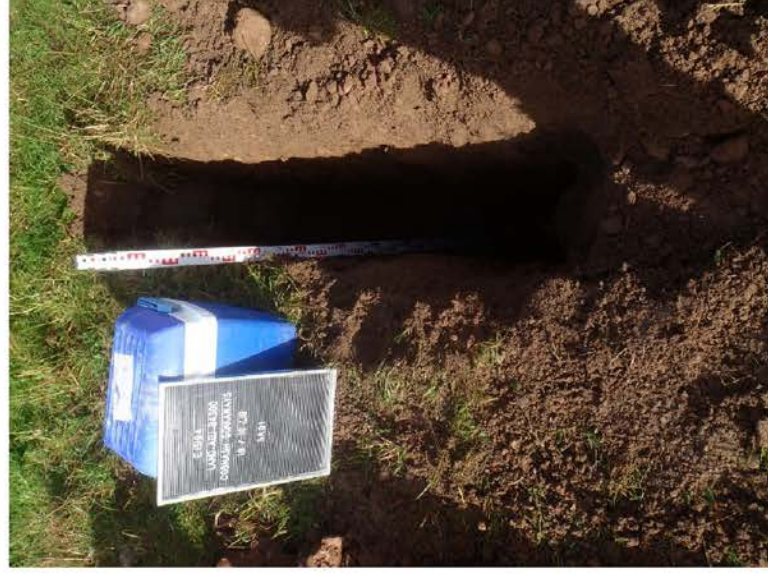
The soft sandy very gravelly CLAY (alluvium) at SA02 has a reasonably high infiltration rate at 1.30 m depth of 2.03 x 10<sup>-5</sup> m/s. The strata tested at SA01 at 1.55 m gives a far lower extrapolated infiltration rate of approximately 2.76 x 10<sup>-6</sup> m/s. This strata although similar to that at SA02 is identified as Made Ground due to some ceramic fragments being found within the matrix. This 'remoulded' CLAY seems to have different permeability properties compared to the natural CLAY. This is also illustrated by the water table being found at 2.55 m (rising to 2.48 m after 5 hours 33 minutes) at TP01 although it was not encountered at TP02 to the extent of the trial pit at 3.0 m. BRE365 guidance recommends that soakaways should not be built within 1.0 m of the water table.

The low permeability and close vicinity to the water table at SA01 means that we do not recommend a soakaway solution in that area. SA01 in comparison is deemed suitable for soakaway solutions.

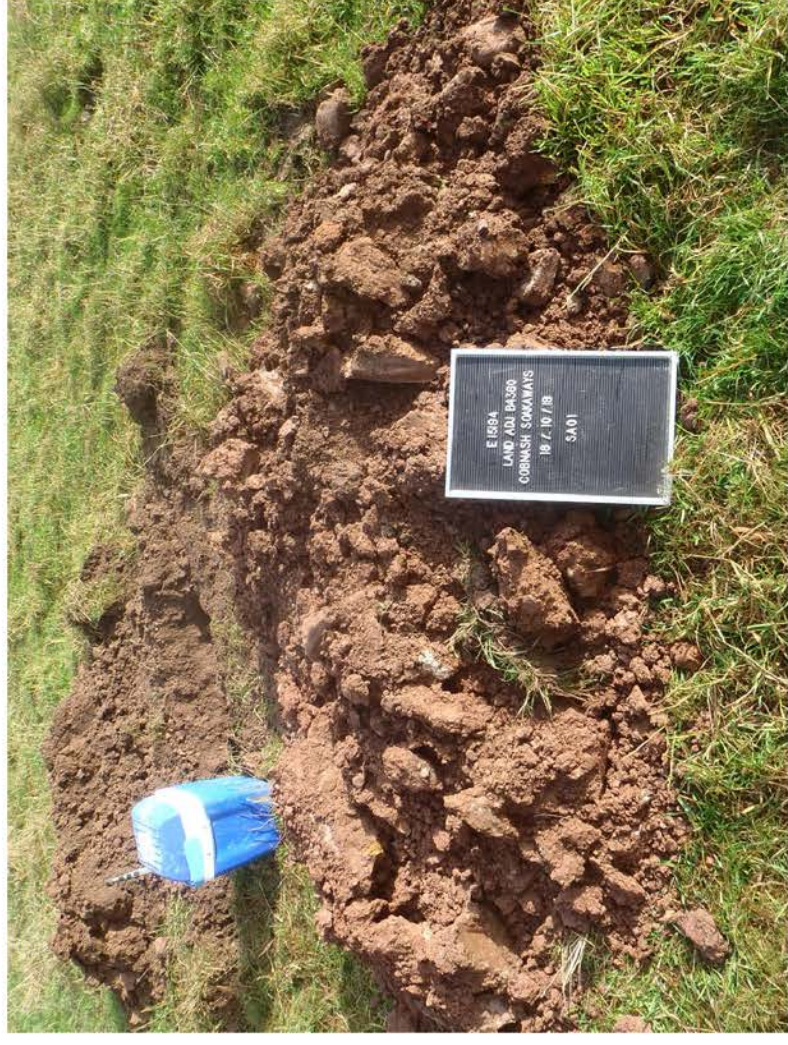
SA01 Arisings

SAMPLES & TESTS		STRATA					Geology	Instrument/ Backfill
Depth	Sample No.	Water	Reduced Level	Legend	Depth (Thick- ness)	DESCRIPTION		
			88.70		(0.30) 0.30	MADE GROUND. Grassed remoulded topsoil of brown slightly gravelly very silty clay. Gravel is subangular coarse mudstone with some plastic waste. Frequent rootlets.		
					(1.25)	MADE GROUND. Remoulded soft to firm reddish brown very gravelly clay. Gravel is subangular to subrounded, fine to coarse sandstone. Frequent cobbles.		
			87.45		1.55

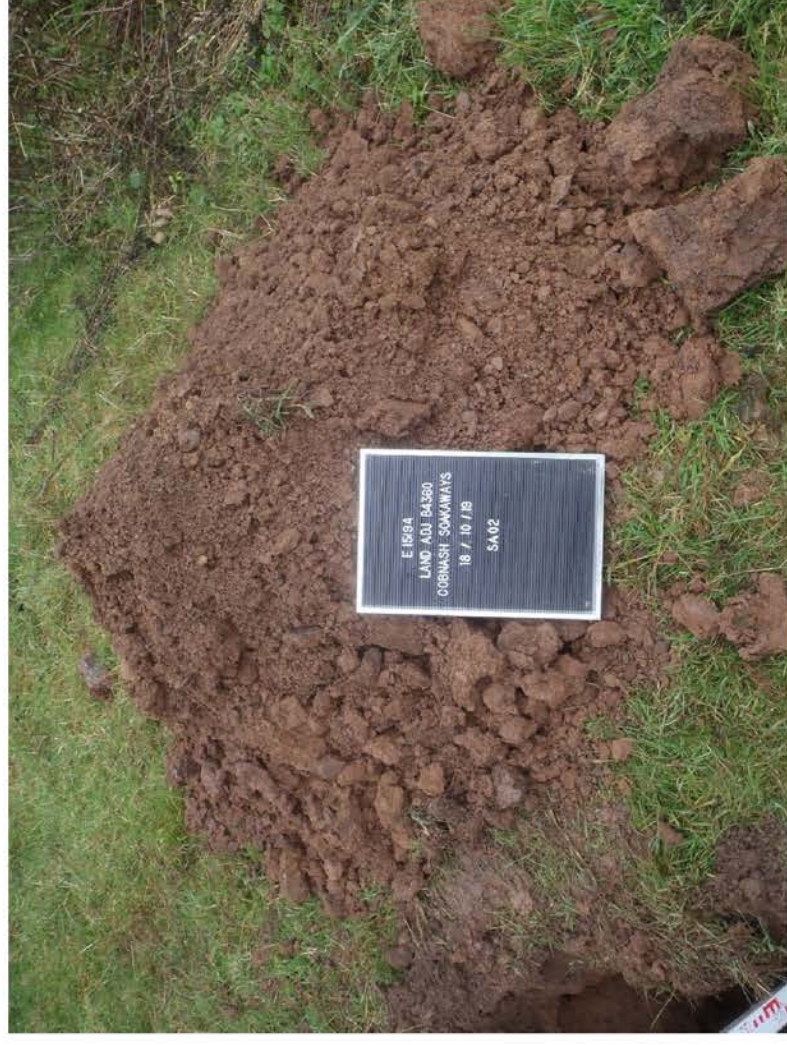
SA02 Arisings

(1.00) 1.30	Soft reddish brown slightly sandy gravelly CLAY. Gravel is subangular to rounded, fine to coarse sandstone and mudstone. Frequent cobbles from 1.2 m.  (ALLUVIUM)

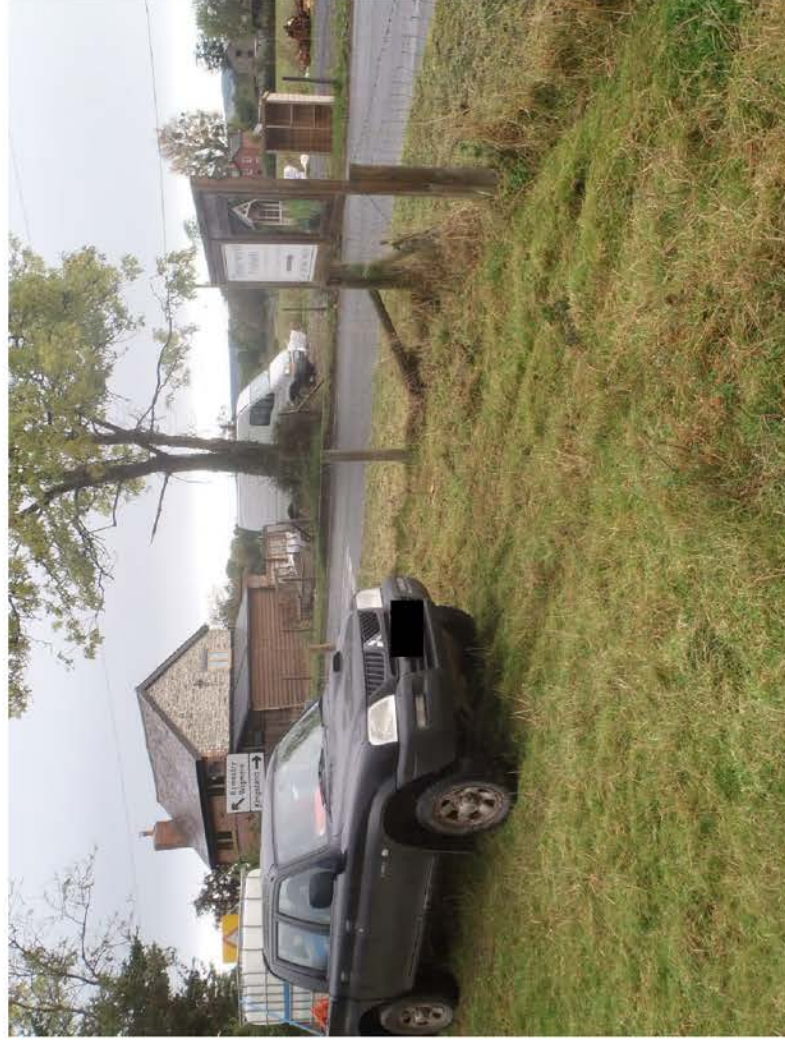
Northern Boundary

The main site comprises a grassed field currently used for grazing. The site is approximately 0.49 ha in size and rectangular in shape. The field slopes from south west to the north east. Ground water is expected to drain towards the road to the north and from anecdotal data the field to the north of the road is susceptible to flooding and it has a noticeably lower elevation than the site.

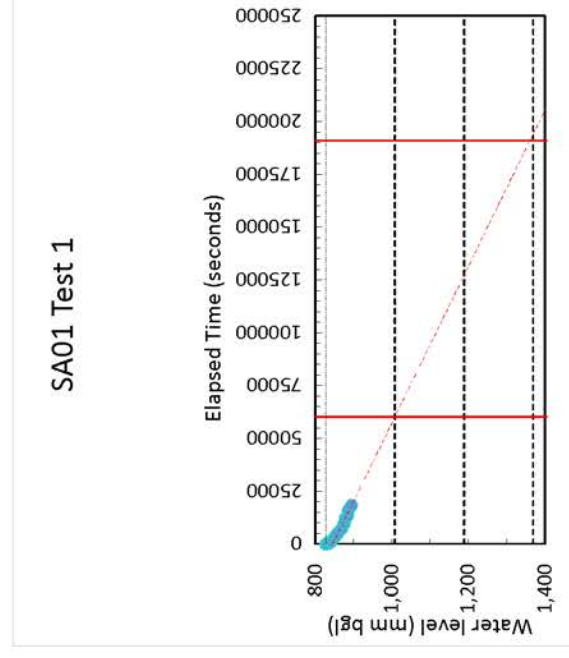
Project Name: Land adjacent B4360, Cobnash Soakaways  
 Project Number: E15194  
 Date of Test: 18/10/2019  
 Test Location: SA01 Test 1

SA01 did not reach TP75 min value during the course of the test (5 hours 6 minutes).

m/s **2.75954E-06**

**Based on extrapolated data. The test did not reach the TP75 point during the duration of the test (5 hours 6 minutes).**

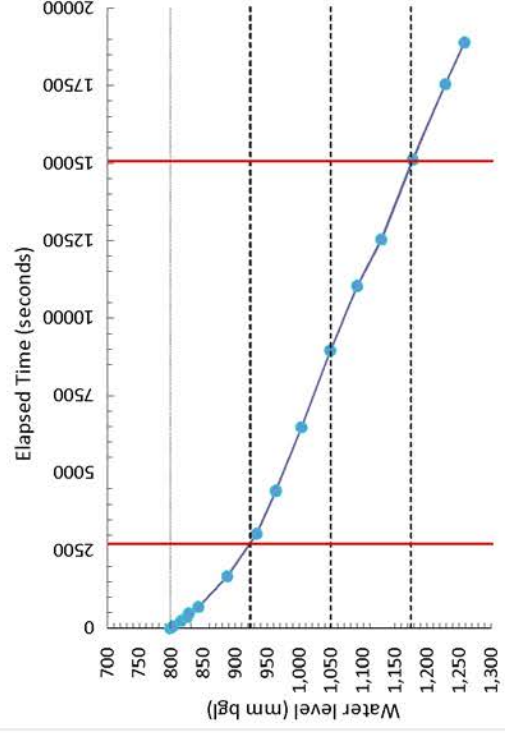
SA02 Test 1

Depth 75% full to 25% full: 251 mm  
Time 75% full to 25% full: 12350 seconds  
 $V_p$  **49 seconds/mm**

m/s **2.03E-05**

Soakaway solutions at the northern boundary of the site are recommended. Consultation with a suitably qualified and experienced drainage engineer is recommended.
