ROSSWYN HOTEL, ROSS-ON-WYE,
HEREFORDSHIRE

INITIAL ECOLOGICAL APPRAISAL AND
BAT INSPECTION

8th January 2015

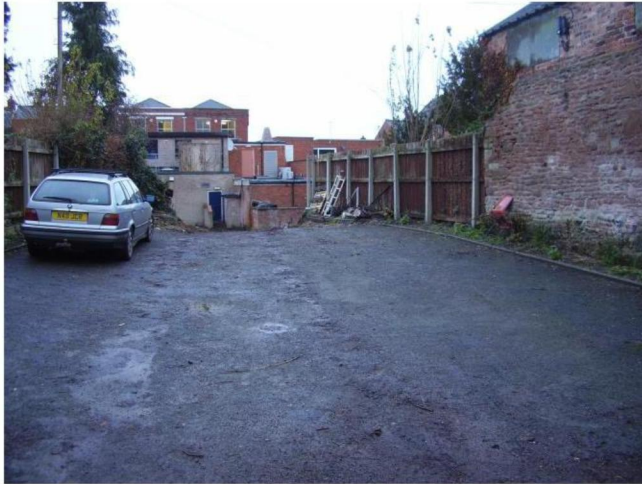
Surfaced parking at entrance

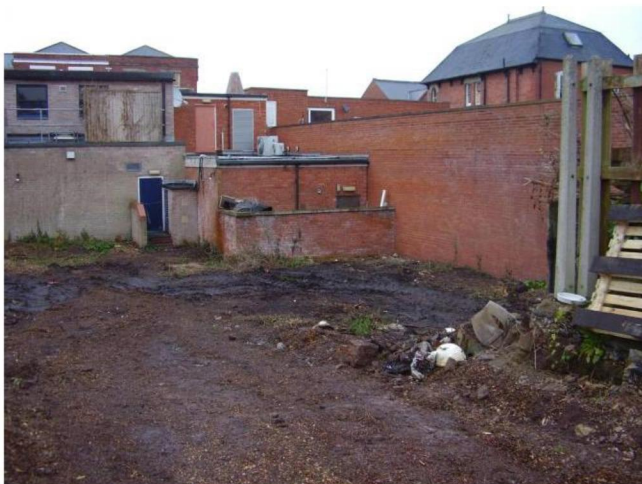
Bare ground after clearance

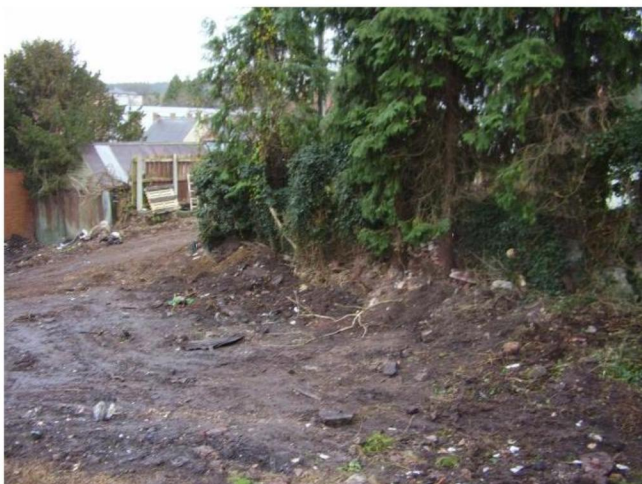
There is no semi-natural habitat on site. The open space has all been either hard-surfaced, or cleared leaving bare earth. There is one small line of four mature Leyland cypress trees on a central site boundary, but no native trees are present.

Leylandii trees on central southern boundary

Birds – The scheme requires clearance of the dense climbing vegetation from over the flat-roof rear extensions, plus felling 4 leylandii trees, where small garden birds are likely to nest during the nesting season. Insensitive timing of this vegetation clearance would allow the potential for unlawful disturbance to nesting birds (eg – if clearance occurred within the March to August nesting season). This is avoided by the precautionary method statement at Section 5 below.

Birds – Conduct the clearance of the climbing vegetation from around the flat-roof extensions, and the tree felling, outside the March to August bird nesting season, eg – clear the trees and vegetation during the period 1st September to the end of February, unless an updated bird survey by a Suitably Qualified Ecologist (SQE) at the time confirms no active nests in affected areas.

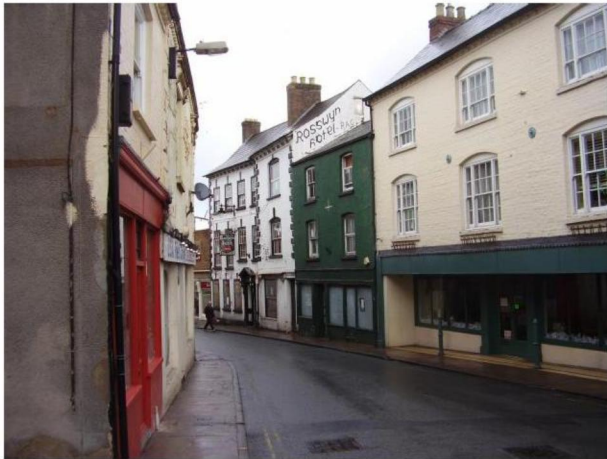
There are a range of building types of mixed ages associated with the site, going back several hundred years. The older ones are on the site's western boundary. These involve brick walls and slate roofs, with bitumen felt. The slates and ridge tiles are all close-fitting, creating negligible bat roosting potential. There are almost no roof voids / attics, since those features have been converted into accommodation in the distant past.

Buildings on western boundary

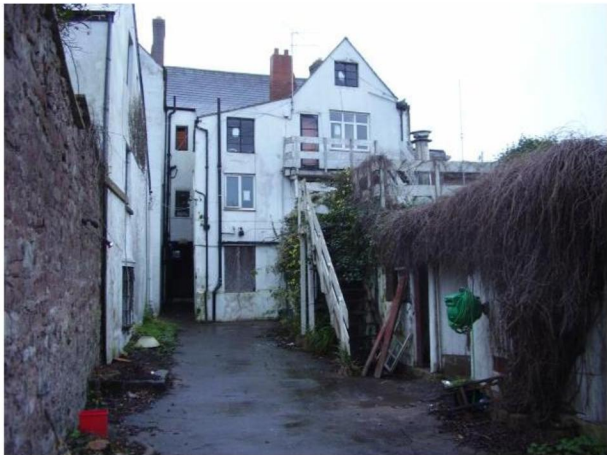
Rear of hotel buildings

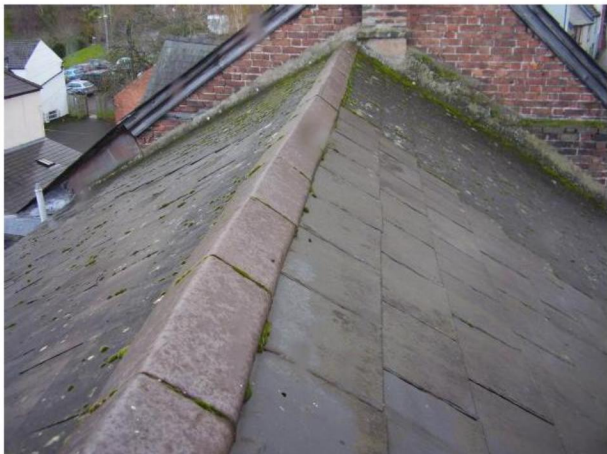
Close-fitting slates

If any re-roofing will include addition of a breathable roof membrane (BRM) or replacement of bitumen felt with a BRM, then the ridge tiles must be closely fixed down or fully cemented, so that no gap wider than 6mm is created beneath ridge tiles. This is because bats must not be encouraged to roost beneath ridge tiles where a BRM is present, since bats' claws get entangled in the BRM leading to death.

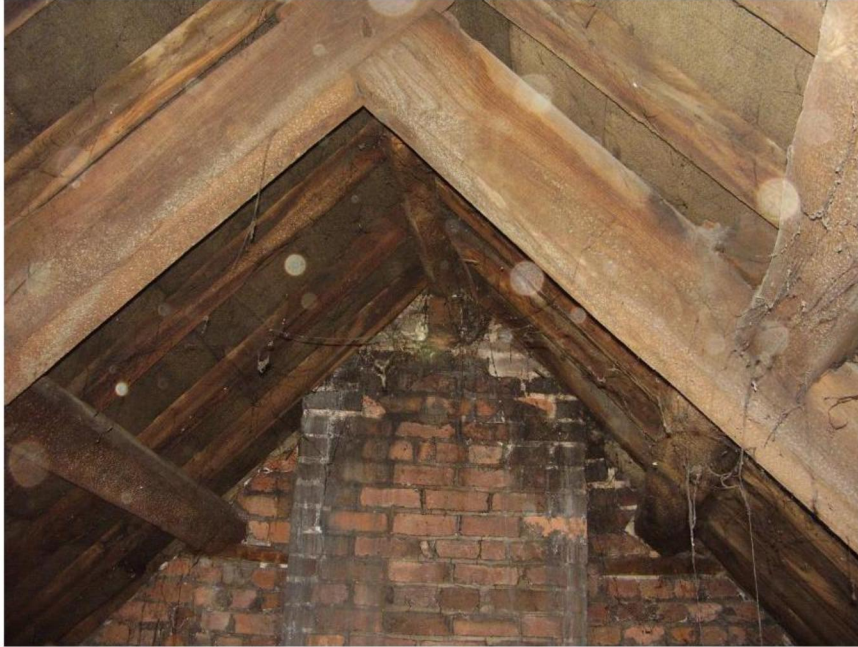
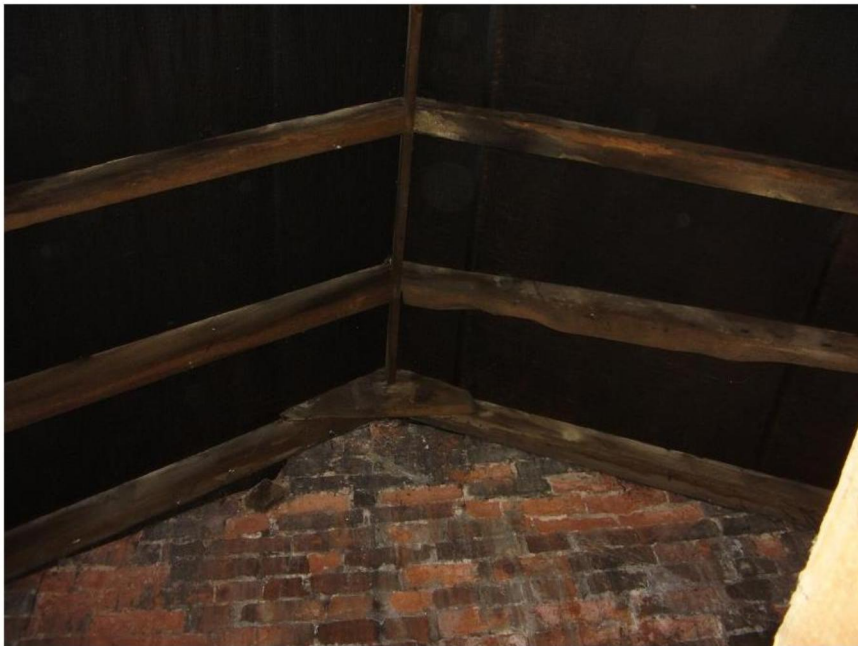
One large attic space is present above the old hotel (overlooking the High Street), and this was seen to be 3m tall, with a roof above of slate and bitumen felt. No 'open' beam mortise joints were found to be associated with the roof structure.

Attic over old hotel

Same attic over old hotel

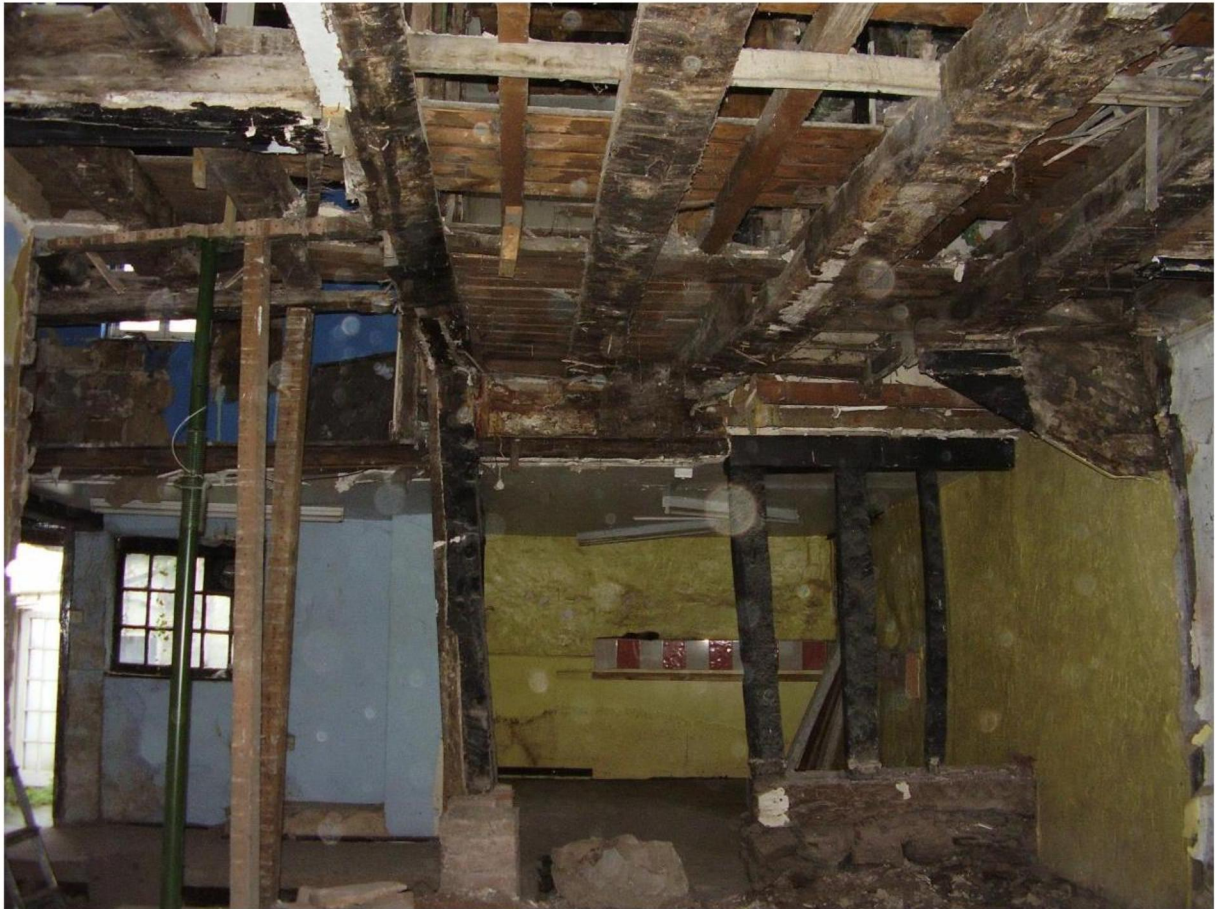
The part of the hotel in the south-western corner of the site is derelict and has been internally stripped out (all floors and ceiling materials removed).

Derelict south-western part of hotel

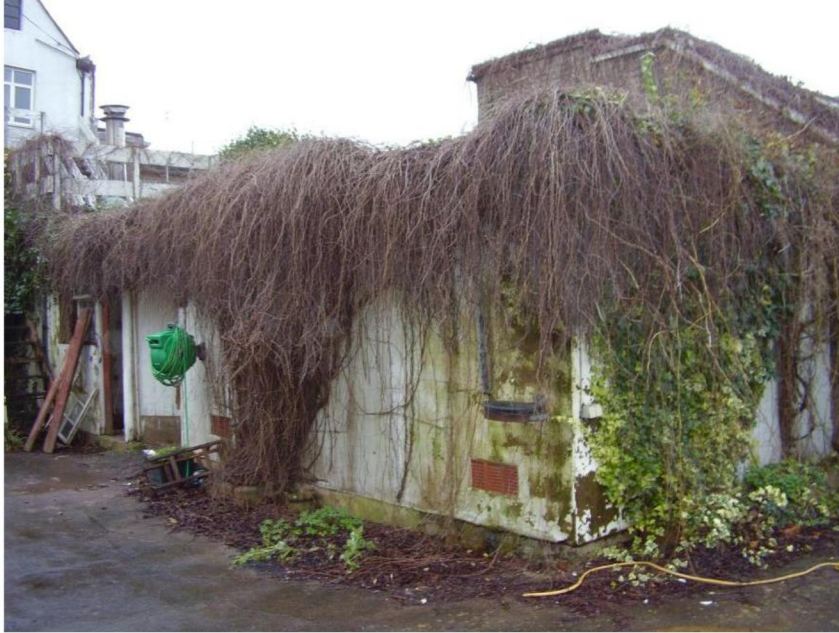
At the rear of the old hotel running eastwards are a series of poor quality single-storey flat-roofed extensions. The flat roofs are bitumen laid over plyboard and softwood beams, all in poor condition and leaking. There is some dense climbing vegetation on these extensions.

Flat-roof extensions

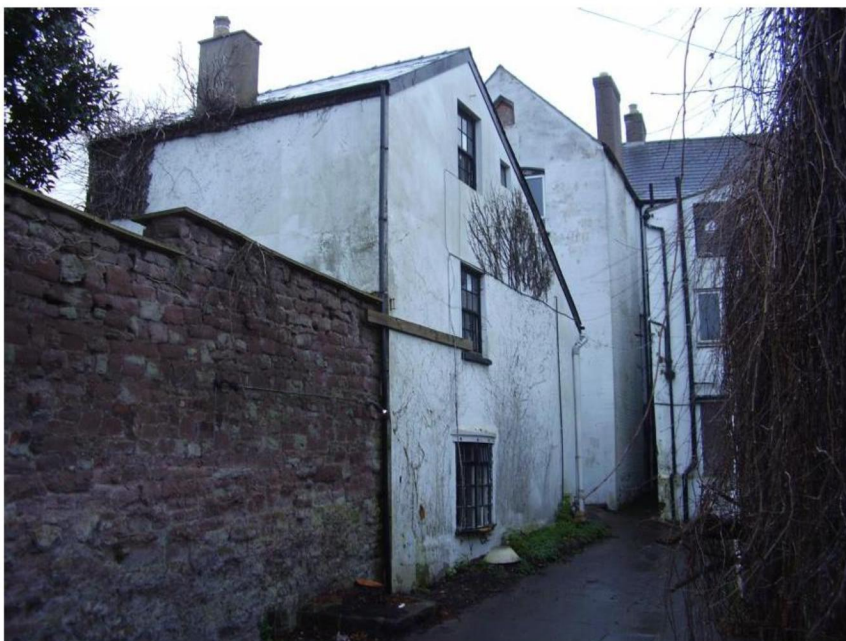
There is also a small 3-storey detached cottage at the rear of the hotel. Part of it has a small mono-slope (lean-to) slate roof that creates a triangular-profile attic, 1.8m tall, with bitumen felt.

Cottage

Bats – The scheme does not involve clearance of any trees with any bat roosting potential, and similarly no buildings with any bat roosting evidence or potential are affected by the proposals. One barge board of the cottage (on the southern wall) was found to offer slight bat roost potential (although no roost evidence), but the cottage is only subject to minor internal renovation and the barge board is unaffected, which therefore provides no potential for impacts to a bat who could roost there in future. There is consequently considered to be no potential for impacts to any bat roost around the site, and so there are no bat roost mitigation requirements or recommendations for further detailed bat survey. However, it is recognised that bat roosting patterns can change in short time frames, new roosts can form at any time, and there are past records of brown long-eared and pipistrelle roosts in central Ross (within 200-300m of the application site), and so some minor precautionary recommendations are made at Section 5 below.

- Erection of a Schwegler 1FF bat box onto the wall-top of the south-facing gable wall of the detached cottage (fixed at around 7m height above ground). This box type is suitable for use by brown long-eared bats and pipistrelles (which both occur locally);
- Erection of 3 'sparrow terrace' nest boxes onto external walls around the site, at 2.5m above the ground, facing into courtyards, to encourage declining sparrow species to nest. Proposed nest/roost box locations are shown in the Enhancement plan below.
