Images of England

IoE Number:	152452
Location:	PORTCULLIS LODGE AND RETAINING WALLS TO FORECOURT OF EASTNOR CASTLE,
	EASTNOR, HEREFORDSHIRE, HEREFORDSHIRE
Photographer:	Mr John Drummond
Date Photographed:	09 October 2002
Date listed:	10 January 1986
Date of last amendment:	10 January 1986
Grade	II

Portcullis Lodge and
Retaining Walls to

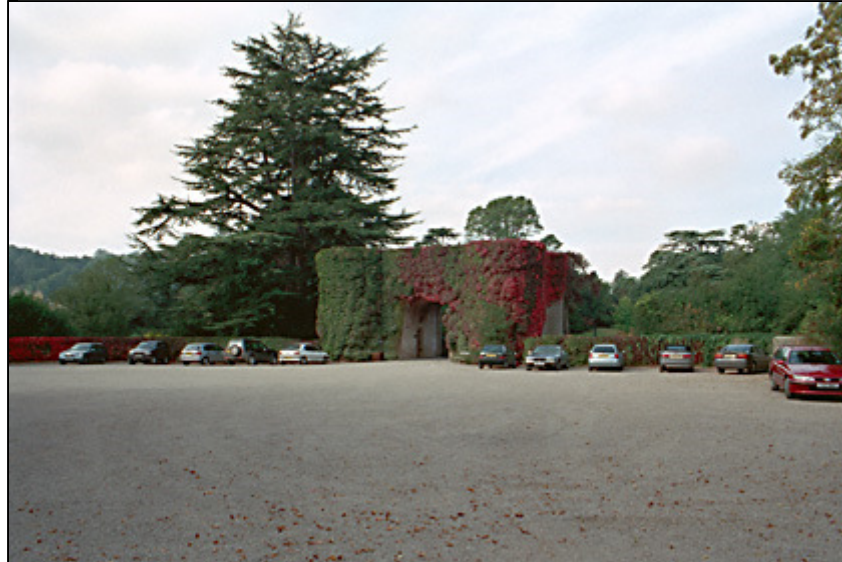
EASTNOR CP EASTNOR SO 73 NW 4/30 Portcullis Lodge and Retaining Walls to Forecourt of Eastnor Castle - GV II Lodge and retaining walls to forecourt. 1815-16 by Robert Smirke. Lodge of coursed squared rubble and freestone dressings; roof concealed behind embattled parapet. Single storey on battered basement. Central pointed archway. 2 stage round corner towers, on battered plinths. On the entrance front tower, narrow slit windows face inwards and round-head windows in deep freestone embrasures face outwards. Chamfered string course and panel of arms in the centre. 2 plank doors in pointed free- stone surrounds on inner side of archway. Flanking the

lodge are tall retaining walls which return towards the castle and enclose the forecourt: coursed rubble with freestone coping and embattled parapet; approximately 6 - 8 m high on the outside and buttressed at north corner.
