**UPDATED BAT SURVEY REPORT FOR THE NURSERY
BUILDING, LANE HEAD FARM, EATON BISHOP,
HEREFORDSHIRE**

30TH MARCH 2011

FOR: CHERRY ORCHARD DEVELOPMENTS LTD,

ARCHITECT: TIM FORD, AXYS DESIGN, 30 GROVE RD,
HEREFORD

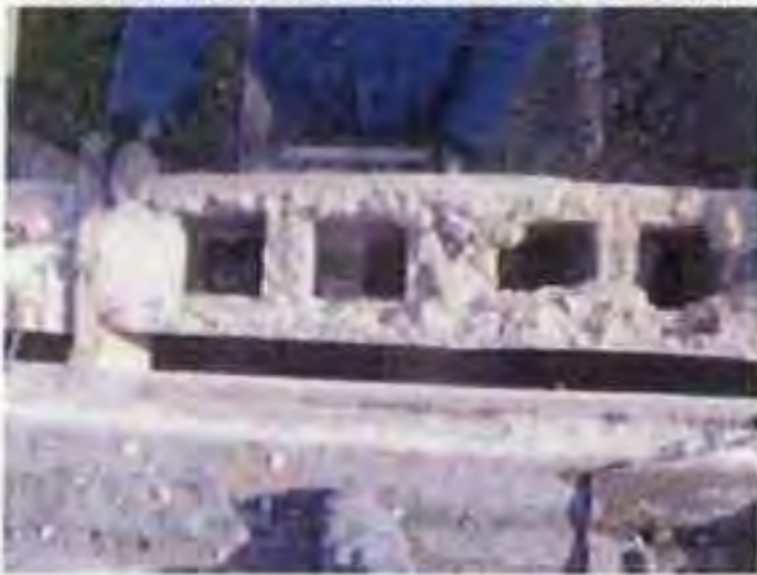
Roost sites in east wall of stable

Bat droppings of two sizes were found in the cavities of the block work on both sides of the stable extension, in greater numbers than originally expected indicating the possibility of a larger roost site. They also were located in the middle of the walls, rather than at the outside edges, with droppings falling into the cavities. There was little evidence of where the access points into these roost sites were.

Yellow marks show location of blocks with droppings

The builders then covered the block work with sterling board to retain roost sites undisturbed.

The walls of the northern stable extension have been marked in yellow paint to indicate roost sites and possible access points.

- a) Retention of existing access points. Access into these cavities from under the weather-boarding and through the battens, builders paper, boarding will be created by forming a timber tunnel leading to blockwork. This will provide a 25 mm high by 100 mm wide tunnel,

sloping up from under the board edge. Two will be needed on each wall in locations to be agreed with builders on site.

- b) The blockwork above will need to be cut to accommodate the tunnels, and then continued up to the top of the wall in such a way that the vertical cavity is continuous down to the existing roosting block. Block work with holes through must be used in this section of the walls. Access under the eaves needs to be constructed in a similar way, but also to give access into the small roof void above the single storey extension. Access into the tunnel will be from behind the barge/soffit boards.

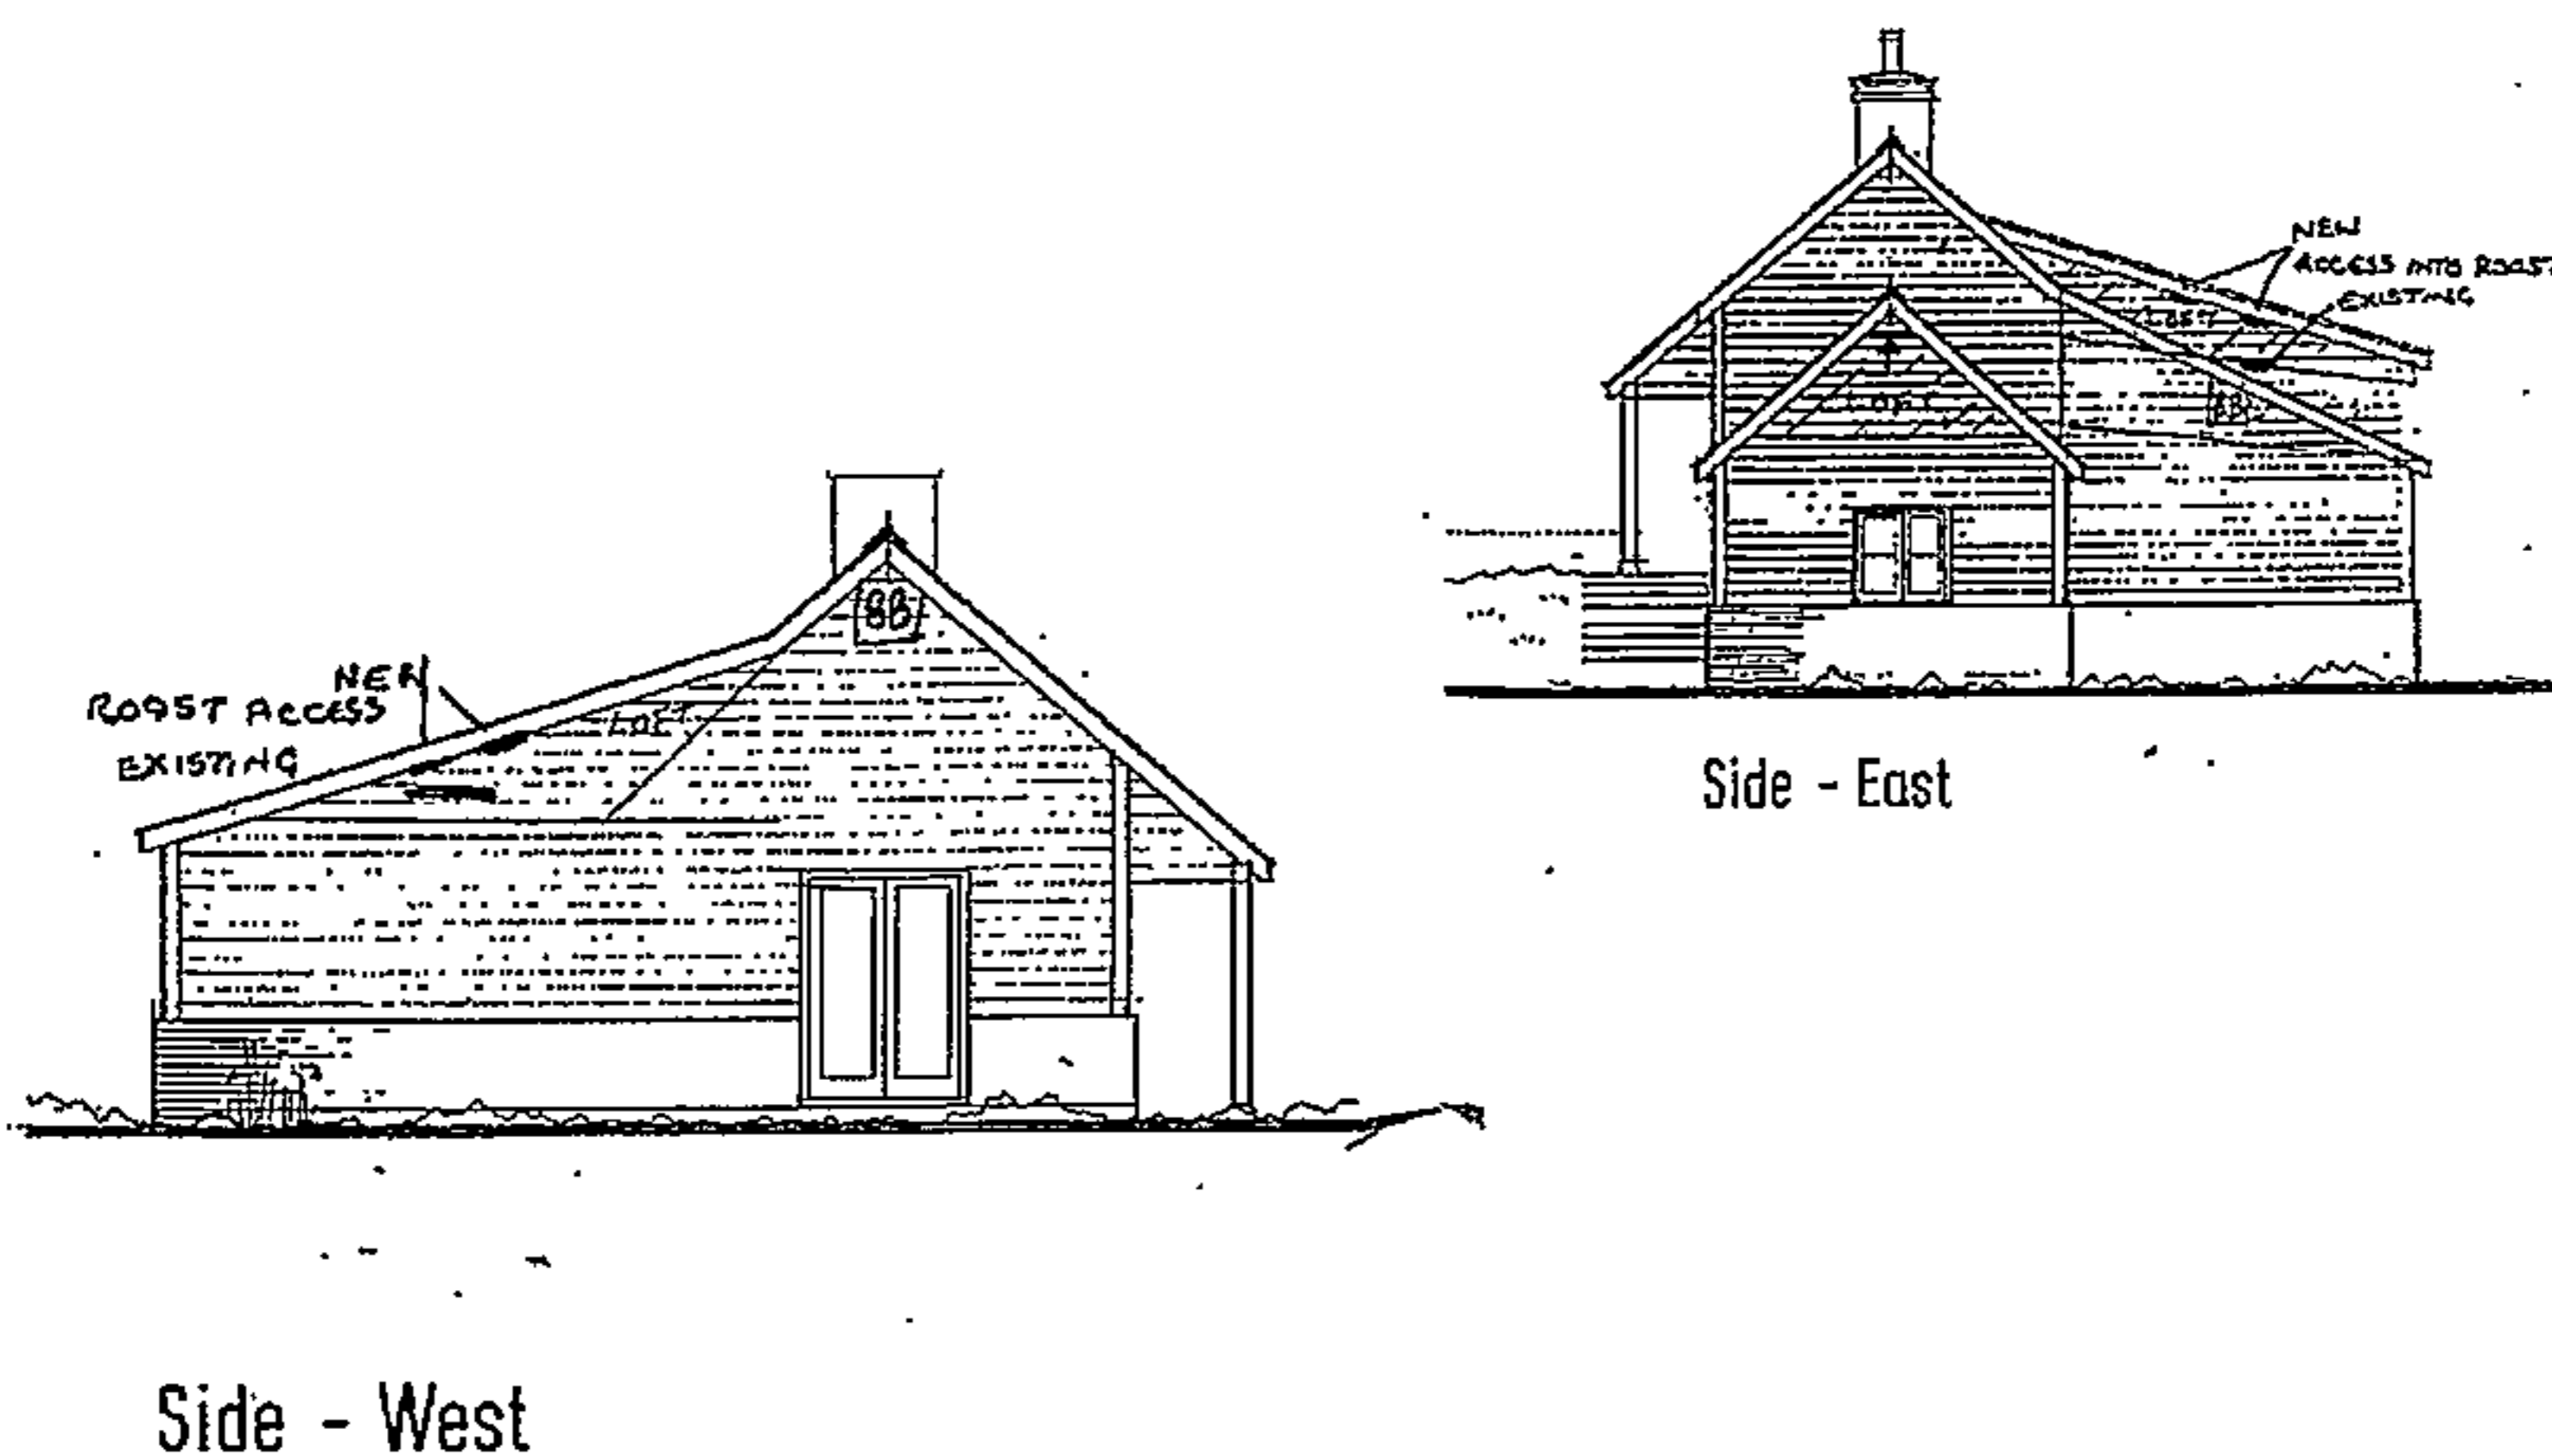
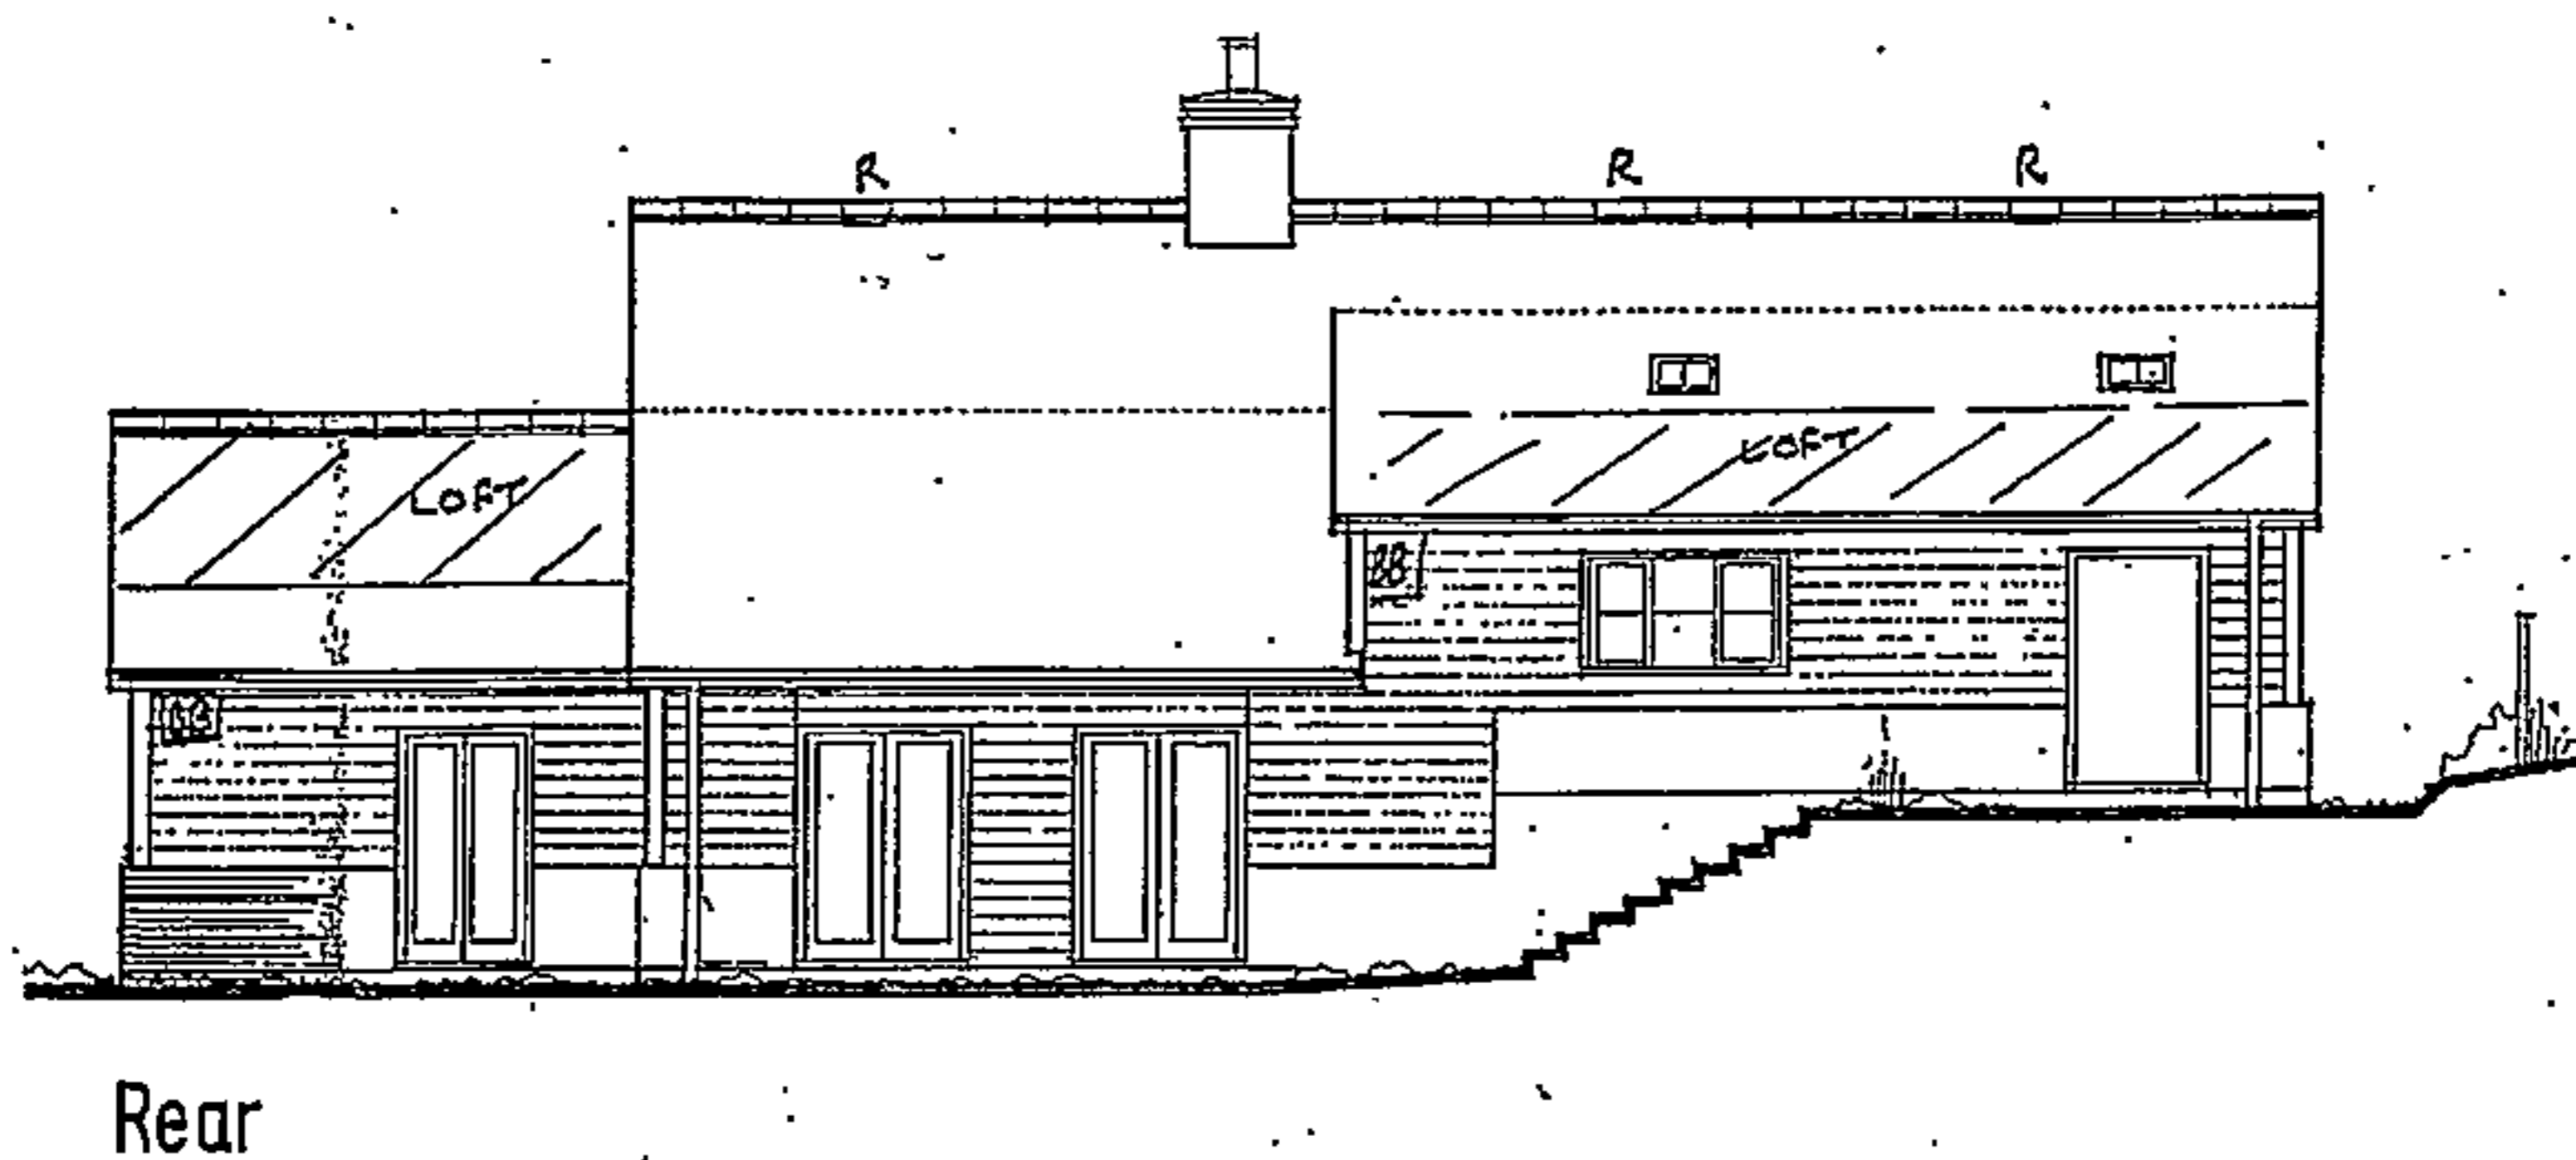
PLAN 1: LANE HEAD FARM BARN SHOWING BAT ROOST PROVISION

R = Raised ridge tile

BB = built in bat box

- o Four built in bat boxes between the weather boarding and breeze block inner wall with access at the eaves.
These will be constructed under the weather-boarding within the space created by the battens and cross battens, and access into them created under the boarding of 25 mm x 100 mm. Bitumen felt will be used to line the rear of the box, over the builders paper. (Location as shown on plan)
- o There will be a small loft space above the eastern section of the building (over bedroom 2). Access into this area will be via a larger slot at the gable apex, under the boards of 50 mm by 150 mm, sloping and lined with Perspex or lead to deter birds from accessing the space. Wooden bat boxes will be created within this area.
- o Two woodcrete bat boxes (1FF) will be installed inside the free standing garage.
- o Raised ridge tiles will also be included at three points along the roof.
